## **Proposed Redevelopment Abel Tasman Village, Chester Hill NSW**

Geotechnical Investigation

Our ref: 6851-G1  
20 May 2022

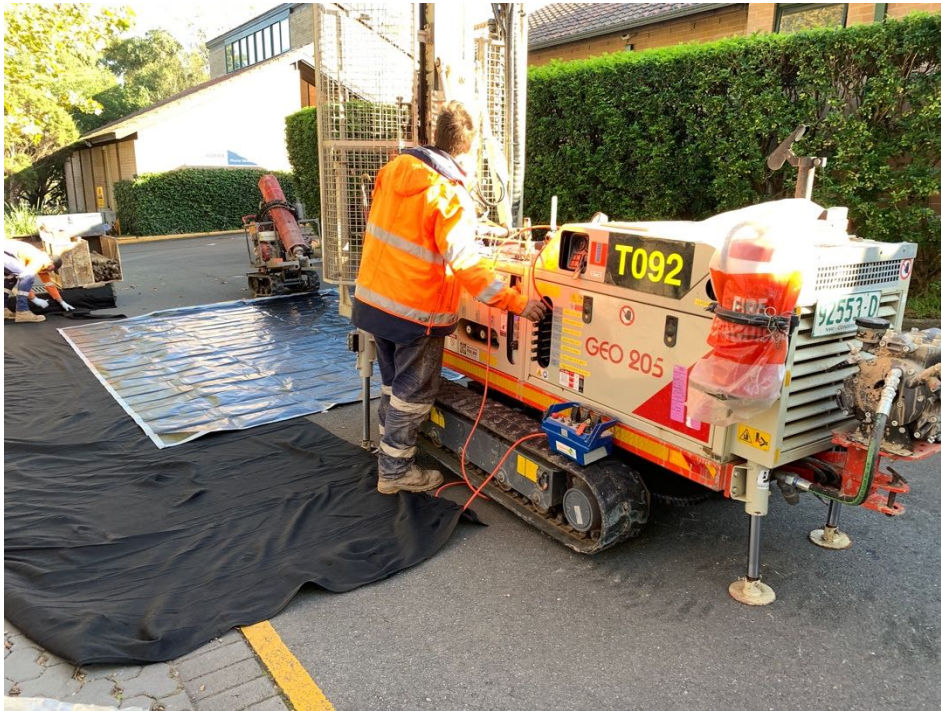
**Photo 1**  
Borehole  
investigation at  
BH101 location
