Certificate of Analysis

Report 291280-S
 Client Reference GEOTLCOV24207AB
 Received Date Feb 22, 2011

| approved | VN | | project: | BLACKTOWN HOSPITAL – ADDITIONAL SITE INVESTIGATION | | |

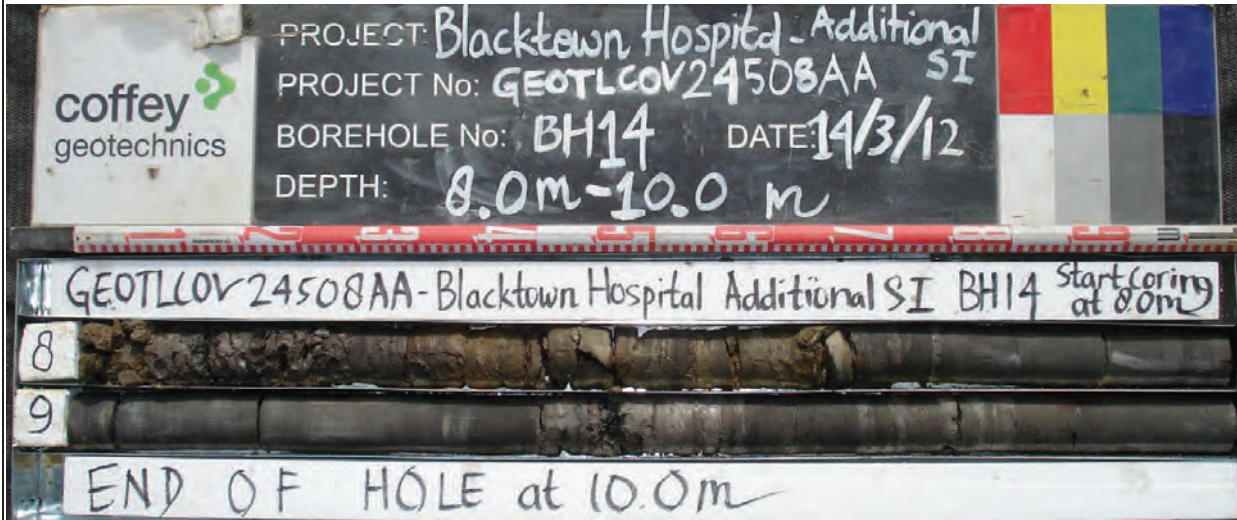
| drilling information | | | | material substance | | | | | | | |
|---|---|---|---|---|---|---|--|---|---|---|---|
| | | | SPT 5,9,13 N*=22 | 57 | 2 | CH | Silty CLAY : high plasticity, pale grey/orange brown, traces of iron oxide staining with some medium ironstone gravel | | H | 530 520 | |
| ADT | | None encountered | | 55 | 3 | | SHALE : grey/orange brown, extremely weathered, very low strength, iron stained, remoulds to clay | | | 550 510 | XW SHALE SPT hammer bouncing |

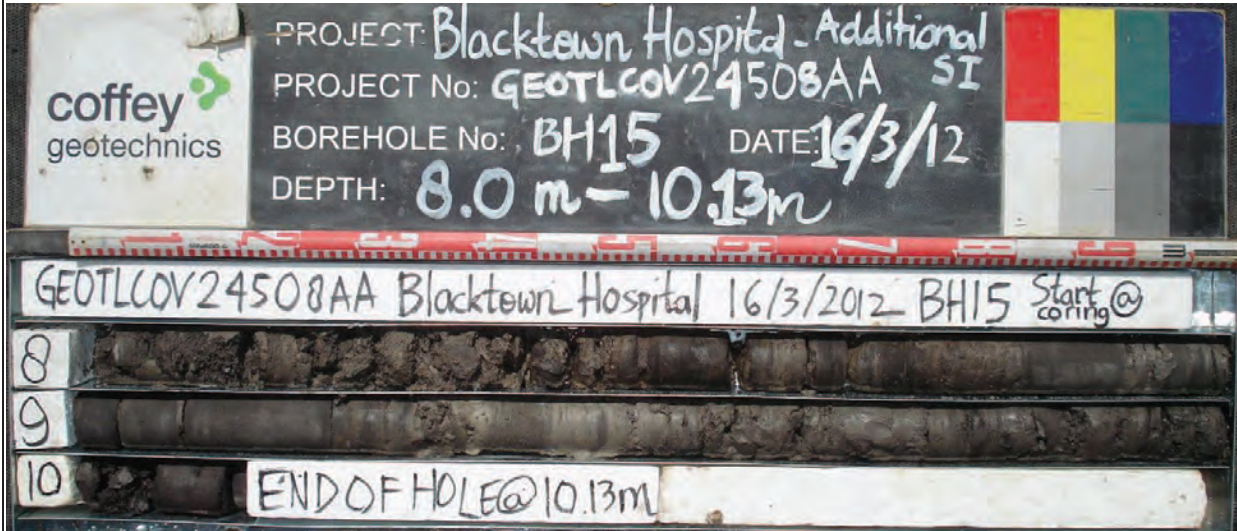
| drilling information | | | | material substance | | | | | | | |
|---|---|---|---|---|---|---|---|---|---|---|---|
| ADV | | | | 58 | | CH | TOPSOIL : Sandy CLAY low plasticity, dark brown with some grass rootlets CLAY : high plasticity, brown to orange brown/pale grey, iron stained | M >Wp | St | | TOPSOIL RESIDUAL SOIL |
| | | | | 56 | | | SHALE : pale grey/red brown, extremely weathered to highly weathered, very low strength, with some iron staining, remoulds to clay | | | | XW SHALE |
| | | | SPT 10,21 N*=R | 54 | | | becoming dark grey with some iron staining, extremely weathered, very low strength, remoulds to clay | | | | hammer bouncing |

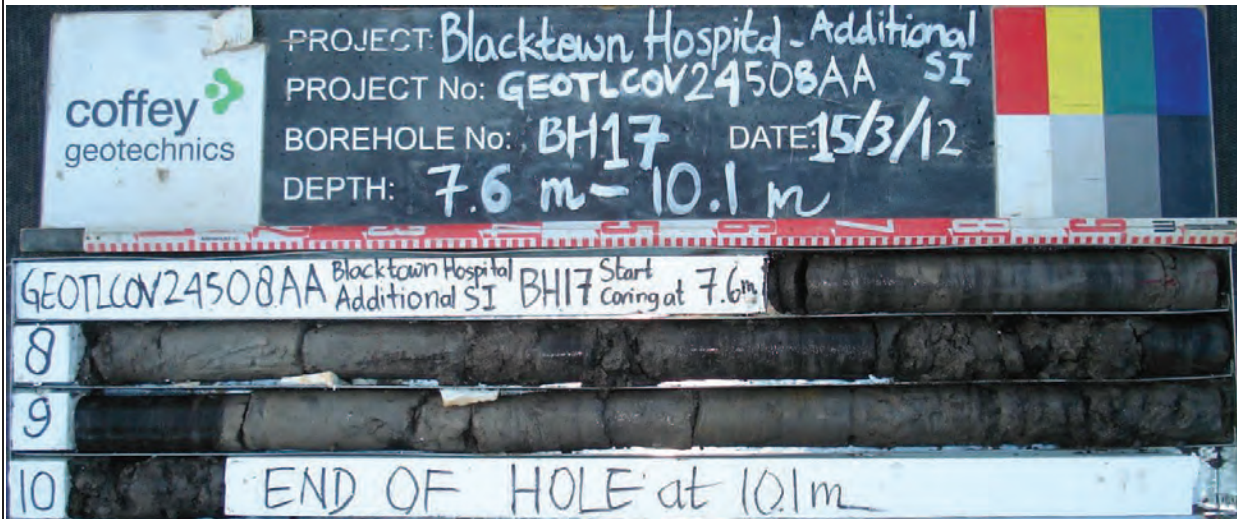
Rock is extremely weathered with soil properties
