Bank Street Park
Blackwattle Bay / Tjerruing

# 1A to 19 Bank Street, Pyrmont

Final Statement of Heritage Impact for Bank Street Park SSDA

Prepared by GML Heritage for Infrastructure NSW

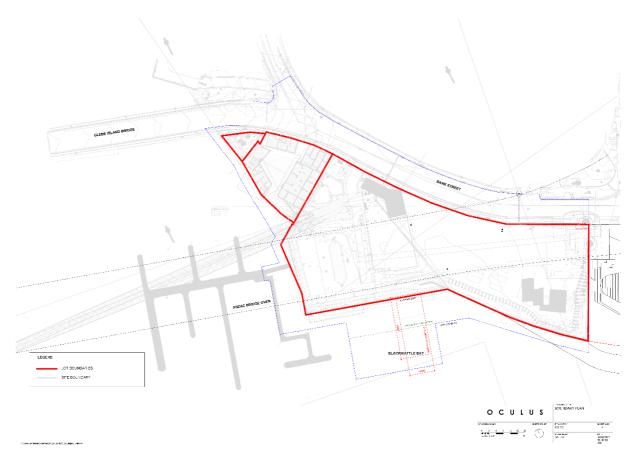
Figure 2.5 The boundary plan for the proposed Bank Street Park. Red indicates the lot boundaries boundary and blue indicates the site boundary. (Source: Oculus 2023)

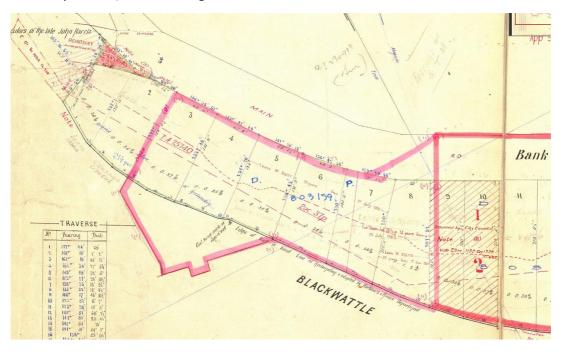
Figure 2.6 Detail of Harris's 1895 subdivision, showing lots 1–10. (Source: NSW Lands Registry Services, Historical Lands Records Viewer [DP3176])

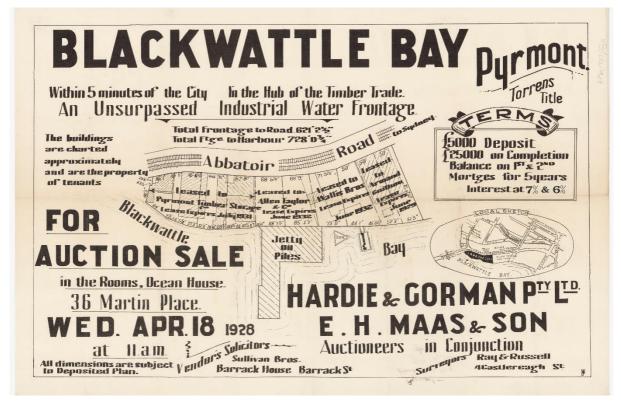
Figure 2.9 Harris's 1928 Blackwattle Bay subdivision sale, showing the businesses leasing the land at the time of sale. (Source: SLNSW [c041010038])

In 1928, Albert Octavius Harris placed lots 1–10 up for sale as one site. On the poster for the sale were details of the current lessees and the end dates of their leases, as well as the footprints of the various buildings on the site. From north to south, this was the Pyrmont Timber Storage Co, Allen Taylor and Co, Wallis Brothers, and Armand Guillhou (Figure 2.9). A large jetty on piles was show in front of the Allen Taylor and Co lease, with a smaller punt and crane in front of the Wallis Brothers land.

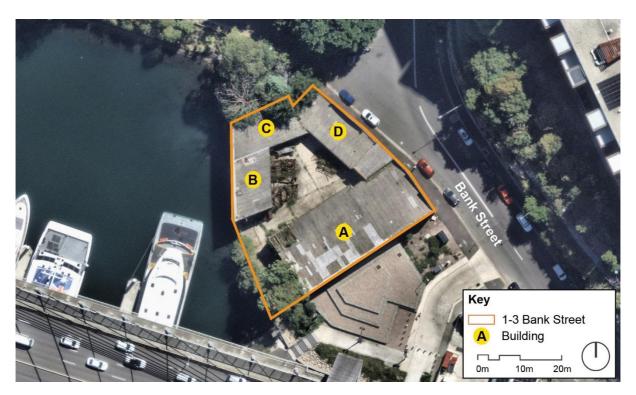
Figure 2.17 An overview of 1-3 Bank Street, showing the buildings in the site. (Source: Nearmap with GML overlay)

1–3 Bank Street is a building group comprising four brick buildings on an irregular shaped site in the northern part of the proposed Bank Street Park. The site is bordered by 1A Bank Street to the north, Bank Street to the east, the Blackwattle Bay Marina site to the south and Blackwattle Bay to the west. Refer to Figure 2.17 for a breakdown of the buildings on the site.

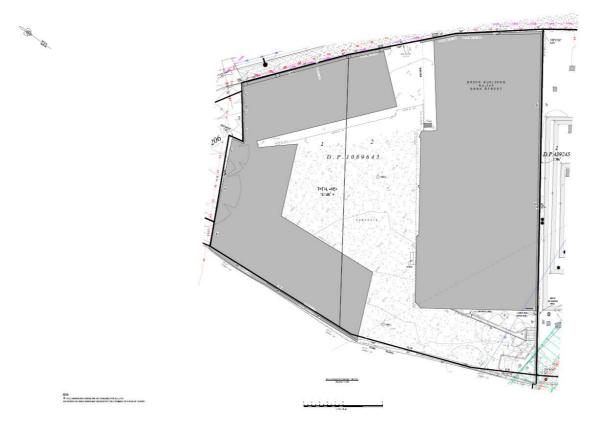
Figure 2.18 Survey plan of the built form at 1–3 Bank Street. (Source: Craig & Rhodes 2023)

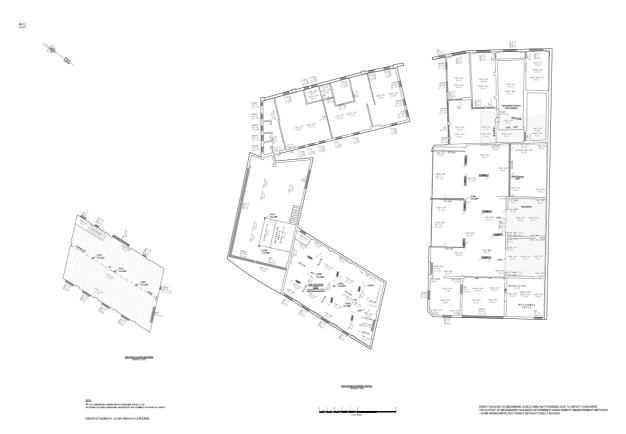
Figure 2.19 Survey plan of the interiors of the buildings at 1–3 Bank Street. (Source: Craig & Rhodes 2023)

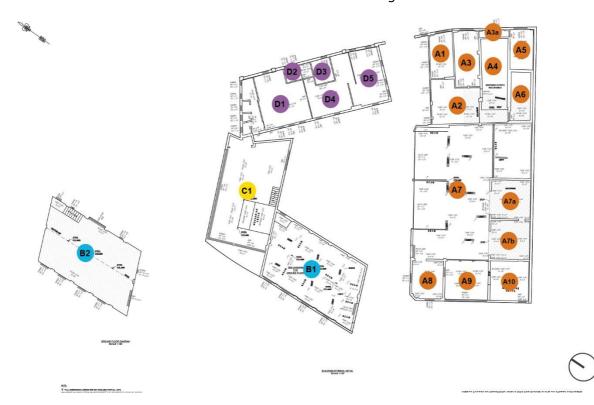
Figure 2.20 A breakdown of the interior rooms of the buildings at 1–3 Bank Street. (Source: Craig & Rhodes 2023 with GML overlay)

GML inspected the interiors of buildings A to D as part of a site inspection to inform an analysis of the intactness of the building group. The following table provides a room-by-room breakdown of what original or early fabric remains in the buildings. Refer to Figure 2.20 for a breakdown of the interior rooms of the buildings at 1–3 Bank Street.

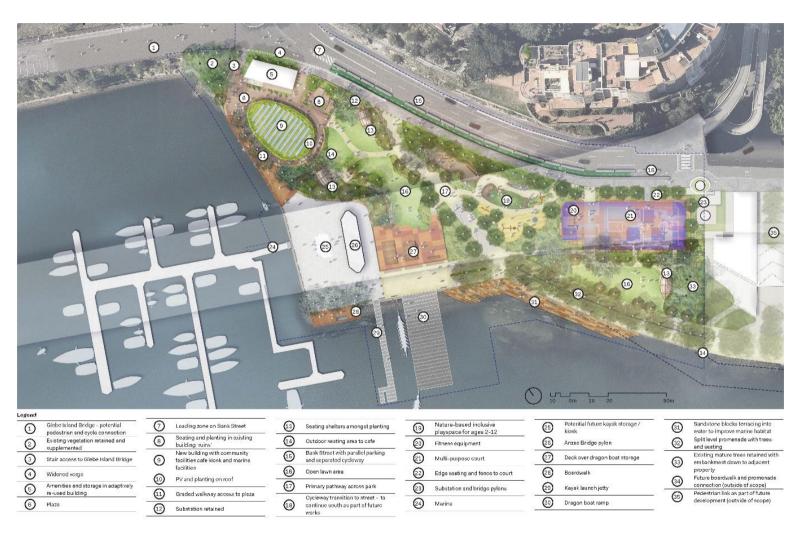
Figure 4.1 Preferred concept plan, Bank Street Park. (Source: Oculus 2023)

The preferred concept design for Bank Street Park has been developed by the design team lead by Oculus. Refer to Figure 4.1. It includes:

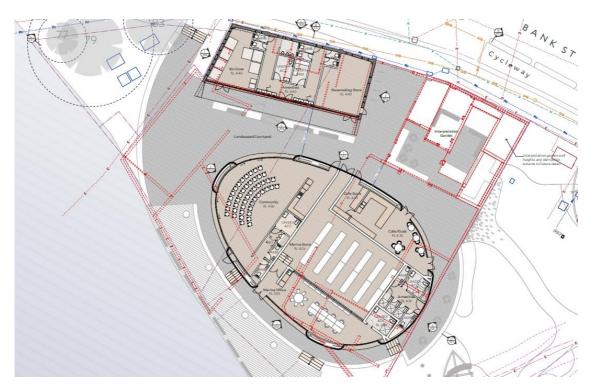
Figure 4.2 Detail of the proposed plan for works to 1-3 Bank Street showing the demolition of the buildings. (Source: Collins and Turner 2023)

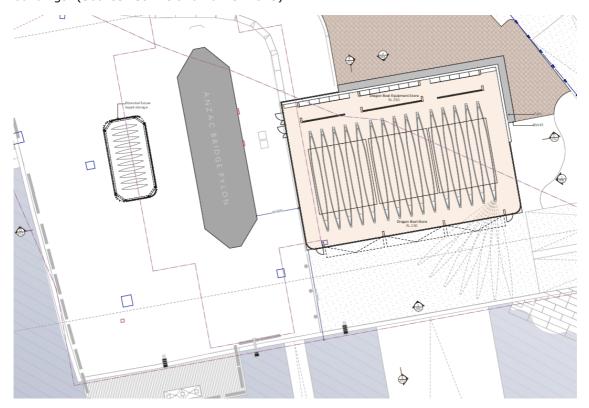
Figure 4.3 Detail of the planned dragon boat storage facility near the eastern pylon of Anzac Bridge. (Source: Collins and Turner 2023)

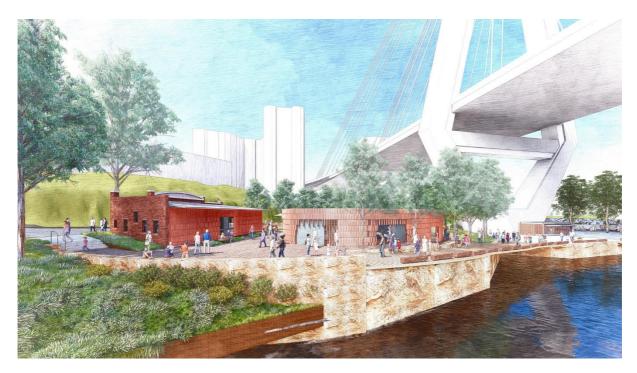
Figure 4.4 An indicative render of the design for 1–3 Bank Street in the proposed Bank Street Park. (Source: Oculus 2023)

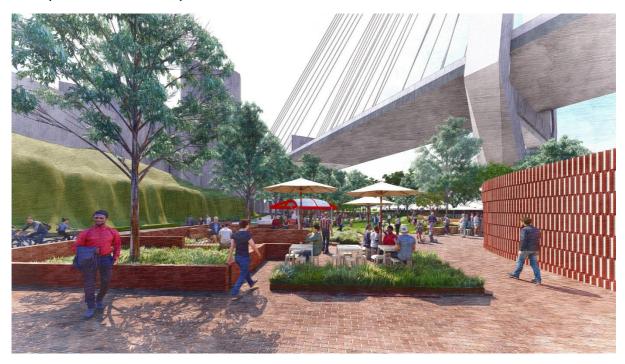
Figure 4.5 An indicative render of the Interpretation Garden of Building A's north rooms (Source: Oculus 2023)

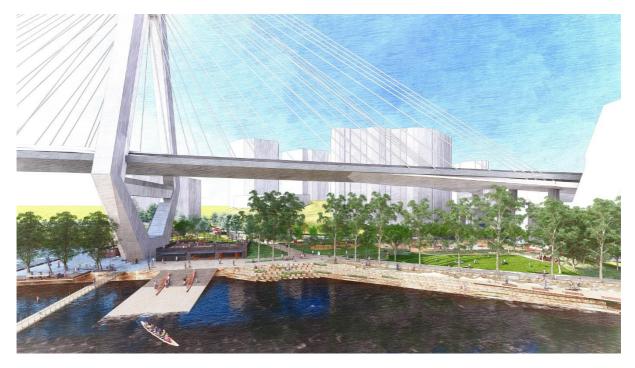
Figure 4.6 An indicative render overview of the rest of the site, showing the dragon boat storage building and sandstone block terrace seawall. (Source: Oculus 2023)

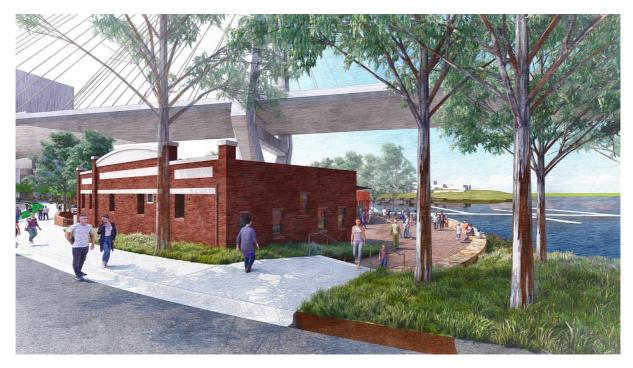
Figure 4.11 An indicative render of the park from View 5—Bank Street, showing the adaptively reused Building D. (Source: Oculus 2023)

Refer to Figure 4.7, Figure 4.8, Figure 4.9, Figure 4.10, Figure 4.11 and Figure 4.12 below for a photomontage of the proposal from key locations within Blackwattle Bay.

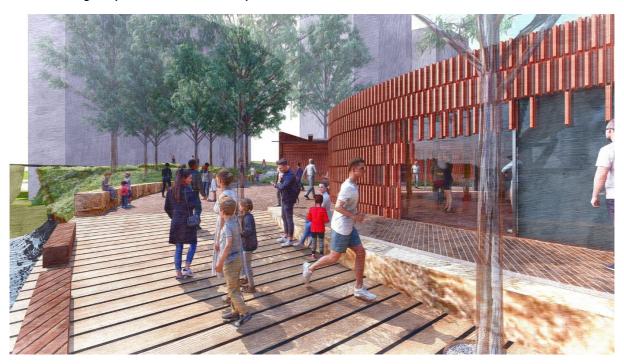
Figure 4.12 An indicative render of site from View 6—the internal courtyard of 1–3 Bank Street. (Source: Oculus 2023).

Internal views of the site will be lost by the demolition of Buildings A, B and C, resulting in impacts to the ability to interpret the site as a former maritime industrial complex. Refer to view 6 (Figure 4.12).	
	This is partially mitigated by the retention of Building D and the use of the truncated walls of Building A's northernmost rooms to create an Interpretation Garden. While views are contributory to the interpretability of the site as a maritime industrial complex, the significance of the site is primarily derived from its historical use, association and rarity.	
	Alteration to the setting of $1-3$ Bank Street will have a neutral impact.	
	The proposal will have a moderate adverse impact on the setting, views and vistas of $1-3$ Bank Street.	
	The impact is partially mitigated by the re-use of Building D and integration of Building A elements into an Interpretation Garden.
