## DILAPIDATION REPORT

**45 – 57 Moxon Road, Punchbowl 2196**

| Document Verification | |
|---|---|
| Description | Condition report of retaining wall and existing property adjacent to new proposed lot. |

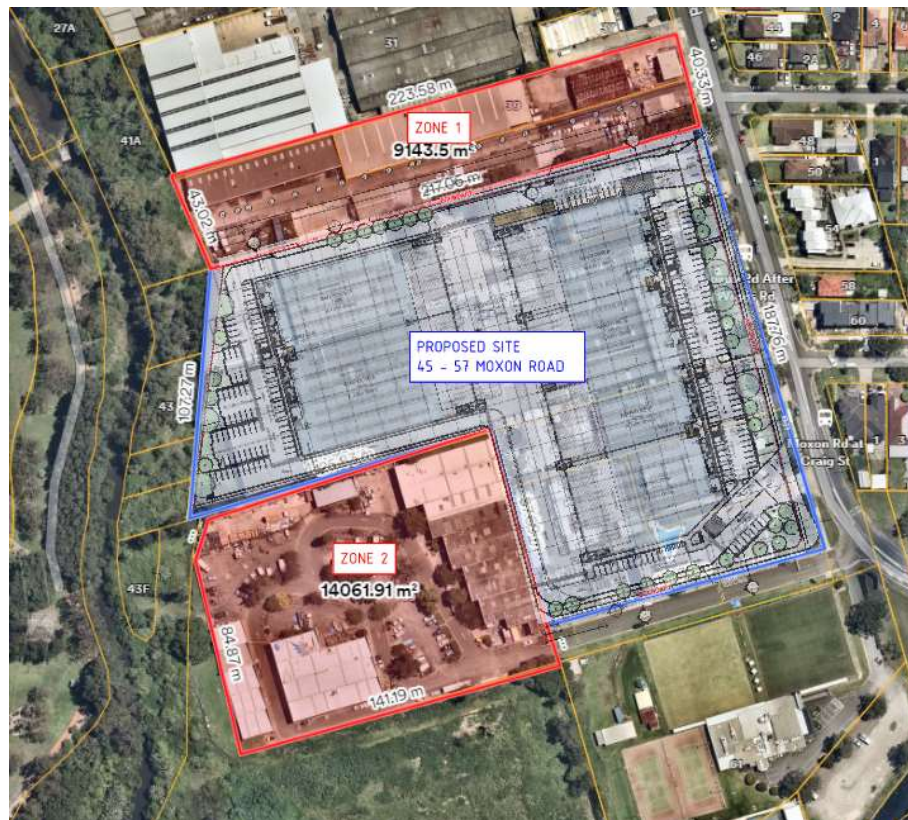
*Image 1: Areas inspected (marked in red) with proposed site (marked in blue)*

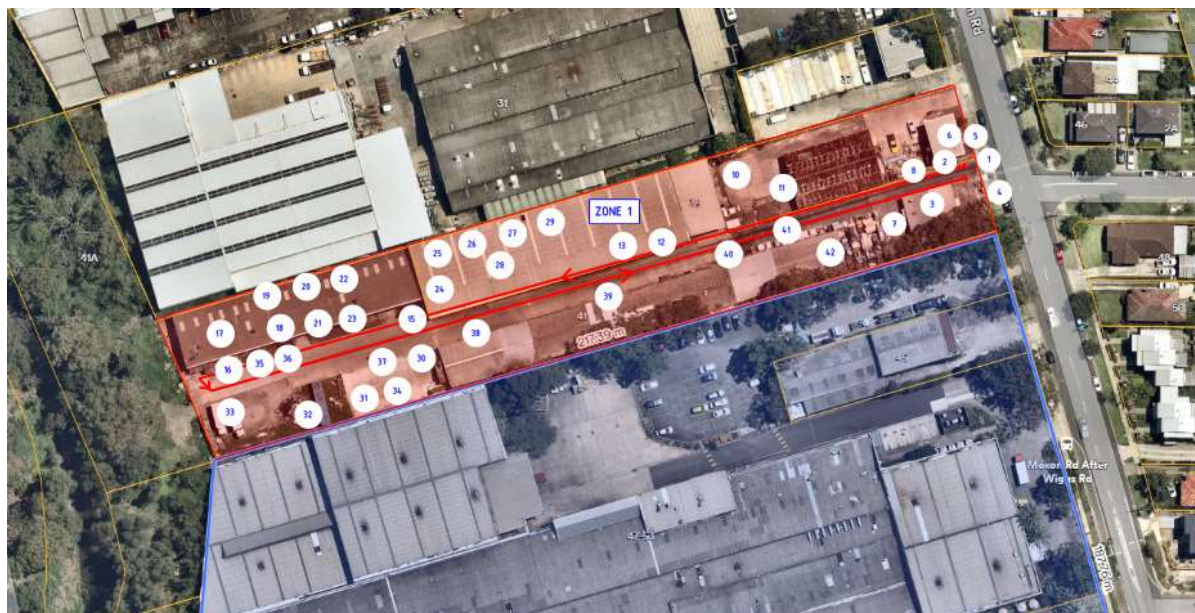
Image 3: Dilapidation survey for Zone 1

Numbers indicated on Image 3 references the location and subsequent photos taken as part of the dilapidation survey. These have been referenced in the table below:

Zone 1, located to the north of the proposed lot consists of a stand-alone residential house, a few steel sheds and 2 warehouses with offices attached. Costin Roe Consulting was allowed to inspect the interiors of both warehouses whereas the steel sheds were shut at the time of inspection. The buildings located on site generally appear to be in good condition. However, the internal access road, made of asphalt appears to be in poor condition with potholes sighted. The concrete hardstand located to the west of the property appears to be in poor condition with cracks and significant spalling spotted.

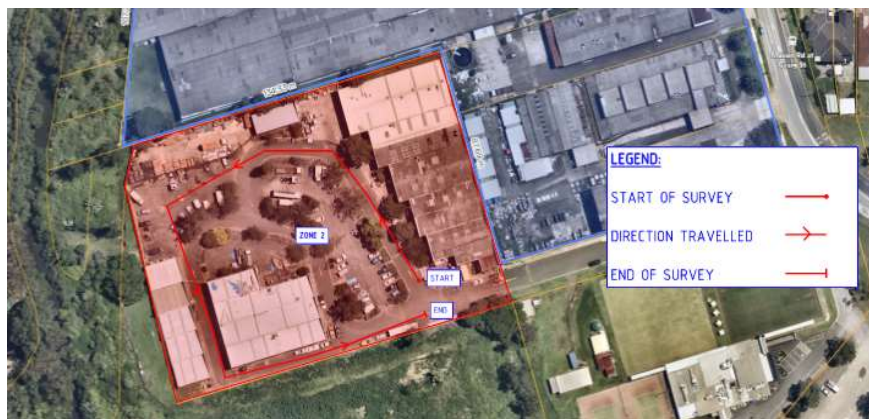
Inspection for Zone 2 involved walking from start to end as shown on Image 4.

Image 4: Direction for dilapidation survey for Zone 2

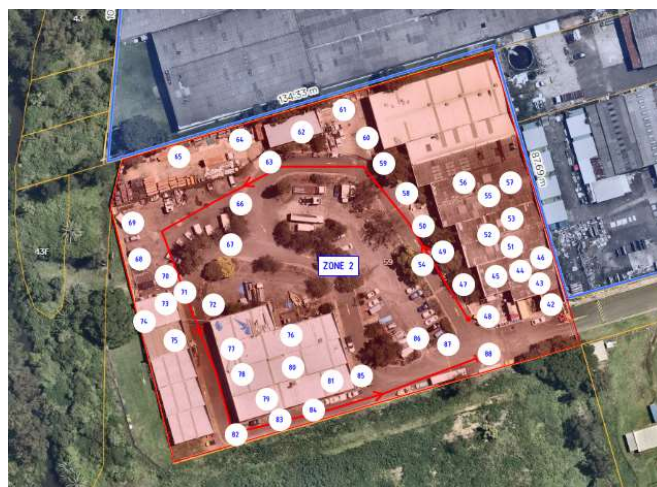
Image 5: Dilapidation survey for Zone 2

Numbers indicated on Image 5 references the location and subsequent photos taken as part of the dilapidation survey. These have been documented in the table below (refer next page):

Zone 2 is similar to Zone 1, consisting of a series of warehouses with attached offices and a vehicle parking lot in the middle of the site. The buildings located on site generally appear to be in good condition. The internal access road, made of asphalt, is generally observed to be in good condition. However, a pedestrian footpath running parallel to the access road within the property appears to be in poor condition with major cracks spotted.

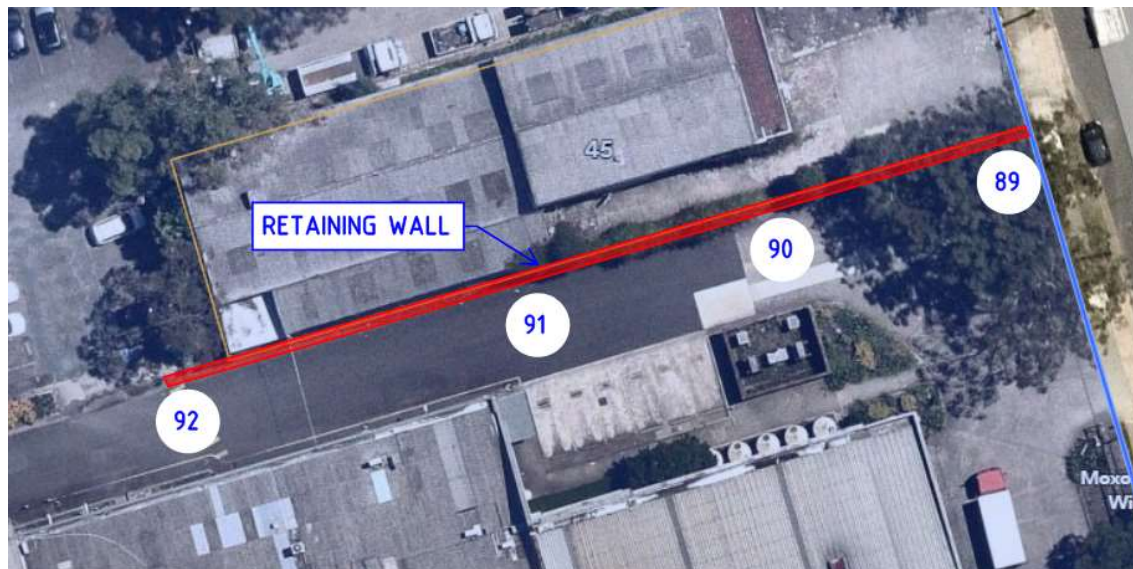
Inspection for Zone 3 involved walking from start to end of the retaining wall as shown on Image 6.

Image 6: Dilapidation survey for Zone 3

Zone 3 consists of a retaining wall ranging from 0 m to approximately 1.8 m high at the other end. This wall spans roughly 50 m and is located within the proposed lot. This retaining wall is constructed with 190 mm wide core filled block walls. The wall generally appears to be in good condition at the time of inspection.
