## GEOTECHNICAL INVESTIGATION: NEW 11-FLOOR BUILDING AT LISMORE BASE HOSPITAL

Uralba Street, Lismore

New South Wales Health Infrastructure

GEOTALST01618AN-AF  
8 March 2012

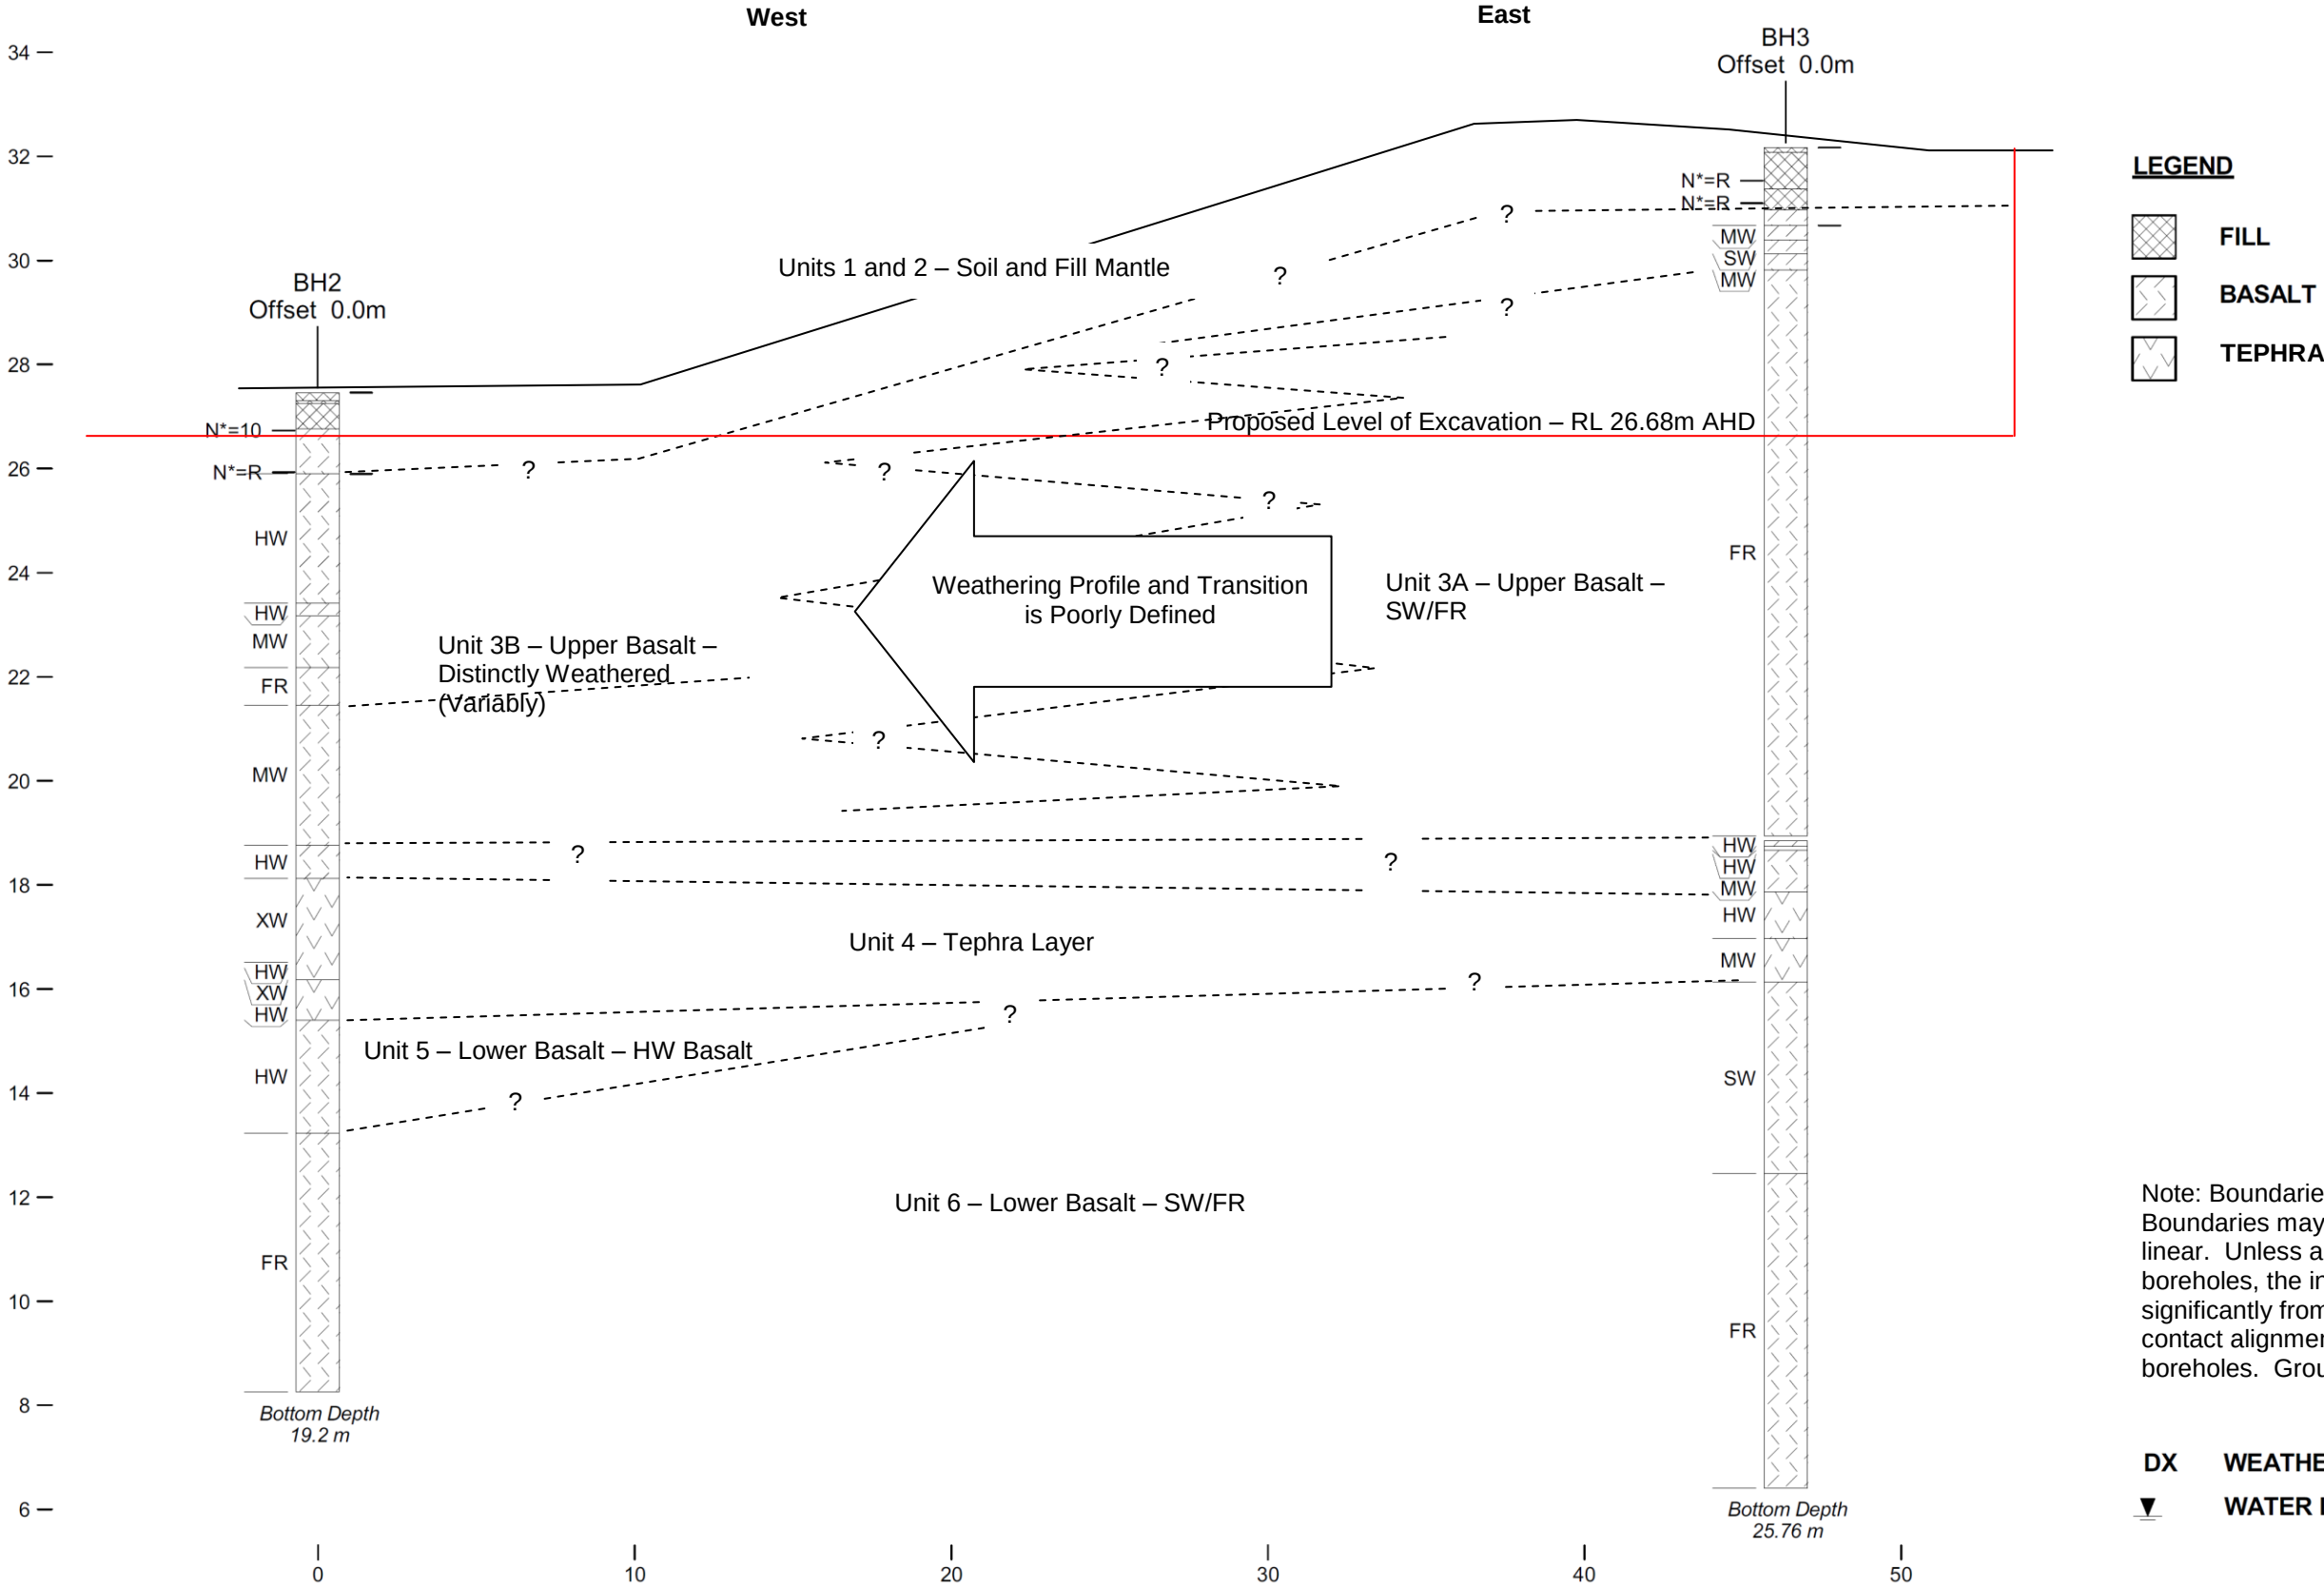
| | | | | | | scale | As Indicated | | project no: | GEOTALST01618AN-AD | figure no: FIGURE 3 |

ALONG SLOPE  
Section B-C

- FILL
- BASALT
- TEPHRA

- Figure 1: Site Plan with Investigation Location
- Figure 2: Geotechnical Cross Section Across Slope
- Figure 3: Geotechnical Cross Section Along Slope
- Figure 4: Core Photographs – BH1
- Figure 5: Core Photographs – BH2
- Figure 6: Core Photographs – BH3
