SSD 5824 MOD 3 and MOD 4 – One Carrington Street Redevelopment

Modification 3

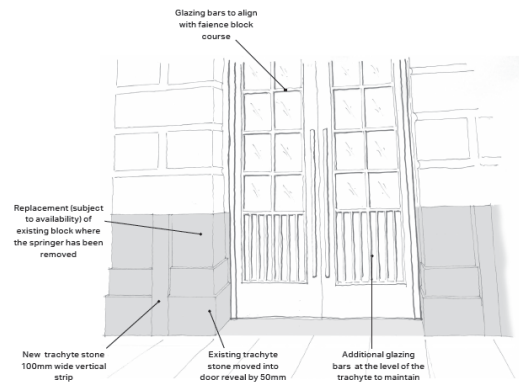
Typical bay with door inset

Typical bay with door inset - trachyte alteration detail

The removal of the steel windows assemblies and the demotion of the wedge shaped trachyte voussoirs that form the base of the building to form door openings will result in the loss of significant fabric and intricate architectural detailing; in addition to the loss of character and loss of character by eroding the strong base of the palazzo design of the building. These elements are key detail elements of the original Spain and Cosh design. The wedge shaped trachyte voussoirs of the base give emphasis to the voussoirs of the faience semicircular arches above and are architecturally mutually dependent. Further, the proportions of the proposed doors are overly vertical and are not representative of the proportions of the façade. The symmetry and balance of the façade is not restored as claimed by the Design Report. It is considered that the opposite results occurs, the façade at the lower levels of the building, becomes asymmetrical in its composition.

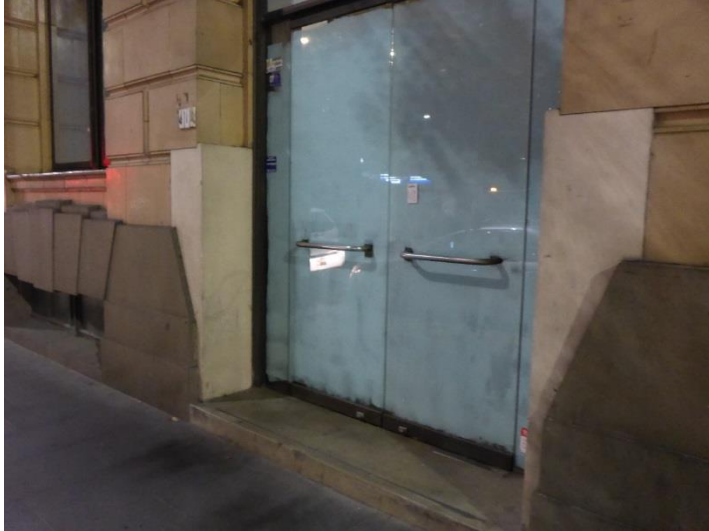
The most southern of the openings in the Carrington Street façade, pictured below, has been previously cut down as a doorway. This clearly shows the visual impact when compared with the image of an intact opening, further below.

Southern most of the openings in the Carrington Street façade.

In addition we reiterate that the previously altered southern ground floor window needs to be redesigned in a sympathetic manner. We request that once the details and amendments requested above are received, that we are given the opportunity to write conditions of consent.

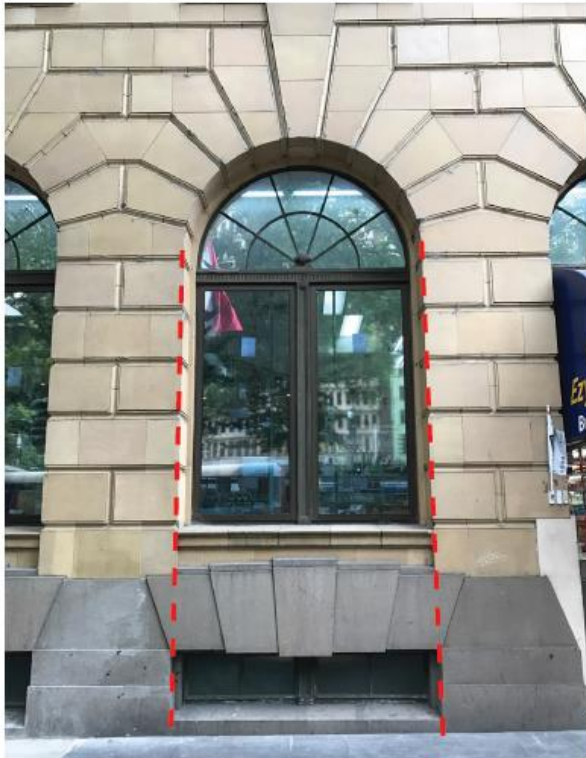
Intact opening.
