# Appendix E

## Plan of Remediation for Each Development Plot & Public Realm

## E1 DEVELOPMENT PLOTS

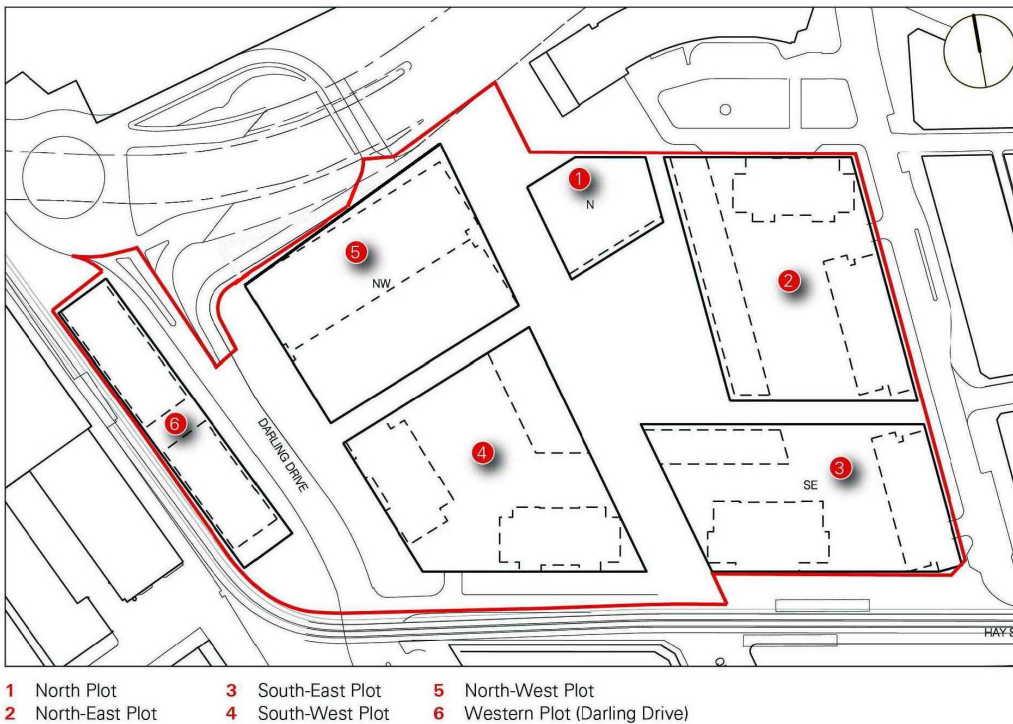
**Figure E1. Proposed Development Plots in Haymarket Precinct**

Lend Lease Development propose to develop the Haymarket Precinct through separate development applications for six (6) Development Plots, and associated portions of the Public Realm. These Development Plots are named according to their plan position within the Haymarket Precinct, as shown on Figure E1. The six Development Plots are:
