<p><b>coffey</b> geotechnics SPECIALISTS MANAGING THE EARTH</p>	client: Lend Lease Development Pty Ltd		
approved			project: SICEEP - International Convention Centre (ICC) Hotel Darling Harbour, Sydney		
date	11/06/2013		title: <b>CORE PHOTOGRAPH BH204A</b>		
scale	N.T.S.		project no: GEOTLCOV24303AH	fig no: <b>FIGURE 11</b>	rev:
original size	A4

## Engineering Log - Borehole

project: **SICEEP - International Convention Centre (ICC) Hotel**

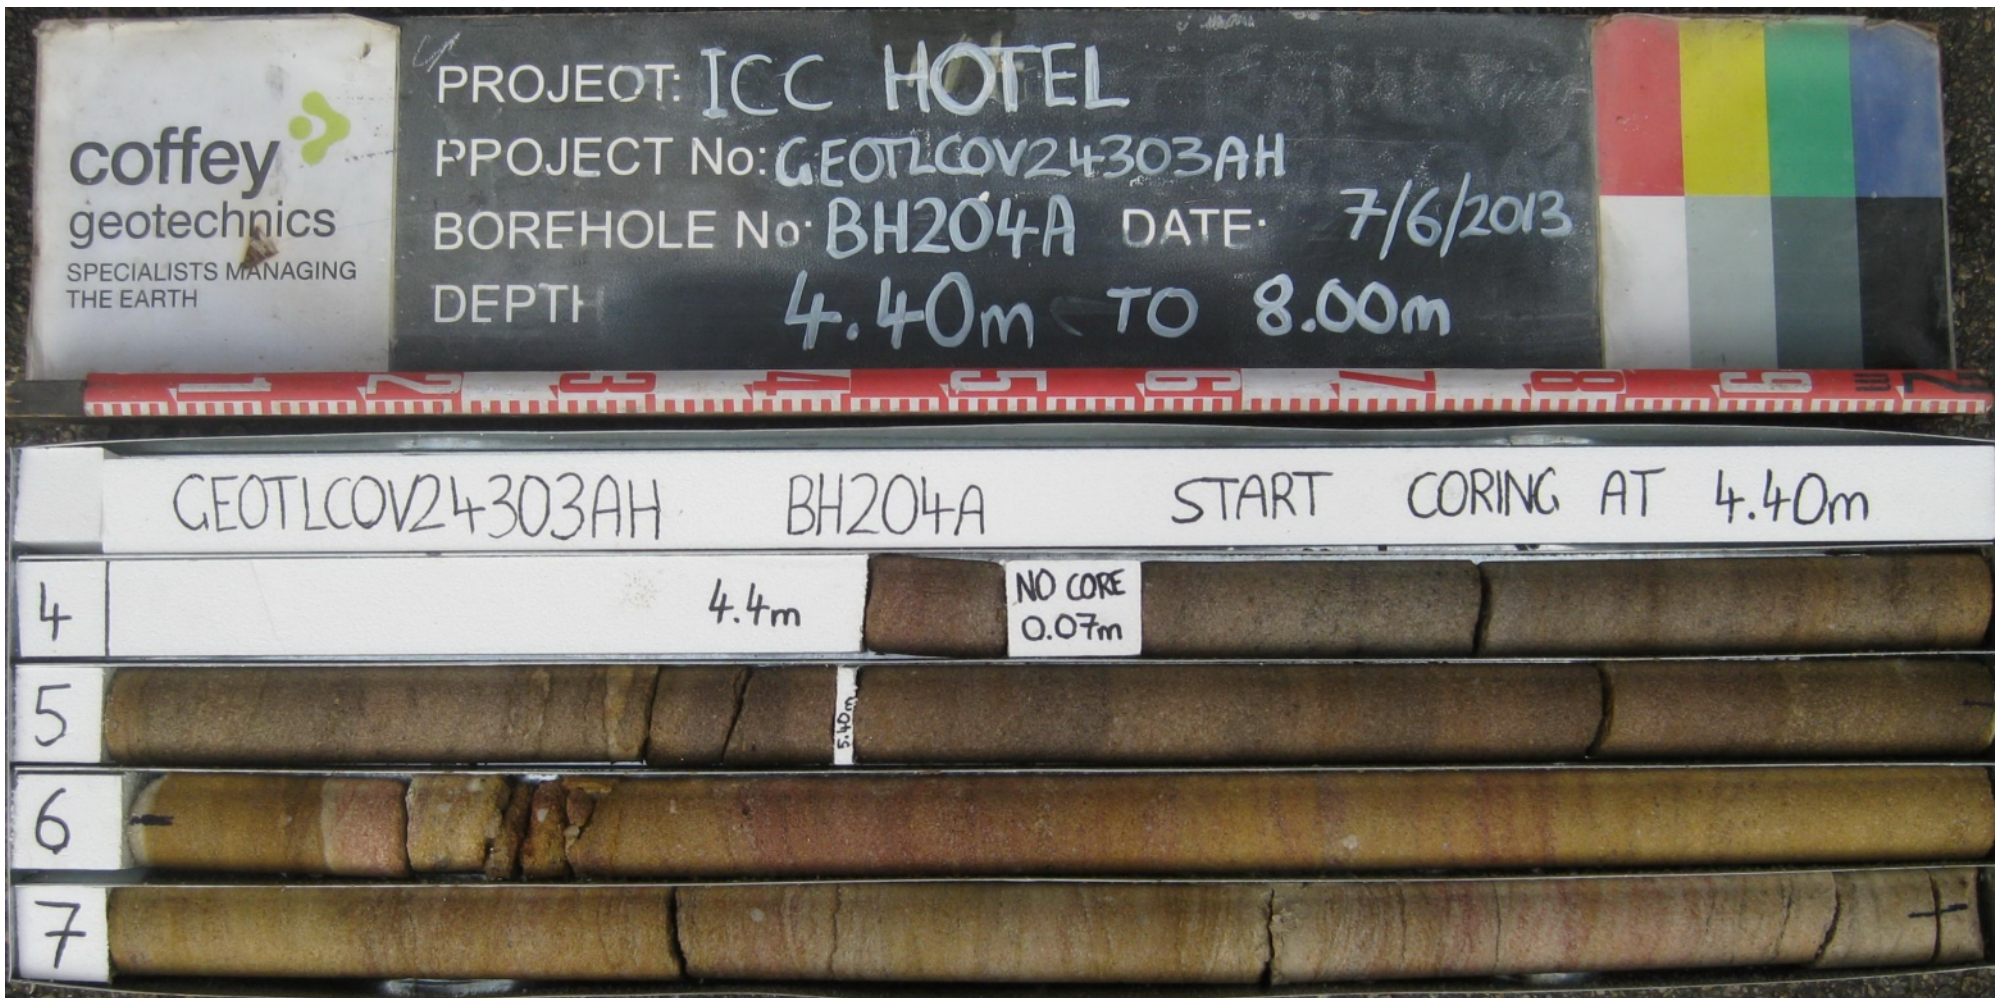
PointID : BH204a Depth Range: 4.40 - 8.00 m

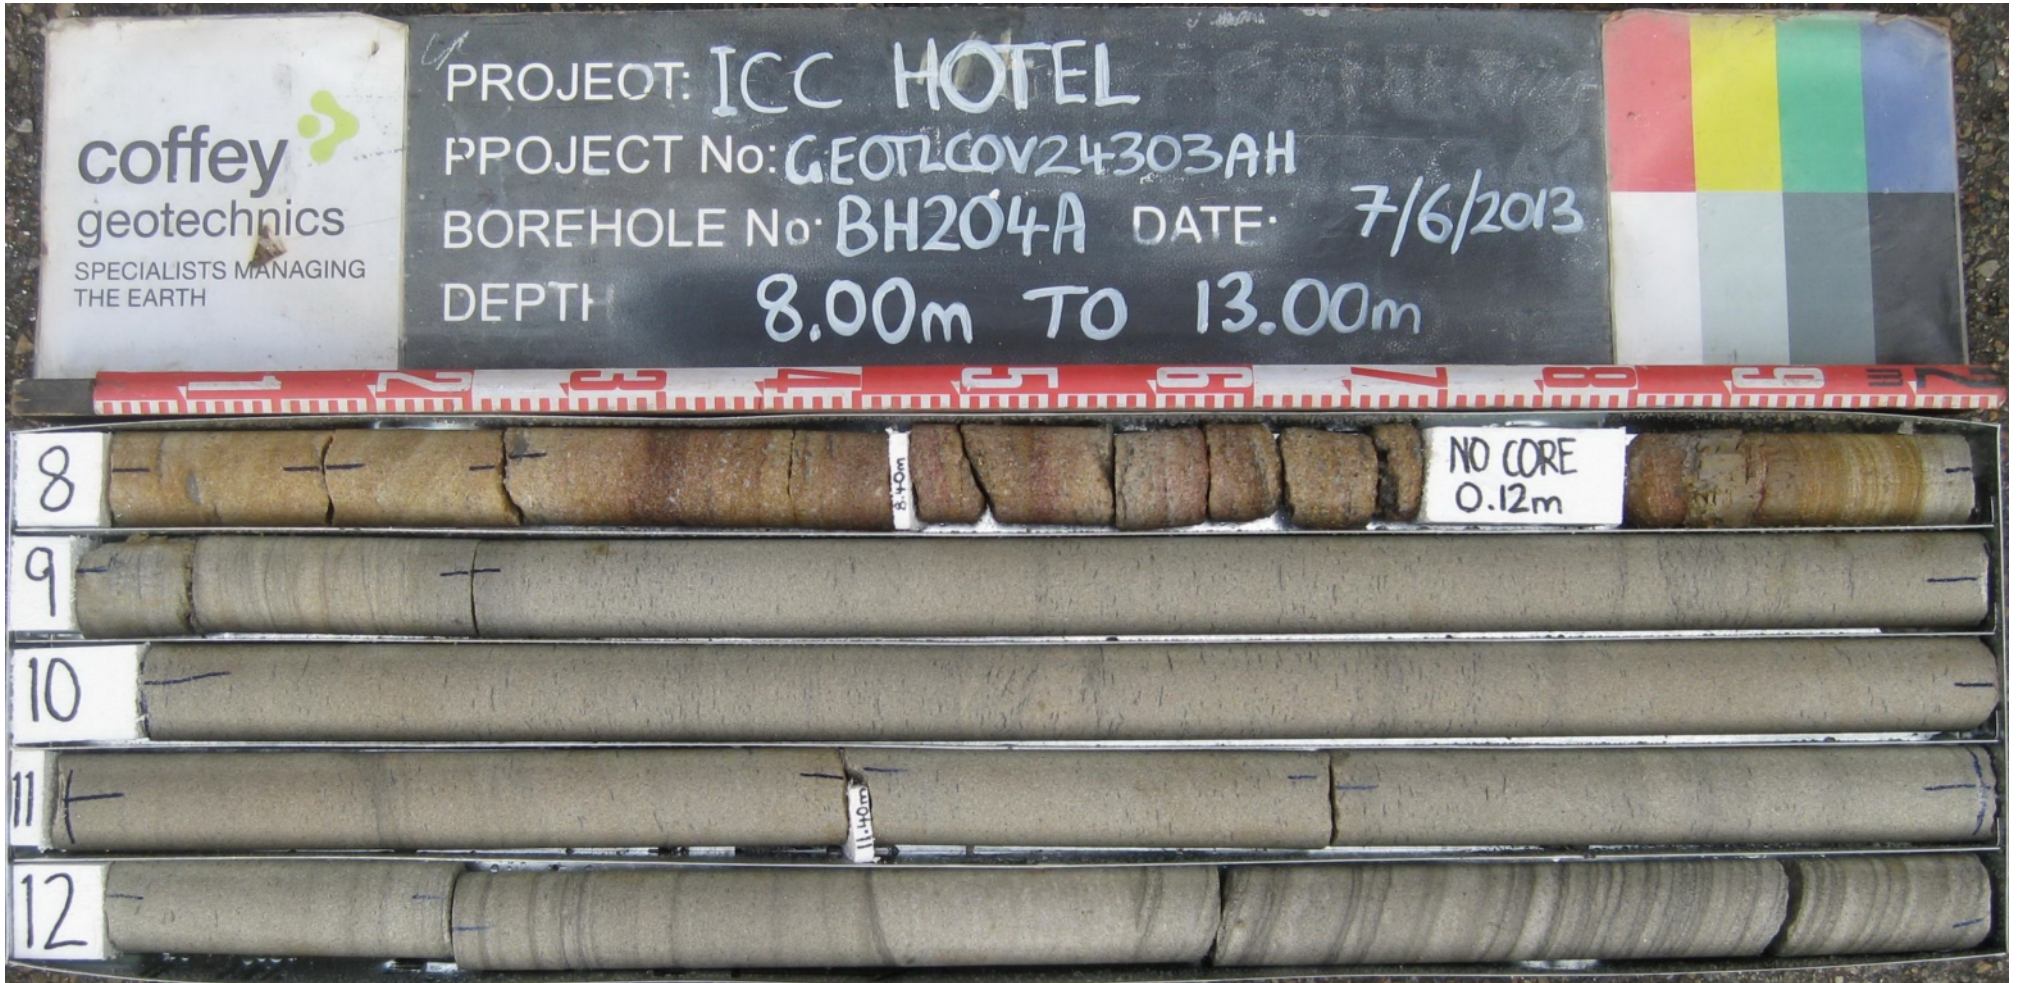
PointID : BH204a Depth Range: 8.00 - 13.00 m

<p><b>coffey</b> geotechnics SPECIALISTS MANAGING THE EARTH</p>	client:	Lend Lease Development Pty Ltd		
approved			project:	SICEEP - International Convention Centre (ICC) Hotel Darling Harbour, Sydney		
date	11/06/2013		title:	<b>CORE PHOTOGRAPH BH204A</b>		
scale	N.T.S.		project no:	GEOTLCOV24303AH	fig no:	<b>FIGURE 12</b>
original size	A4				rev:

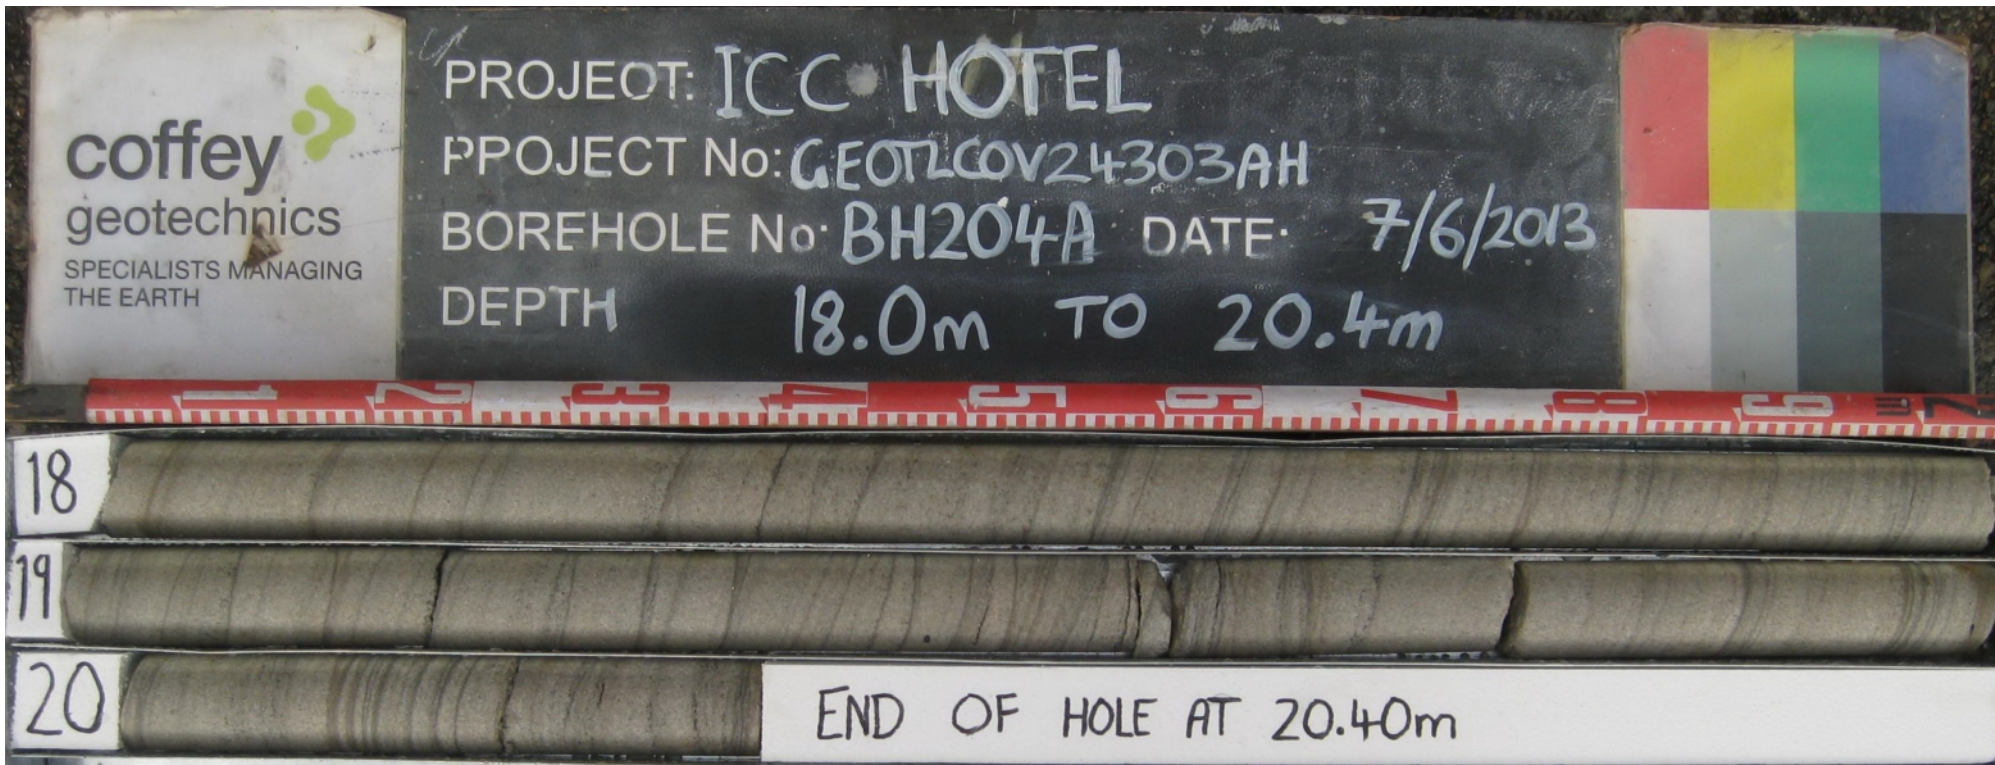
PointID : BH204a Depth Range: 18.00 - 20.40 m

client: Lend Lease Development Pty Ltd		
approved			project: SICEEP - International Convention Centre (ICC) Hotel Darling Harbour, Sydney		
date	11/06/2013		title: <b>CORE PHOTOGRAPH BH204A</b>		
scale	N.T.S.		project no: GEOTLCOV24303AH	fig no: <b>FIGURE 14</b>	rev:
original size	A4

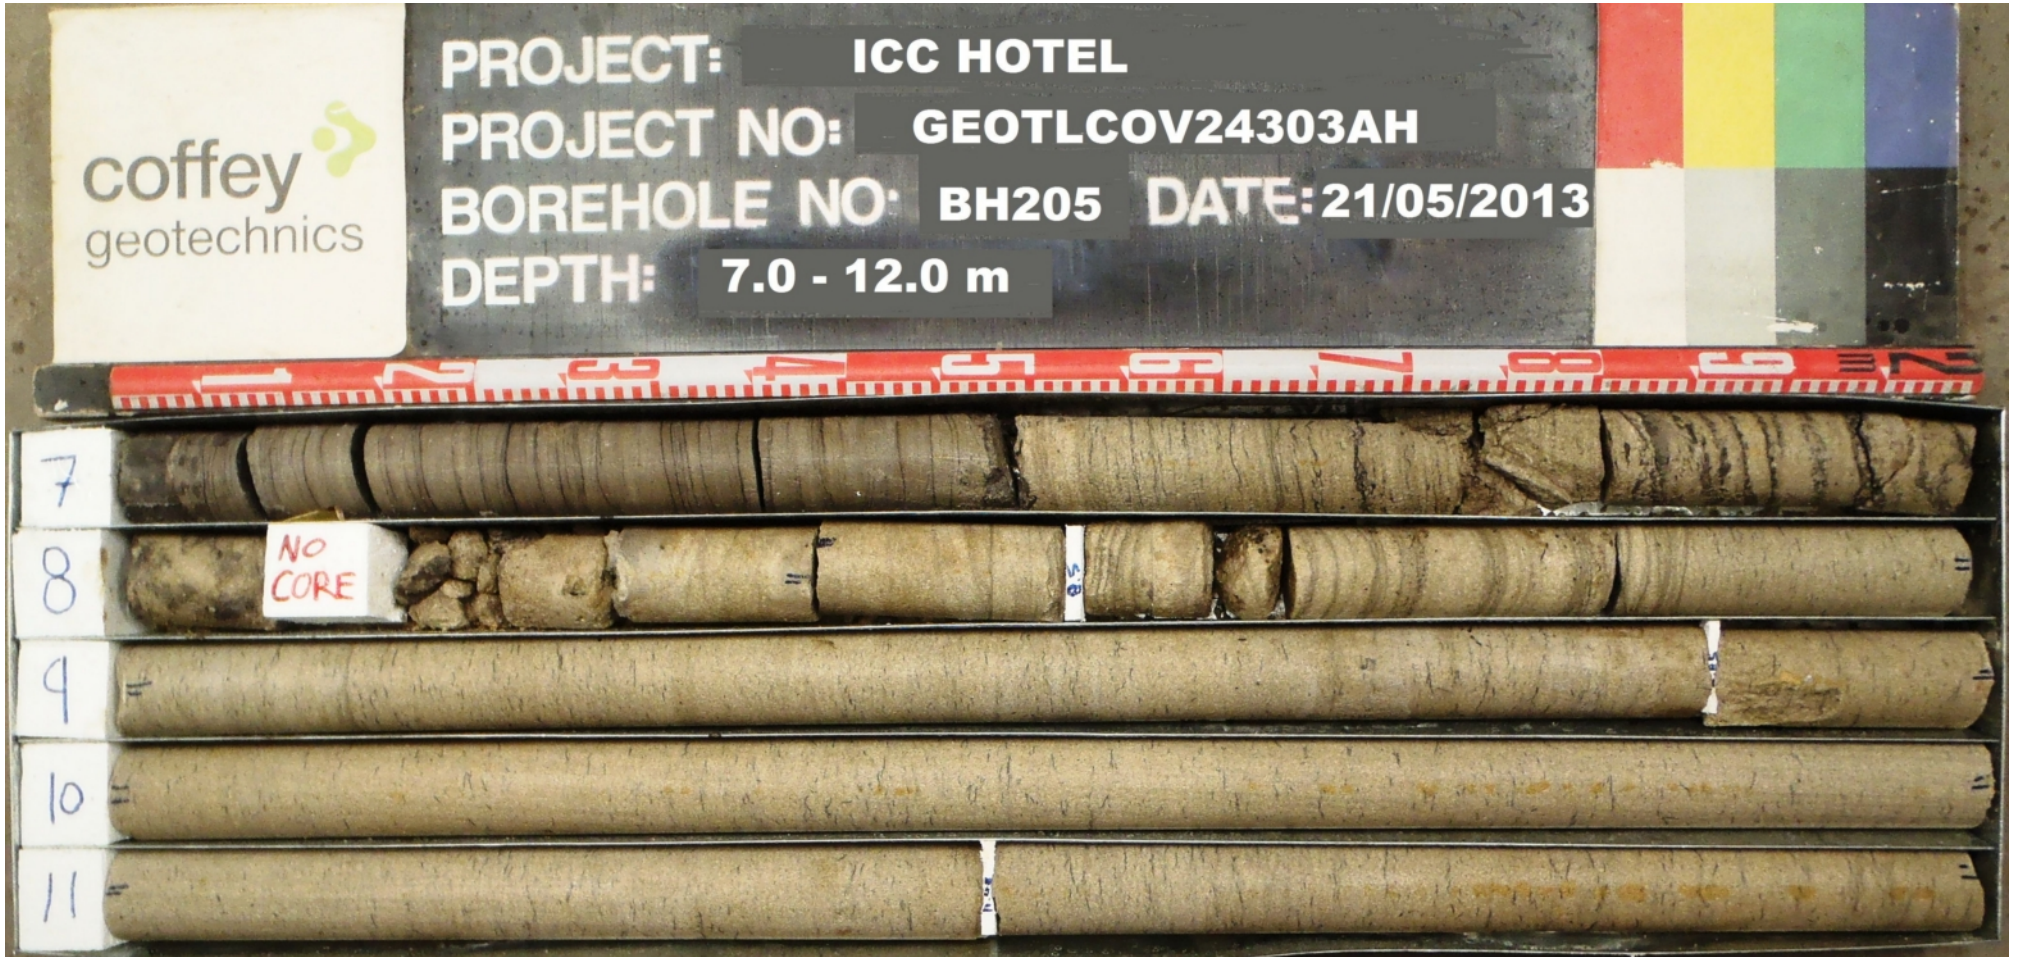
PROJECT: ICC HOTEL  
 PROJECT NO: GEOTLCOV24303AH  
 BOREHOLE NO: BH205 DATE: 21/05/2013  
 DEPTH: 7.0 - 12.0 m

PointID : BH205 Depth Range: 7.00 - 12.00 m

SPECIALISTS MANAGING THE EARTH	client:	Lend Lease Development Pty Ltd		
approved			project:	SICEEP - International Convention Centre (ICC) Hotel Darling Harbour, Sydney		
date	07/06/2013		title:	<b>CORE PHOTOGRAPH BH205</b>		
scale	N.T.S.		project no:	GEOTLCOV24303AH	fig no:	<b>FIGURE 16</b>
original size	A4		rev:

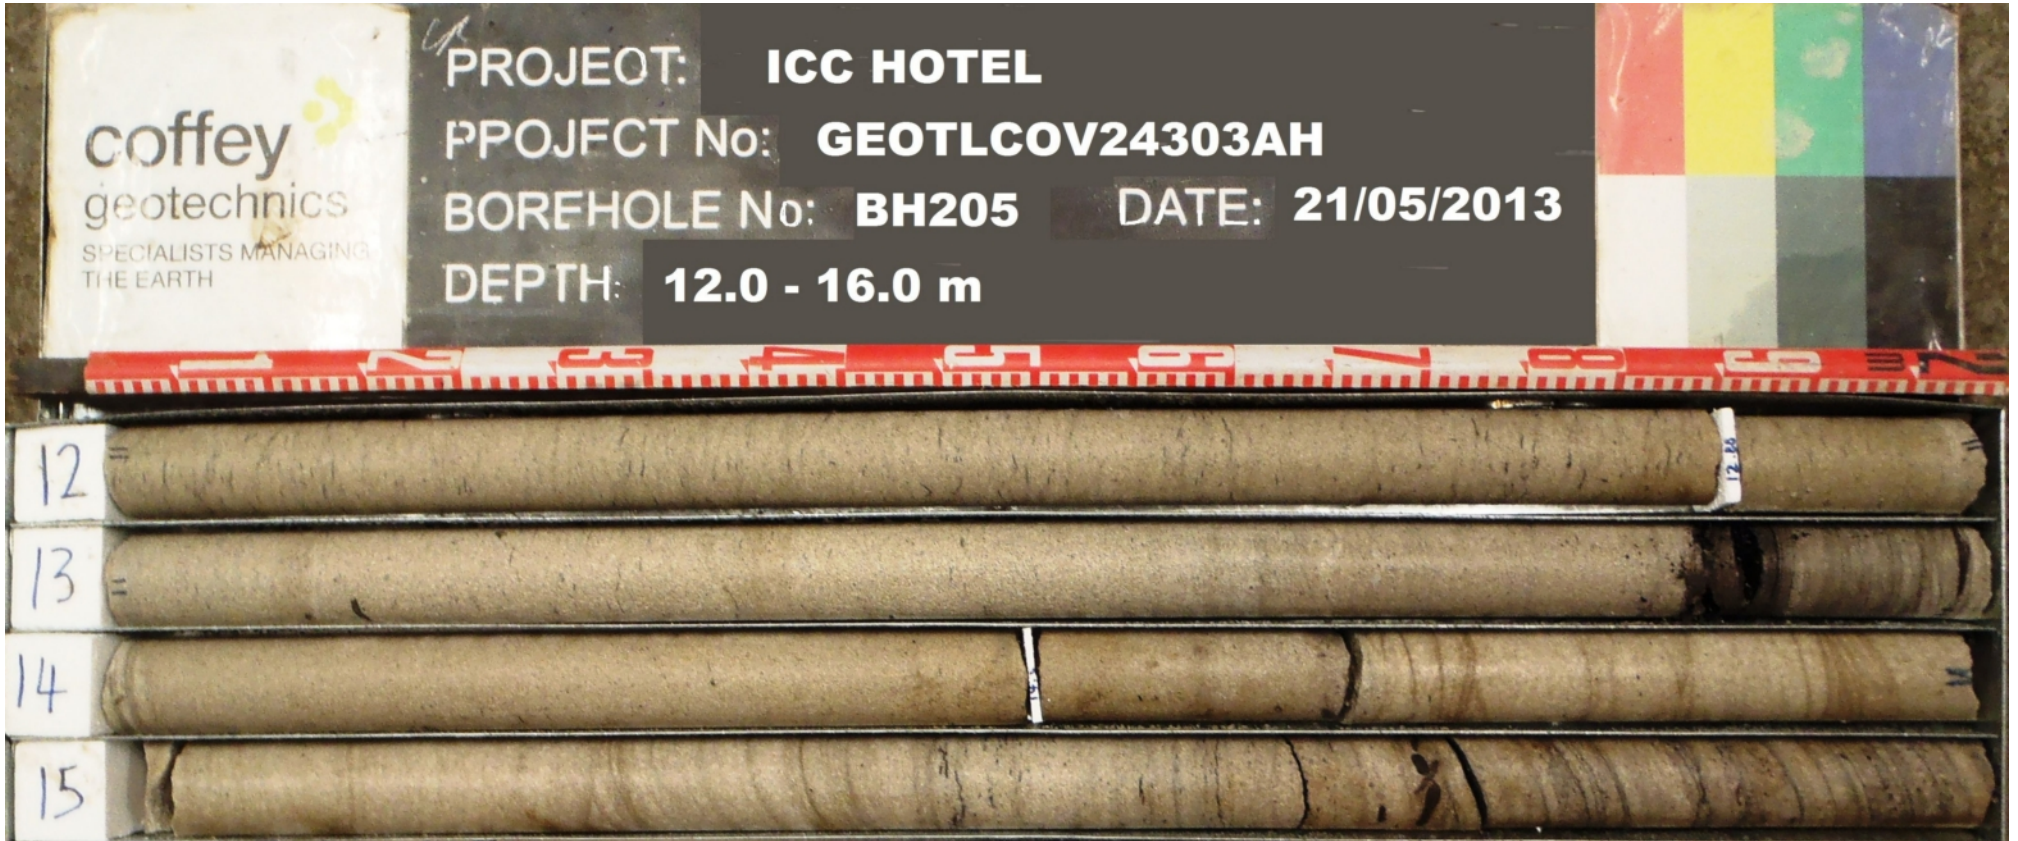
PointID : BH205 Depth Range: 12.00 - 16.00 m

drawn			client:	Lend Lease Development Pty Ltd		
approved			project:	SICEEP - International Convention Centre (ICC) Hotel Darling Harbour, Sydney		
date	07/06/2013		title:	<b>CORE PHOTOGRAPH BH205</b>		
scale	N.T.S.		project no:	GEOTLCOV24303AH	fig no:	<b>FIGURE 17</b>
original size	A4		rev:
