# Engineering Log - Cored Borehole

project: **SICEEP - International Convention Centre (ICC) Hotel**

Borehole ID. **BH205**

project no. **GEOTLCOV24303AH**

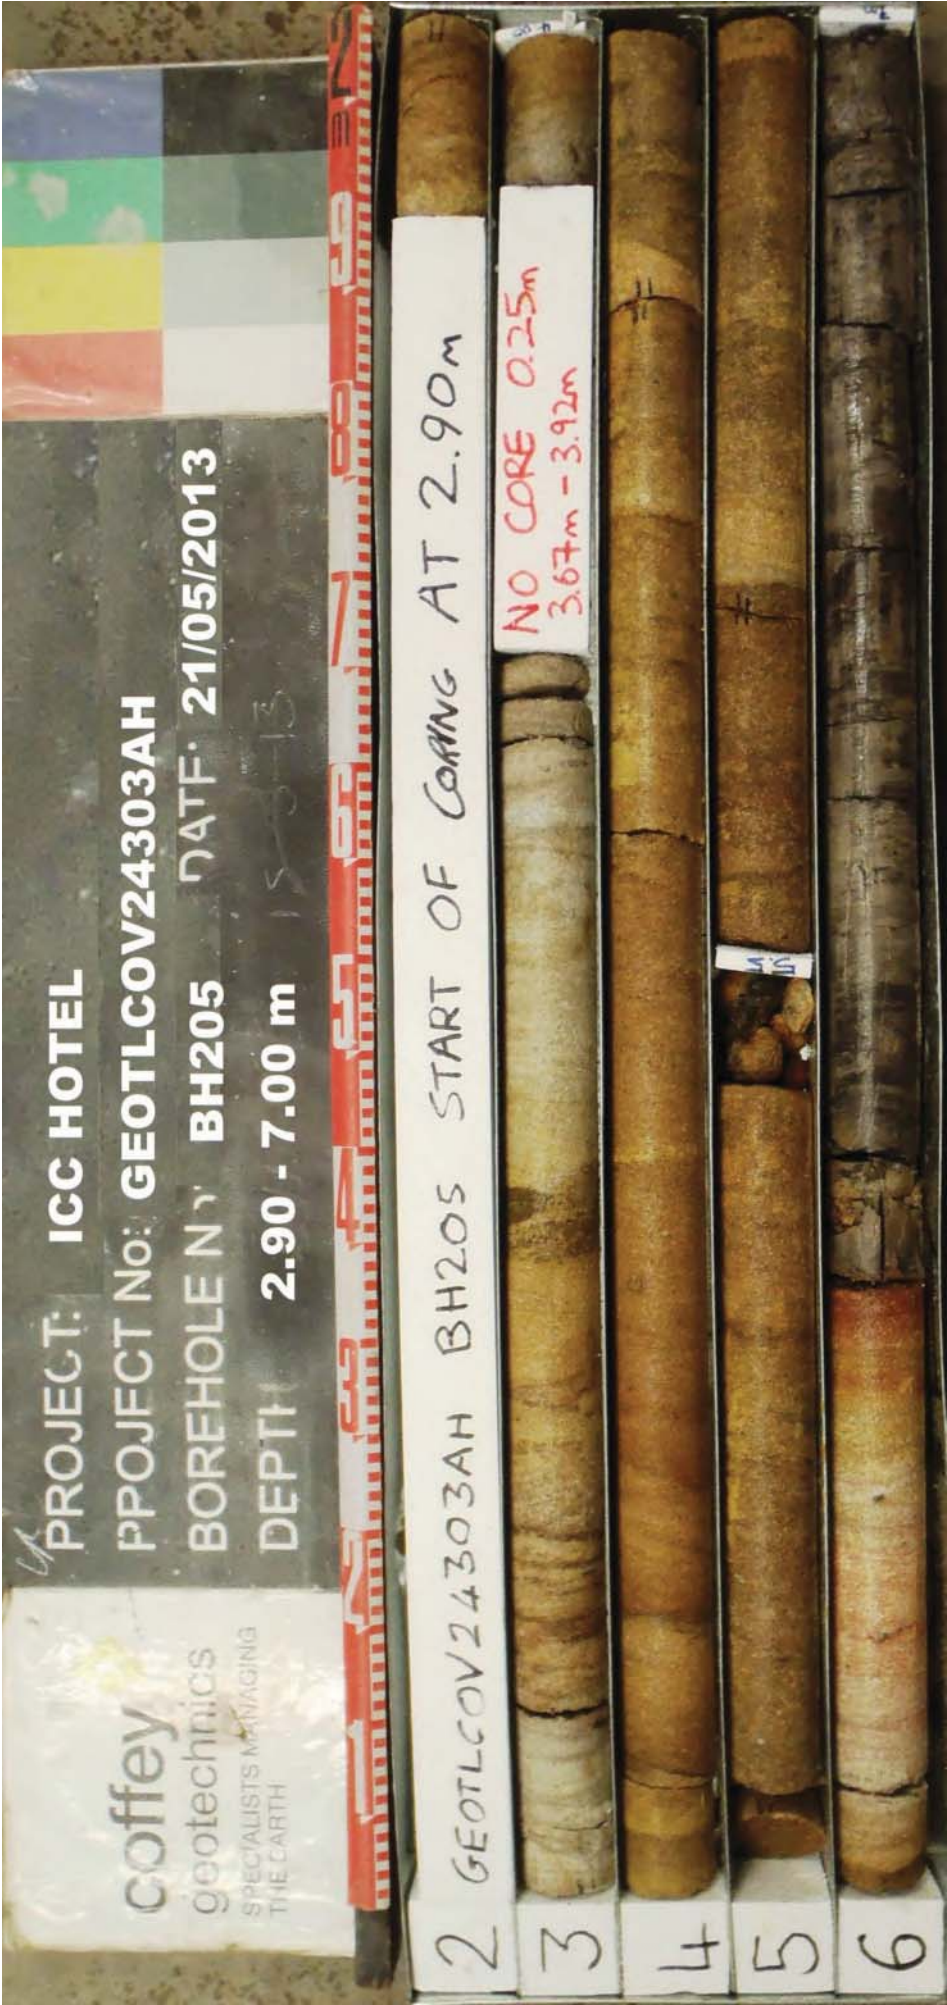
| project no: | GEOTLCOV24303AH | fig no: | FIGURE 15 |

PointID : BH205 Depth Range: 2.90 - 7.00 m

| | | title: | CORE PHOTOGRAPH<br>BH205 |

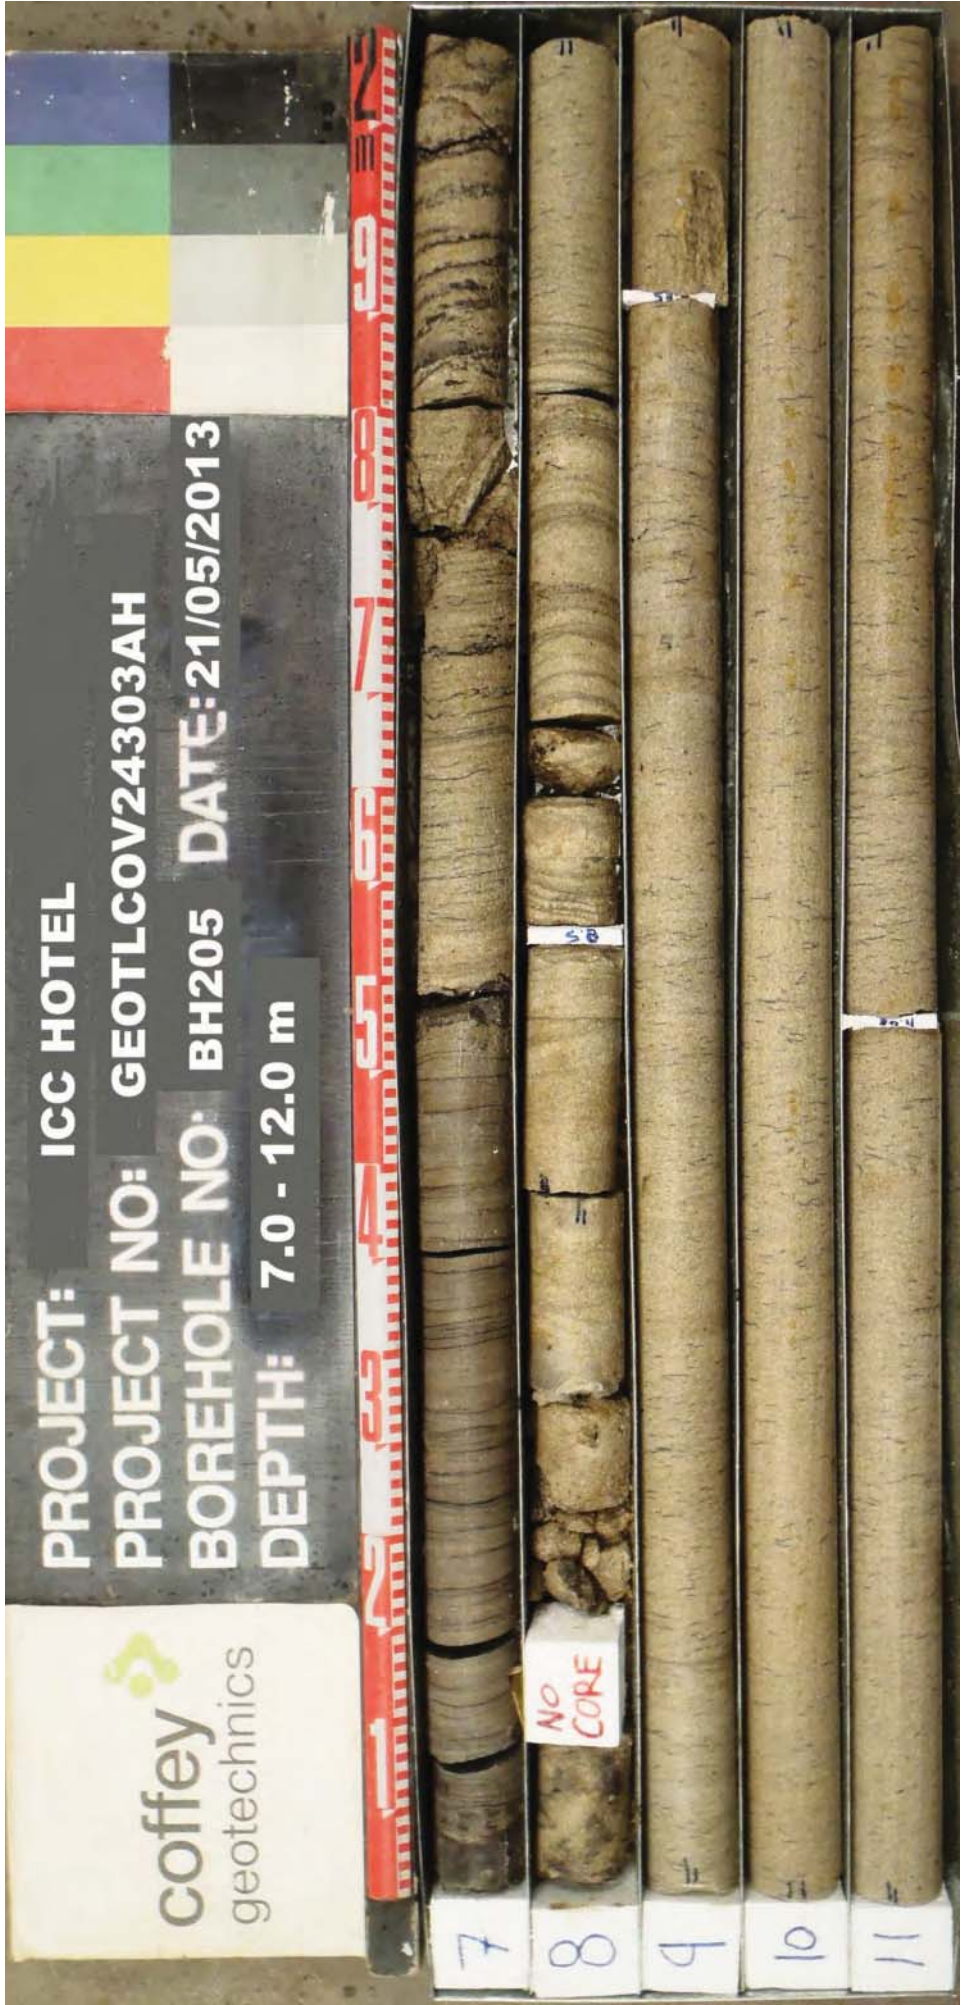
| scale | N.T.S. | | project no: GEOTLCOV24303AH | fig no: FIGURE 16 |

PointID : BH205 Depth Range: 7.00 - 12.00 m

| date | 07/06/2013 | | title: CORE PHOTOGRAPH<br>BH205 | |

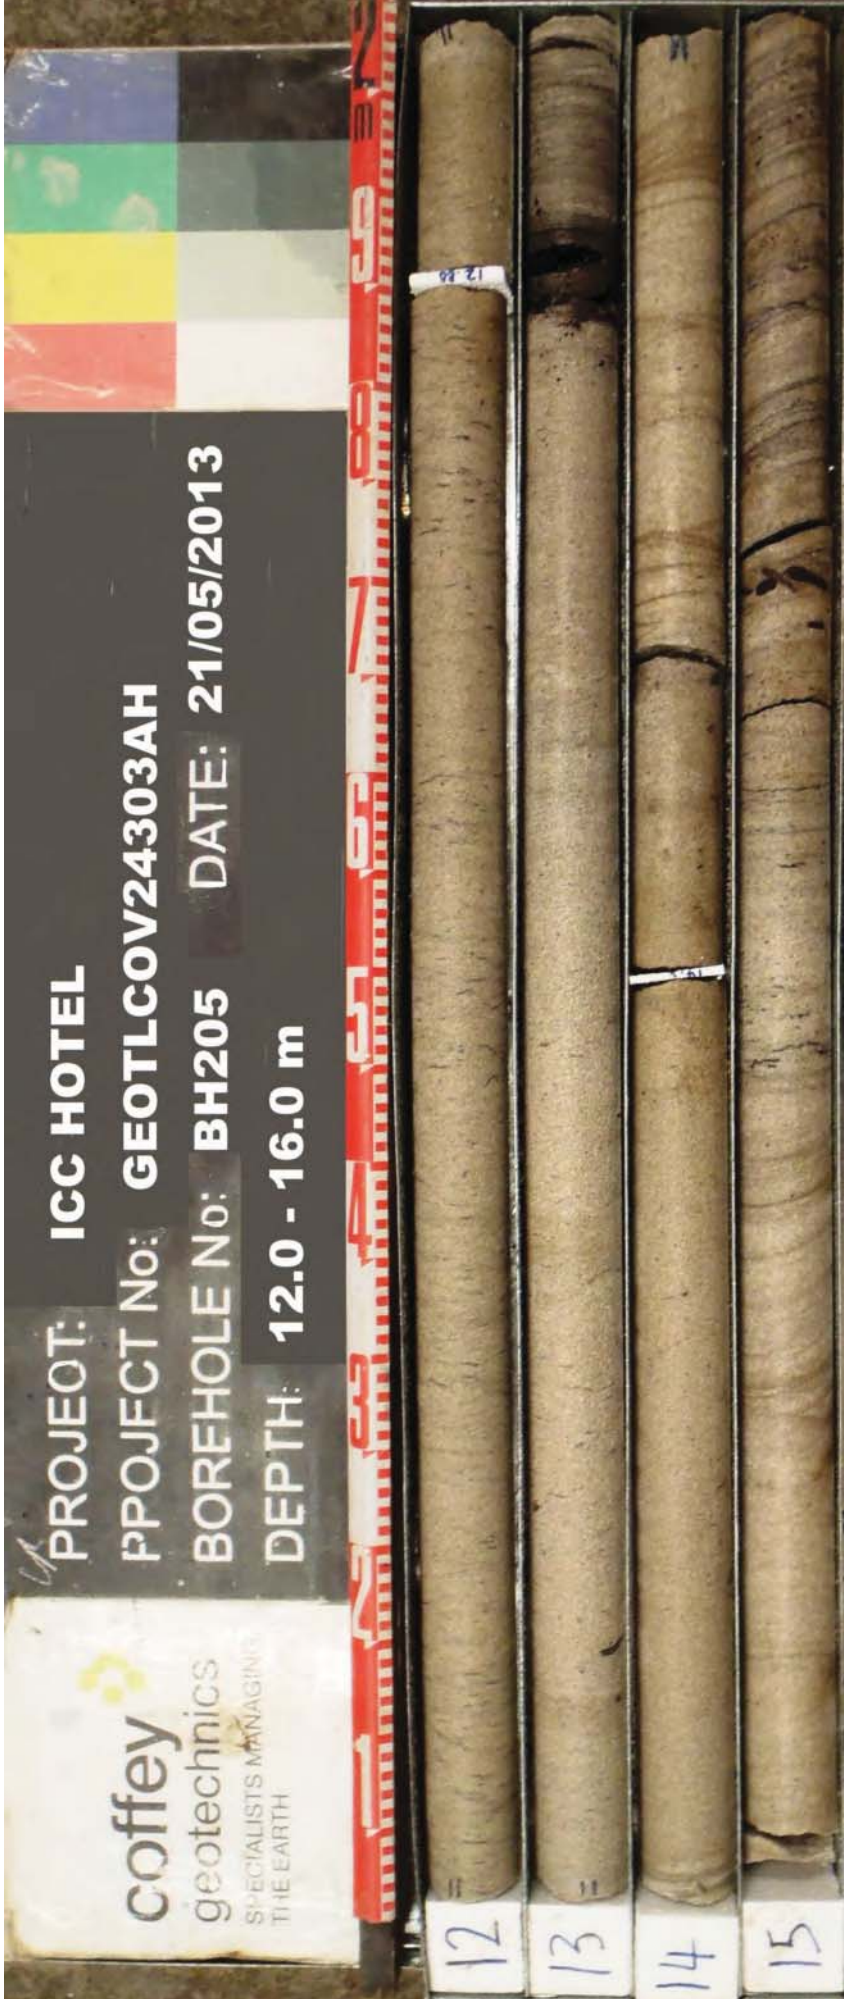
| original size | A4 | | fig no: FIGURE 17 | rev: |

PointID : BH205 Depth Range: 12.00 - 16.00 m

| date | 07/06/2013 | | title: CORE PHOTOGRAPH<br>BH205 | |

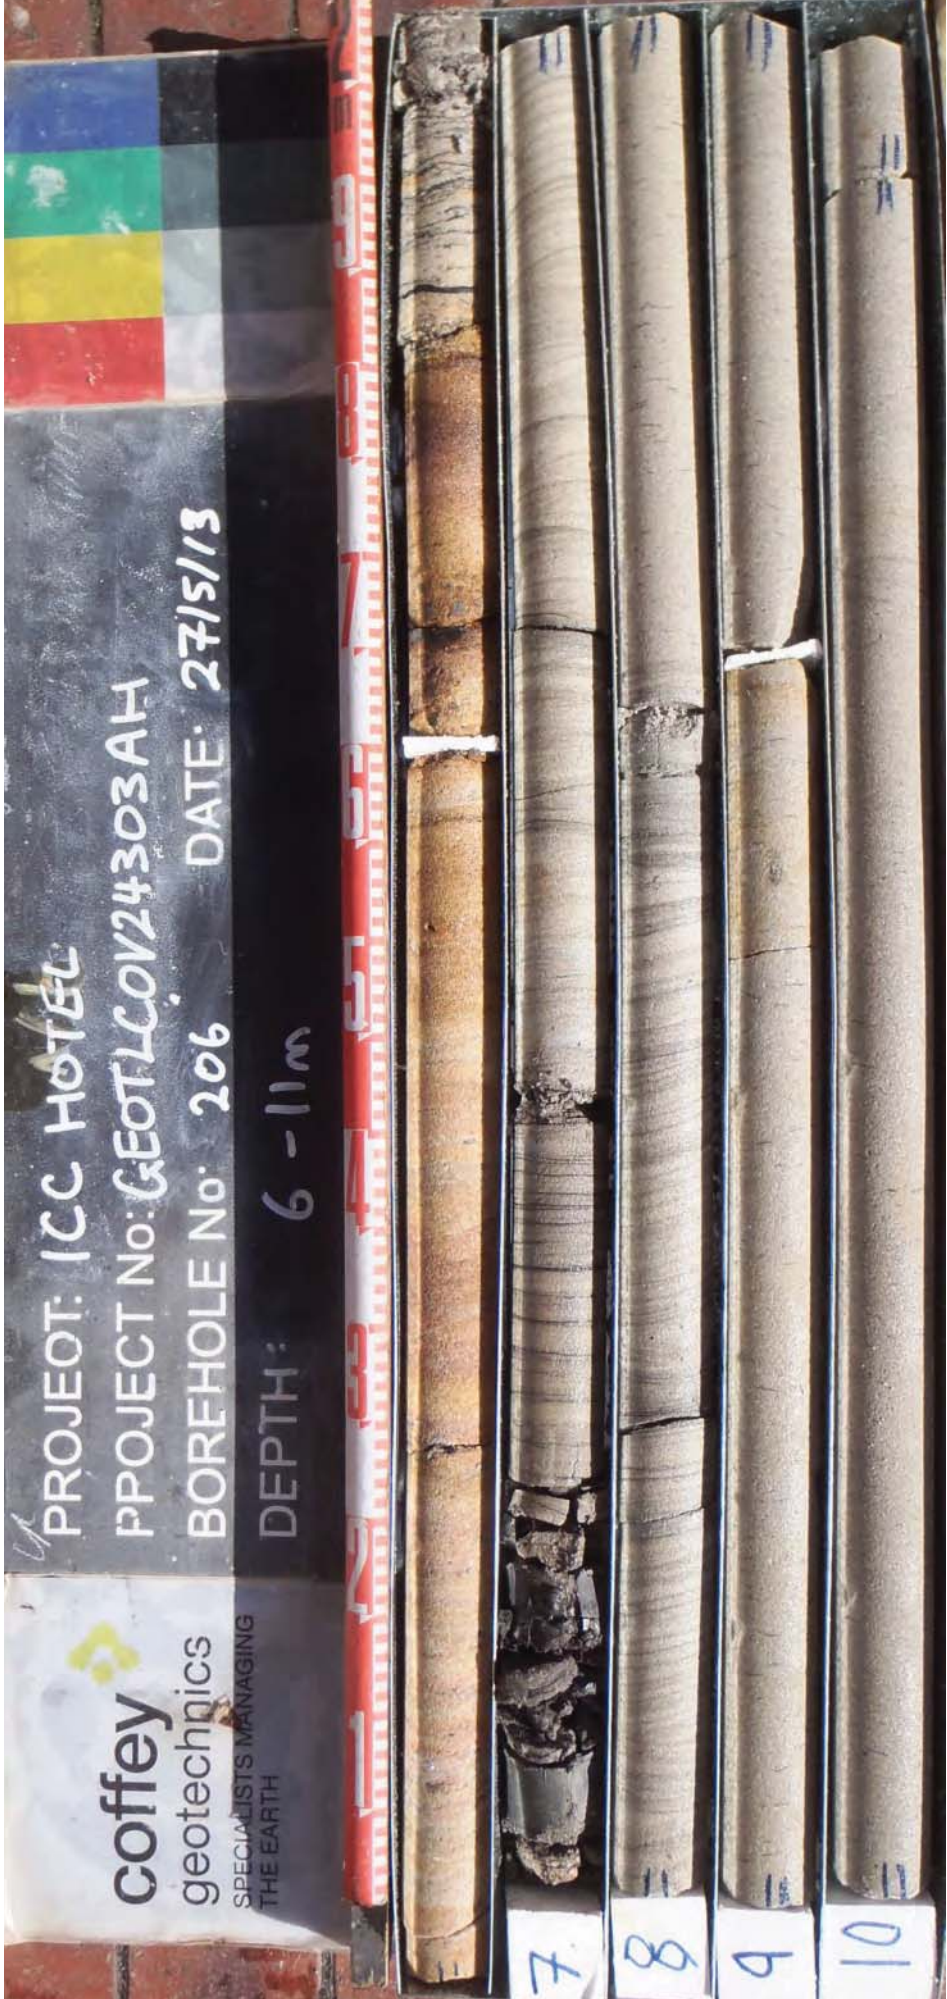
| project no: | GEOTLCOV24303AH | fig no: | FIGURE 20 |

PointID : BH206 Depth Range: 6.00 - 11.00 m

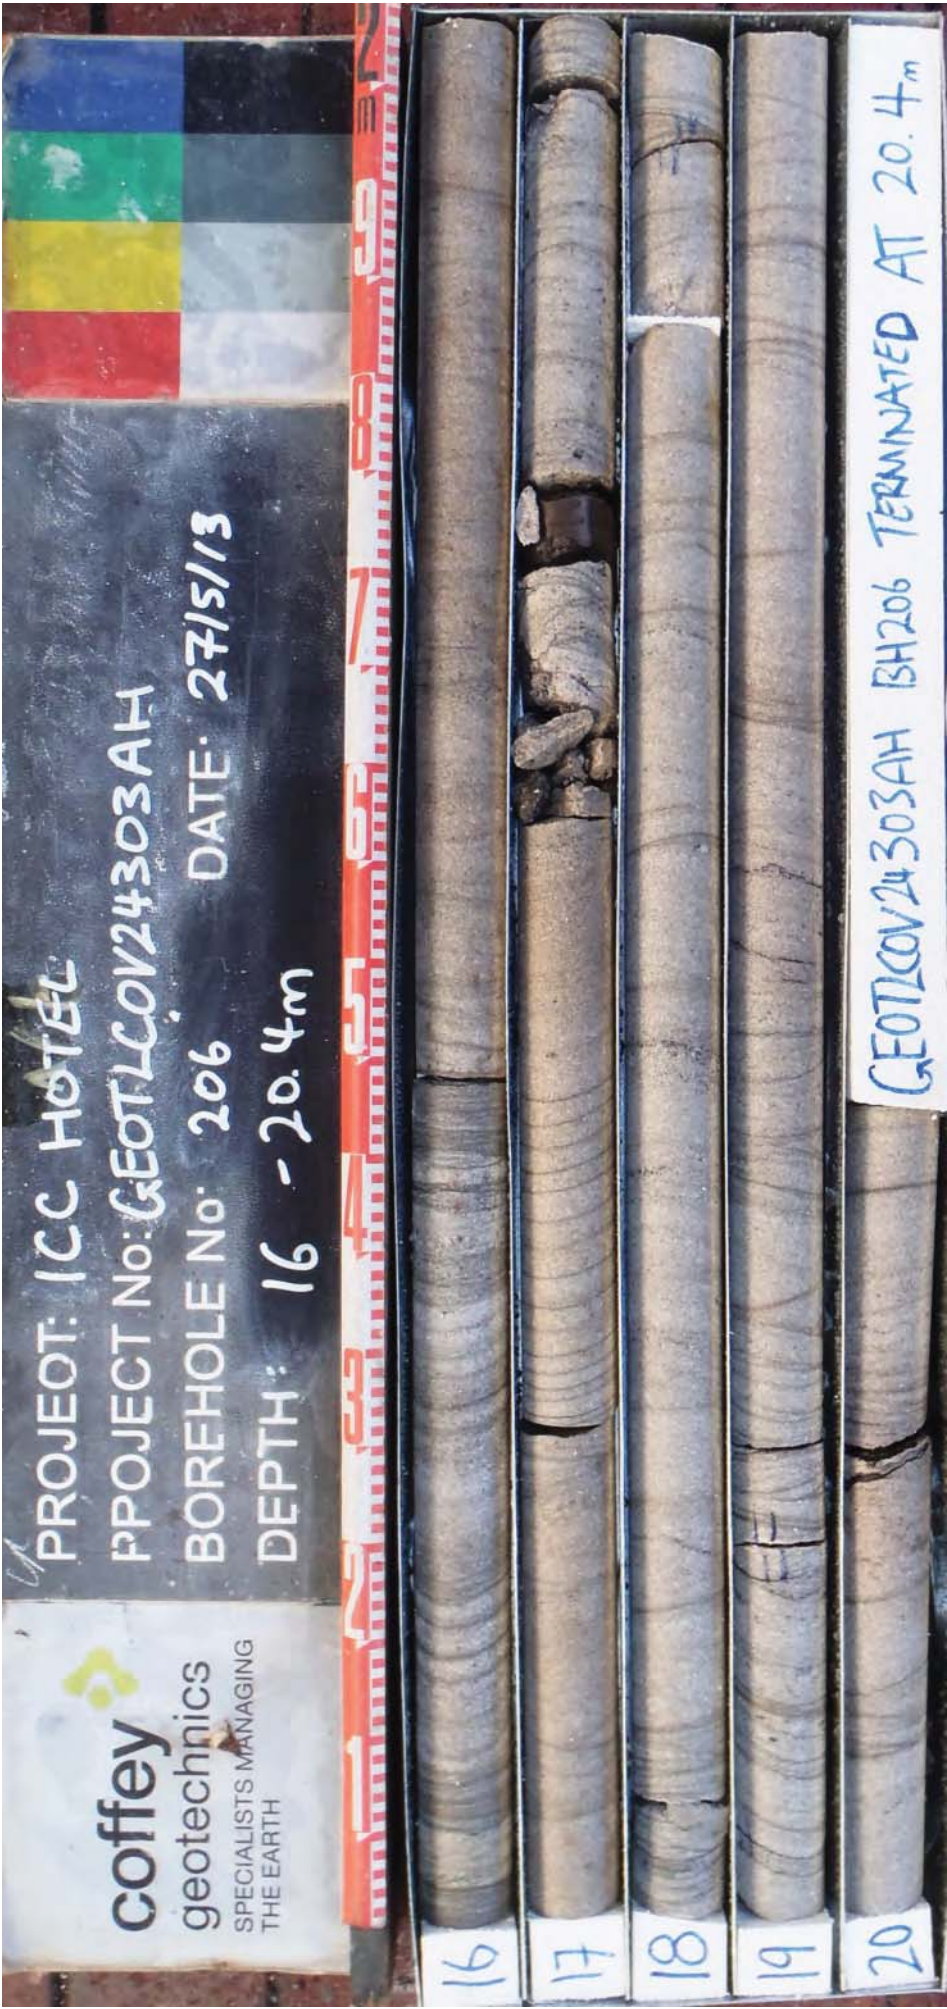
PointID : BH206 Depth Range: 16.00 - 20.40 m

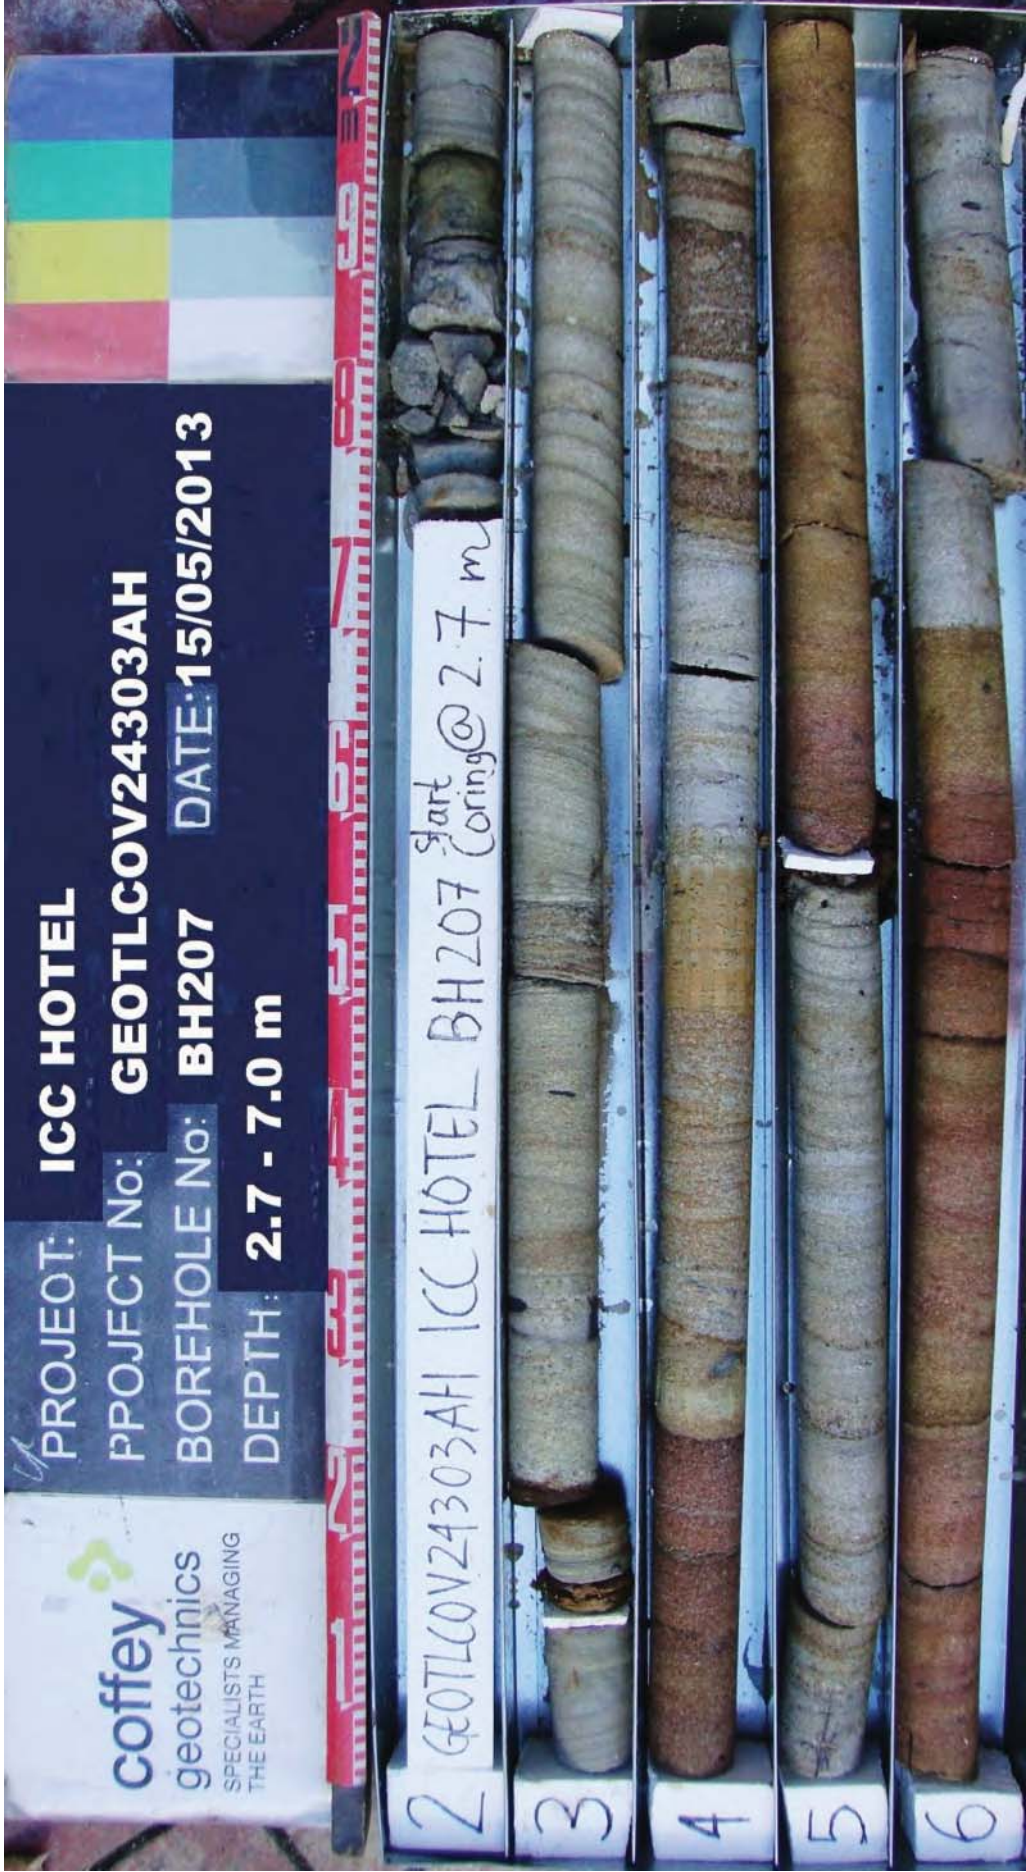
| scale | N.T.S. | project no: GEOTLCOV24303AH | fig no: FIGURE 23 |

PointID : BH207 Depth Range: 2.70 - 7.00 m

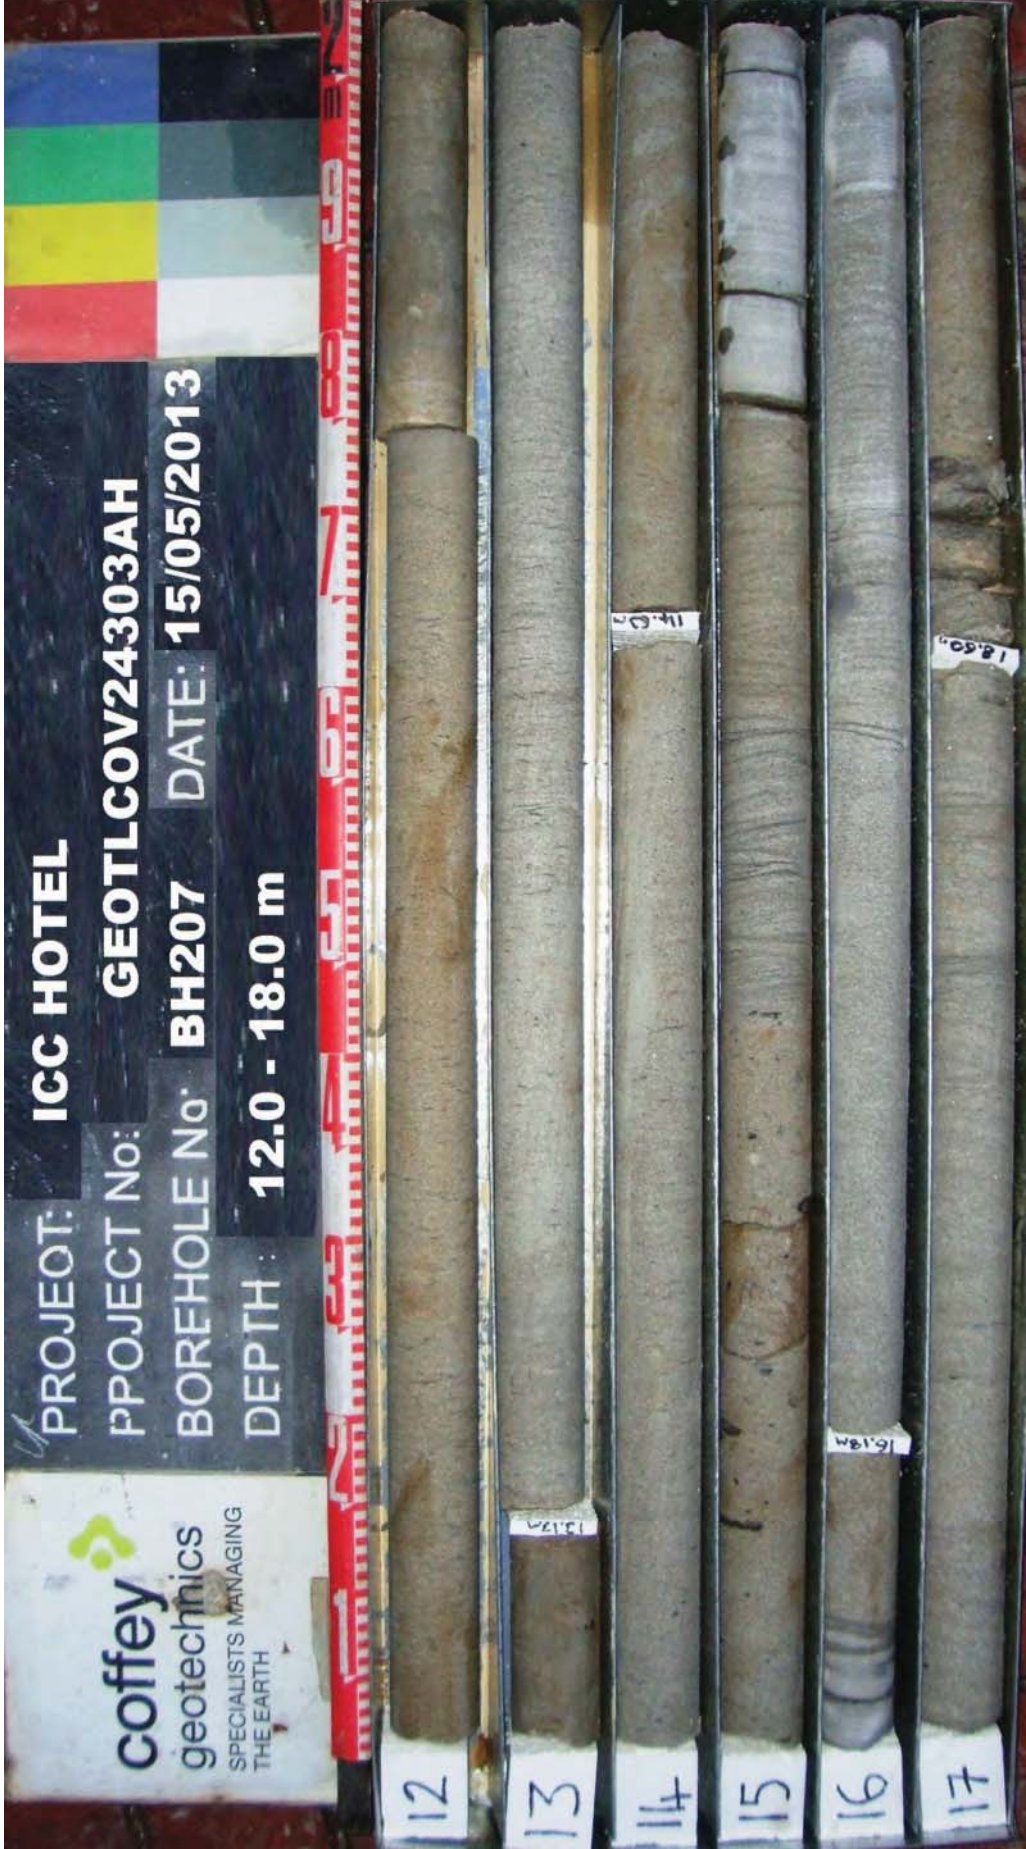
PointID : BH207 Depth Range: 12.00 - 18.00 m

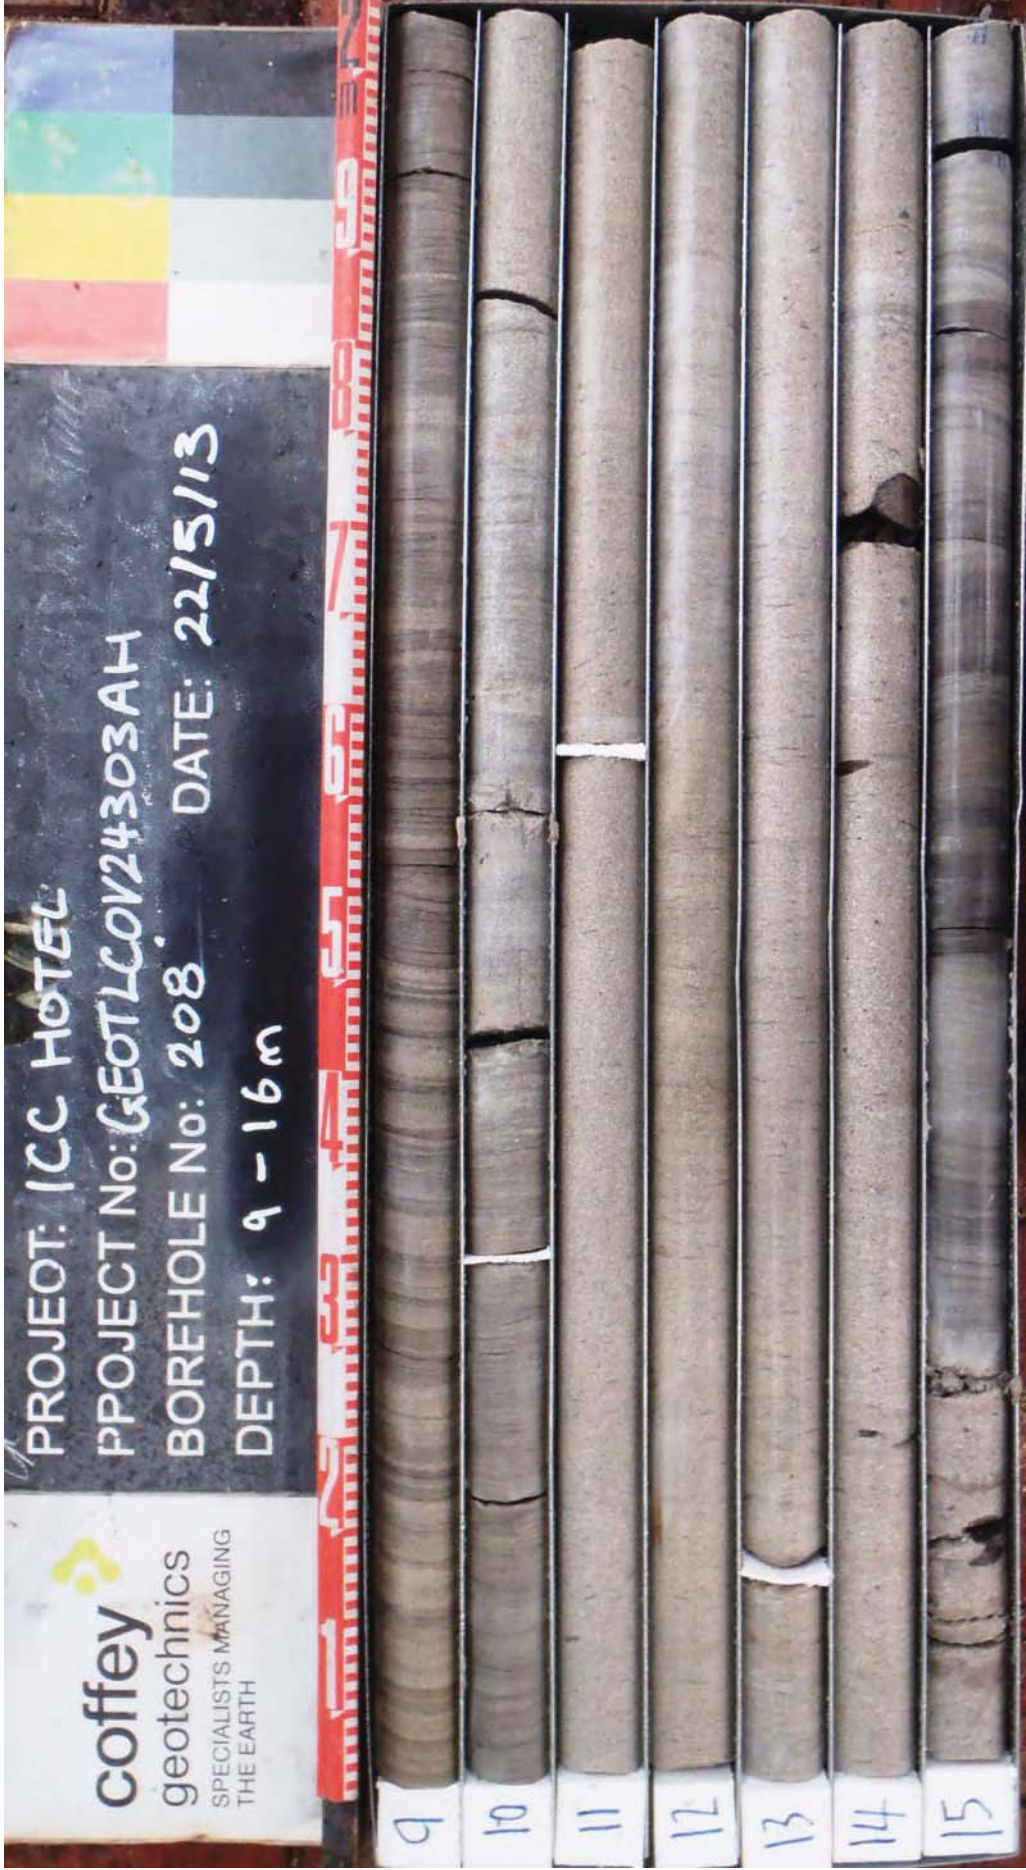
| scale | N.T.S. | | project no: GEOTLCOV24303AH | fig no: FIGURE 28 |

PointID : BH208 Depth Range: 9.00 - 16.00 m

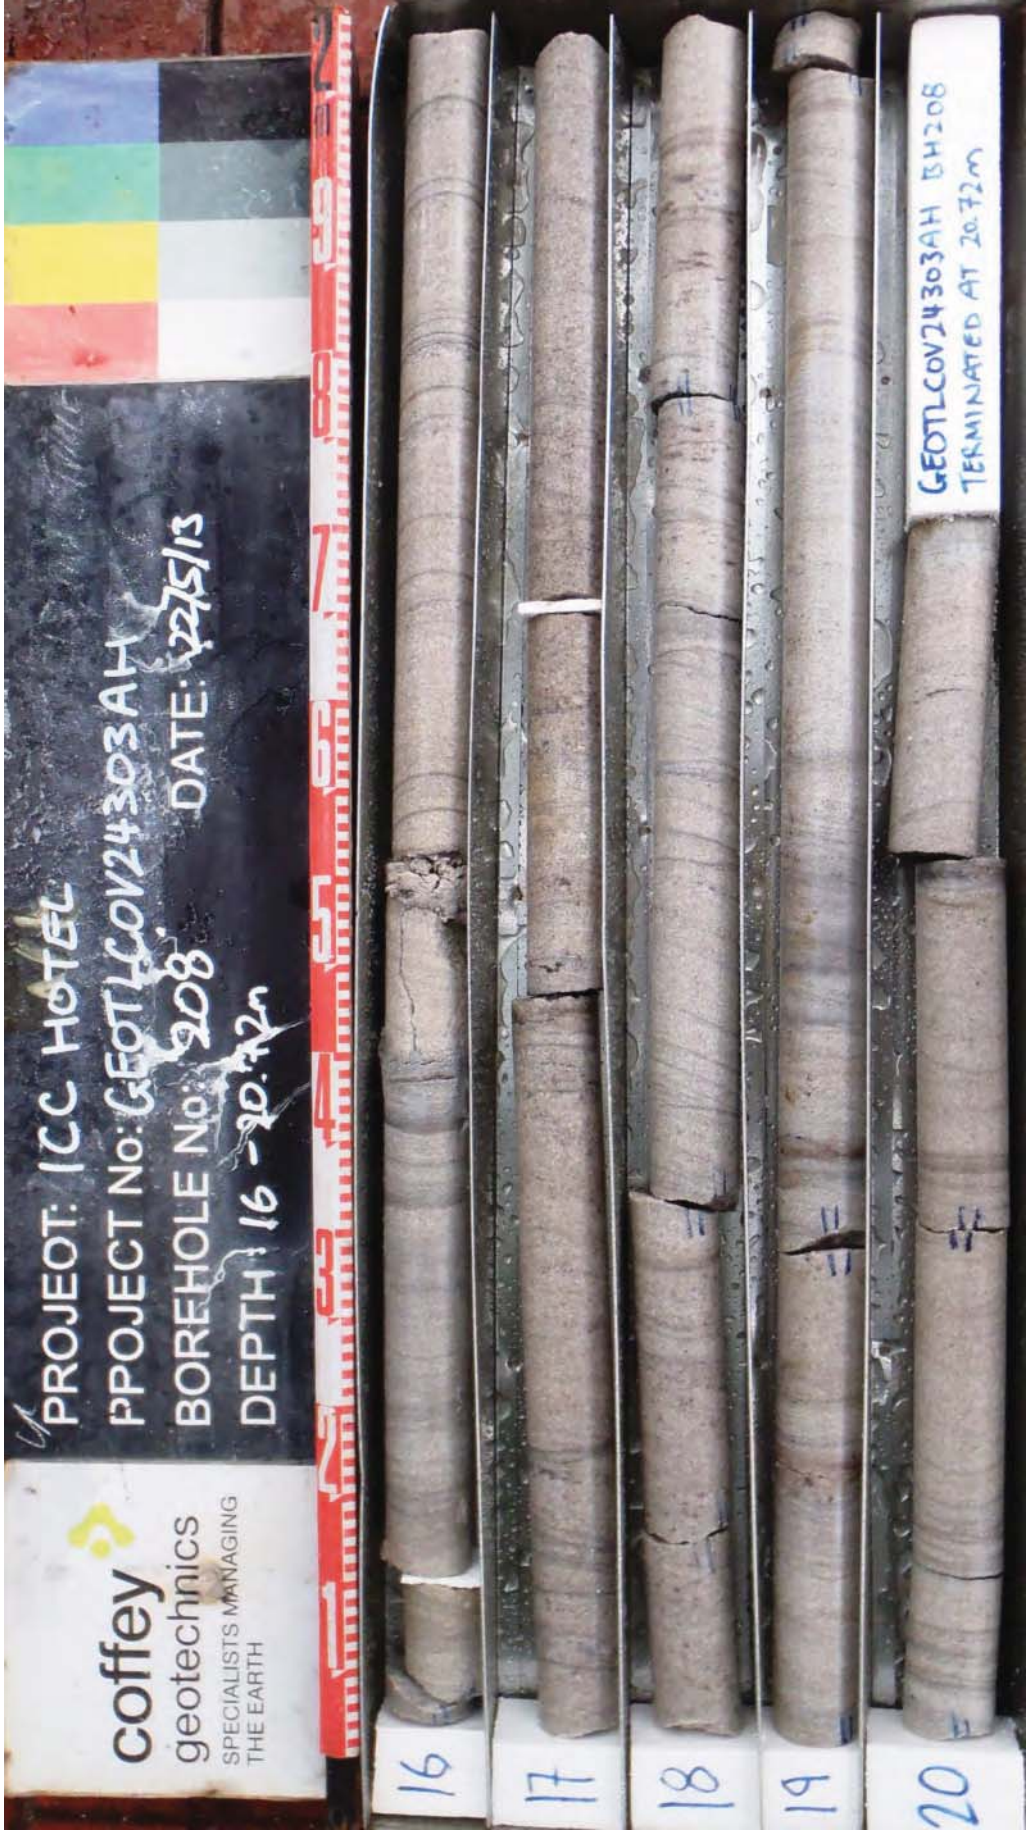
PointID : BH208 Depth Range: 16.00 - 20.72 m

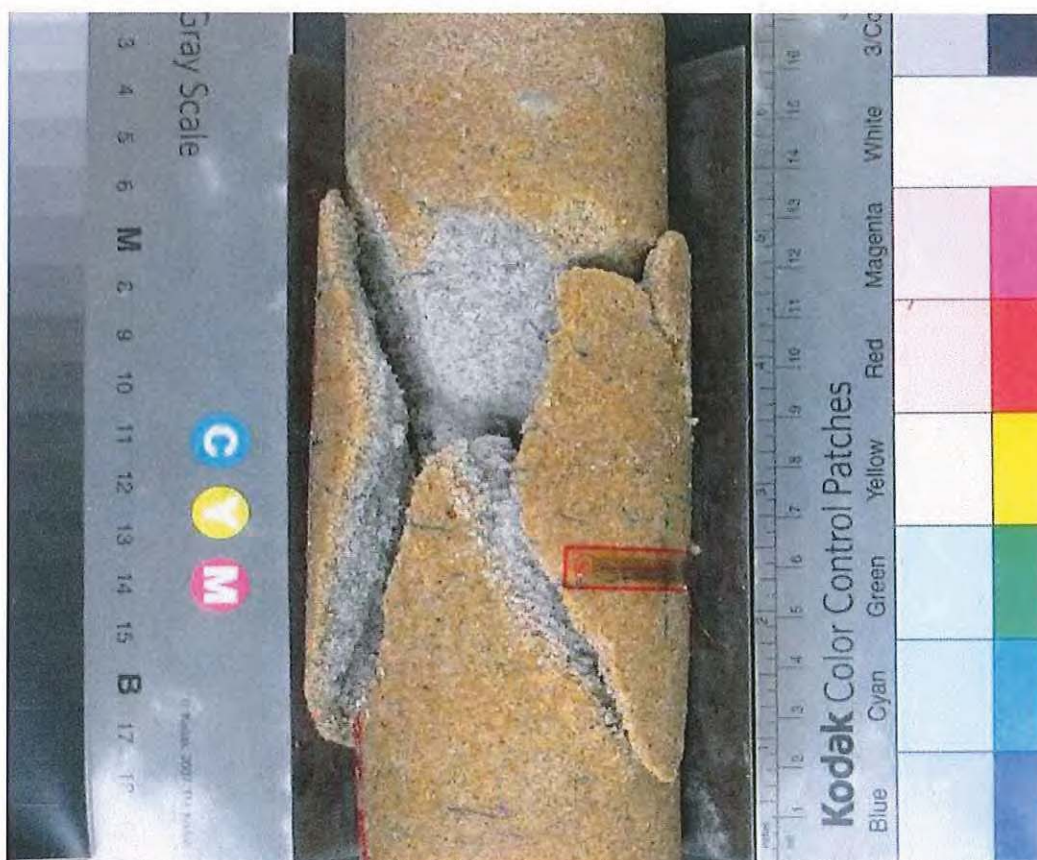
BH205 / 12.56 - 12.85

photo after test

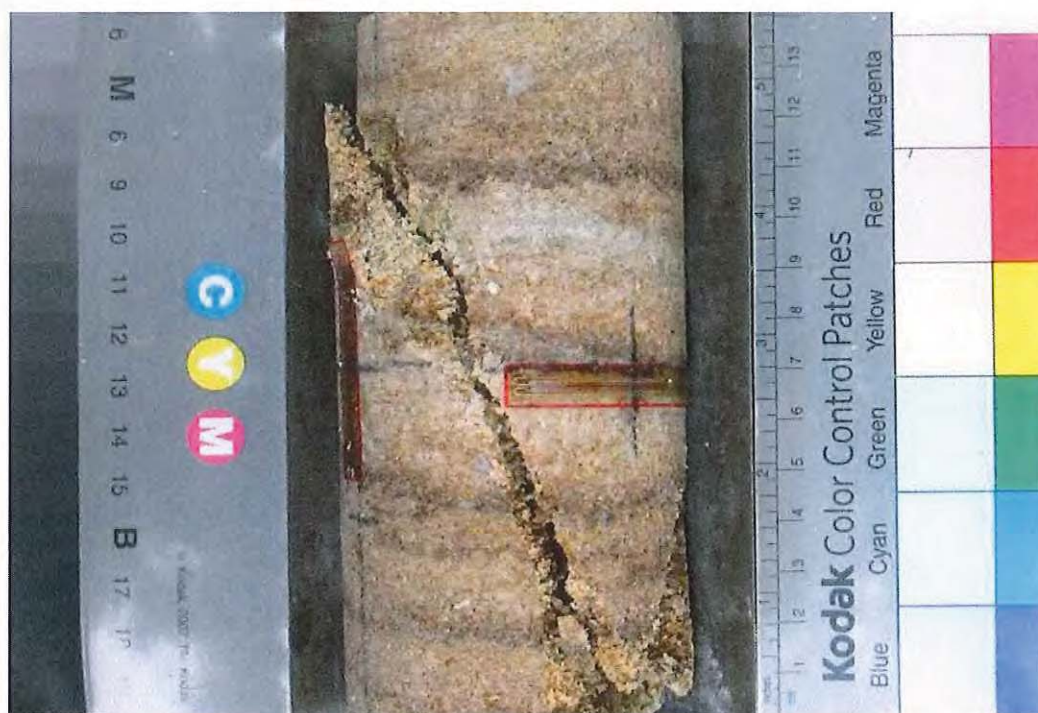
BH206 / 3.49 - 3.64

photo after test

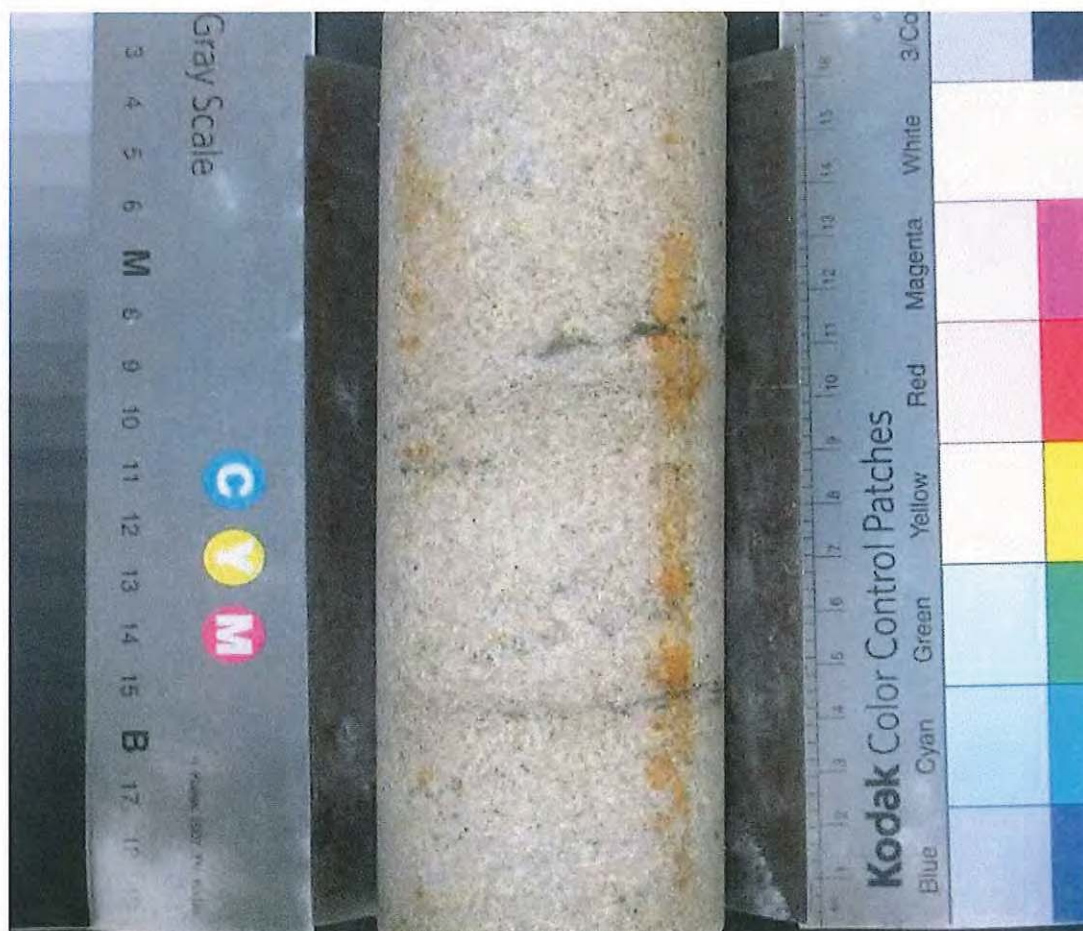
BH208 / 7.07 - 7.27  
 photo before test

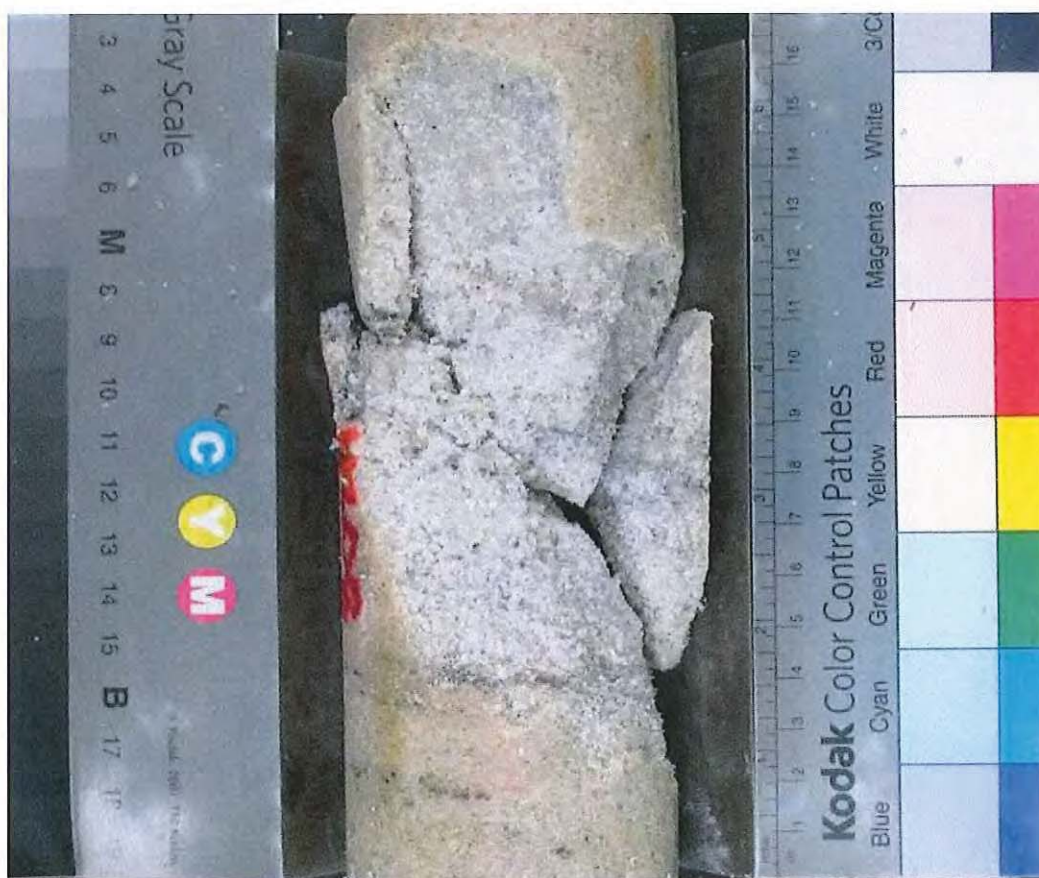
BH208 / 7.07 - 7.27  
 BH208 / 7.07 - 7.27 photo  
 after test
