**GEOTECHNICAL INVESTIGATION  
REPORT FOR SSDA6**

**SYDNEY INTERNATIONAL EXHIBITION  
AND ENTERTAINMENT PRECINCT - ICC  
HOTEL**

Lend Lease Development Pty Ltd

GEOTLCOV24303AH-AH Rev 1  
26 August 2013

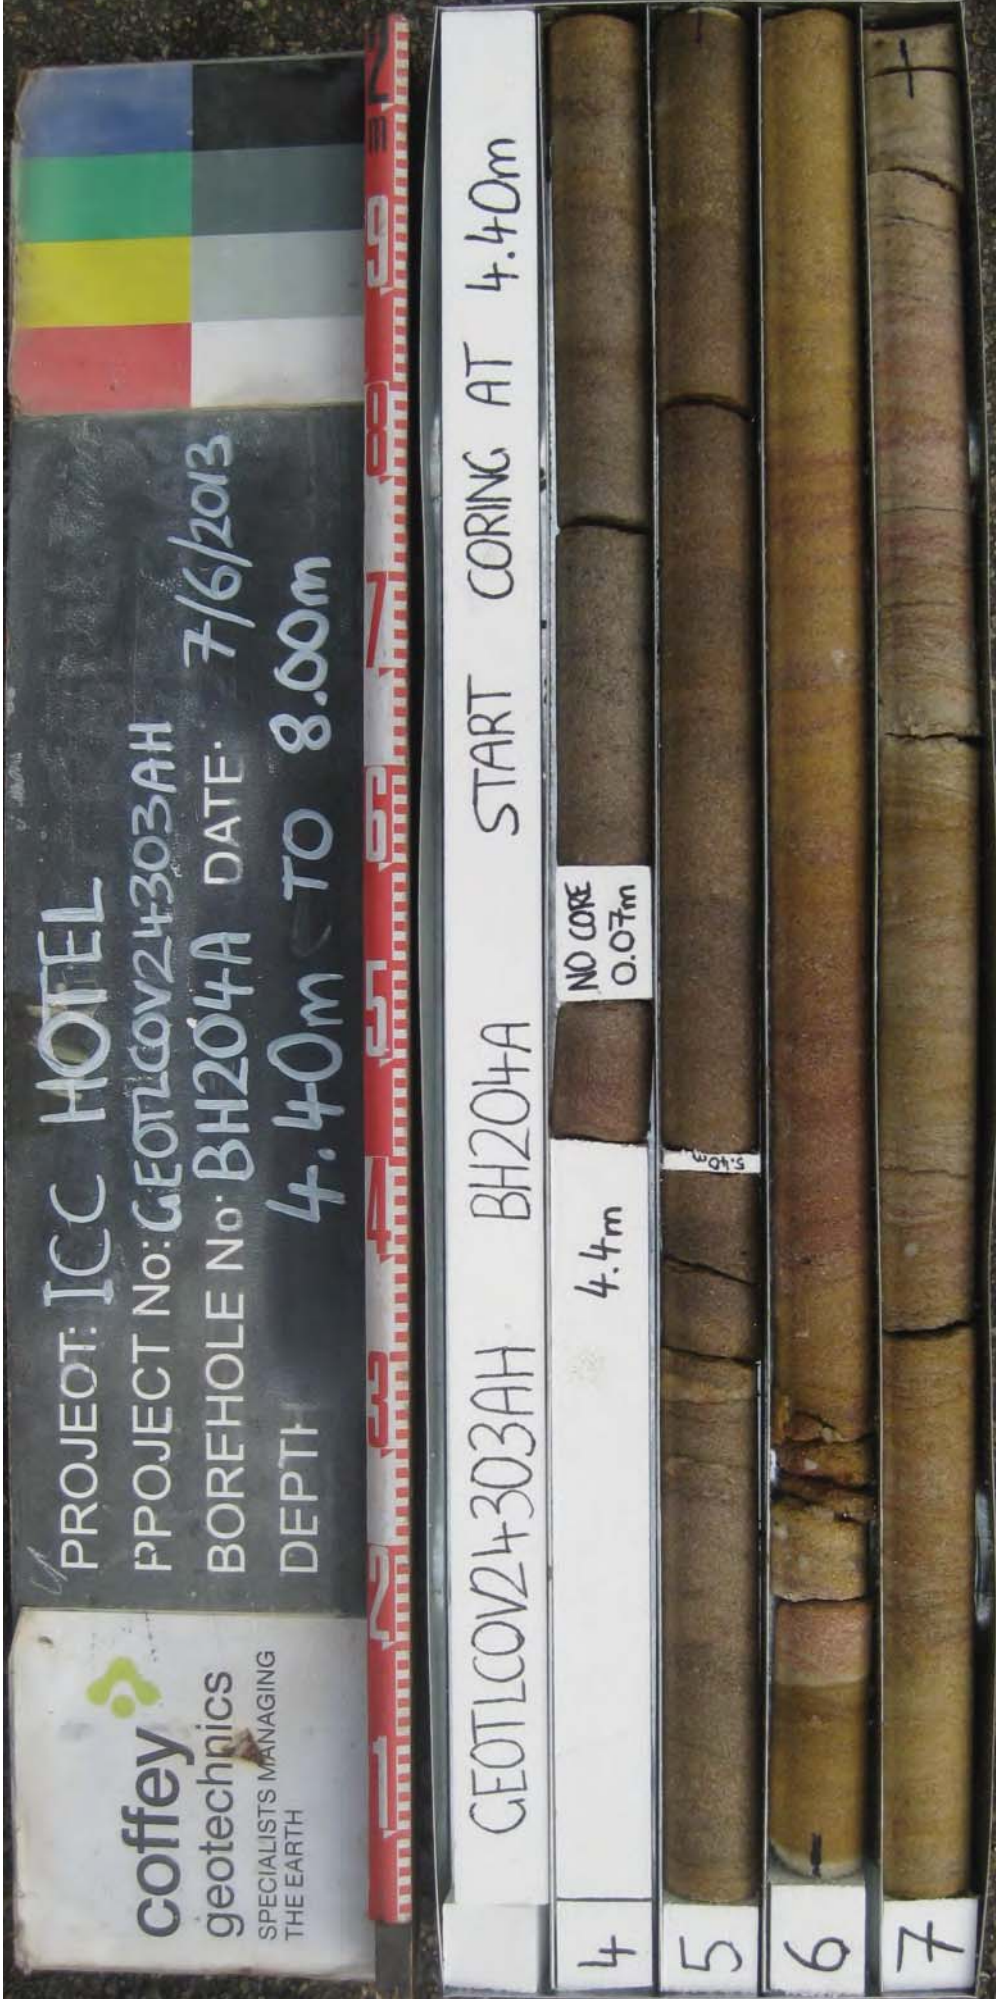
PointID : BH204a Depth Range: 4.40 - 8.00 m

| title: | CORE PHOTOGRAPH<br>BH204A | | | |
