Preliminary Site Investigation

Proposed Campus Improvement Program
Camperdown and Darlington Campus,
University of Sydney

Prepared for
University of Sydney – Campus Infrastructure and Services

Project 73716.00
November 2013

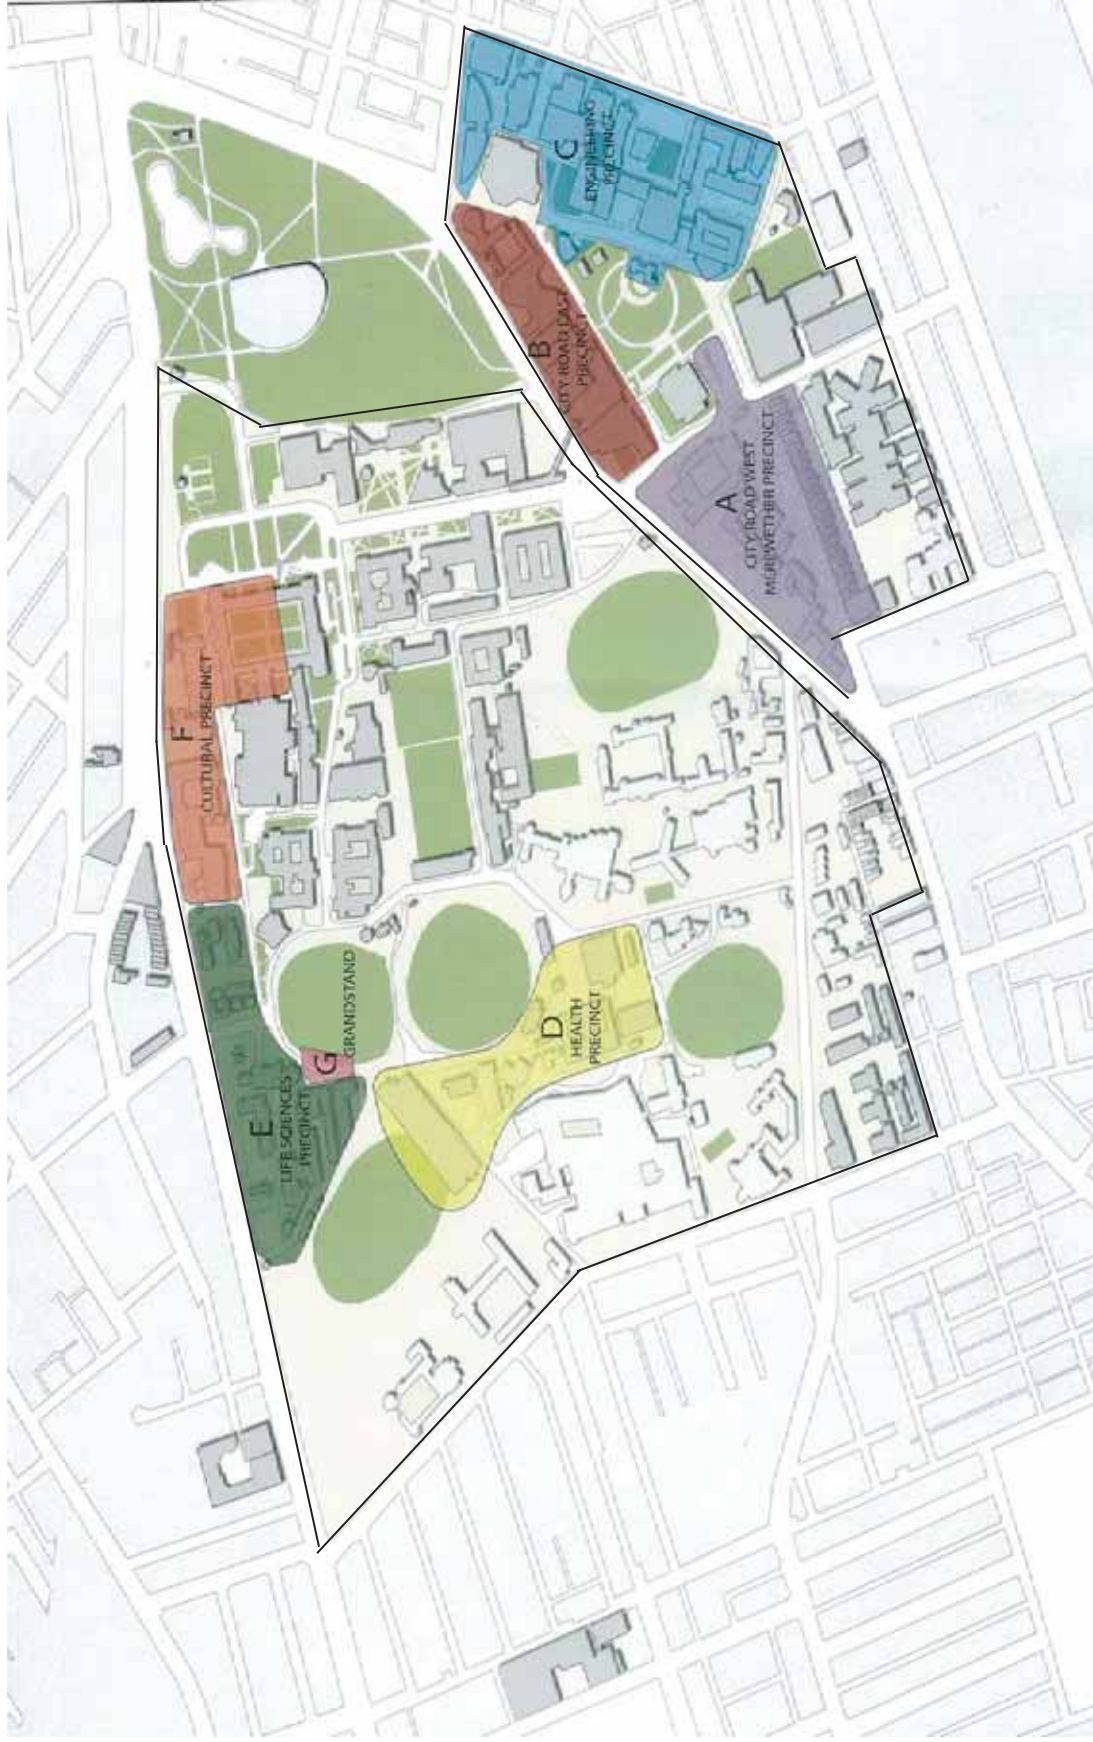
PROJECT No:	73716
DWG No:	1
REVISION:	A

Site Location Plan and Precincts
Preliminary Site Investigation
University of Sydney
