MTW Annual Review Appendix 6 – Rehabilitation Summary

MTW Rehabilitation Areas 2020

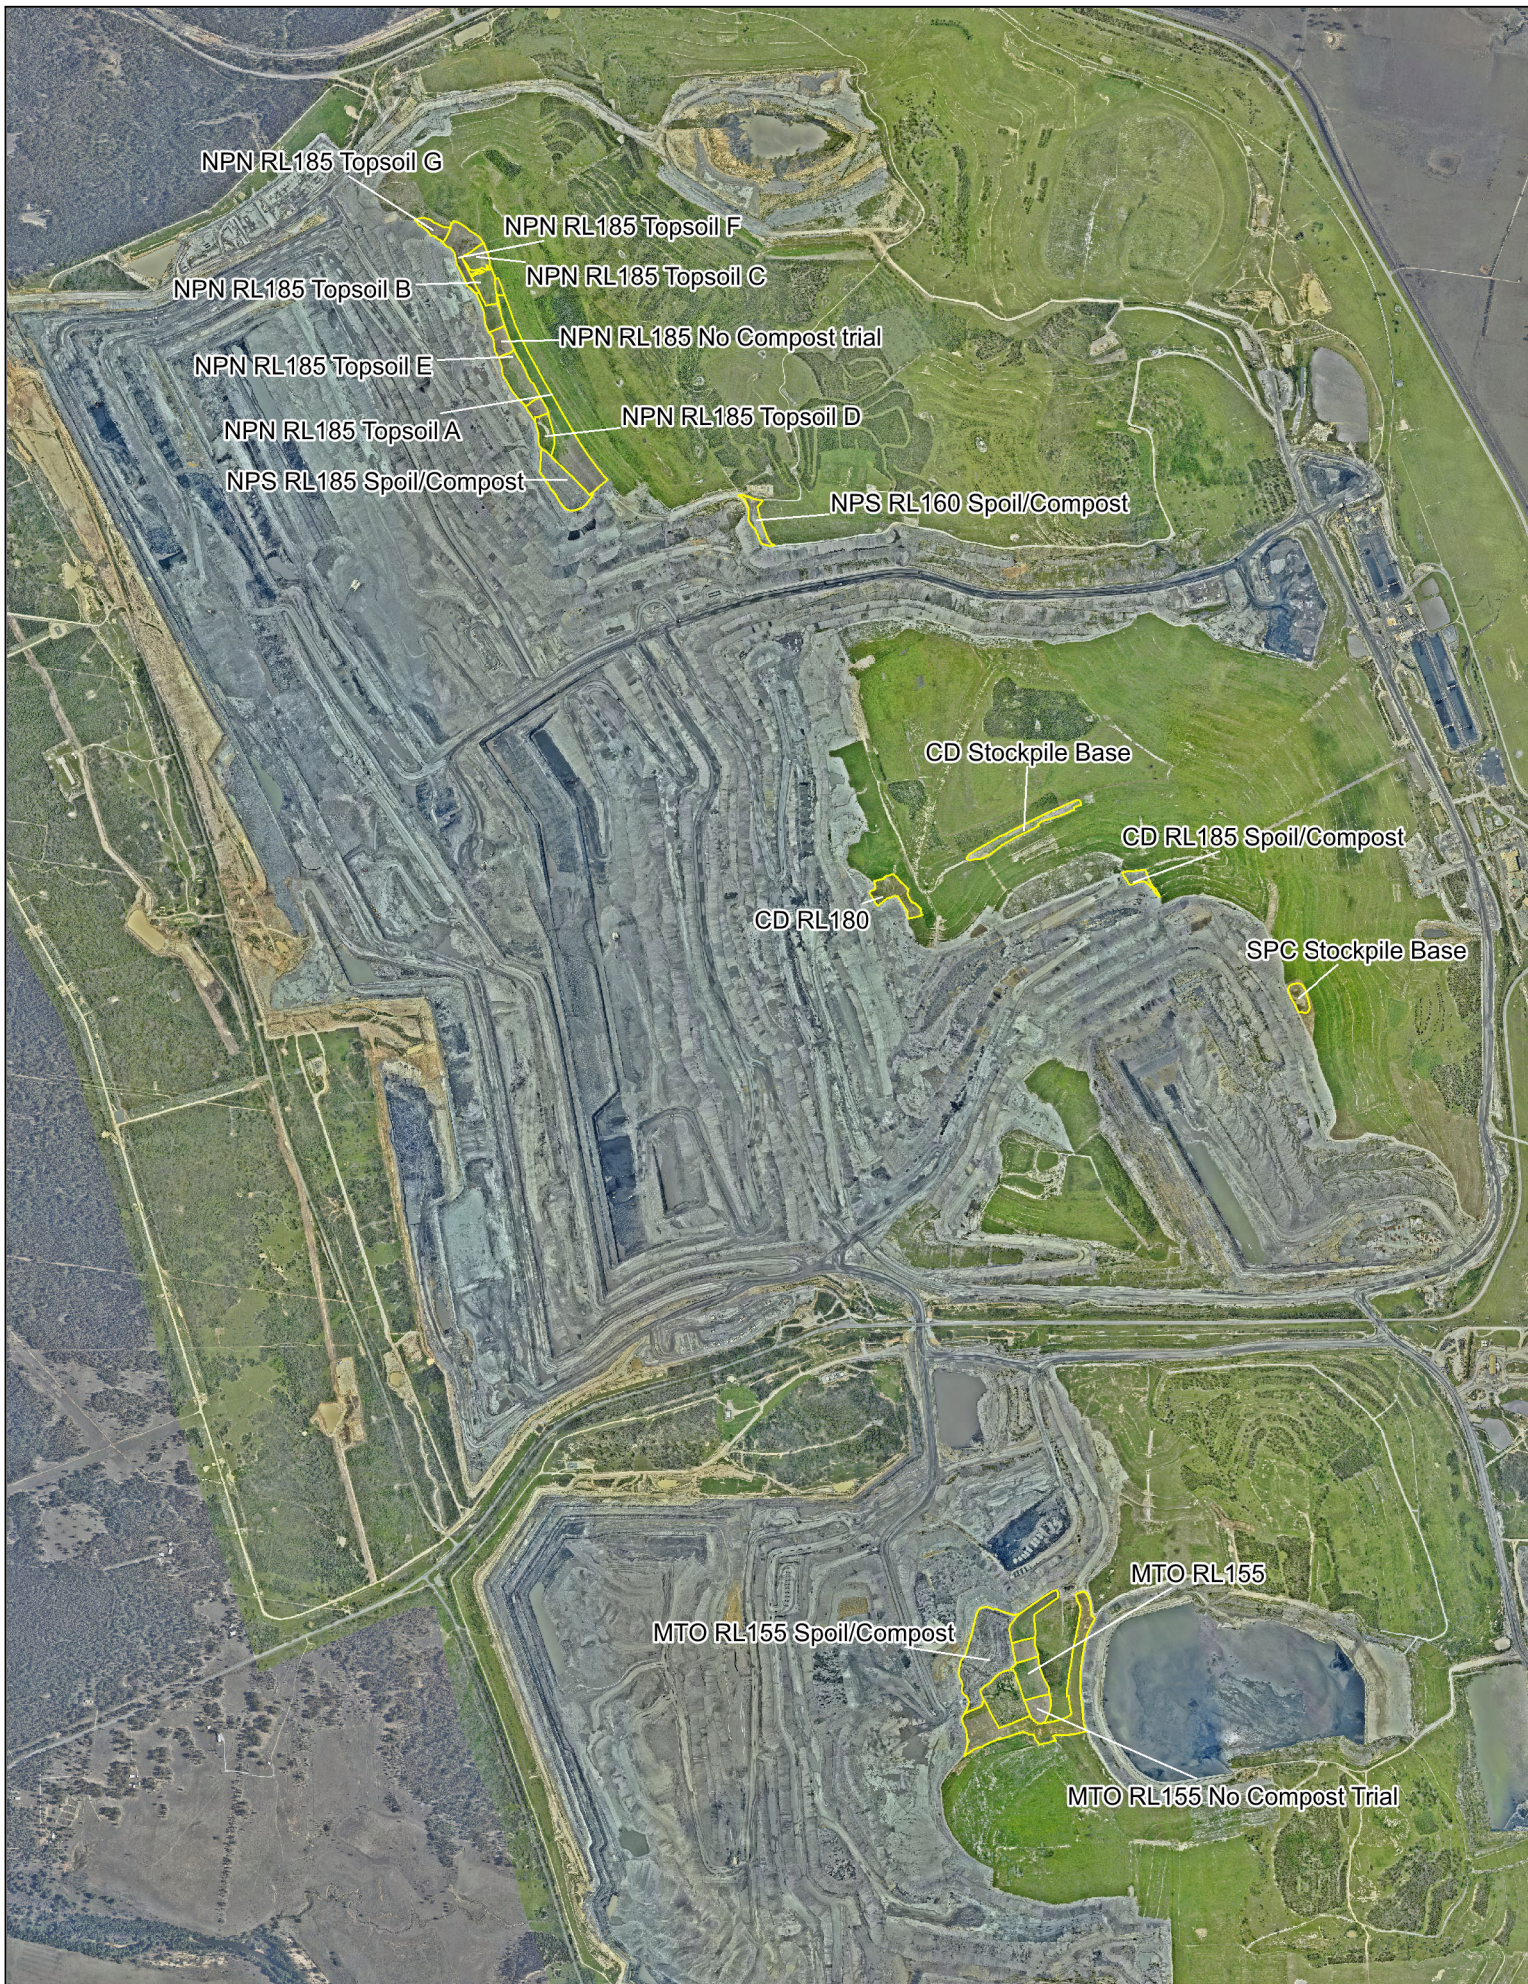
File: Rehab areas 2020.wor
Rehab Areas 2020.PDF
Aerial photo taken December 2020
