Art Gallery of NSW Expansion Project –
Sydney Modern

Stage 1 Preliminary Environmental Study

25 September 2017

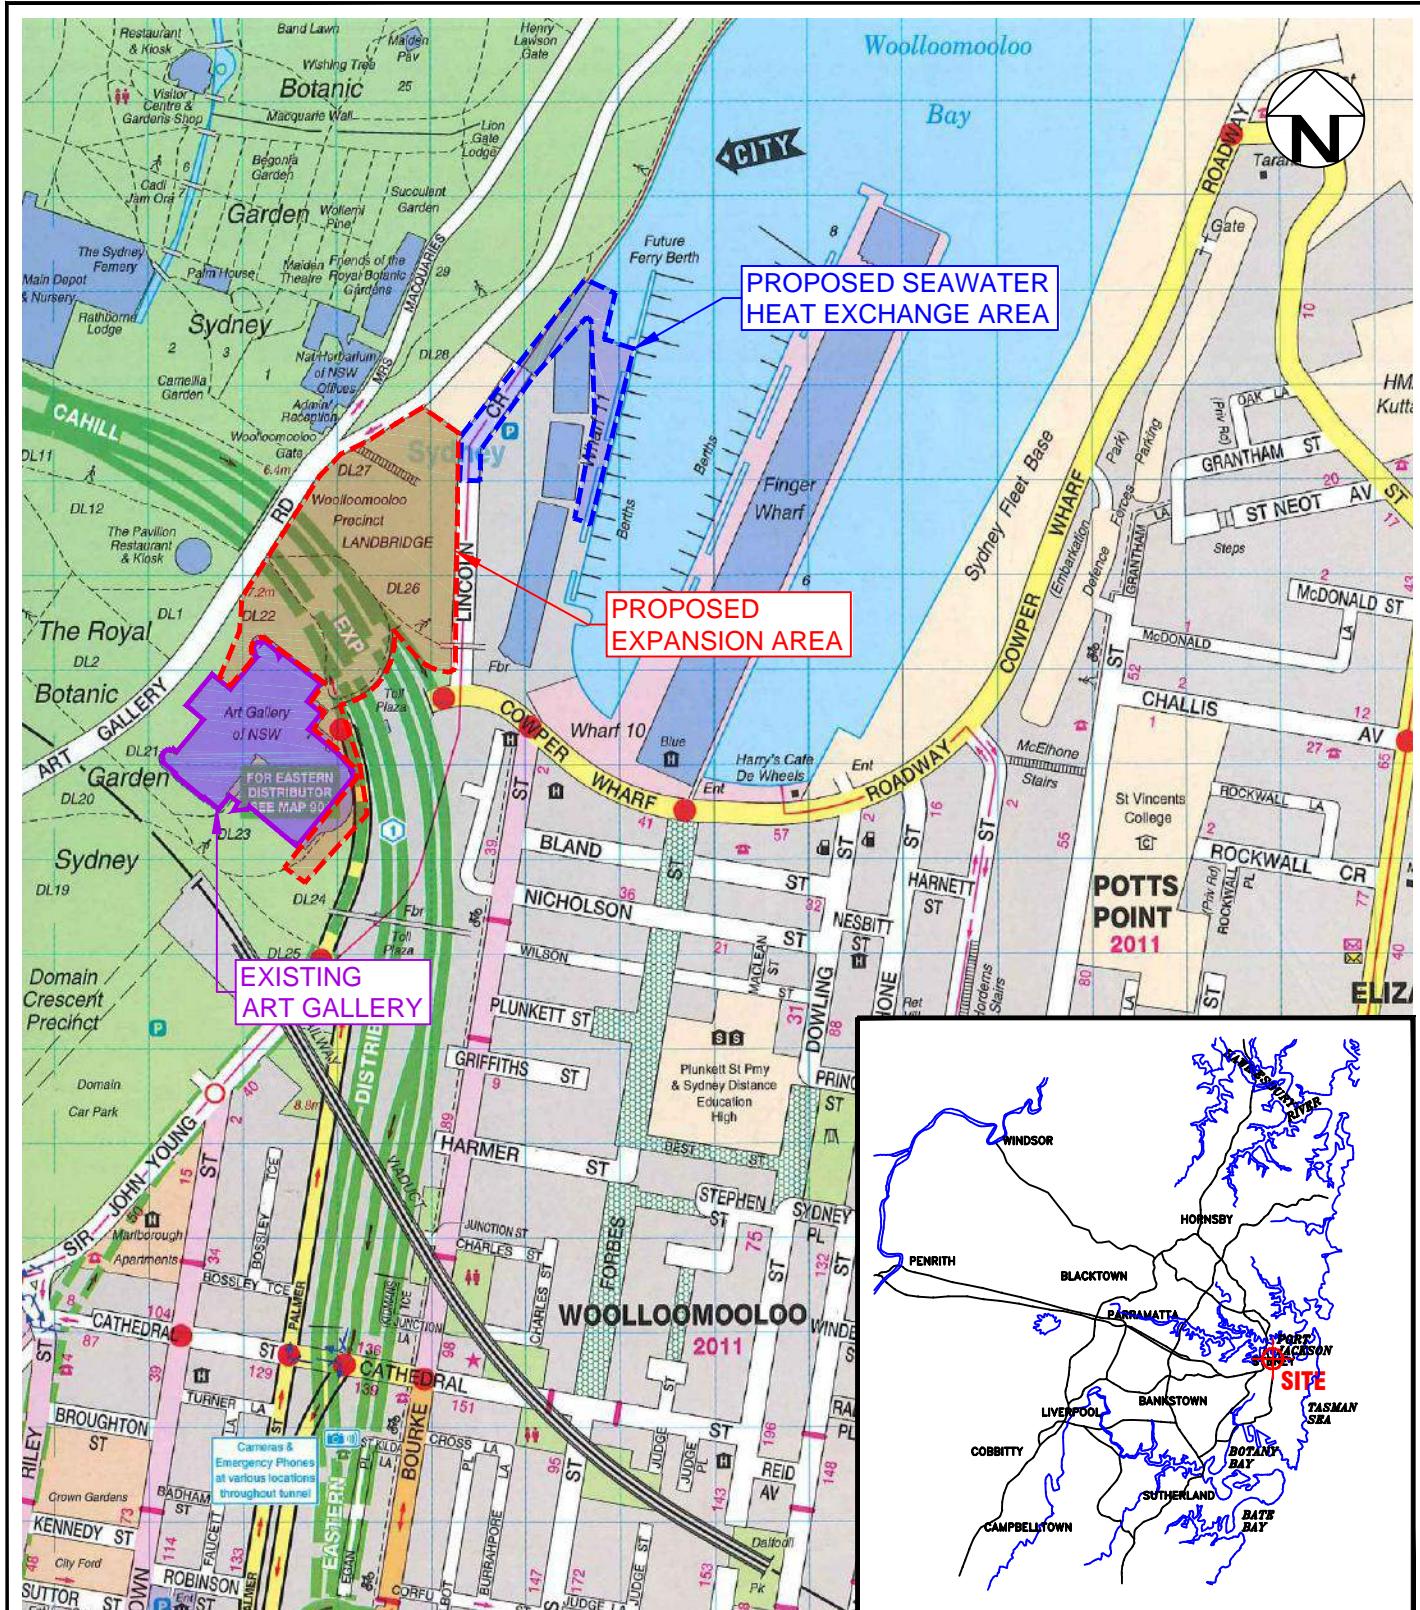
client:	ART GALLERY OF NSW		
approved	-		project:	STAGE 1 PRELIMINARY ENVIRONMENTAL STUDY SYDNEY MODERN PROJECT ART GALLERY ROAD, SYDNEY, NSW		
date	23 / 05 / 16		title:	SITE LOCATION PLAN		
scale	AS SHOWN		project no:	GEOTLCOV25037AC-R01	figure no:	FIGURE 1
original size	A4		rev:	A

The site location and site layout are shown in Figure 1 and Figure 2 respectively.

The location and layout of the site is show in Figures 1 and 2 respectively.

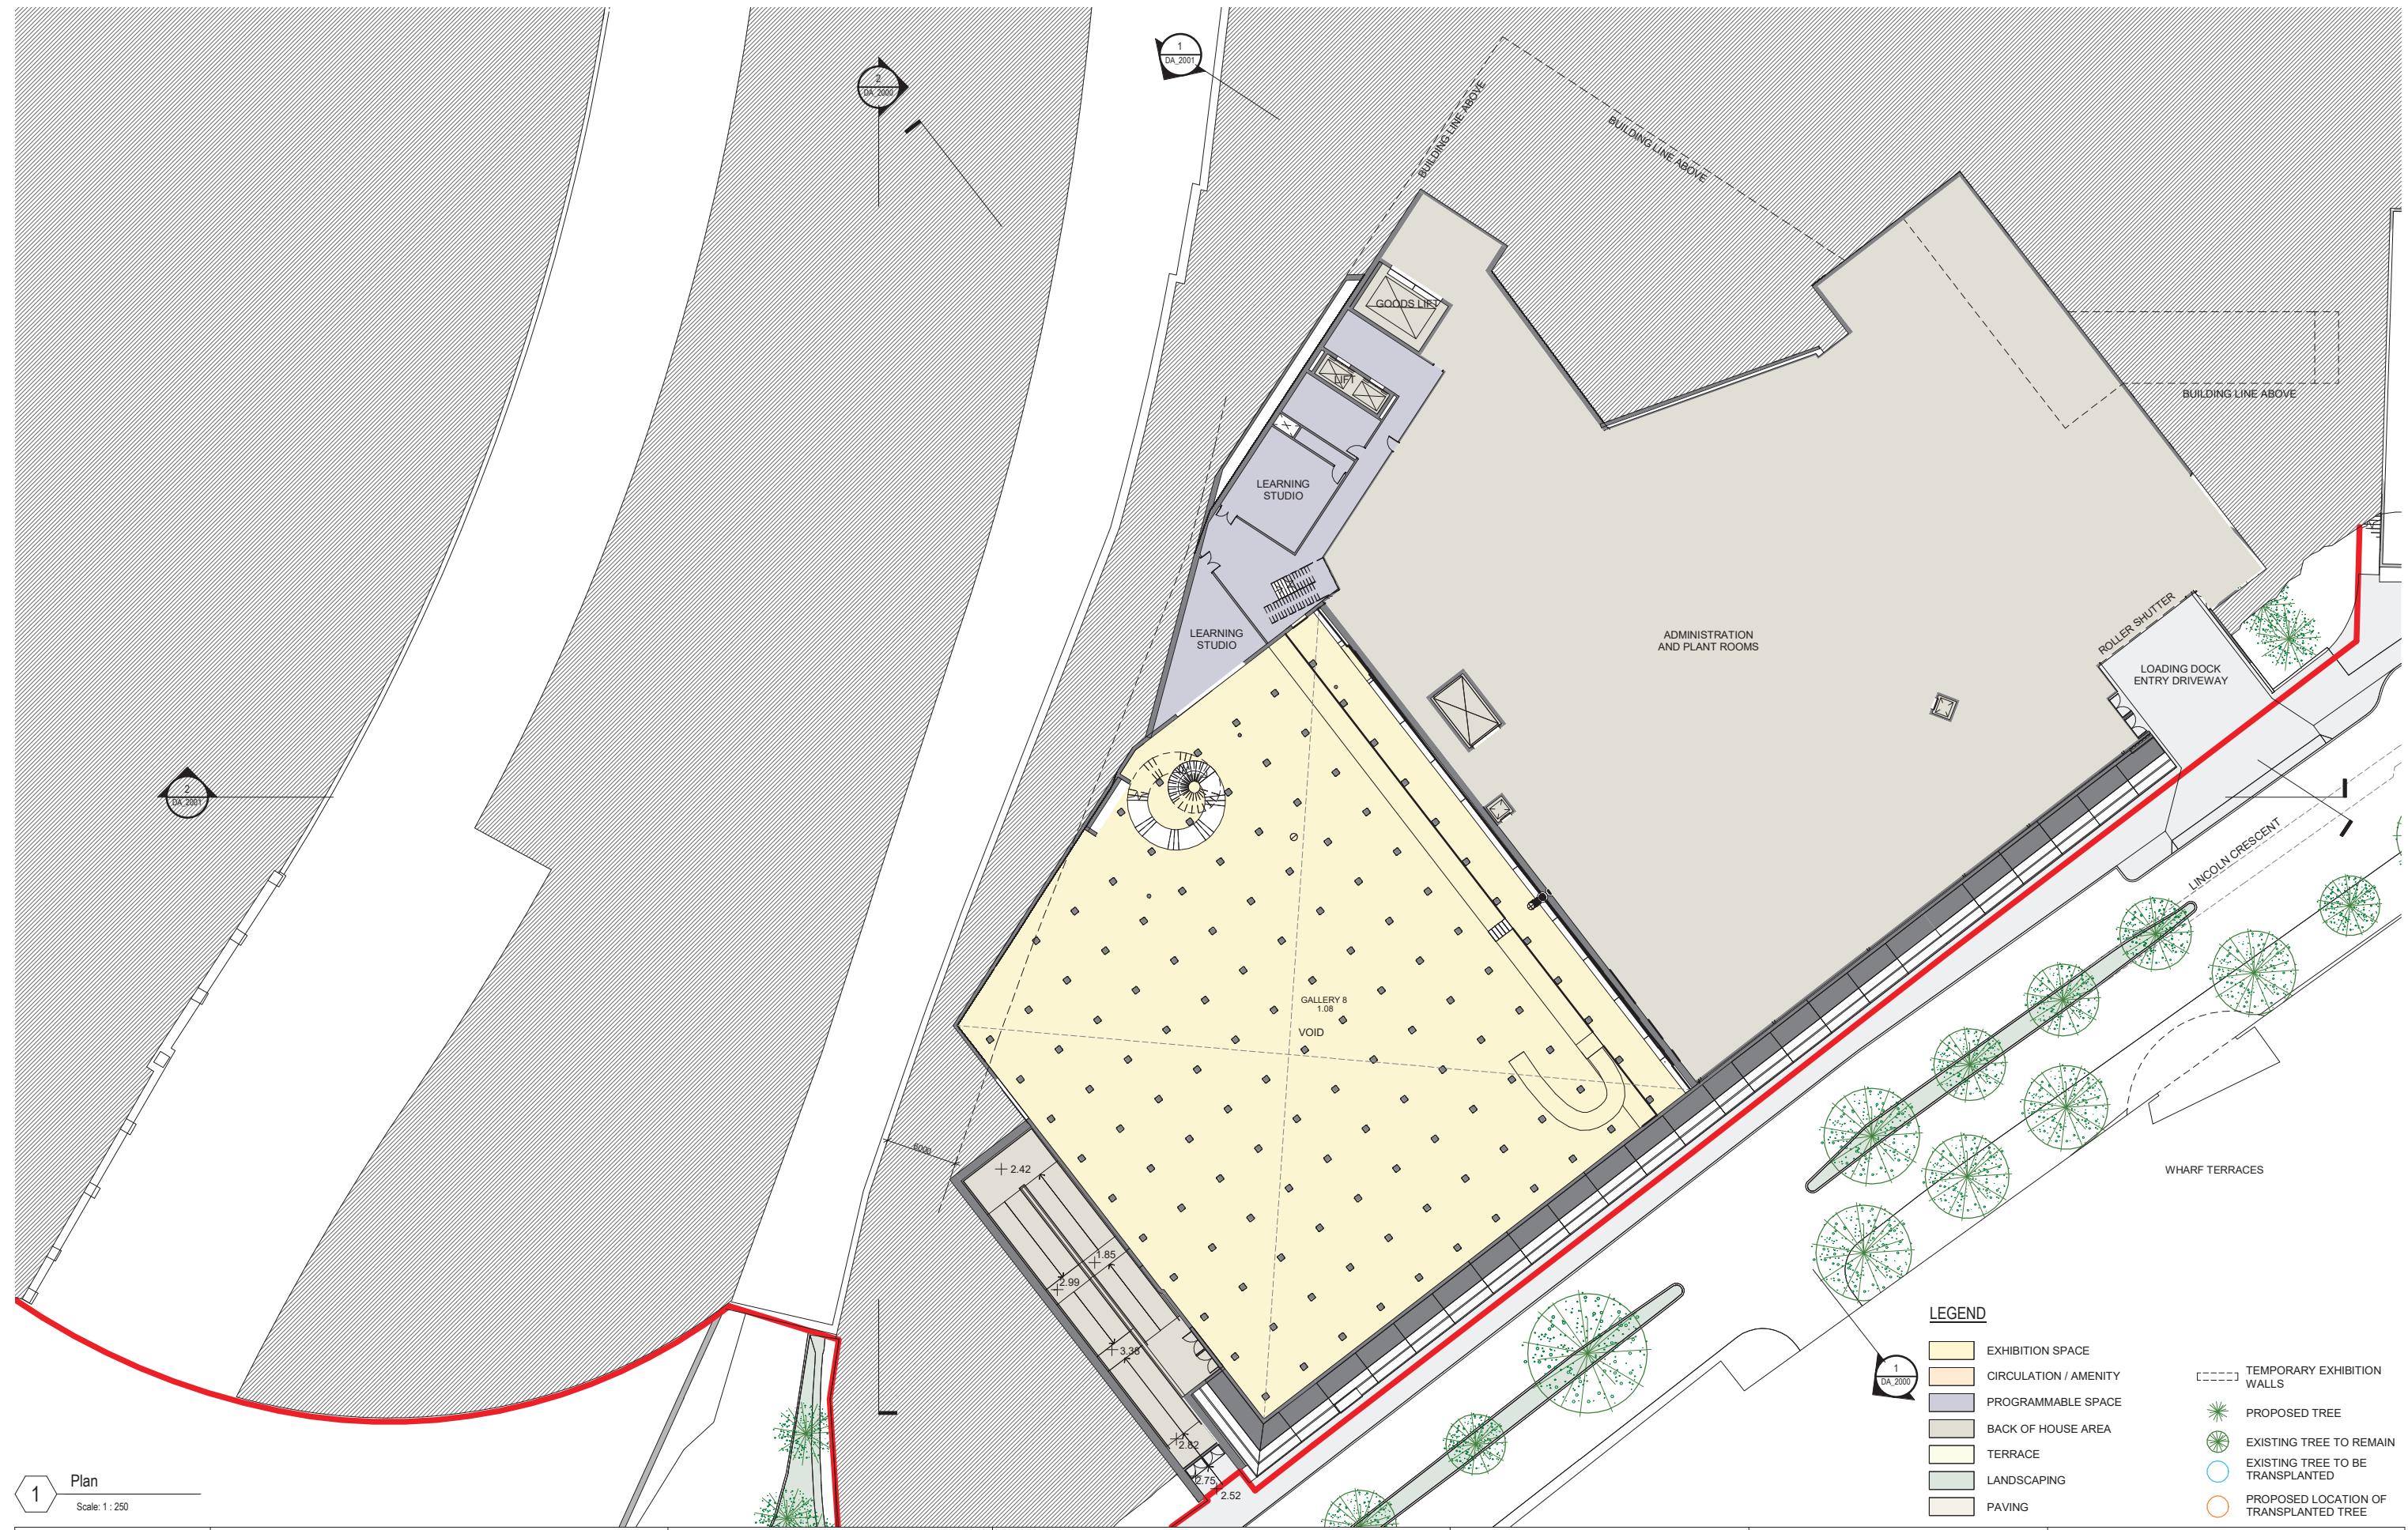
1 Plan
Scale: 1:250

drawing
 Lower Level 3 Plan - Demolition plan
 drawing no.
 Revision
DA_1004
C

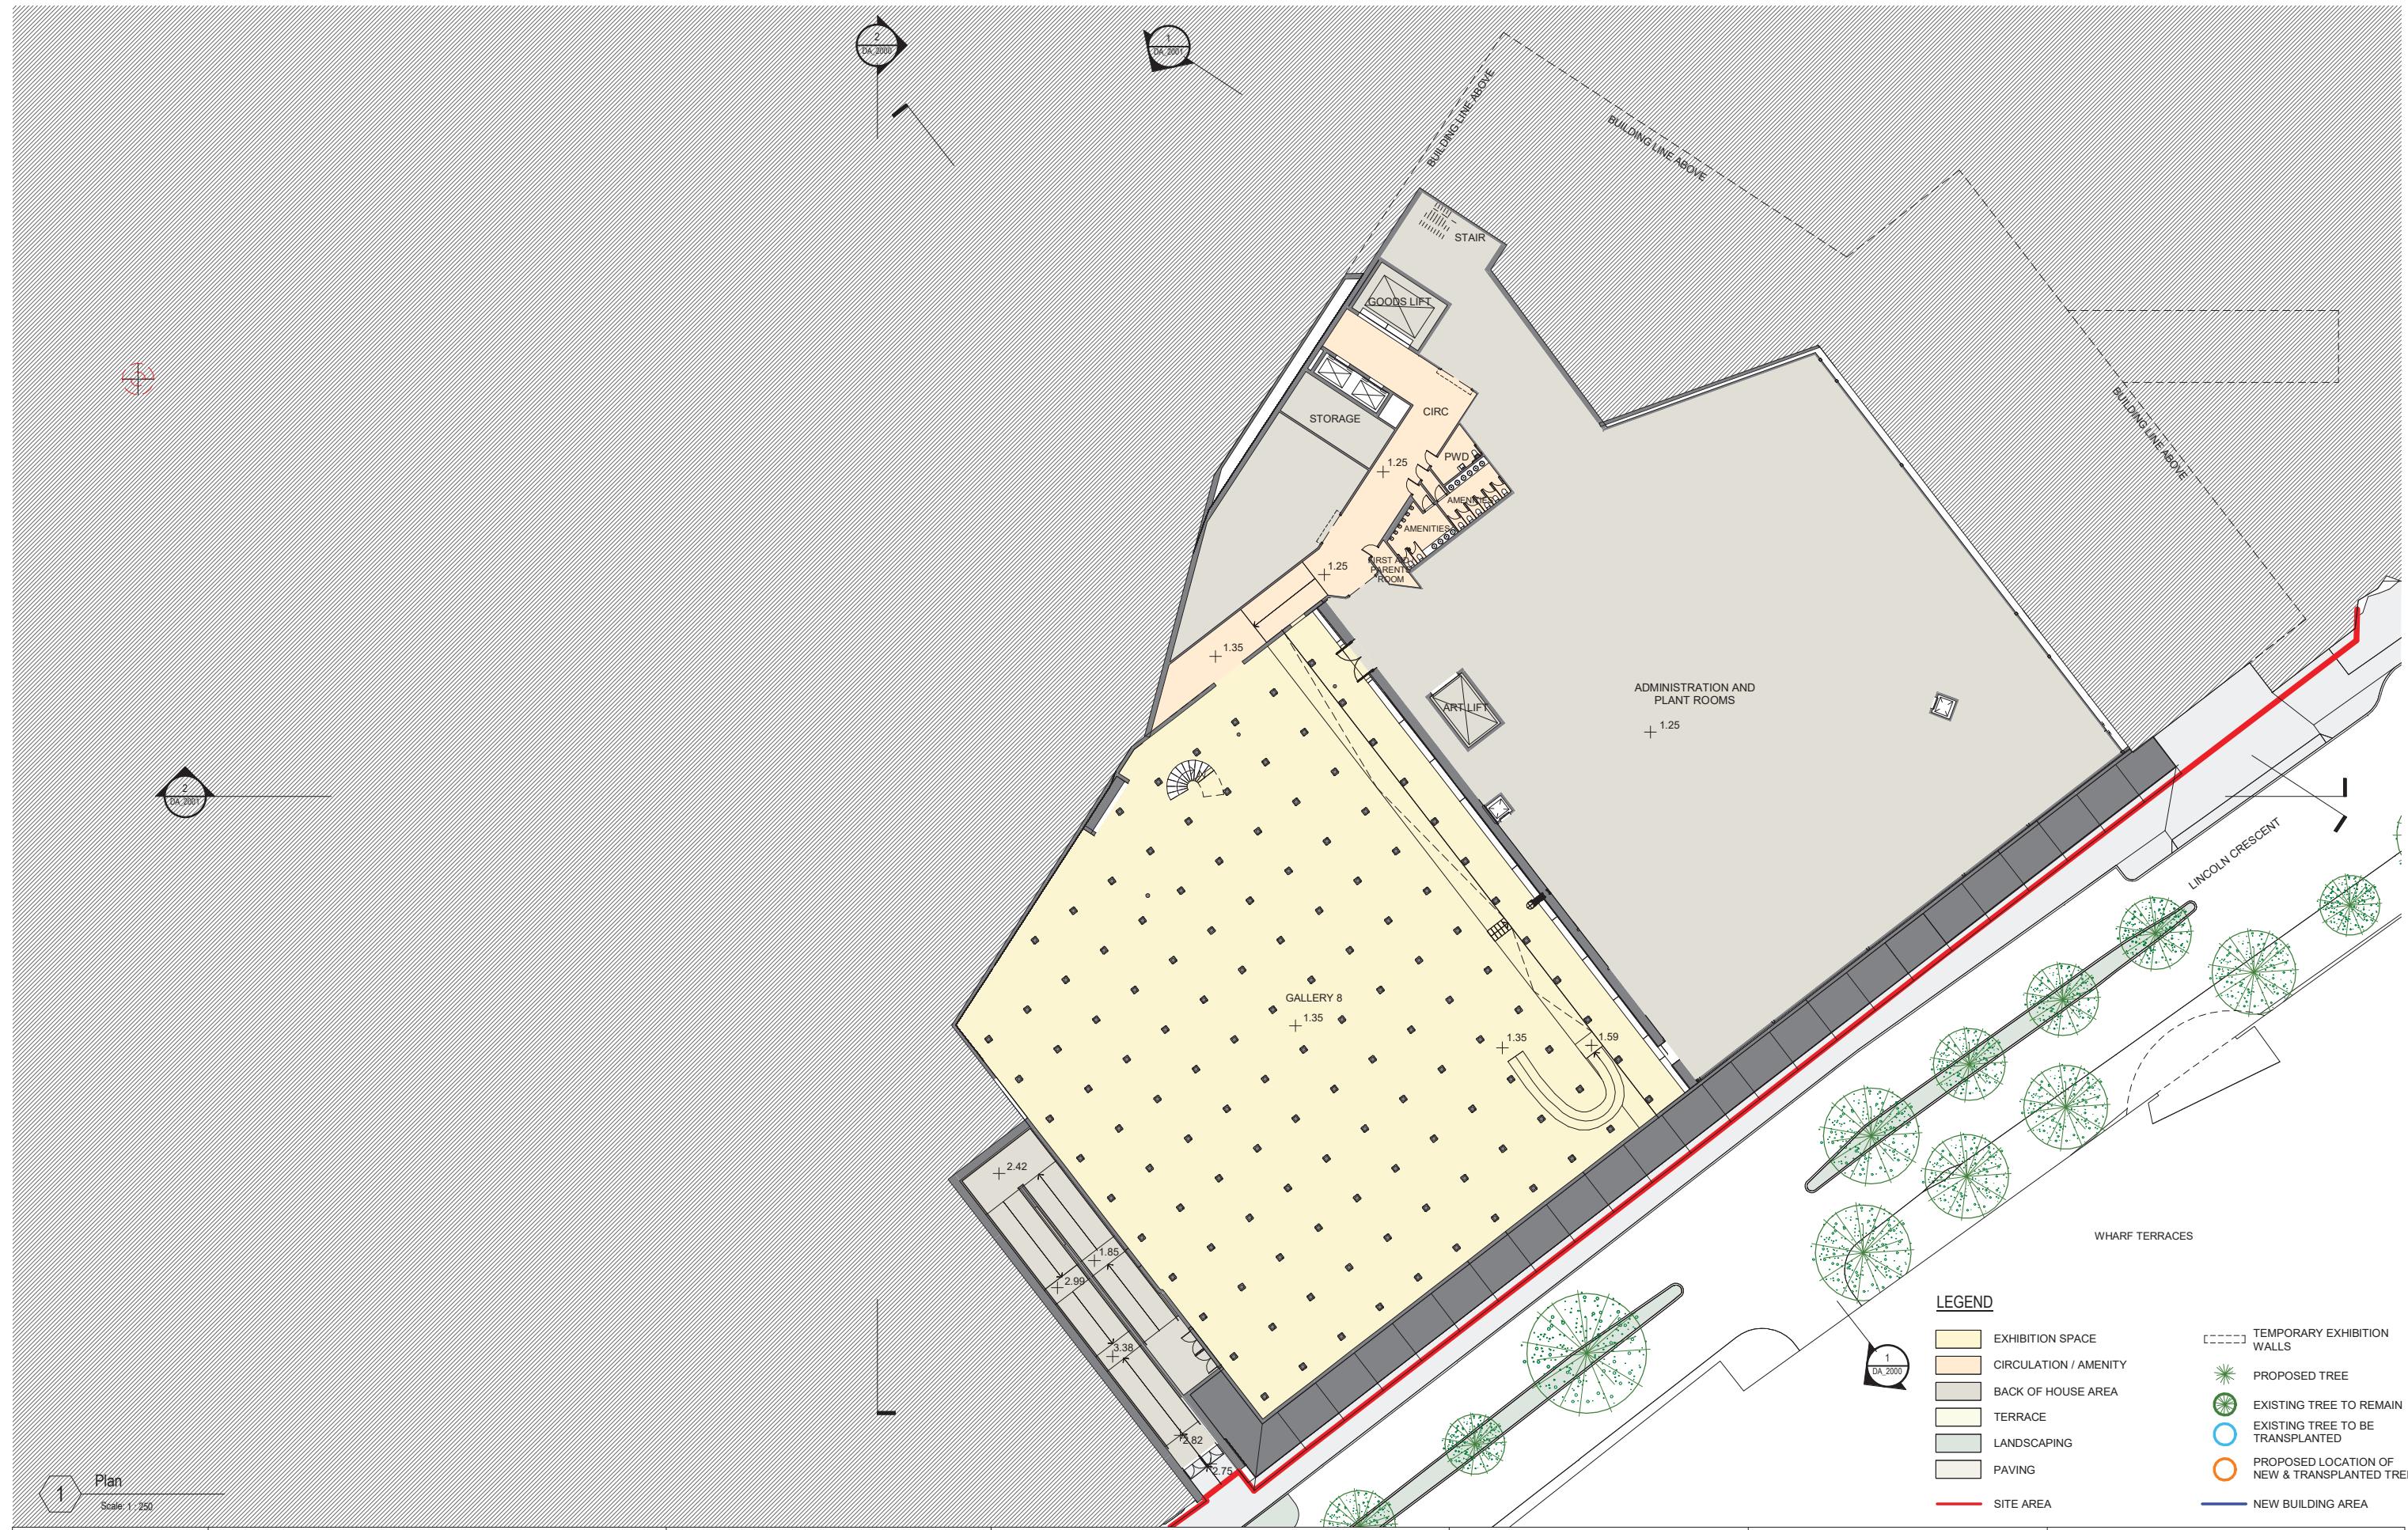
drawing no. DA_1005
Revision D

drawing
Lower Level 3 Plan - Proposed Plan
