## **Art Gallery of NSW**

### **Remedial Action Plan**

Art Gallery of NSW Expansion Project –  
Sydney Modern  
Art Gallery Road, Sydney, NSW

GEOTLCOV25037AC-R03 Rev3

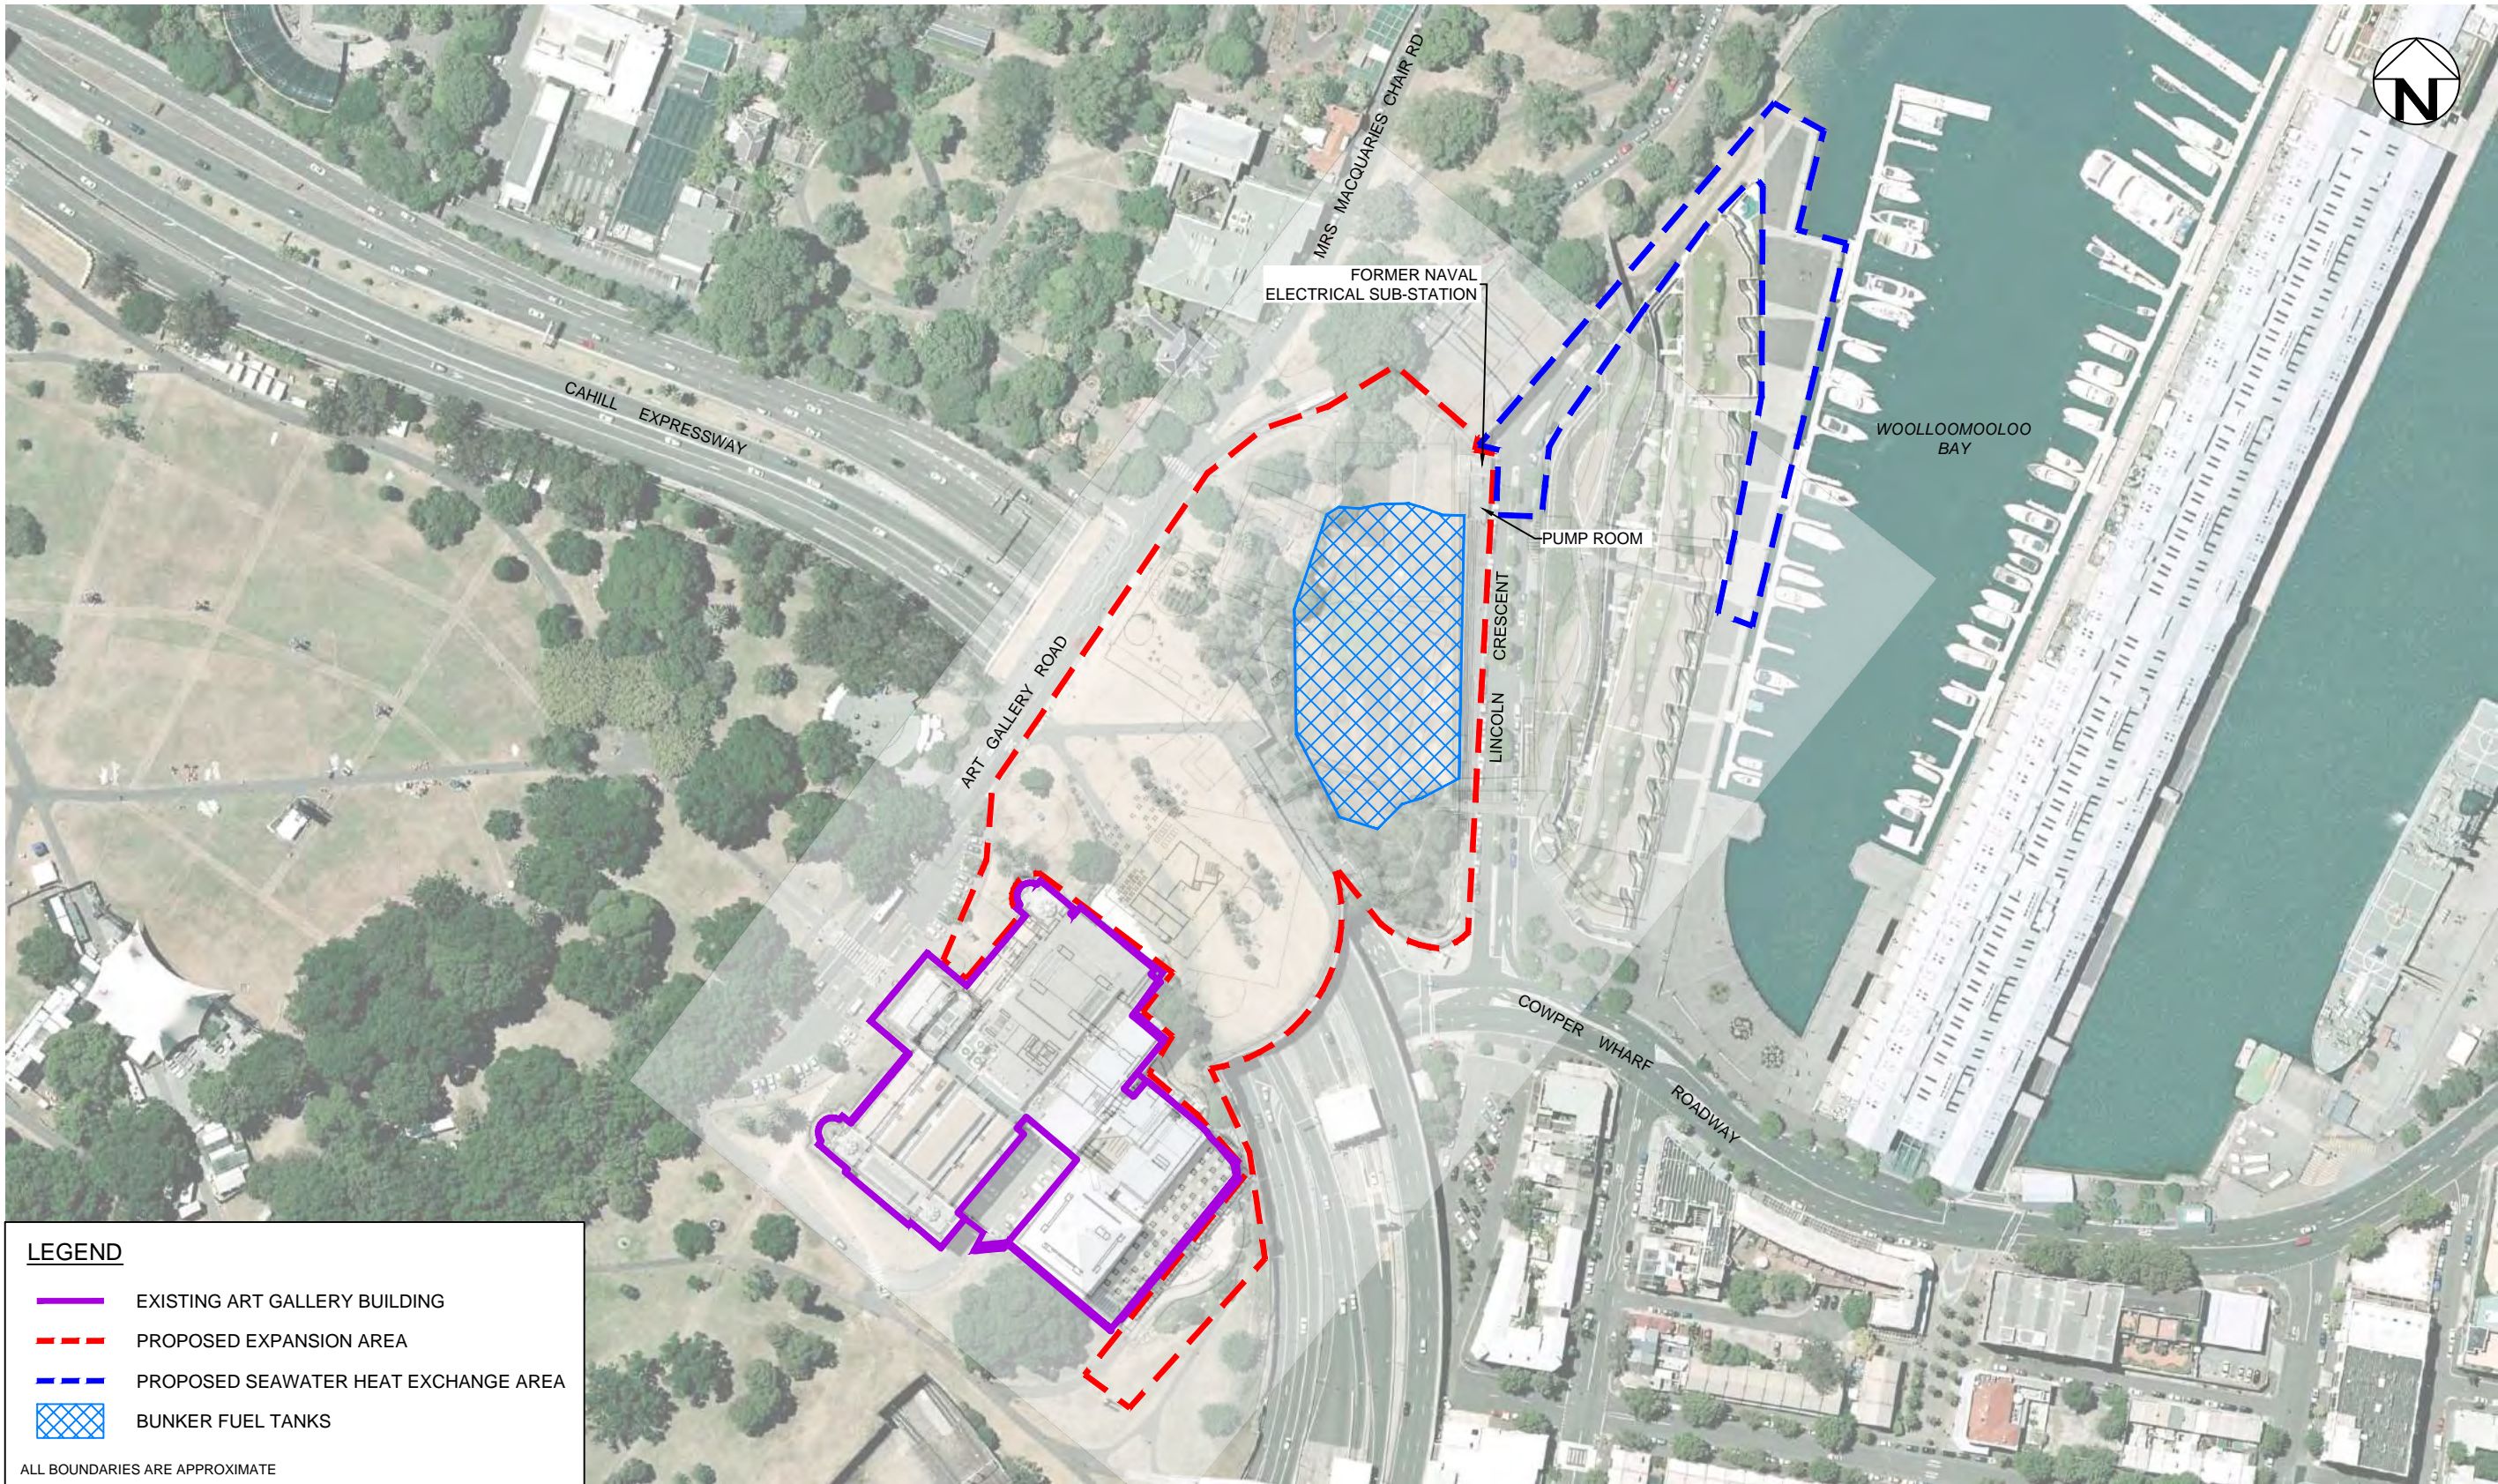
client:	ART GALLERY OF NSW		
project:	REMEDIAL ACTION PLAN SYDNEY MODERN PROJECT ART GALLERY ROAD, SYDNEY, NSW		
title:	PROPOSED DEVELOPMENT AREA		
project no:	GEO\TCOV25037AC-R03B	figure no:	FIGURE 2
		rev:	A

Site identification details and surrounding land uses are summarised in Table 2. The site layout and surrounding areas are shown on Figures 2 and 3.

- Former electrical substation to the north of the pump room - low likelihood of TRH and / or PCB contamination.
- An area of fill to the east of the Cahill Expressway and adjacent to Art Gallery Road (in the vicinity of BH2 and BH4 on Figure 2) contains elevated concentrations of PAHs likely associated with coal and / or bitumen and strong hydrocarbon odours were observed during boring of BH2 and BH4. Based on additional assessment and delineation works undertaken, the area of impact appears to be localised. Based on the results and subject to leachate testing as part of future waste classification works, soils in this area would likely classify as General Solid Waste. Visual observation of soil in the vicinity of BH2 and BH4 is also required during excavation works to confirm that the source of B(a)P is likely to be attributed to asphalt waste.

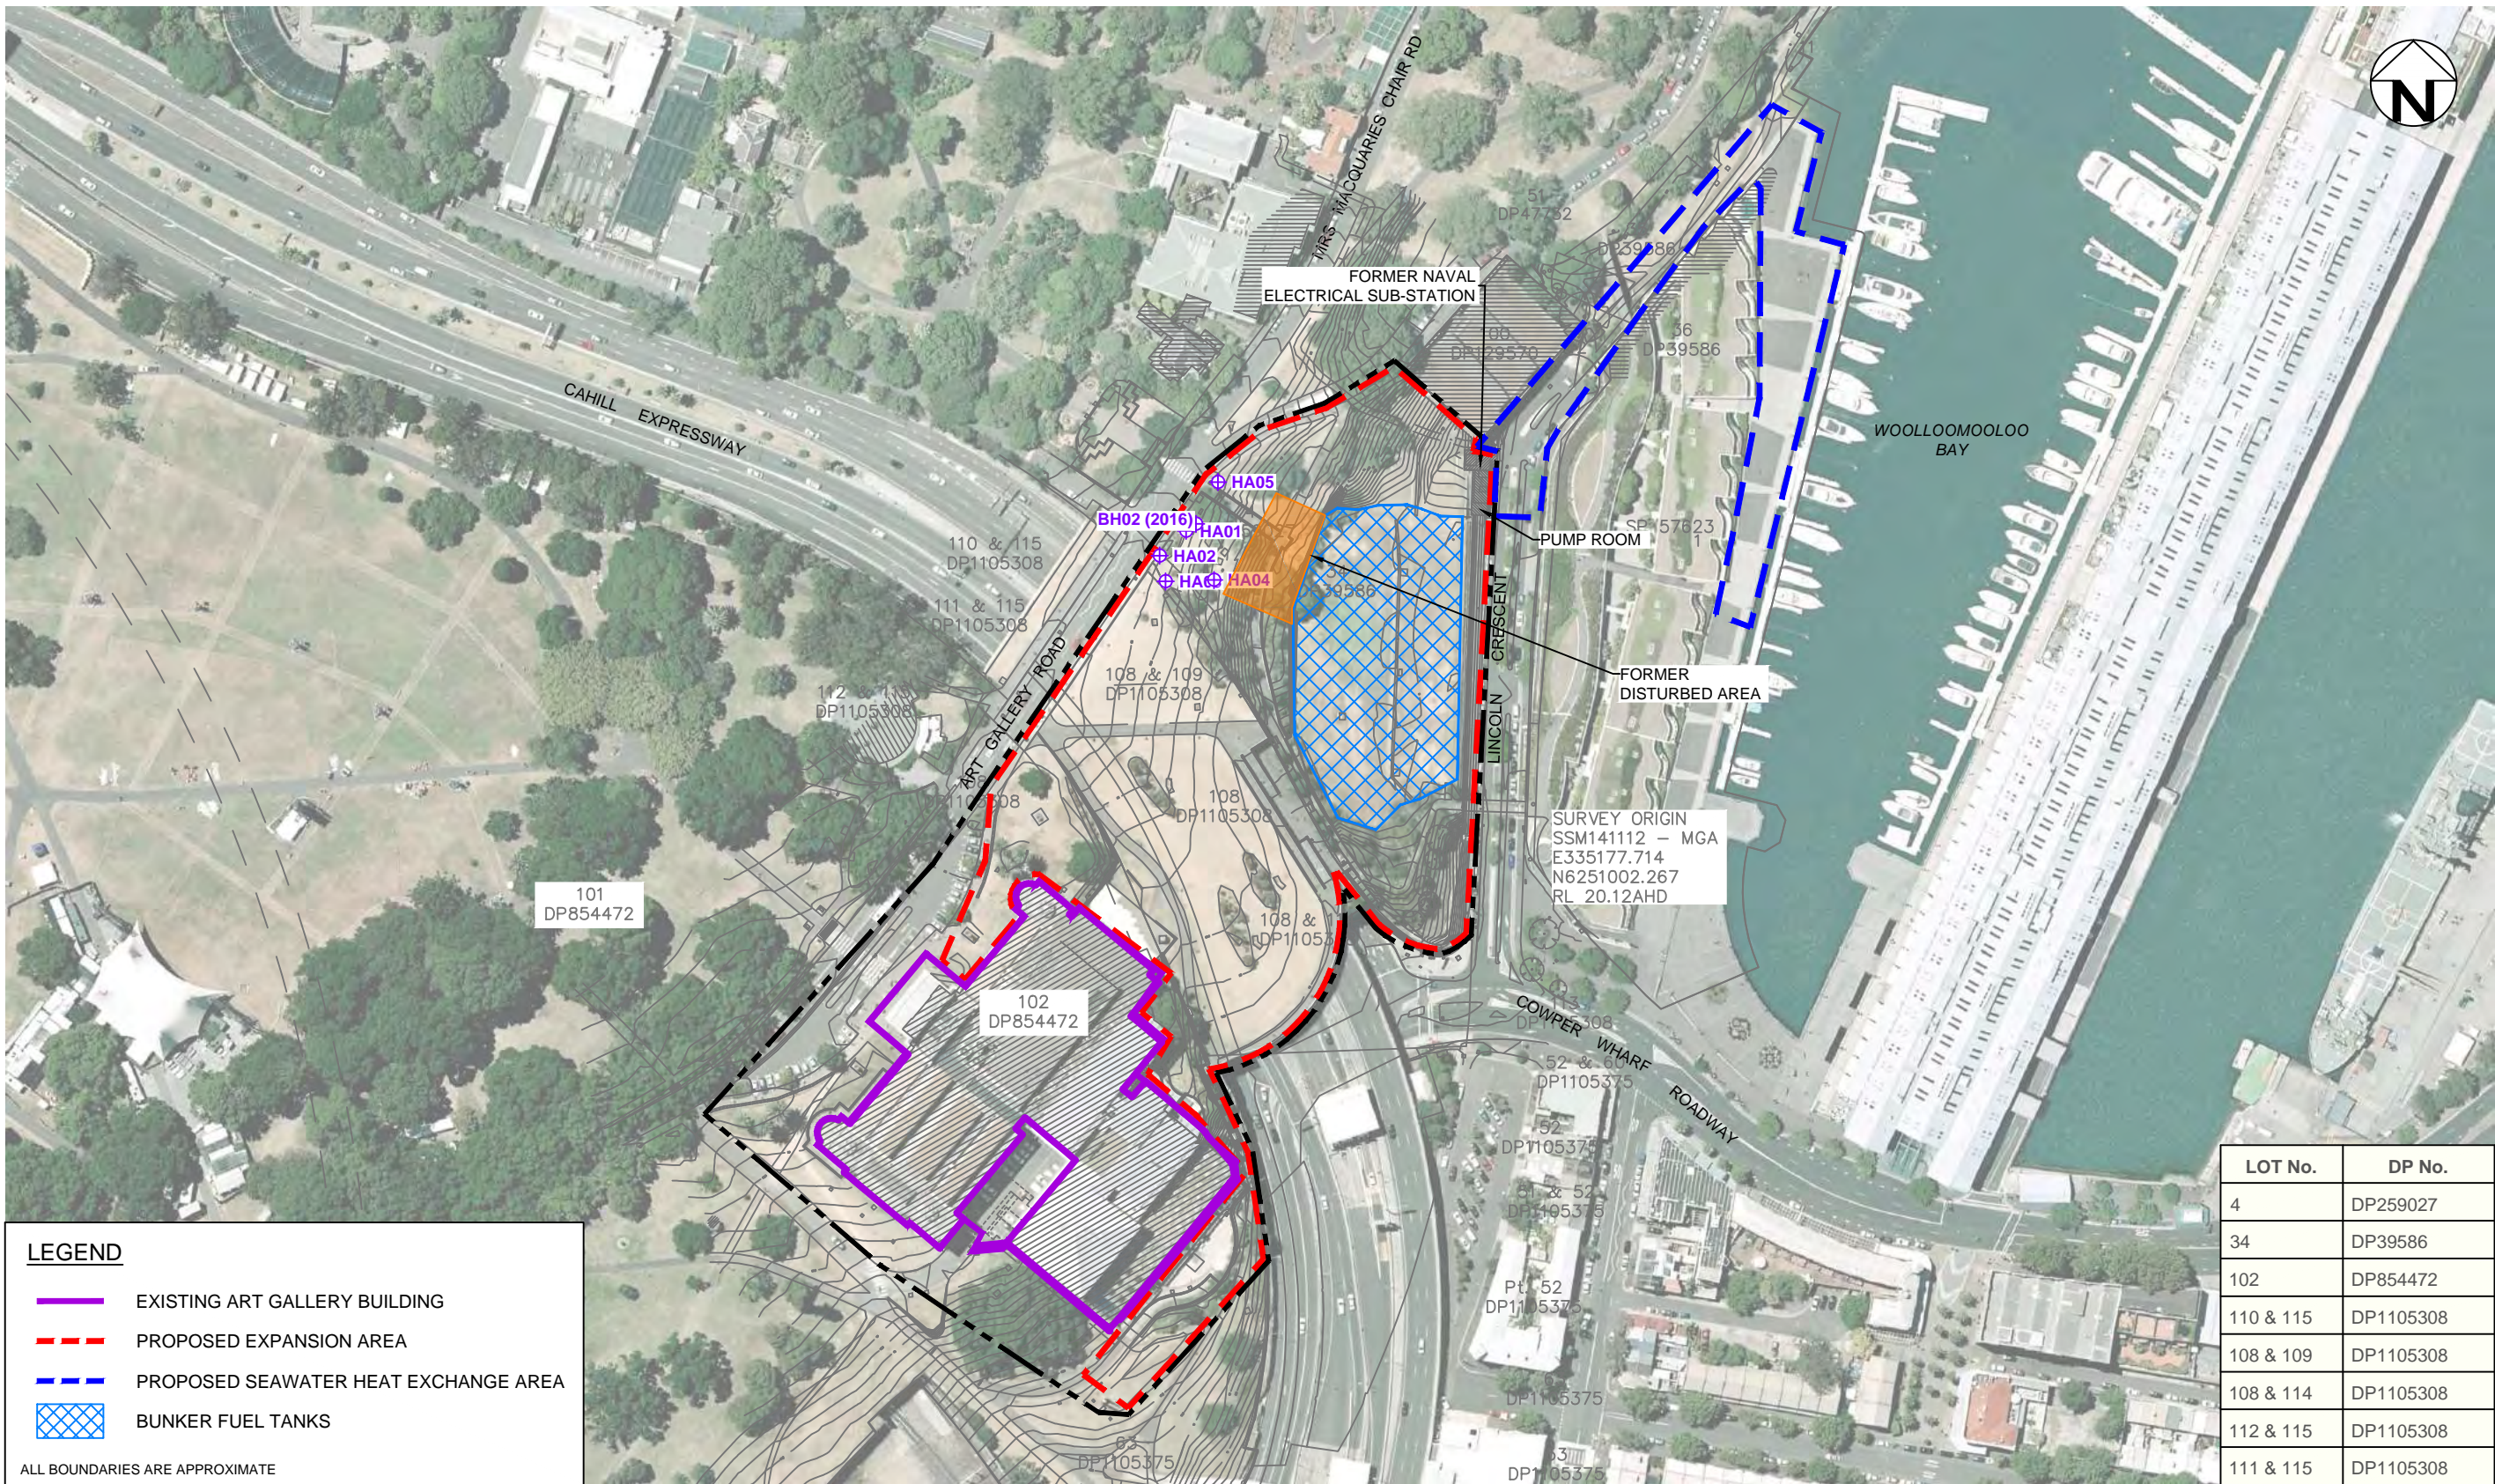
client:	ART GALLERY OF NSW		
project:	REMEDIAL ACTION PLAN SYDNEY MODERN PROJECT ART GALLERY ROAD, SYDNEY, NSW		
title:	SITE SURVEY DRAWING		
project no:	GEO\TCOV25037AC-R03B	figure no:	FIGURE 3
		rev:	A

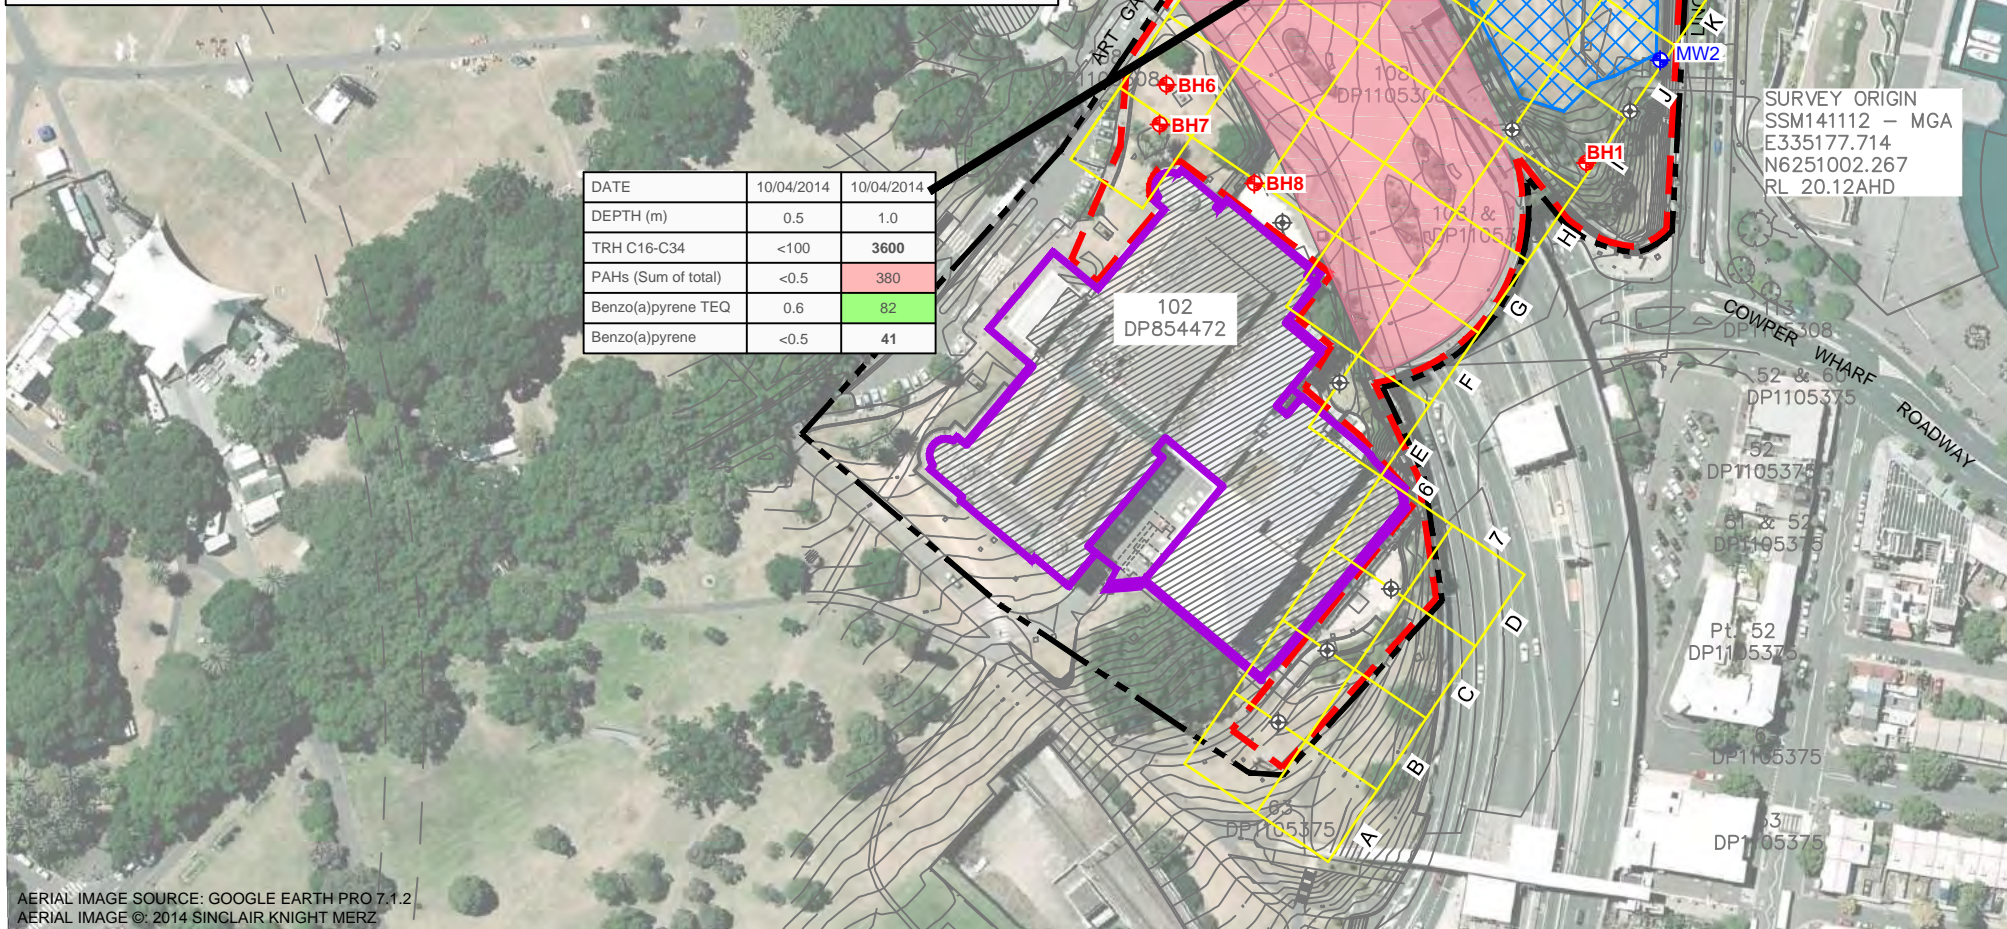
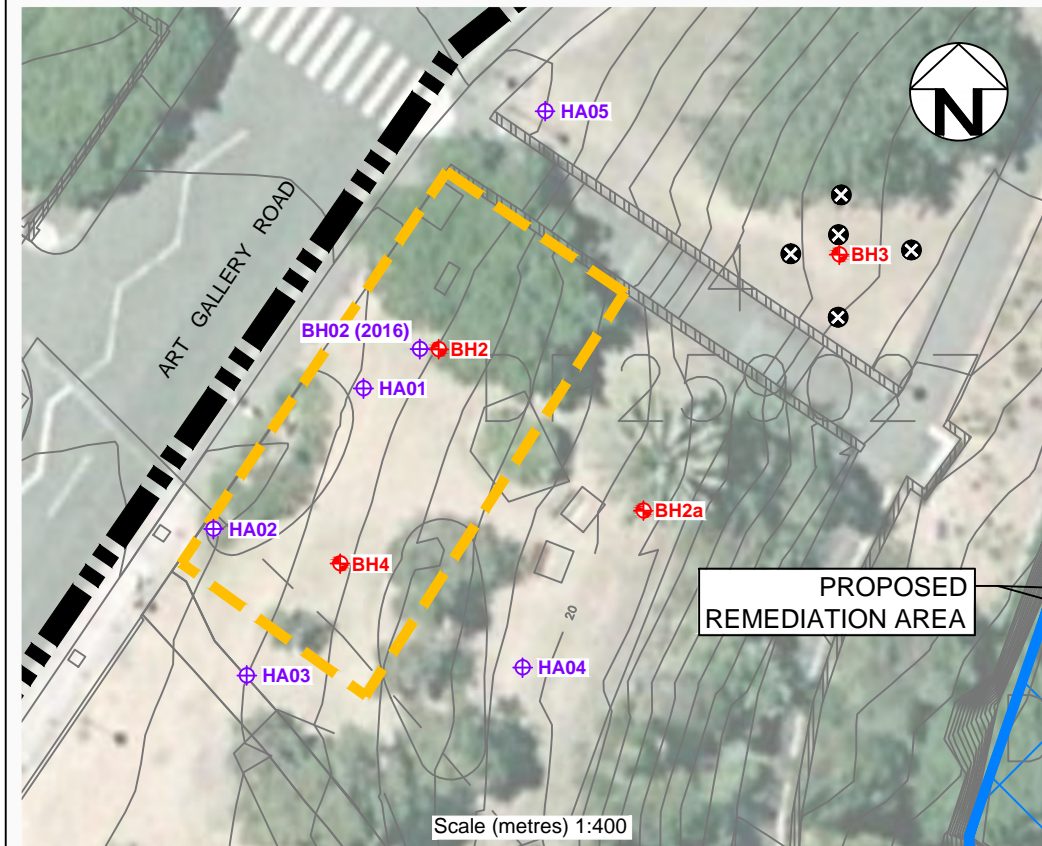
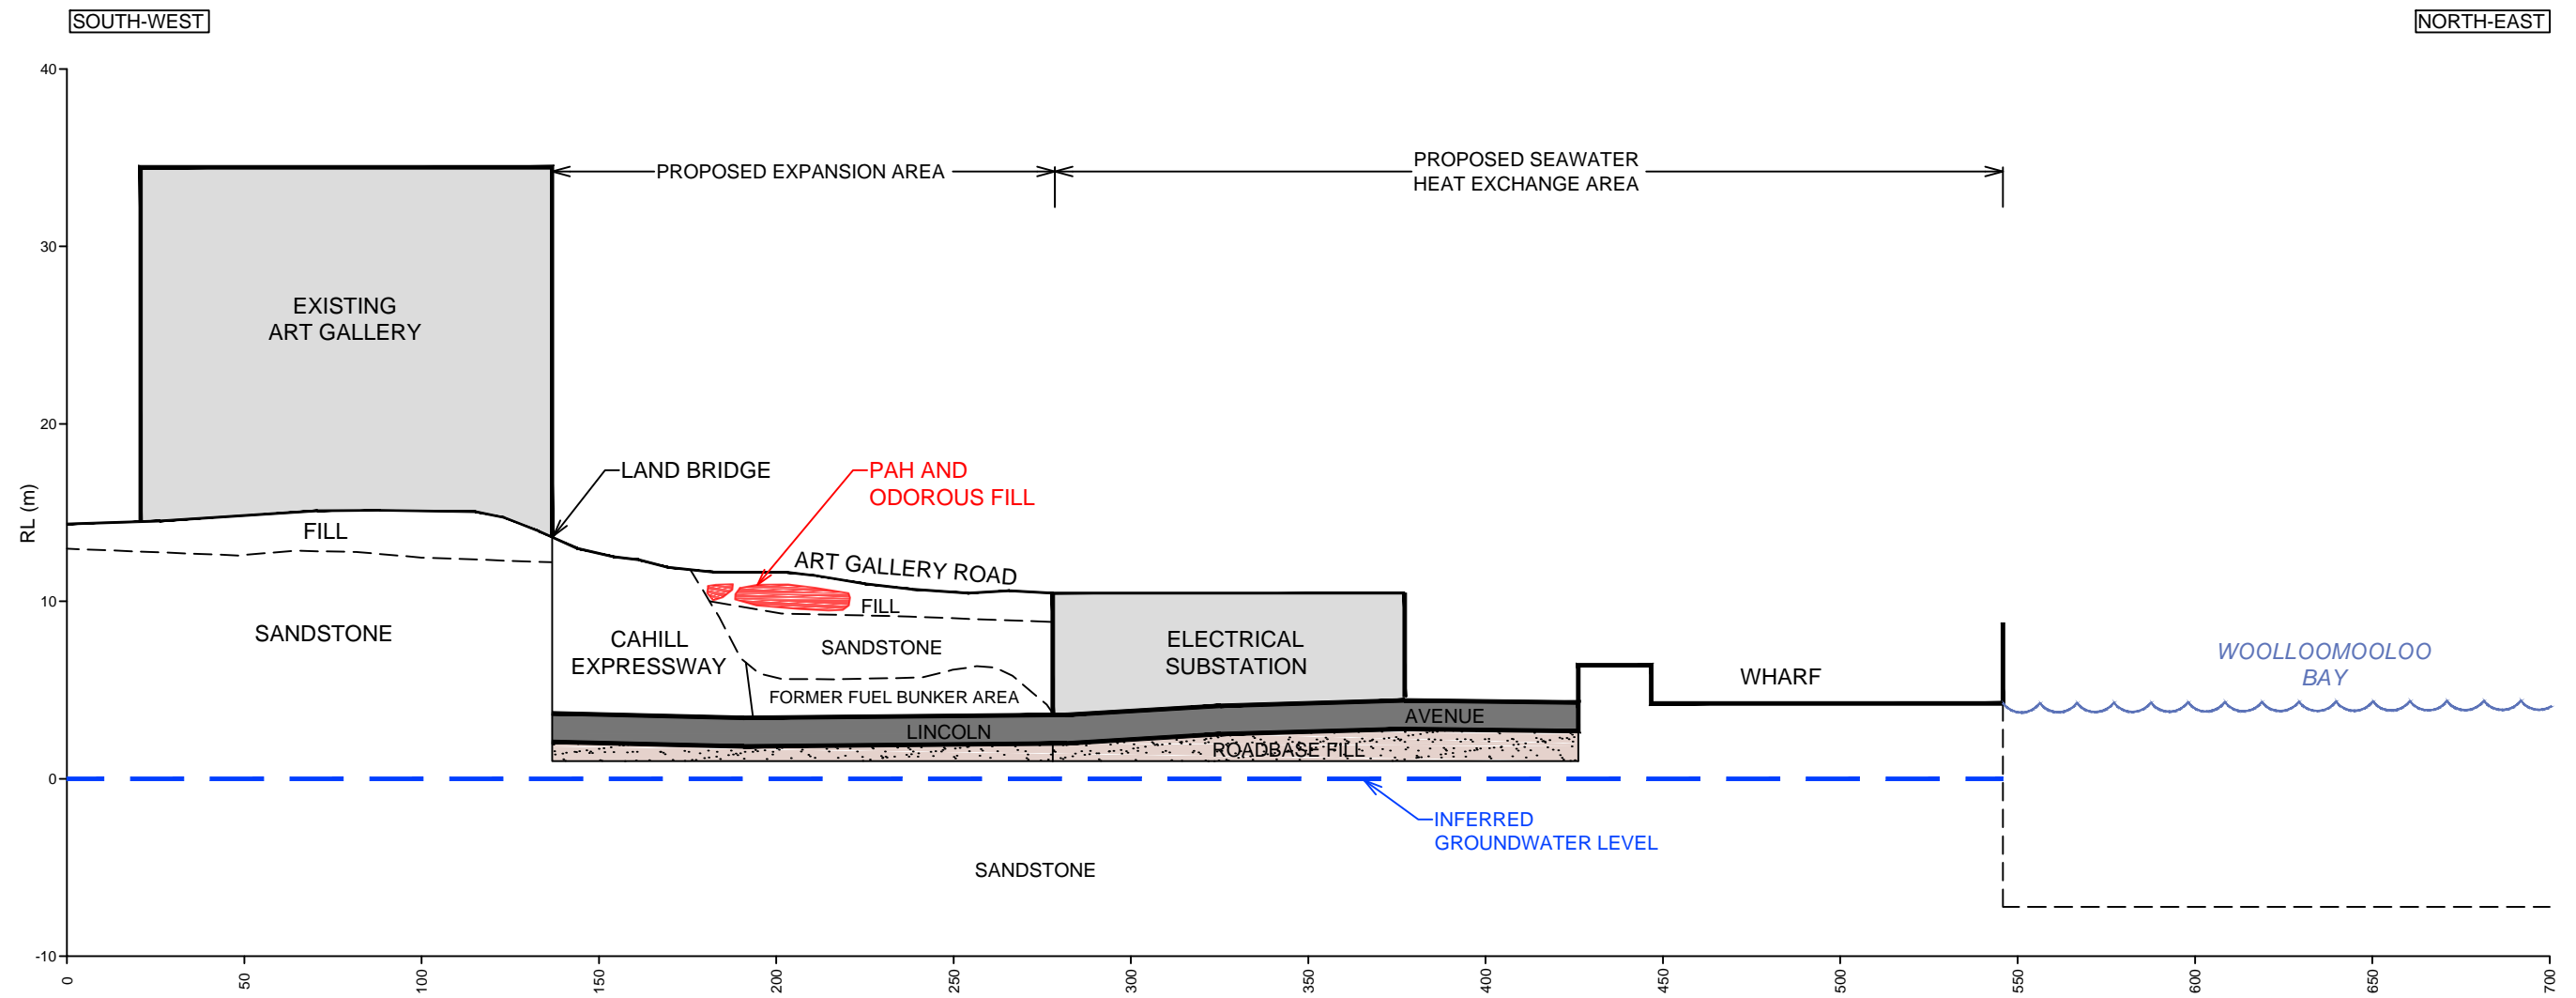
DATE	7/04/2014	7/04/2014
DEPTH (m)	0.5	1.0
TRH C16-C34	190	300
PAHs (Sum of total)	35	45
Benzo(a)pyrene TEQ	4.1	6.5
Benzo(a)pyrene	2.9	4.6

NEPM 2013 HILs C	NEPM 2013 HILs D	Management Limits / ESLs (Open Space)
TRH C16-C34			3500 / 300
PAHs (Sum of total)	300	4000	
Benzo(a)pyrene TEQ	3	4	
Benzo(a)pyrene			NA / 1.4

client:	ART GALLERY OF NSW		
project:	REMEDIAL ACTION PLAN SYDNEY MODERN PROJECT ART GALLERY ROAD, SYDNEY, NSW		
title:	SITE LAYOUT PLAN SHOWING PROPOSED REMEDIAL ACTION AREAS & VALIDATION SAMPLING LOCATIONS		
project no:	GEO\TCOV25037AC-R03B	figure no:	FIGURE 4
rev:	A

<b>Evidence of contamination:</b>	<ul style="list-style-type: none"> <li>BH02: Very strong hydrocarbon odours from 1.1m</li> <li>BH03: Hydrocarbon odours from 1m</li> <li>BH04: Strong hydrocarbon odours between 1m and 1.5m</li> </ul> <p>Refer to Figure 4 for borehole locations.</p>
<b>Groundwater bores:</b>	<ul style="list-style-type: none"> <li>None registered within 500m of site however three groundwater bores are located between 500m and 800m radius of the site.</li> <li>Two groundwater monitoring wells designated MW1 and MW2 are located along the eastern side of the fuel bunker adjacent to Lincoln Crescent.</li> </ul>
<b>Depth to groundwater:</b>	Ranges between approximately 1.6m and 2.0m bgs at Lincoln Crescent (based on MW1 and MW2 measured in April and May 2016). The groundwater elevation at these locations is estimated to range between approximately 0.4m and 1.3m Australian Height Datum (AHD) based on available nearby survey data. No information on depth to groundwater is available for the majority of the site, however the presence of the Domain Tunnel is expected to result in substantial depression of groundwater levels across much of the site.

Borehole locations are shown on Figure 4.

Groundwater monitoring events (GMEs) were undertaken by Coffey in 2014 and 2016. The GMEs included sampling of the two existing groundwater monitoring wells (MW1 and MW2) adjacent to and downgradient of the former fuel bunker (refer to Figure 4 for locations) as well as sampling of water from the pump room sump at the northern end of the former fuel bunker. The results are reported in Coffey (2014 and 2016).

Based on currently available information, one remediation area has been identified and is shown on Figure 4. One additional area of potential contamination has also been identified, and delineation sampling is recommended. However, there is the potential for other (likely localised) areas of contamination to be present on the site. Validation of these areas of the site not previously assessed is outlined in Section 10.3.1.

Available information indicates that the extent of the odorous contaminated soils is estimated to be 12m by 25m in area and is estimated to extend to the top of sandstone, which varies between 1.1m and 2.2m bgs. This area is shown on Figure 4 and is approximate only<sup>2</sup>. However, it is noted that HA01 and BH02 were bored within this area in 2016 and there was no indication of the strong hydrocarbon odours observed in 2014. It is therefore considered that the odorous soils may therefore be present in discrete pockets.

The proposed sampling locations are shown on Figure 4.

Based on our current knowledge of this area, the remedial excavation is expected to be approximately 12m by 25m in area and up to 2.2m (deep). The estimated excavation area is shown in Figure 4. We expect a minimum of 6 to 12 wall samples and 4 base samples, with 1 or 2 duplicate samples and other quality control samples as appropriate.

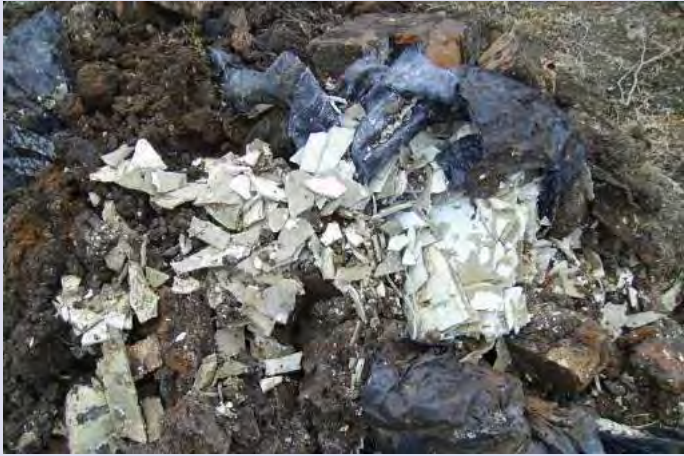
Potential Unexpected Find	Observed Characteristic	Typical Key Contaminant of Concern	Example of an unexpected find where applicable
Asbestos containing materials and/or buried asbestos pipes	<p>It is often very difficult to identify the presence of asbestos by sight. The only way to be certain is to have a sample of the material analysed by a laboratory. Cement bound asbestos (fibro cement sheet) may be present in building materials such as wall sheeting, pipes and roofing, backing of electrical switch boards, linoleum floor tiles etc and may be found as fragments of broken building materials (often found close to the building) and building wastes.</p> <p>Friable forms of asbestos including lagging and insulation may be evidenced by fibrous material which flakes and powders easily. Textured coatings may also contain asbestos.</p>	Asbestos

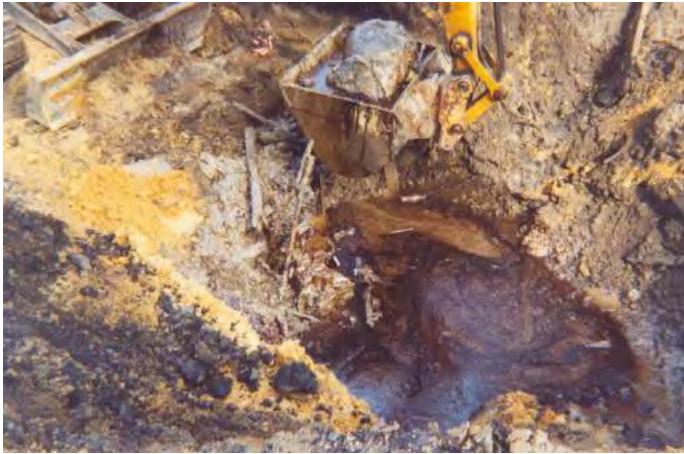
Buried waste materials	May include a variety of waste materials, inclusive of waste oil drums, wood, plastic, metal fragments, building rubble (e.g. concrete, brick, asphalt, asbestos containing materials), lead paint. We do not consider that a trivial piece or fragment of foreign material constitutes as an unexpected find (e.g. a single brick).	TRH, BTEXN, PAHs, VHCs Asbestos, heavy metals

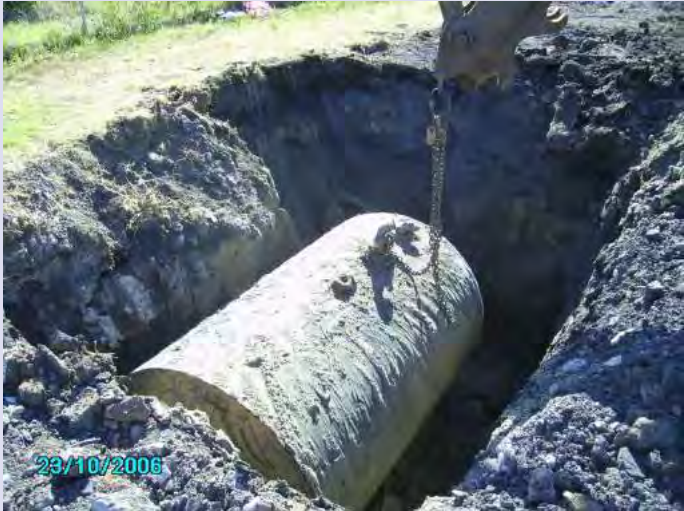
Underground storage tanks (USTs)	<p>Though unlikely but can be identified as follows:</p> <ul style="list-style-type: none"><li>• A buried steel underground tank;</li><li>• Deeper sand fill is sometimes observed and / or hydrocarbon odours or staining.</li><li>• Encountering relatively small concrete footings or steel pipelines, sometimes with observed hydrocarbon odours or staining.</li></ul>	TRH, BTEXN, PAHs, VHCs, phenols, lead

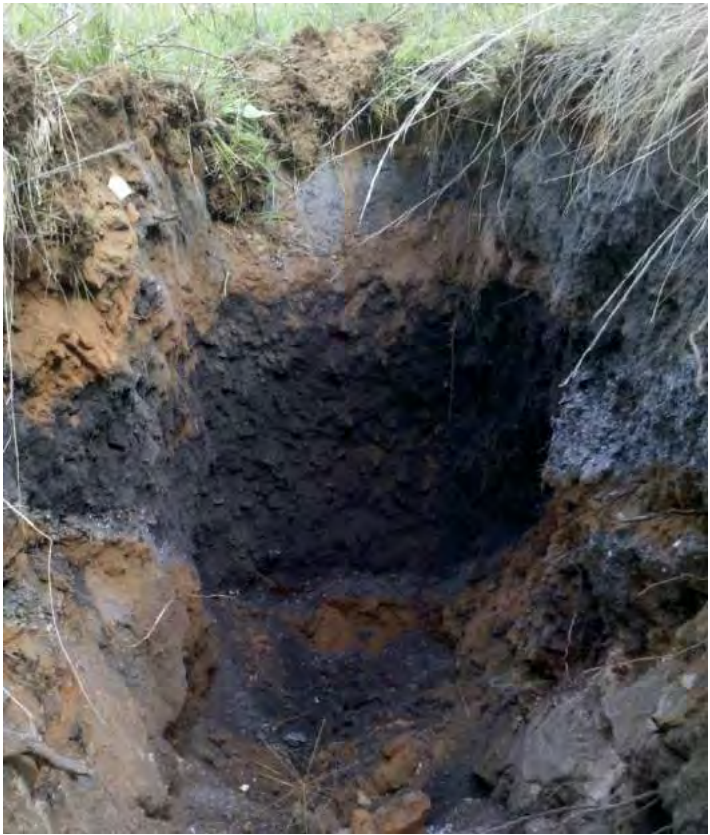
Potential Unexpected Find	Observed Characteristic	Typical Key Contaminant of Concern	Example of an unexpected find where applicable
Ash or slag deposits	<p>Ash materials typically light weight, grey and white gravel and sand sized (1mm to 10mm) particles (see photograph example).</p> <p>Slag materials can be varied in consistency and colour. Typically slags from steelmaking are pale grey to grey, however can be blue/green/grey, loose or cemented. Slag gravels can be very angular and appear to have a vesicular (i.e. 'honeycomb') shape.</p>	PAHs, heavy metals

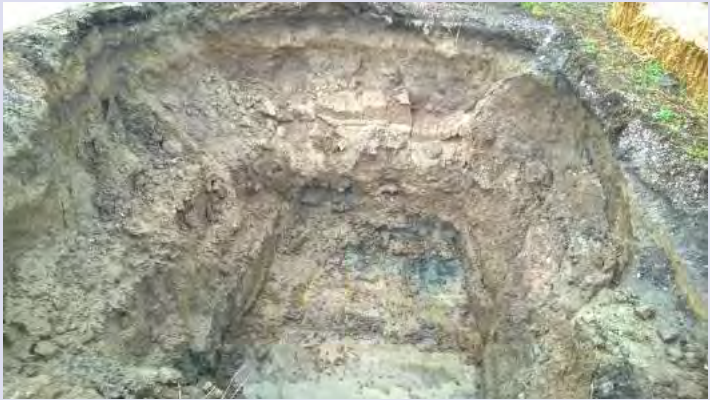
Hydrocarbon Compounds	<p>May be identified by a hydrocarbon (e.g. petrol, diesel or oil) odour which may vary in strength from possible (just detectable) to very strong (easily detectable at a distance from the source).</p> <p>The odour may or may not be accompanied by specific areas of dark staining (black-grey) or larger scale discolouration of strata from a previously identified 'natural colour' e.g. staining of orange and brown clay to dark grey and green.</p>	TRH, BTEXN, PAHs, lead

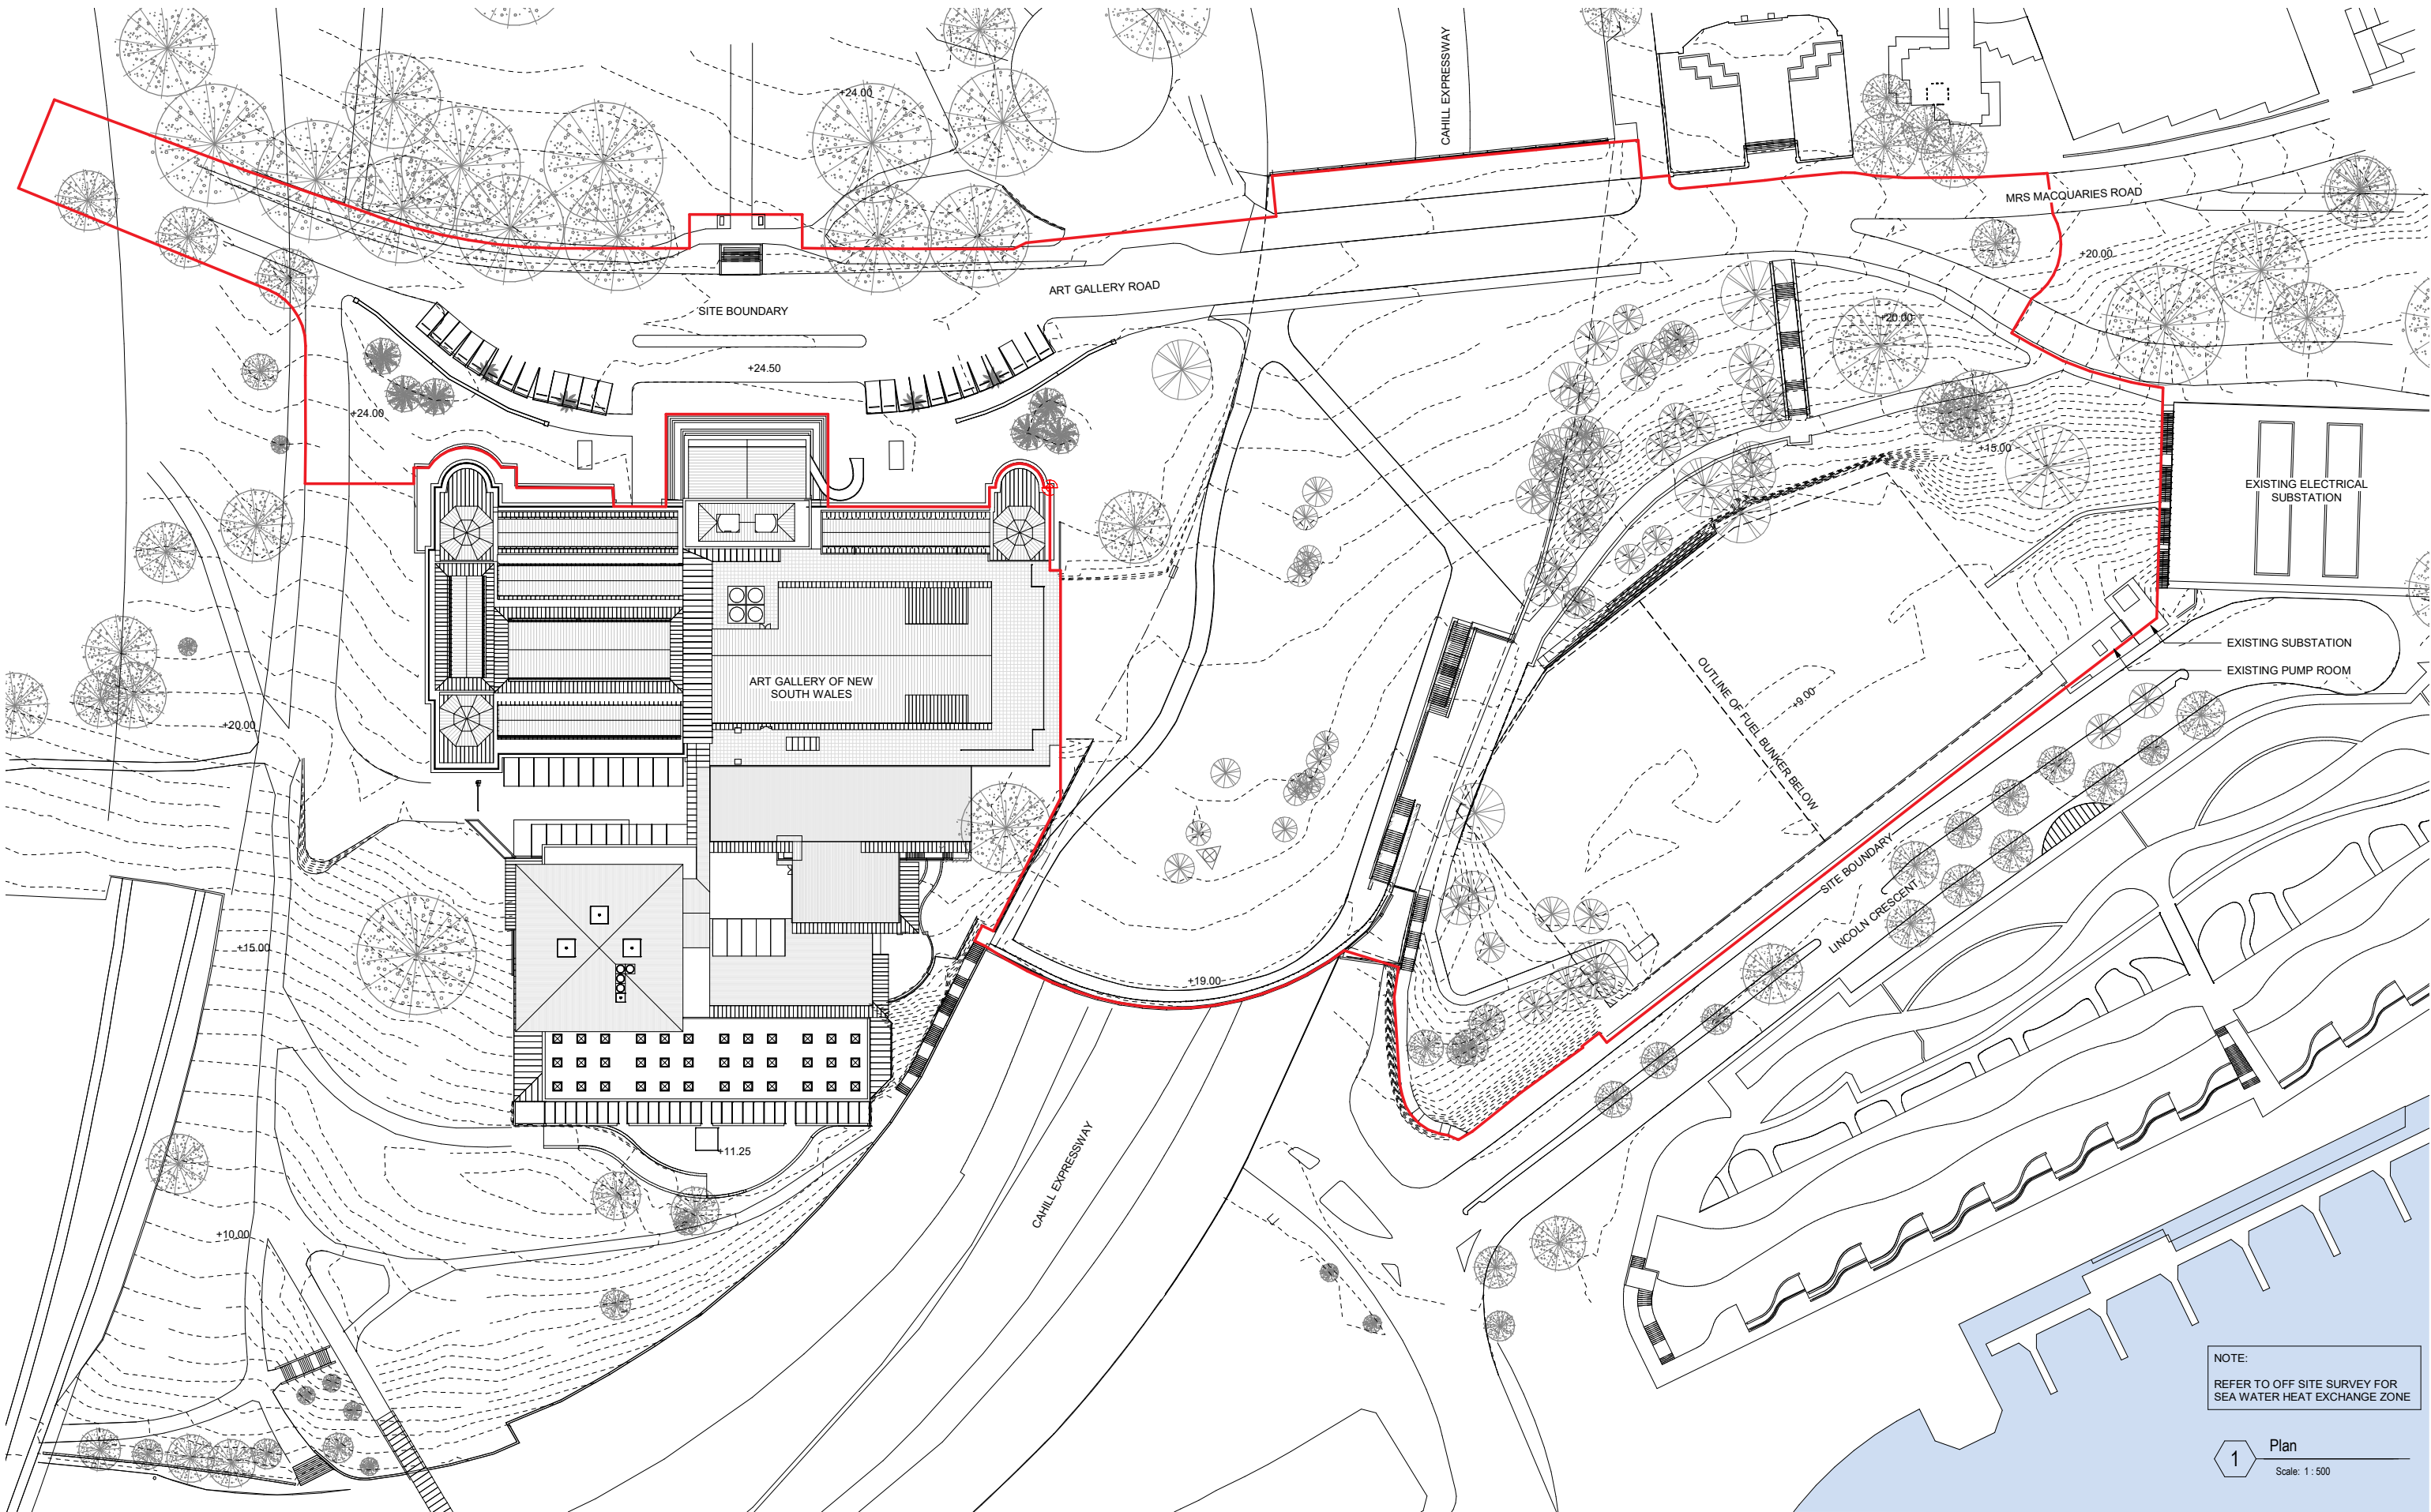
1 Plan  
Scale: 1 : 500

NOTE:  
REFER TO OFF SITE SURVEY FOR  
SEA WATER HEAT EXCHANGE ZONE

<p><b>Copyright:</b></p> <p>The copyright subsisting in these drawings, plans, designs and specifications vests with The Art Gallery of New South Wales. They must not be used, reproduced or copied, in whole or in part, nor may the information, ideas and concepts therein contained (which are confidential to The Art Gallery of New South Wales) be disclosed to any person without the prior written consent of The Art Gallery of New South Wales.</p>	<table><tr><th>Revision</th><th>Description</th><th>Date</th></tr><tr><td>A</td><td>SSDA DRAFT</td><td>06 10 2017</td></tr><tr><td>B</td><td>SSDA Issue</td><td>19 10 2017</td></tr><tr><td>C</td><td>SSDA Issue</td><td>03 11 2017</td></tr></table>	Revision	Description	Date	A	SSDA DRAFT	06 10 2017	B	SSDA Issue	19 10 2017	C	SSDA Issue	03 11 2017	<table><tr><td><p>Scale:</p><p>0 5 10 15</p><p>1:500 @ A1</p><p>1:1000 @ A3</p></td><td></td></tr><tr><td colspan="2"><p>checked L.J/J.W/J.J.</p></td></tr><tr><td><p>drawn Architectus</p></td><td><p>project no 140419</p></td></tr><tr><td colspan="2"><p>Do not scale drawings.</p></td></tr></table>	<p>Scale:</p> <p>0 5 10 15</p> <p>1:500 @ A1</p> <p>1:1000 @ A3</p>		<p>checked L.J/J.W/J.J.</p>		<p>drawn Architectus</p>	<p>project no 140419</p>	<p>Do not scale drawings.</p>		<p>Key Plan:</p>	<p>Client:</p> <p><b>ART GALLERY NSW</b></p> <p>Art Gallery of NSW Art Gallery Road Sydney, NSW, 2000 T (61 2) 9225 1780</p>	<p>Lead Architect:</p> <p><b>SANAA</b></p> <p>Kazuyo Sejima + Ryue Nishizawa / S A N A A SANAA JIMMUSHO LTD. Tokyo, Japan 1-5-27 Taitsumi, Koto-ku, Tokyo Japan 135-0053 T +81 3 5534 1780 sanaa@sanaa.co.jp www.sanaa.co.jp</p> <p>Executive Architect:</p> <p><b>architectus</b></p> <p>Architectus Sydney Level 18, MLC Centre 19 Martin Place Sydney NSW 2000 T (61 2) 8252 8400 F (61 2) 8252 8600 sydney@architectus.com.au ABN 11 098 489 448</p>	<p>project</p> <p><b>ART GALLERY OF NSW EXPANSION PROJECT - SYDNEY MODERN</b></p> <p>drawing</p> <p><b>Existing Site Plan</b></p> <p>drawing no.</p> <p><b>DA_0052</b></p> <p>Revision</p> <p><b>C</b></p>
