## **Additional Points of Assessment for Reflectivity**

**Sydney Modern Art Gallery of NSW**

Reference: 17033

Revision: 03

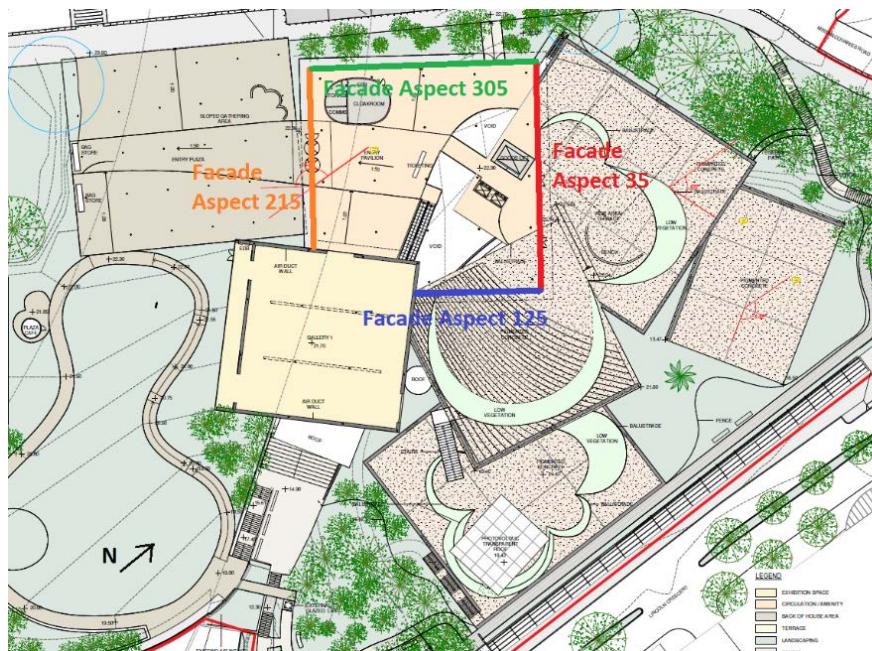
The images below show the external glazed elevations facing the additional viewpoints

Figure 1 Entry Level Glazing

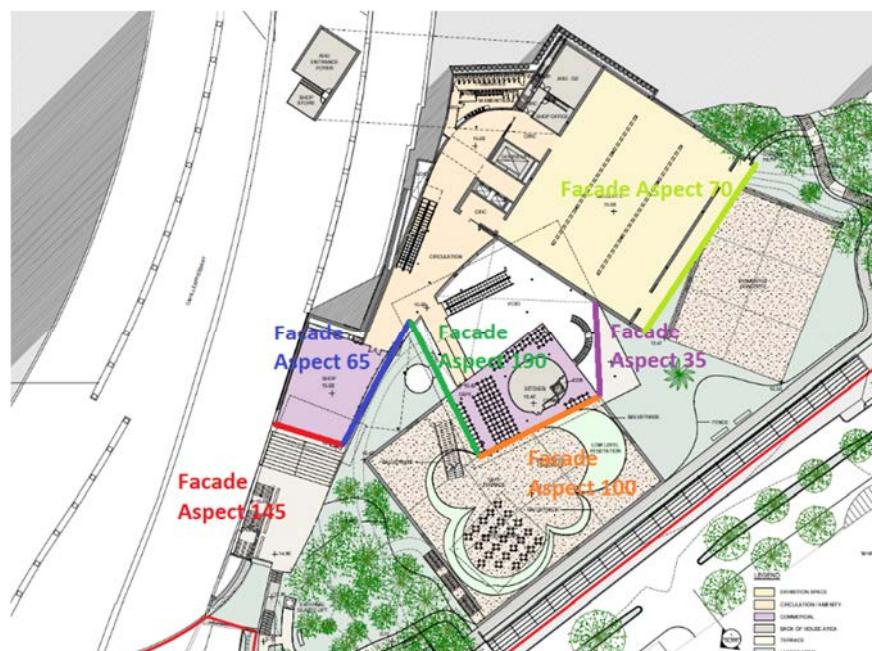
Figure 2 Lower Level 1 Glazing

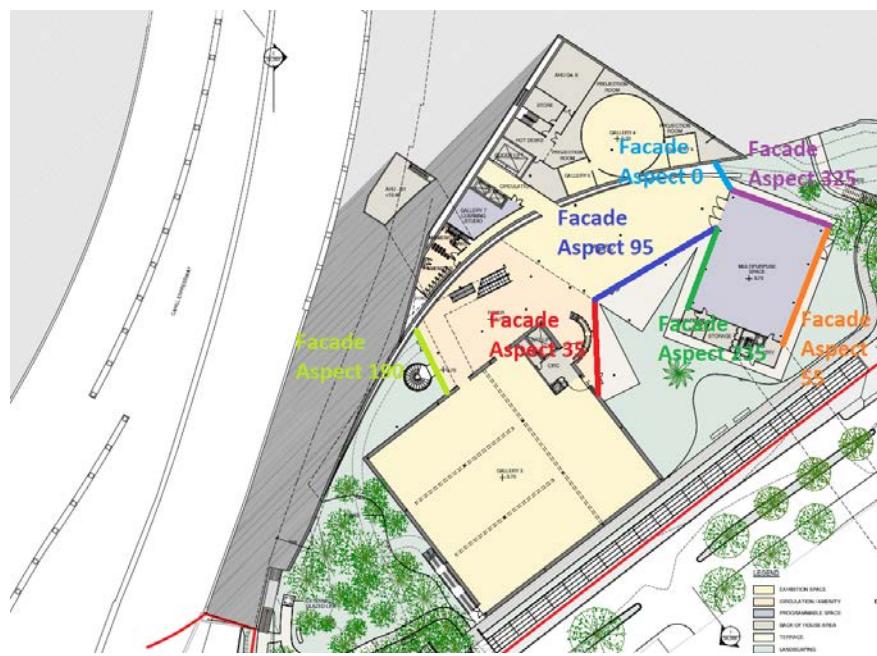
Figure 3 Lower Level 2 Glazing

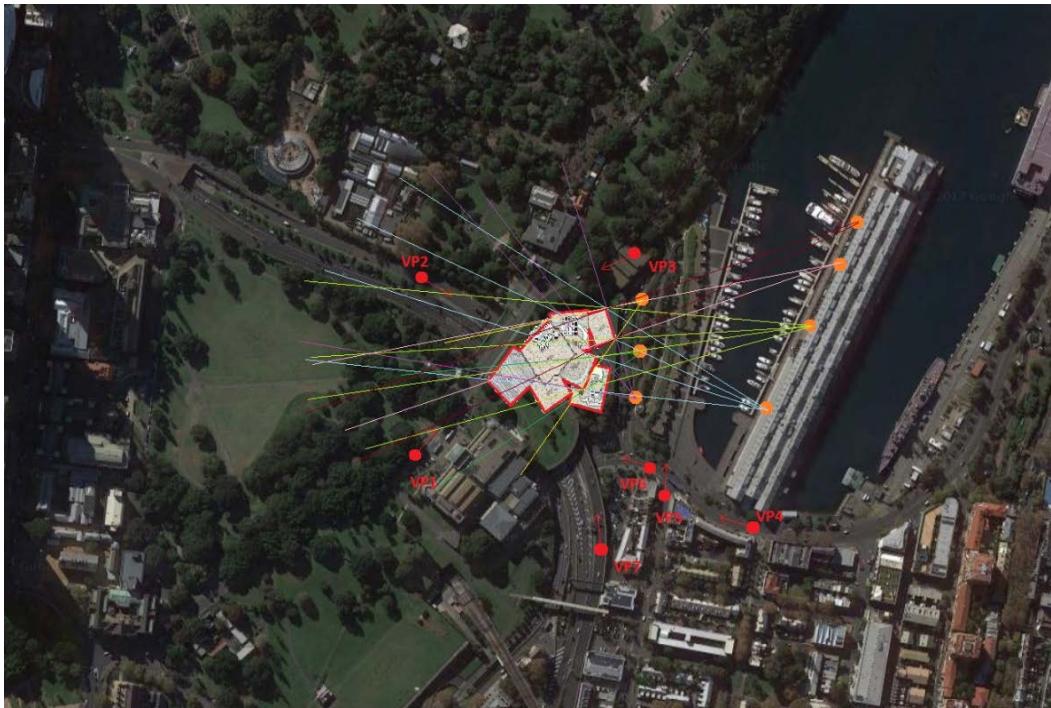
The image below is a consolidated set of viewpoints and view angles these viewpoint have of the facades.

Figure 4 Consolidated Viewpoints including those from Pedestrian and Traffic Reflectivity Assessment

- The orientation of each of the glazed facades has been determined and is identified on the image above as the Façade Aspect. These angles are used in the generation of the reflected image stereographic diagram.
- Each of the glazed façades visible from the viewpoint have been identified and are shown in the images for each location. These angles are recorded for each location in the relevant table.

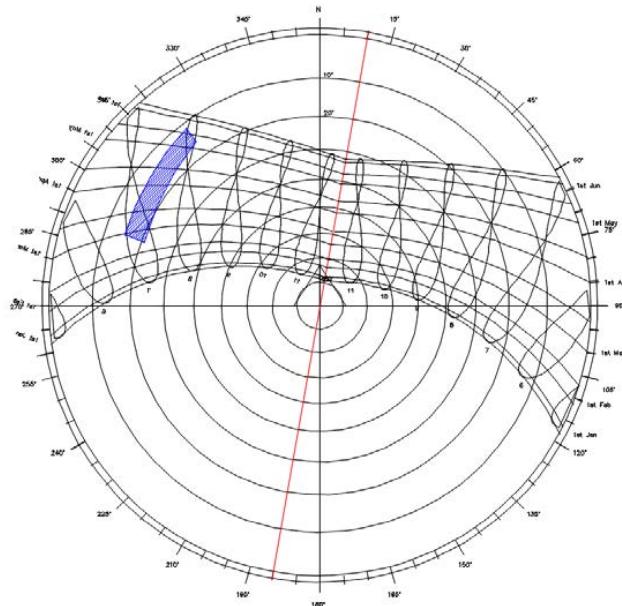
- The extent of façade visible from the viewpoint has been determined as both vertical and horizontal bearing angle. These bearing angles are overlayed on the reflected stereographic diagram and where the reflected sunpath and intersect align the sun maybe be visible to the viewpoint.

The intersection does not guarantee a reflected light will be visible or cause nuisance as obstruction and actual viewpoint may result in the sun not being visible.

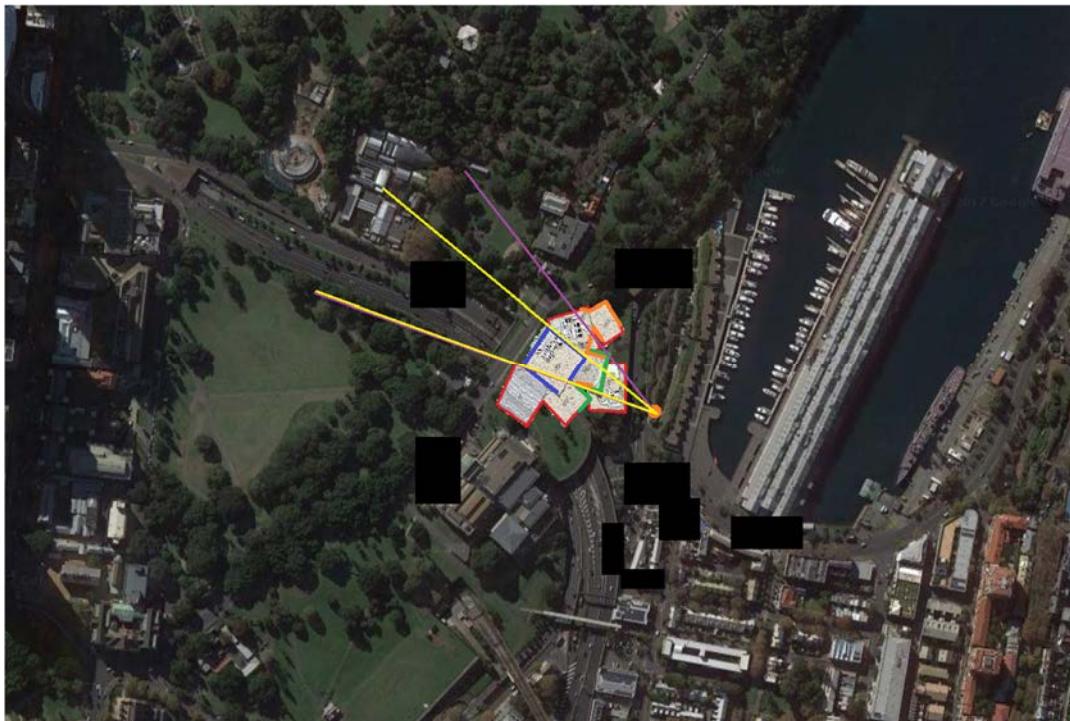
The image below identifies the glazed façades visible from the viewpoint in question.

There are two glazed facades visible from this viewpoint:

- o Eastern wall of Entry Level of Entry Pavilion
- o Eastern wall of Level 1 of café

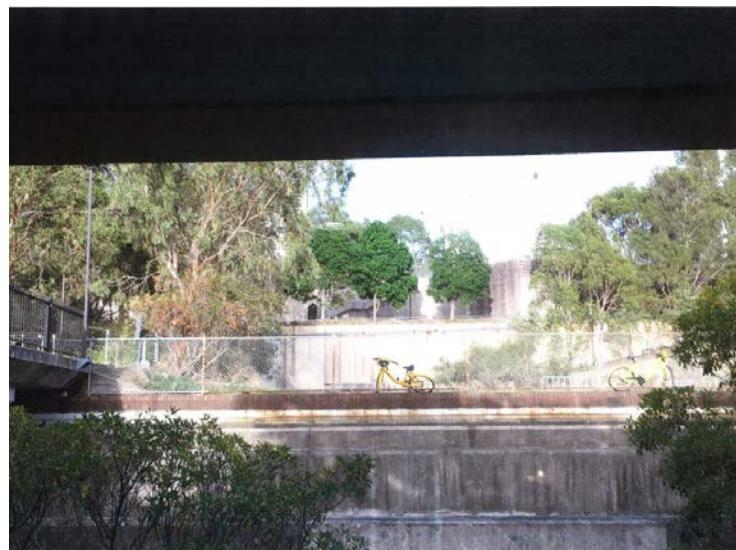
Vertical Bearing Angle		Horizontal Bearing Angle (0° at North)	
	Lower Bound	Upper Bound	Lower Bound	Upper Bound
Façade Aspect 125 (70m distant) Eastern wall of Entry Level of Entry Pavilion	17.5°	19.9°	290°	310°
Façade Aspect 100 (58m distant) Eastern wall of Level 1 of café	15.8°	20.77°	290°	323°

View image above, reflected sun image and view angle – blue lines (below)

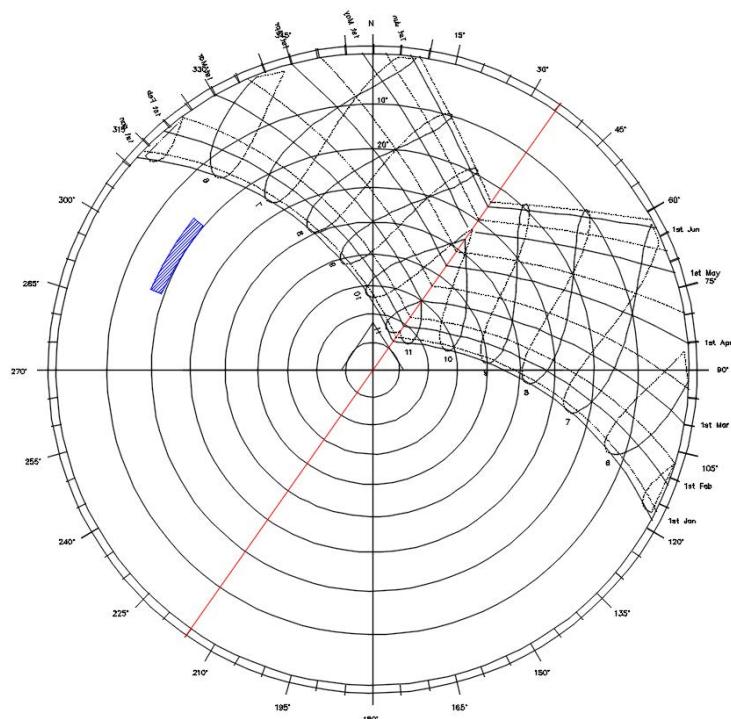
### 3.1.1 Point 1 -Façade Aspect 125 - Eastern wall of Entry Level of Entry Pavilion

There is no reflection from this façade to this viewpoint.

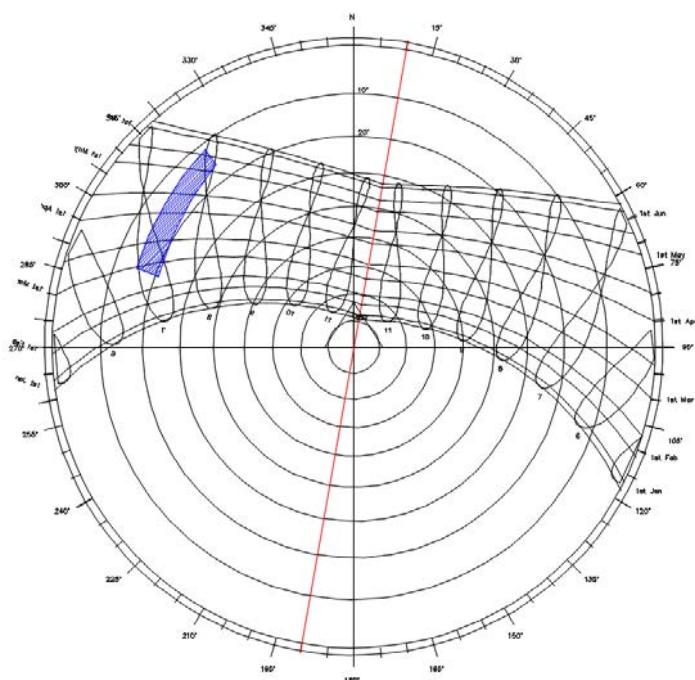
3.1.2 Point 1- Façade Aspect 100 - Eastern wall of Level 1 of café

There is the potential for light being reflected between 6am and 9am in the summer months through to 7am and 8am in winter.

The vertical view angle may be impacted by the embankment and cut off the view of café due to the terrace area over Gallery 3.

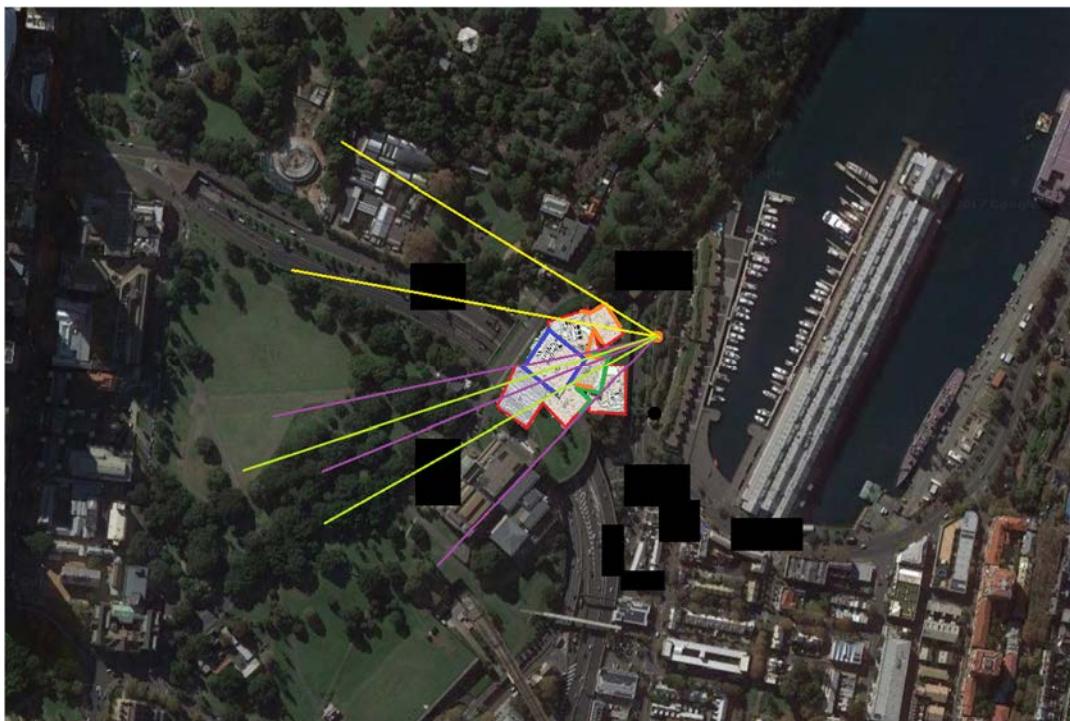
The image below identifies the glazed façades visible from the viewpoint in question.

There are 5 façade elevations visible from this viewpoint:

- o North-eastern glazed wall of Level 2 Multi-Purpose Hall
- o Northern wall of Entry Level of Entry Pavilion
- o Eastern wall of Entry Level of Entry Pavilion
- o Eastern wall of Level 1 of café
- o Northern wall of Level 1 of café

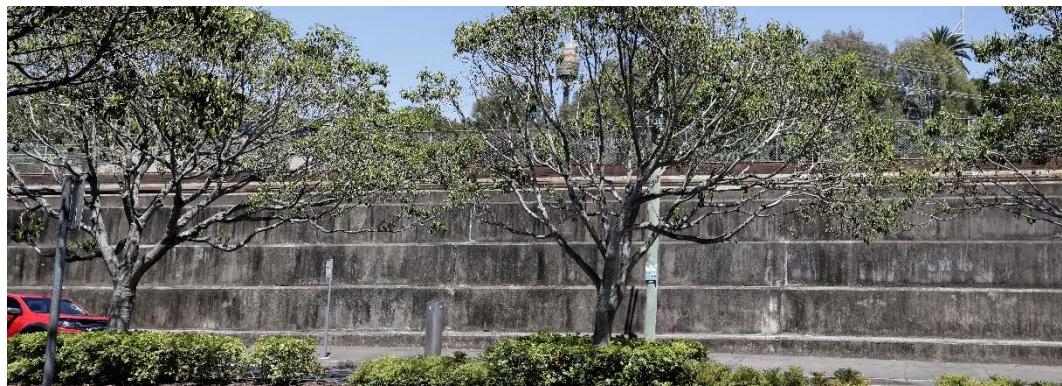
Vertical Bearing Angle		Horizontal Bearing Angle (0° at North)	
	Lower Bound	Upper Bound	Lower Bound	Upper Bound
Façade Aspect 55 (40m) North-eastern glazed wall of Level 2 Multi-Purpose Hall	13.6°	22.3°	280°	302°
Façade Aspect 35 (80m) Northern wall of Entry Level of Entry Pavilion	15.4°	17.6°	252°	275°
Façade Aspect 125 (80m) Eastern wall of Entry Level of Entry Pavilion	15.4°	17.6°	240°	252°
Façade Aspect 100 (55m) Eastern wall of Level 1 of café	16.6°	21.8°	243°	253°
Façade Aspect 35 (55m) Northern wall of Level 1 of café	16.6°	21.8°	218°	243°

View image above, reflected sun image and view angle – blue lines (below)

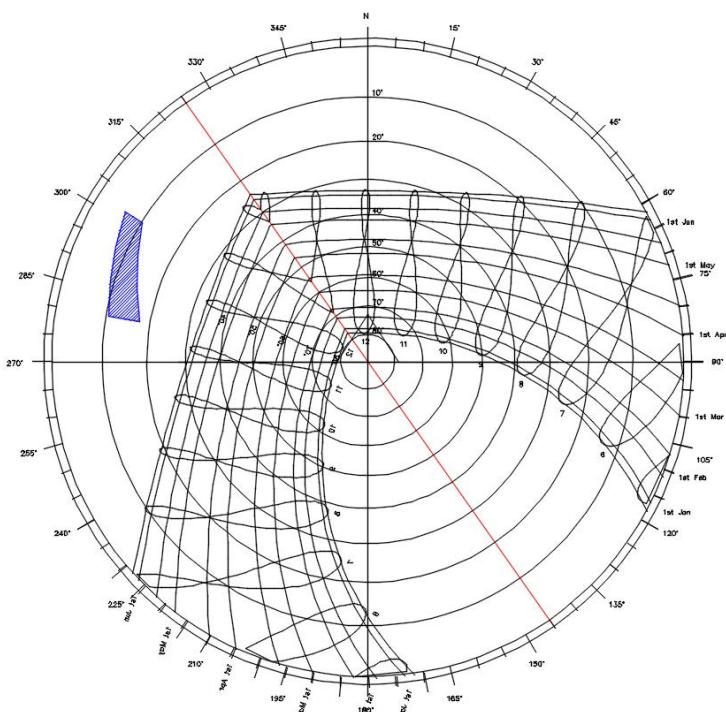
### 3.2.1 Point 2 - Façade Aspect 55 - North-eastern glazed wall of Level 2 Multi-Purpose Hall

There is no risk of rogue reflections from this façade to this viewpoint.

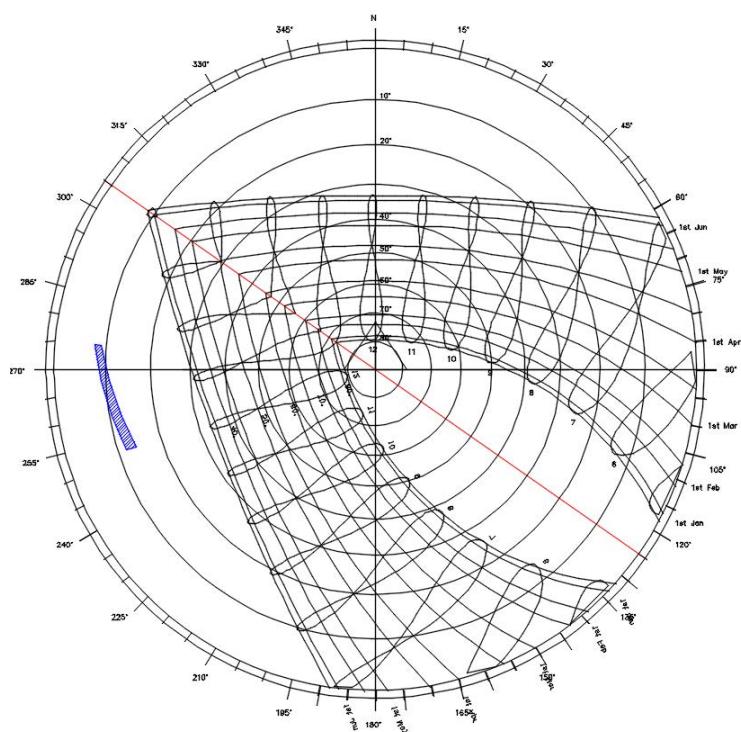
### 3.2.2 Point 2- Façade Aspect 35 - Northern wall of Entry Level of Entry Pavilion

There is no risk of rogue reflections from this façade to this viewpoint.

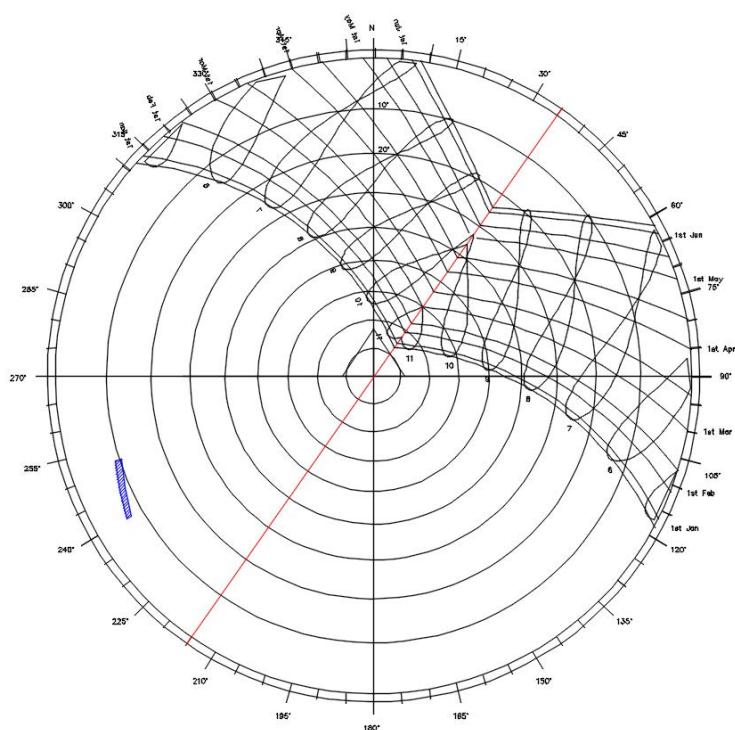
### 3.2.3 Point 2 -Façade Aspect 125 - Eastern wall of Entry Level of Entry Pavilion

There is no risk of rogue reflections from this façade to this viewpoint.

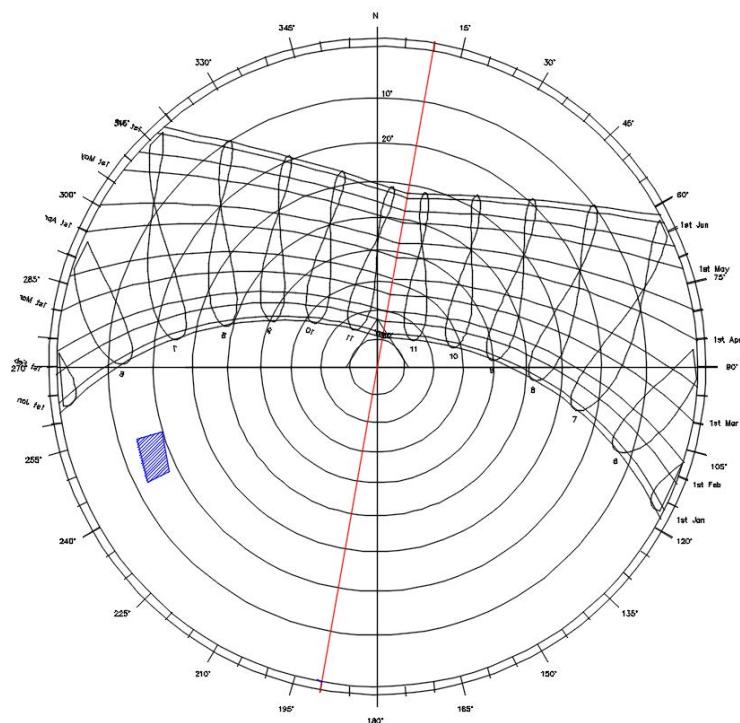
**3.2.4 Point 2 -Façade Aspect 100 - Eastern wall of Level 1 of café**

There is no risk of rogue reflections from this façade to this viewpoint.

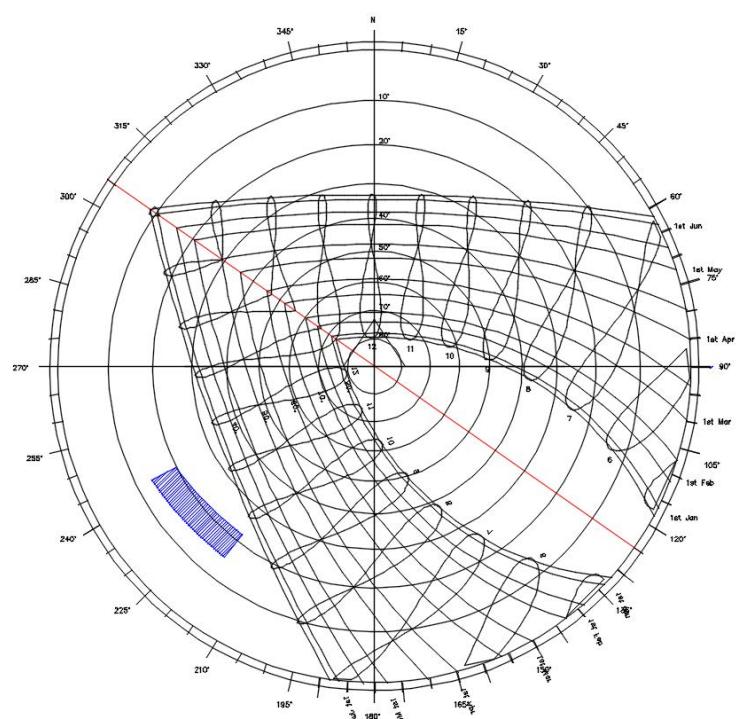
**3.2.5 Point 2- Façade Aspect 35 - Northern wall of Level 1 of café**

There is no risk of rogue reflections from this façade to this viewpoint.

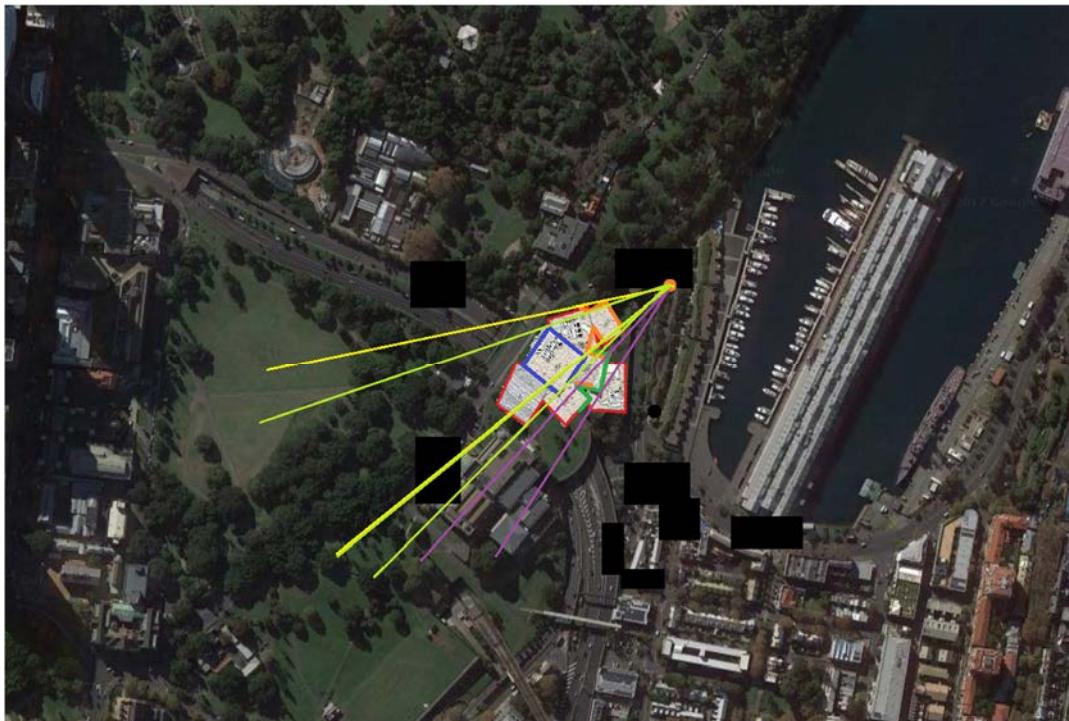
The image below identifies the glazed façades visible from the viewpoint in question. There are potentially 4 glazed façade elevations visible from this viewpoint. The substation may obstruct some views.

- North-eastern glazed wall of Level 2 Multi-Purpose Hall
- Northern wall of Entry Level of Entry Pavilion
- Eastern wall of Entry Level of Entry Pavilion
- Eastern wall of Level 1 of café

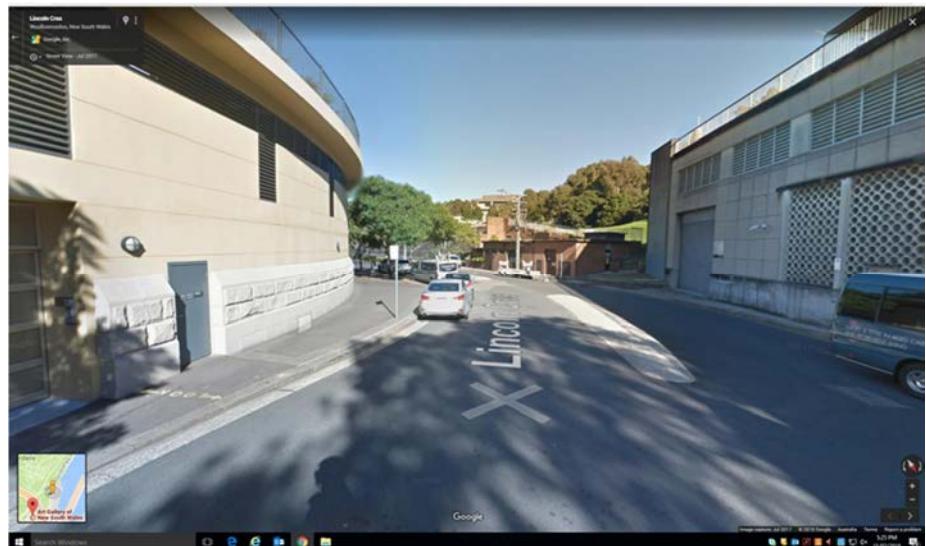
Vertical Bearing Angle		Horizontal Bearing Angle (0° at North)	
	Lower Bound	Upper Bound	Lower Bound	Upper Bound
Façade Aspect 55 (65m) North-eastern glazed wall of Level 2 Multi-Purpose Hall	8.5°	14.1°	230°	258°
Façade Aspect 35 (115m) Northern wall of Entry Level of Entry Pavilion	10.8°	12.5°	230°	251°
Façade Aspect 125 (115m) Eastern wall of Entry Level of Entry Pavilion	10.8°	12.5°	225°	230°
Façade Aspect 100 (95m) Eastern wall of Level 1 of café	9.8°	13°	212°	222°

View image above, reflected sun image and view angle – blue lines (below)

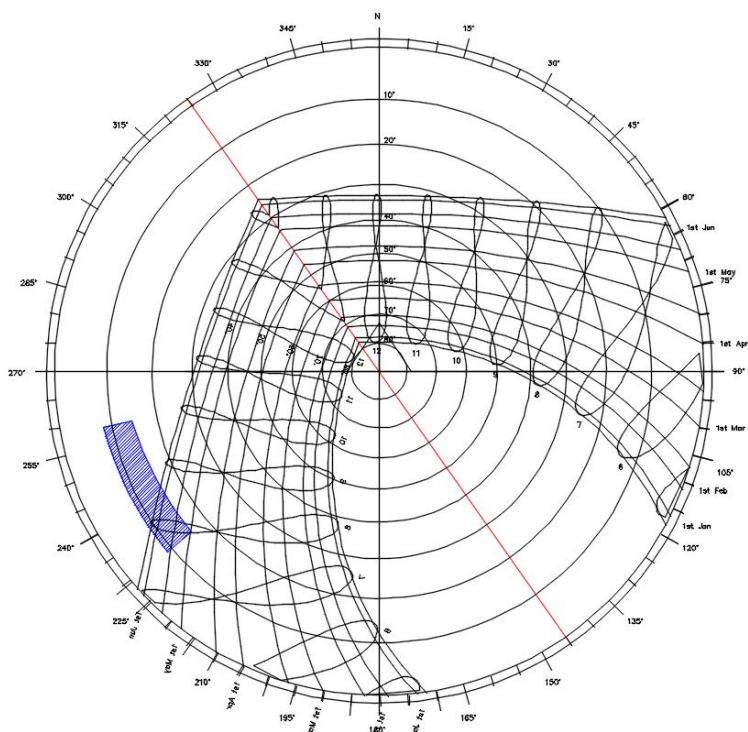
### 3.3.1 Point 3 - Façade Aspect 55 - North-eastern glazed wall of Level 2 Multi-Purpose Hall

There is the potential for disability glare for between 07:00am and 08:30 am between May and July. A Glare protector has been overlaid onto the driver position in the next image. It can be shown that glare is not an issue if the reflectivity of materials used is less than 15%

From these studies two cases result in very limited periods of reflected light reaching the study points and one case where it is recommended to modify glazing properties to reduce impact on the garage exit.

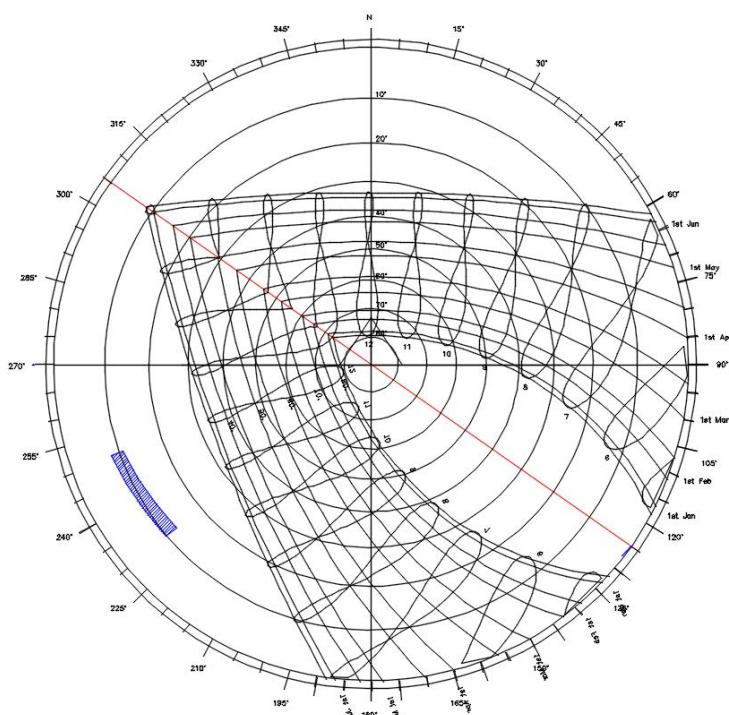
### 3.3.2 Point 3 - Façade Aspect 35 - Northern wall of Entry Level of Entry Pavilion

There is no risk of rogue reflections from this façade to this viewpoint.

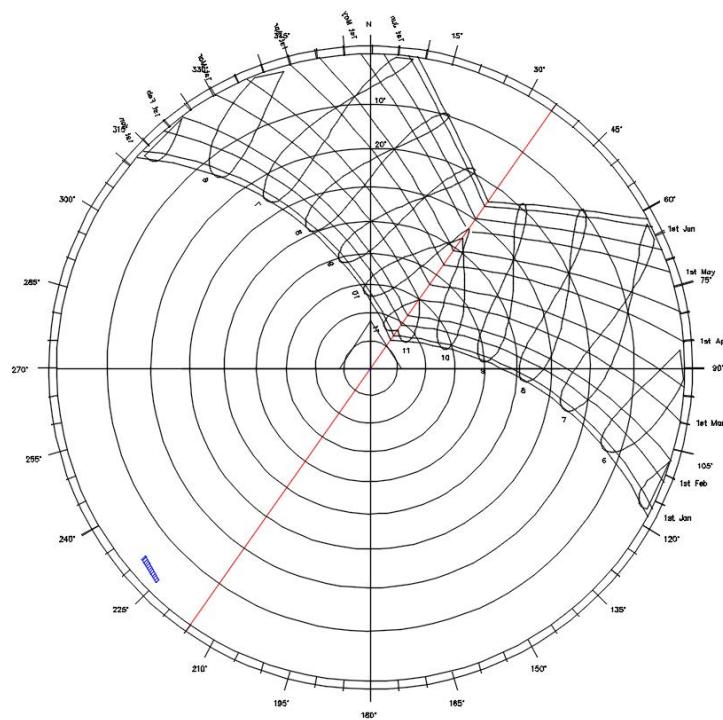
**3.3.3 Point 3 -Façade Aspect 125 - Eastern wall of Entry Level of Entry Pavilion**

There is no risk of rogue reflections from this façade to this viewpoint.

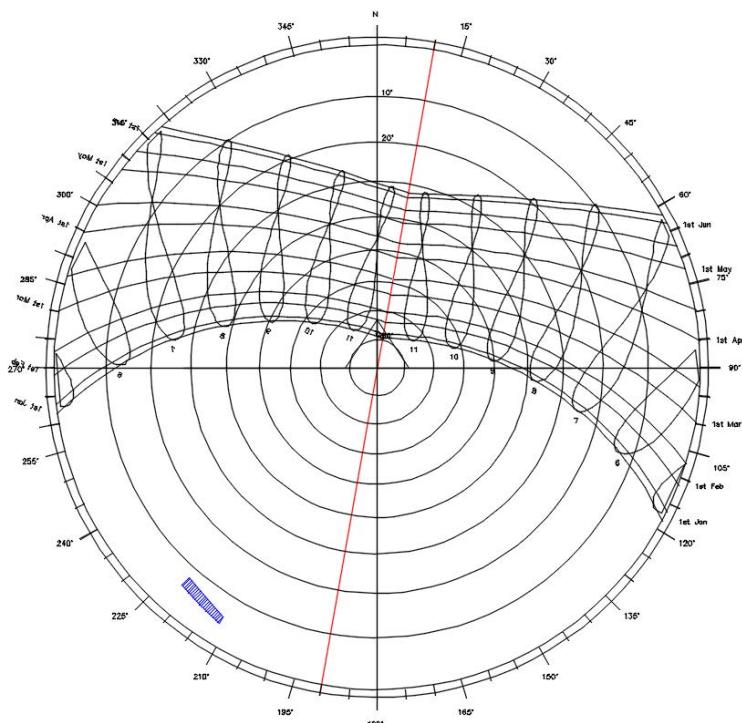
**3.3.4 Point 3 - Façade Aspect 100 - Eastern wall of Level 1 of café**

There is no risk of rogue reflections from this façade to this viewpoint.

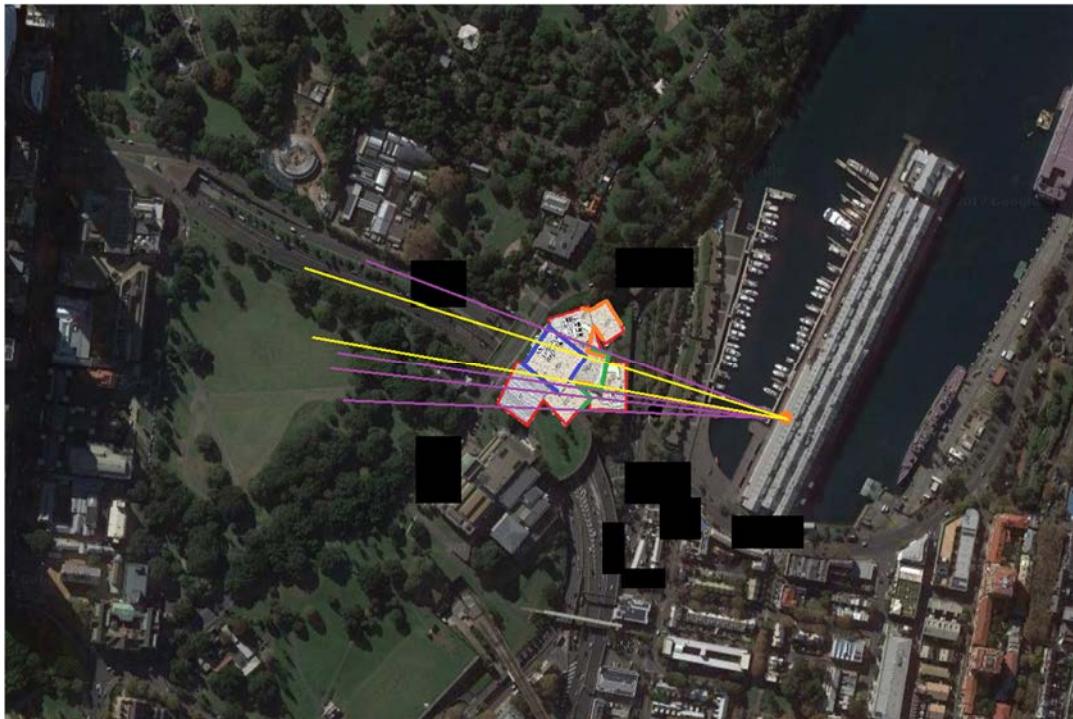
The image below identifies the glazed façades visible from the viewpoint in question.

There are four facades visible from this viewpoint:

- o Northern wall of Entry Level of Entry Pavilion
- o Eastern wall of Entry Level of Entry Pavilion
- o Eastern wall of Level 1 of café
- o Eastern wall of Level 1 of shop

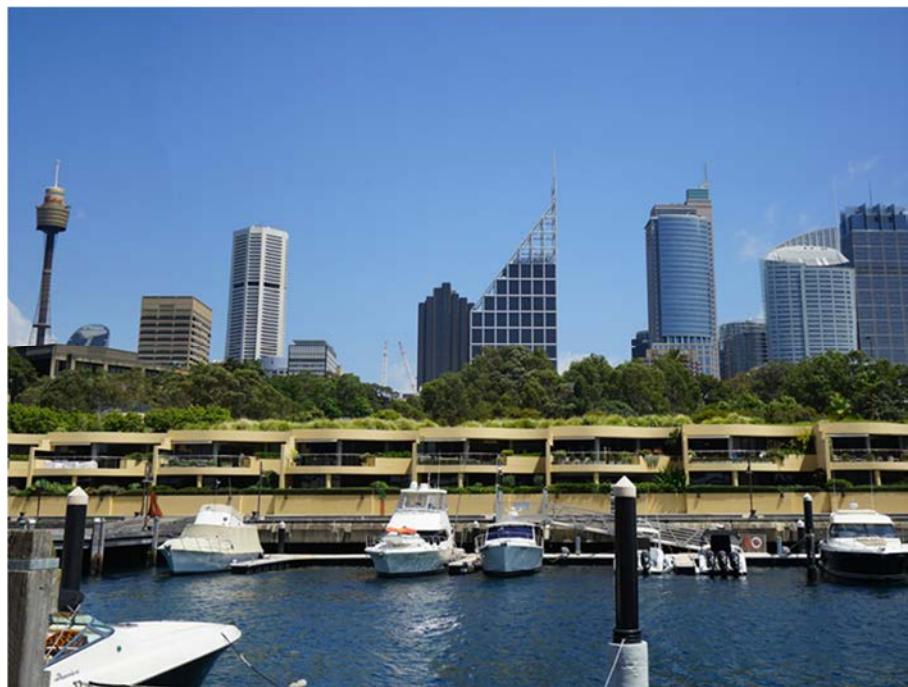
Vertical Bearing Angle		Horizontal Bearing Angle (0° at North)	
	Lower Bound	Upper Bound	Lower Bound	Upper Bound
Façade Aspect 35 (210m) Northern wall of Entry Level of Entry Pavilion	4.6°	5.6°	282°	285°
Façade Aspect 125 (210m) Eastern wall of Entry Level of Entry Pavilion	4.6°	5.6°	279°	282°
Façade Aspect 100 (190m) Eastern wall of Level 1 of café	3.4°	5.1°	278°	285°
Façade Aspect 145 (190m) Eastern wall of Level 1 of shop	3.4°	5.1°	272°	275°

View image above, reflected sun image and view angle – blue lines (below)

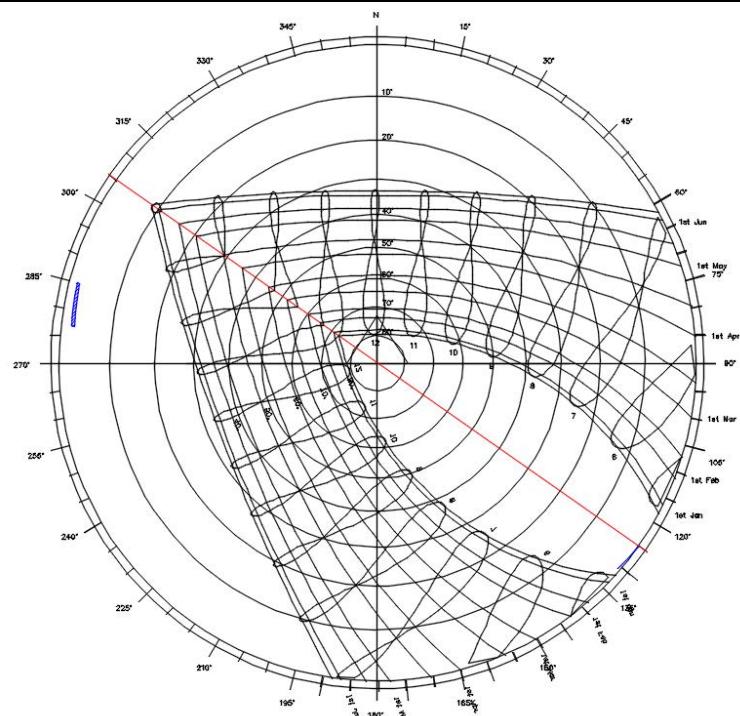
#### 4.1.1 Point 4 -Façade Aspect 35 - Northern wall of Entry Level of Entry Pavilion

There is no risk of rogue reflections from this façade to this viewpoint.

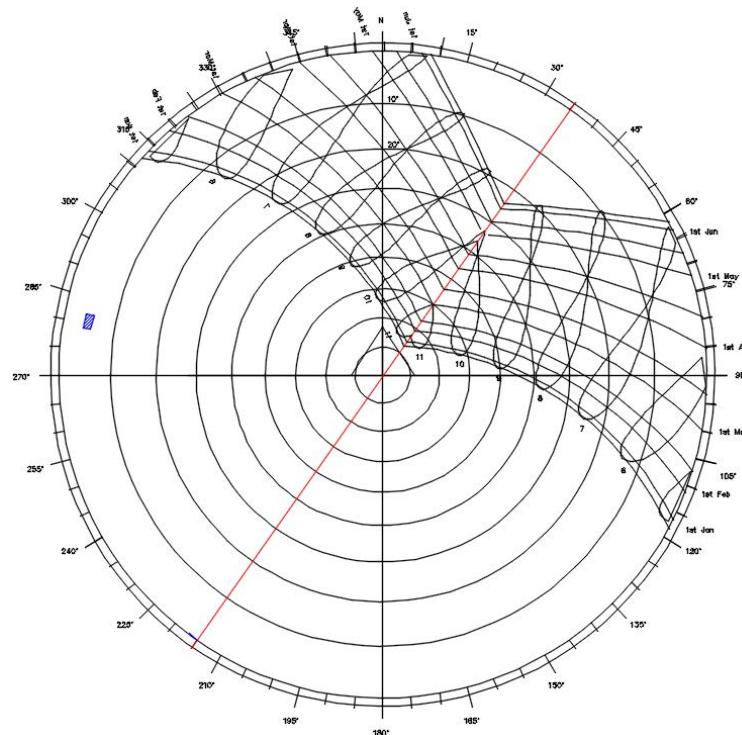
**4.1.2 Point 4 - Façade Aspect 125 - Eastern wall of Entry Level of Entry Pavilion**

There is no risk of rogue reflections from this façade to this viewpoint.

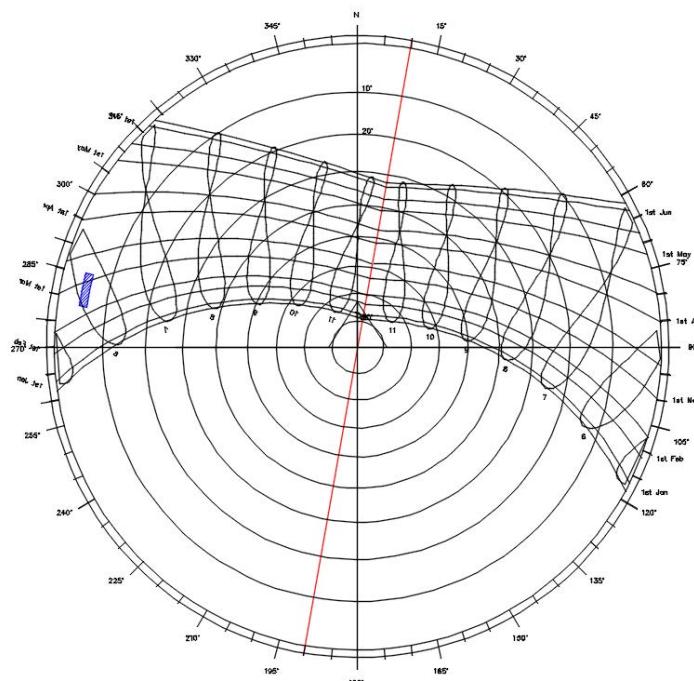
**4.1.3 Point 4 - Façade Aspect 100 - Eastern wall of Level 1 of café**

Glare will reach this viewpoint for approximately 10 minutes each day, between 545am and 6am in February and November.

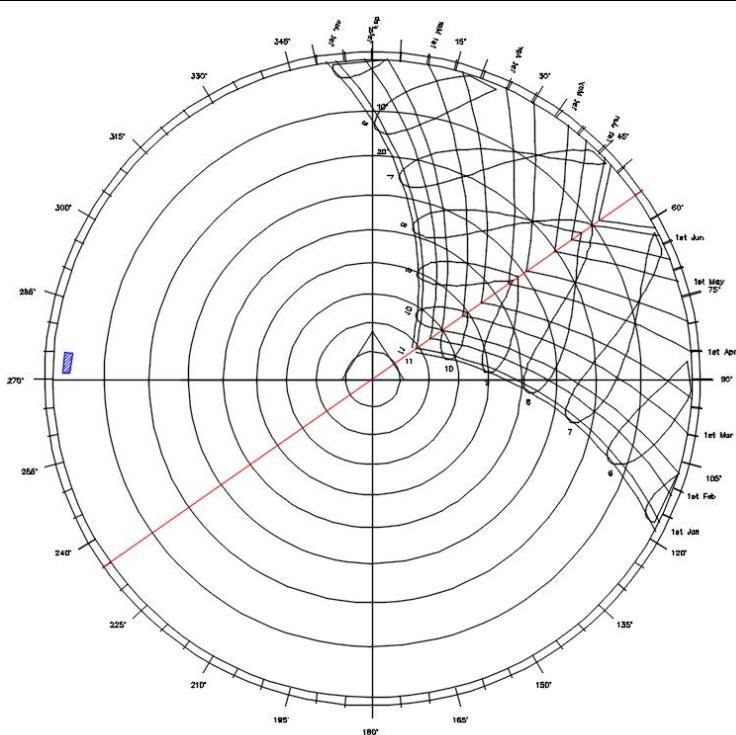
4.1.4 Point 4 - Façade Aspect 145 - Eastern wall of Level 1 of shop

There is no risk of rogue reflections from this façade to this viewpoint.

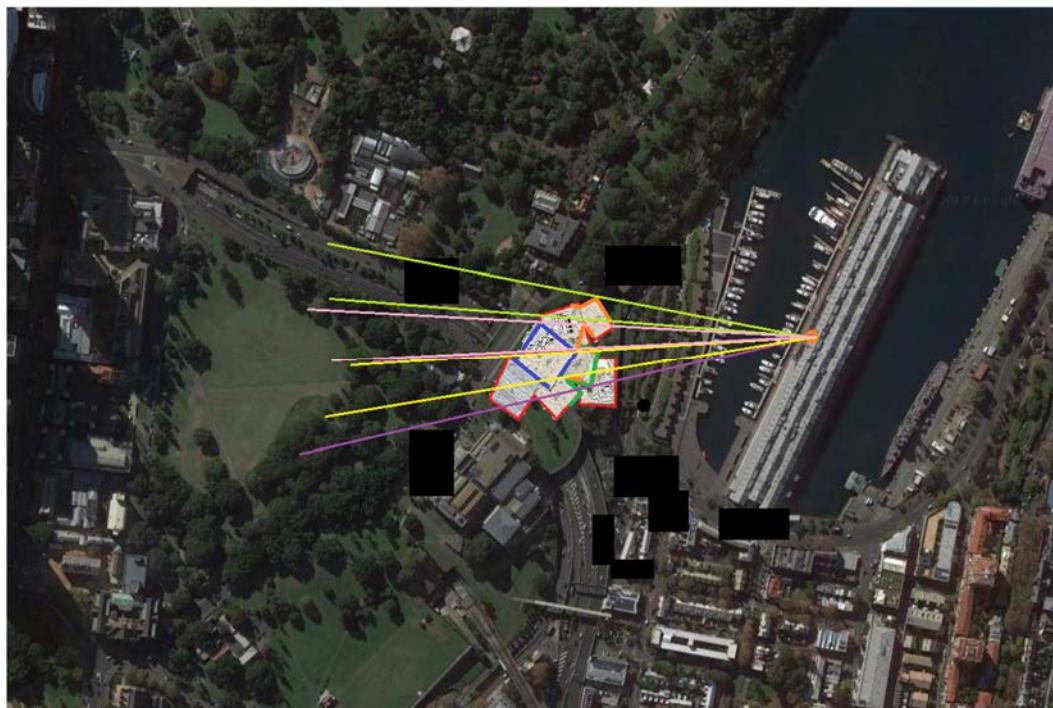
The image below identifies the glazed façades visible from the viewpoint in question.

There are 5 glazed facades visible from this viewpoint:

- o North-eastern glazed wall of Level 2 Multi-Purpose Hall
- o Northern wall of Entry Level of Entry Pavilion
- o Eastern wall of Entry Level of Entry Pavilion
- o Eastern wall of Level 1 of café
- o Northern wall of Level 1 of café

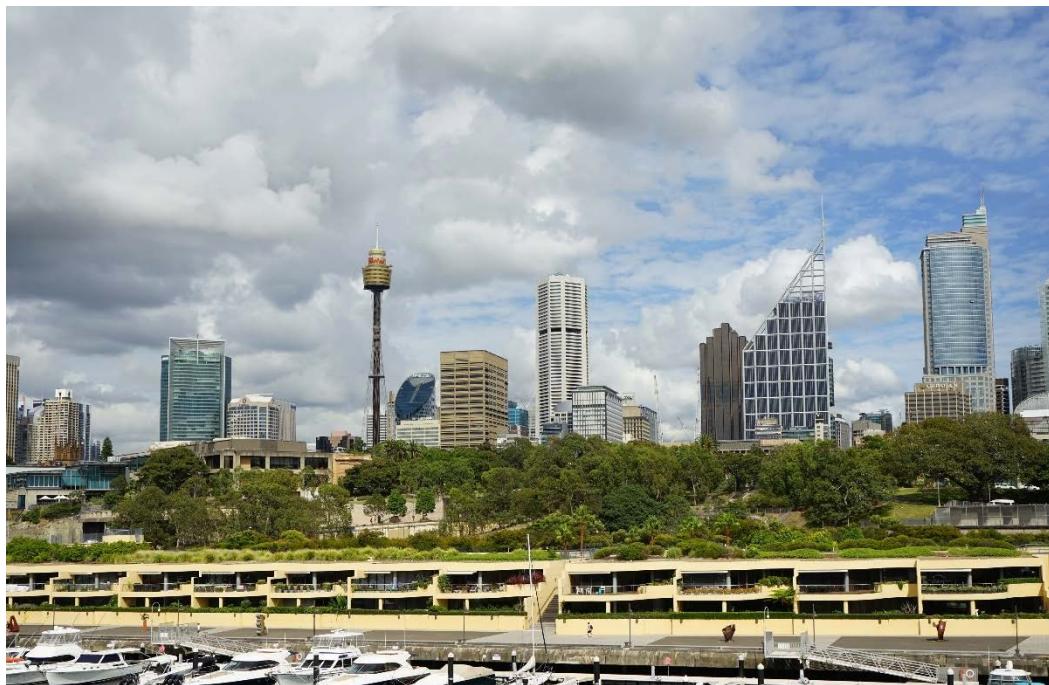
Vertical Bearing Angle		Horizontal Bearing Angle (0° at North)	
	Lower Bound	Upper Bound	Lower Bound	Upper Bound
Façade Aspect 55 (215m) North-eastern glazed wall of Level 2 Multi-Purpose Hall	1.4°	3.17°	274°	280°
Façade Aspect 35 (250m) Northern wall of Entry Level of Entry Pavilion	4°	4.8°	266°	273°
Façade Aspect 125 (250m) Eastern wall of Entry Level of Entry Pavilion	4°	4.8°	260°	266°
Façade Aspect 100 (230m) Eastern wall of Level 1 of café	3.0°	4.35°	257°	266°
Façade Aspect 35 (230m) Northern wall of Level 1 of café	3.0°	4.35°	266°	268°

View image above, reflected sun image and view angle – blue lines (below)

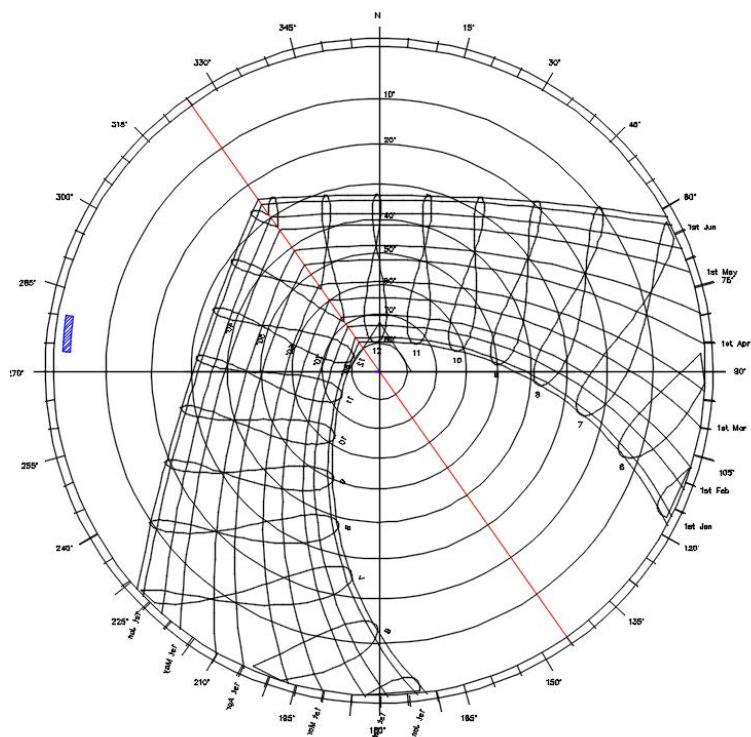
#### 4.2.1 Point 5 - Façade Aspect 55 - North-eastern glazed wall of Level 2 Multi-Purpose Hall

There is no risk of rogue reflections from this façade to this viewpoint.

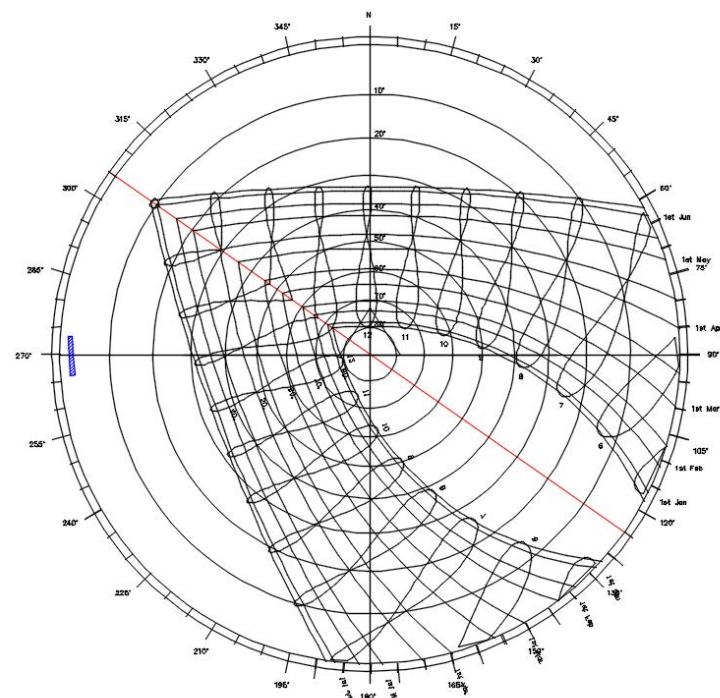
**4.2.2 Point 5 -Façade Aspect 35 - Northern wall of Entry Level of Entry Pavilion**

There is no risk of rogue reflections from this façade to this viewpoint.

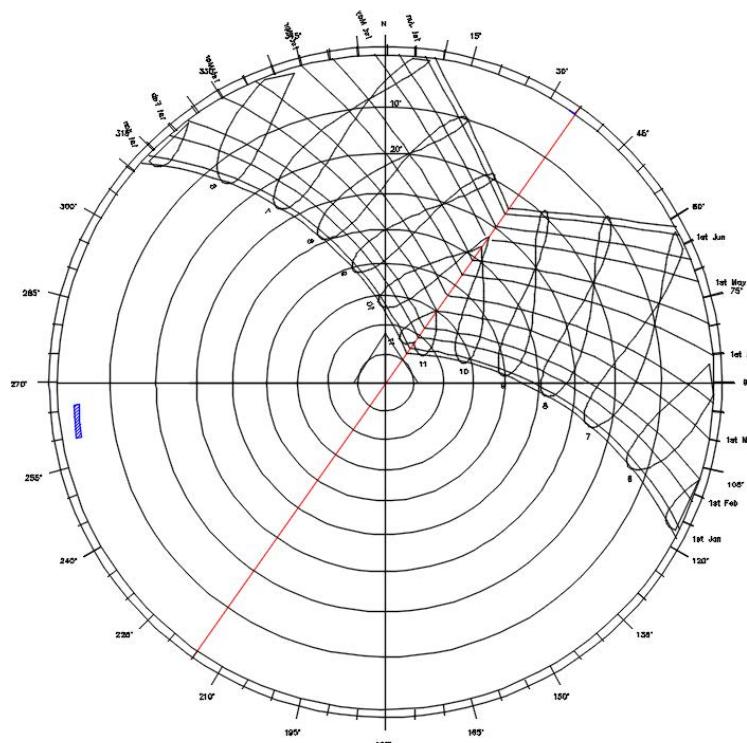
**4.2.3 Point 5 -Façade Aspect 125 - Eastern wall of Entry Level of Entry Pavilion**

There is no risk of rogue reflections from this façade to this viewpoint.

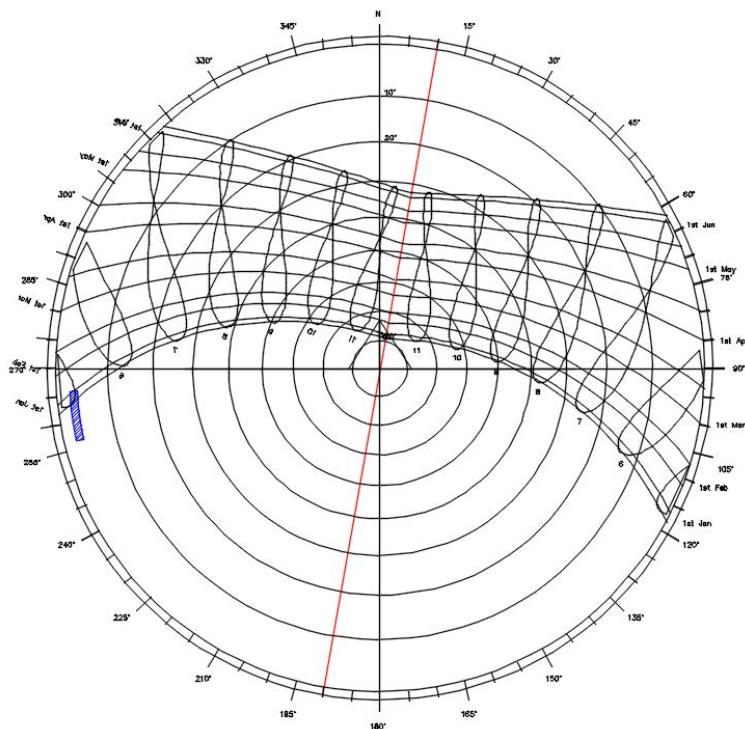
**4.2.4 Point 5 -Façade Aspect 100 - Eastern wall of Level 1 of café**

There is the potential for glare between 5am and 5:15am from late December to early January.

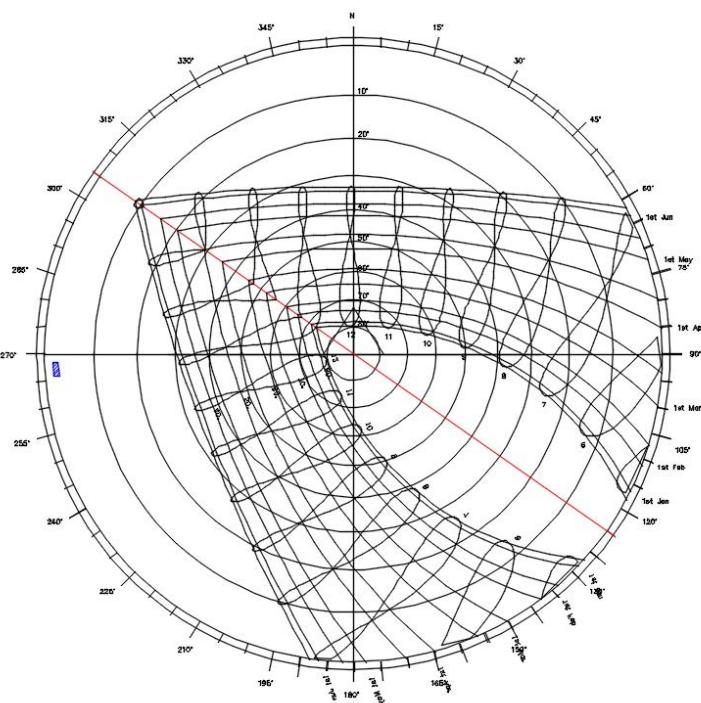
**4.2.5 Point 5 - Façade Aspect 35 - Northern wall of Level 1 of café**

There is no risk of rogue reflections from this façade to this viewpoint.
