## **Additional Points of Assessment for Reflectivity**

**Sydney Modern Art Gallery of NSW**

Reference: 17033

Revision: 03

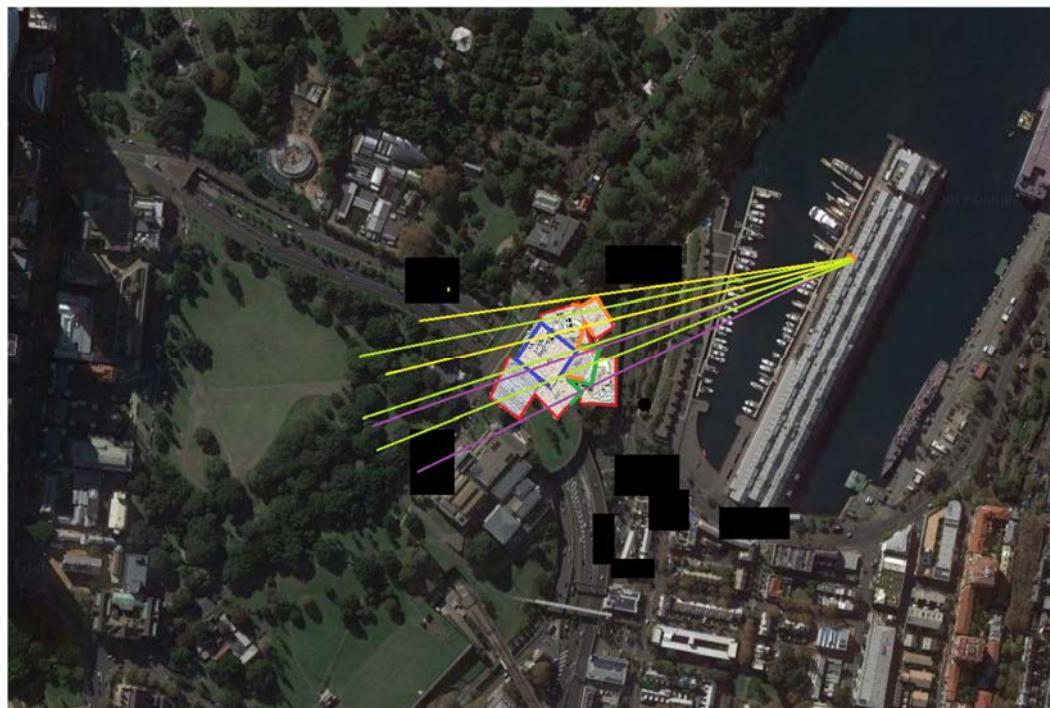
The image below identifies the glazed façades visible from the viewpoint in question.

There are 5 glazed facades visible from this viewpoint;

- o North-eastern glazed wall of Level 2 Multi-Purpose Hall
- o Northern wall of Entry Level of Entry Pavilion
- o Eastern wall of Entry Level of Entry Pavilion
- o Eastern wall of Level 1 of café
- o Northern wall of Level 1 of café

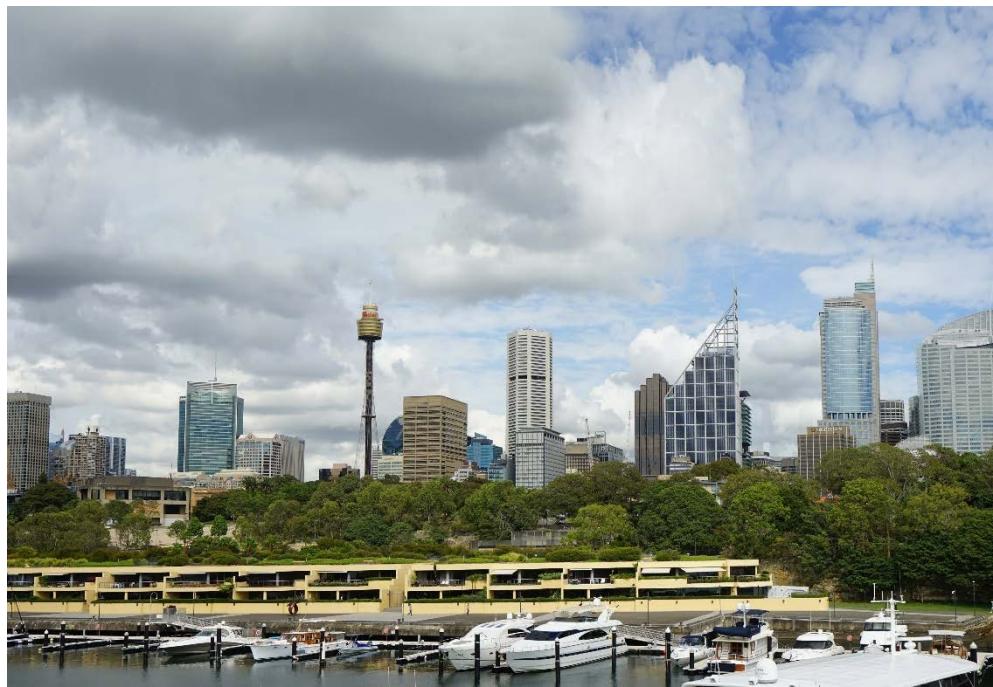
Vertical Bearing Angle		Horizontal Bearing Angle (0° at North)	
	Lower Bound	Upper Bound	Lower Bound	Upper Bound
Façade Aspect 55 (260m) North-eastern glazed wall of Level 2 Multi-Purpose Hall	1.1°	2.6°	256°	262°
Façade Aspect 35 (310m) Northern wall of Entry Level of Entry Pavilion	3.2°	3.9°	251°	258°
Façade Aspect 125 (310m) Eastern wall of Entry Level of Entry Pavilion	3.2°	3.9°	247°	251°
Façade Aspect 100 (290m) Eastern wall of Level 1 of café	2.4°	3.5°	243°	250°
Façade Aspect 35 (290m) Northern wall of Level 1 of café	2.4°	3.5°	250°	253°

View image above, reflected sun image and view angle – blue lines (below)

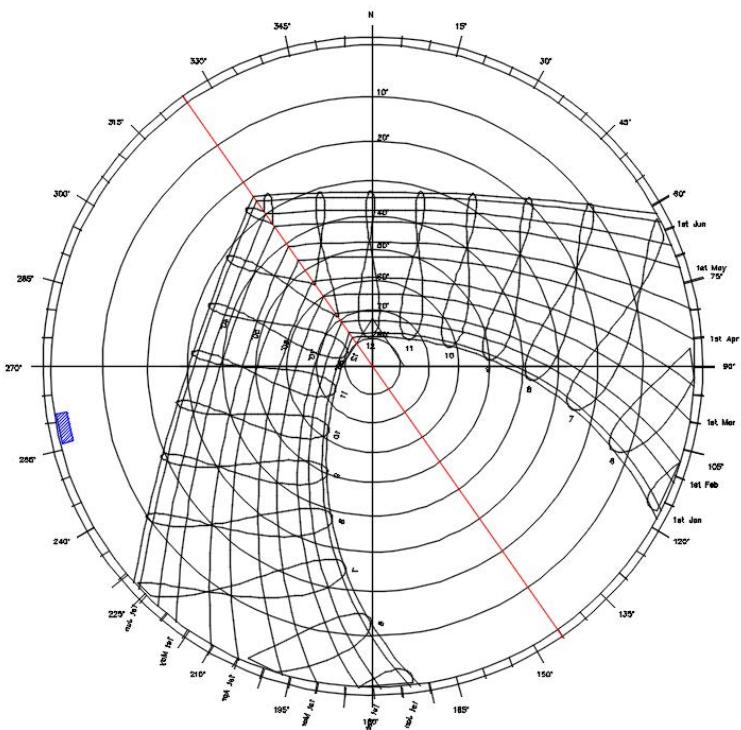
#### 4.3.1 Point 6 -Façade Aspect 55 - North-eastern glazed wall of Level 2 Multi-Purpose Hall

There is no risk of rogue reflections from this façade to this viewpoint.

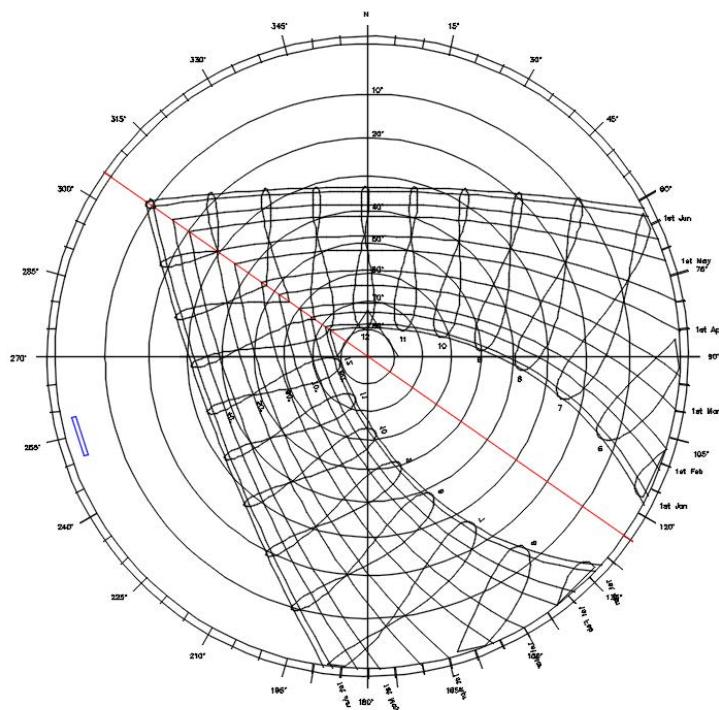
**4.3.2 Point 6 - Façade Aspect 35 - Northern wall of Entry Level of Entry Pavilion**

There is no risk of rogue reflections from this façade to this viewpoint.

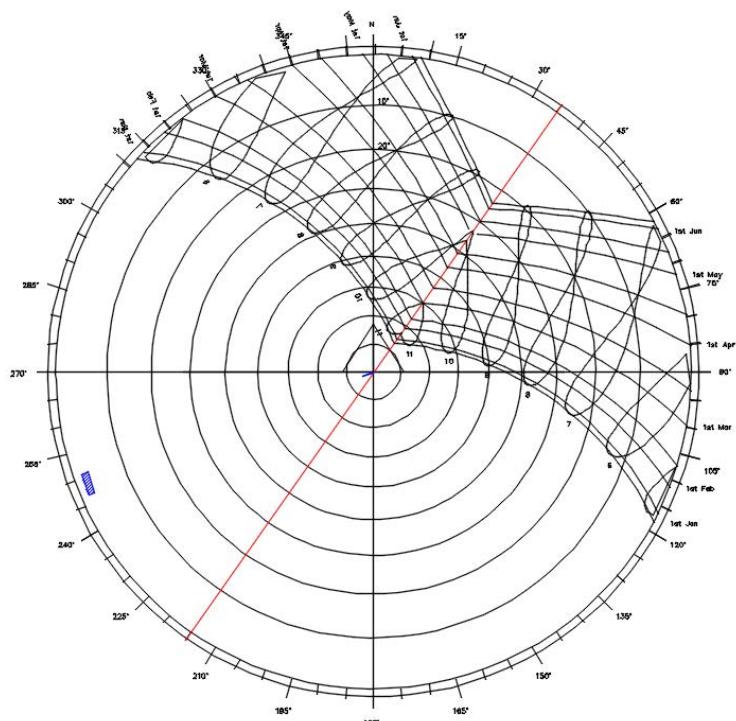
**4.3.3 Point 6 - Façade Aspect 125 - Eastern wall of Entry Level of Entry Pavilion**

There is no risk of rogue reflections from this façade to this viewpoint.

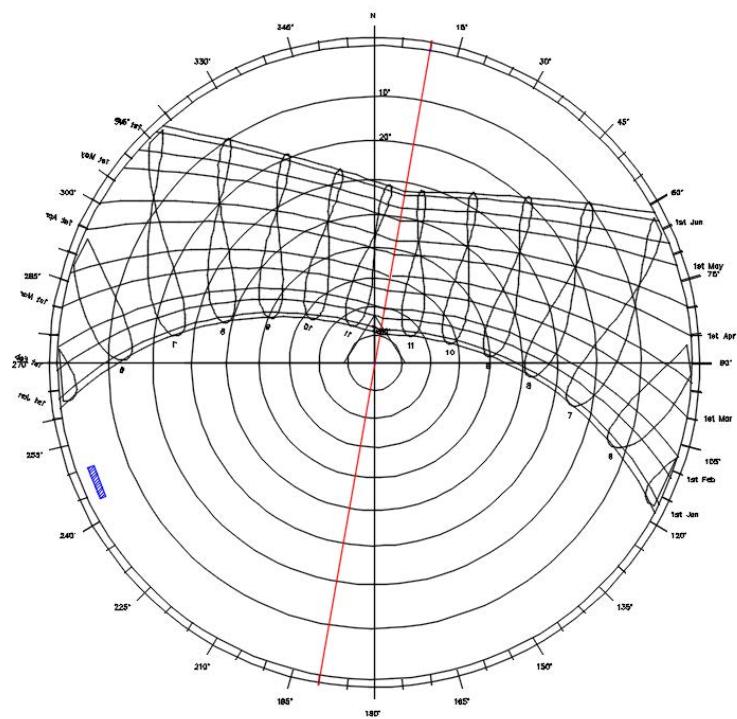
**4.3.4 Point 6 - Façade Aspect 100 - Eastern wall of Level 1 of café**

There is no risk of rogue reflections from this façade to this viewpoint.

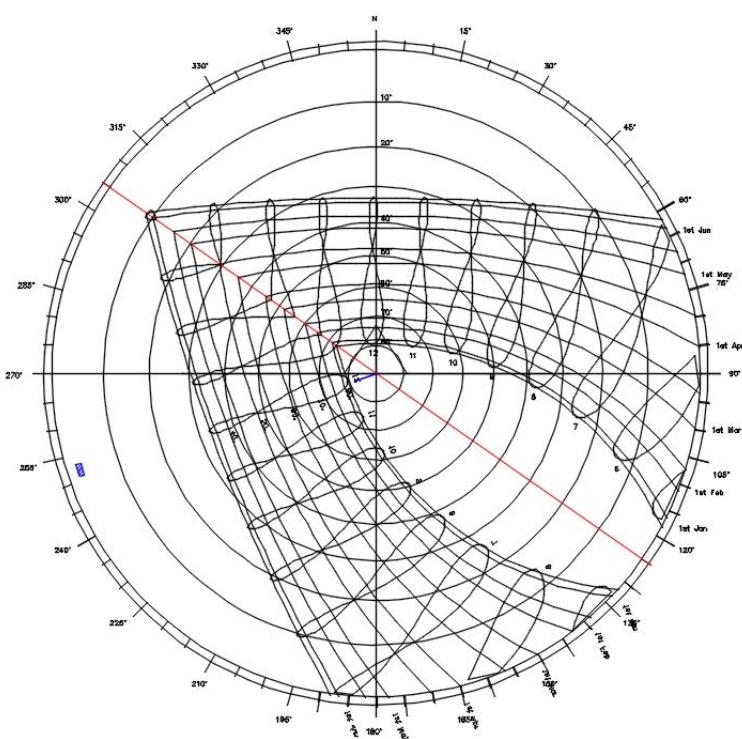
**4.3.5 Point 6 - Façade Aspect 35 - Northern wall of Level 1 of café**

There is no risk of rogue reflections from this façade to this viewpoint.

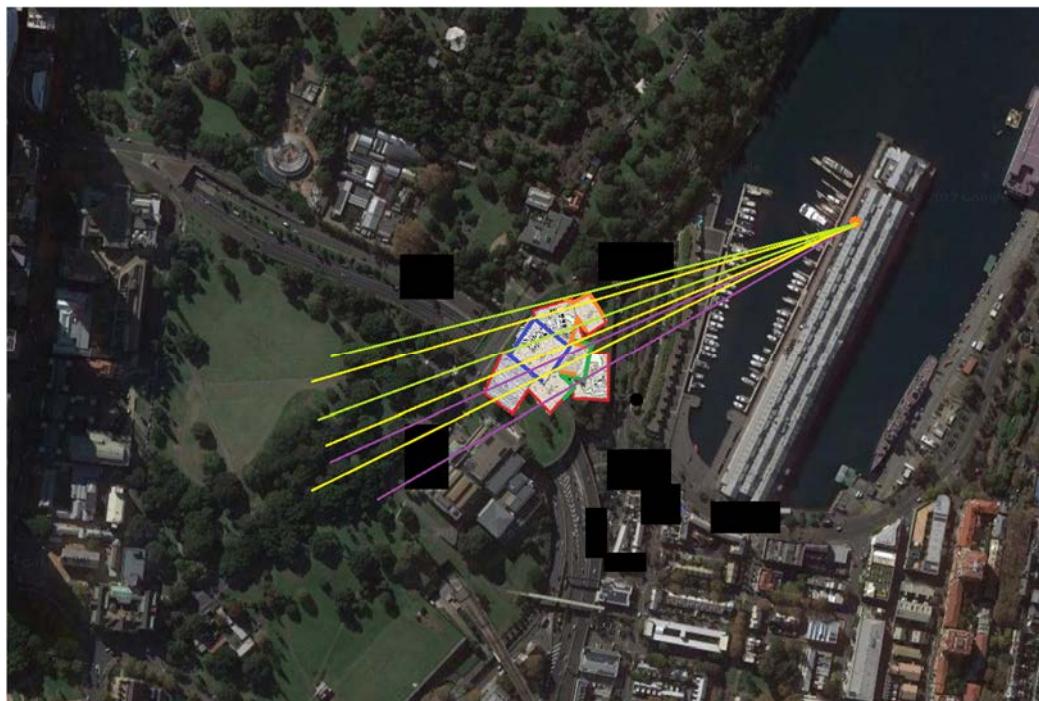
The image below identifies the glazed façades visible from the viewpoint in question.

There are 5 glazed facades visible from this viewpoint;

- o North-eastern glazed wall of Level 2 Multi-Purpose Hall
- o Northern wall of Entry Level of Entry Pavilion
- o Eastern wall of Entry Level of Entry Pavilion
- o Eastern wall of Level 1 of café
- o Northern wall of Level 1 of café

The bottom of the Level 1 apartment on the wharf is approximately 4.5m RL to the Art Gallery and the top of the Level 1 apartment on the wharf is approximately 11m RL to the Art Gallery (worst case is used). The bottom of the Lower Level 2 glazing is at 9.7m RL, the top of the Lower Level 2 glazing is at 16.42m RL; the top of Lower Level 1 glazing is at 22.0m RL and the top of the Entry Level glazing is at 25.4m RL. The Vertical bearing angles have been calculated based on these heights.

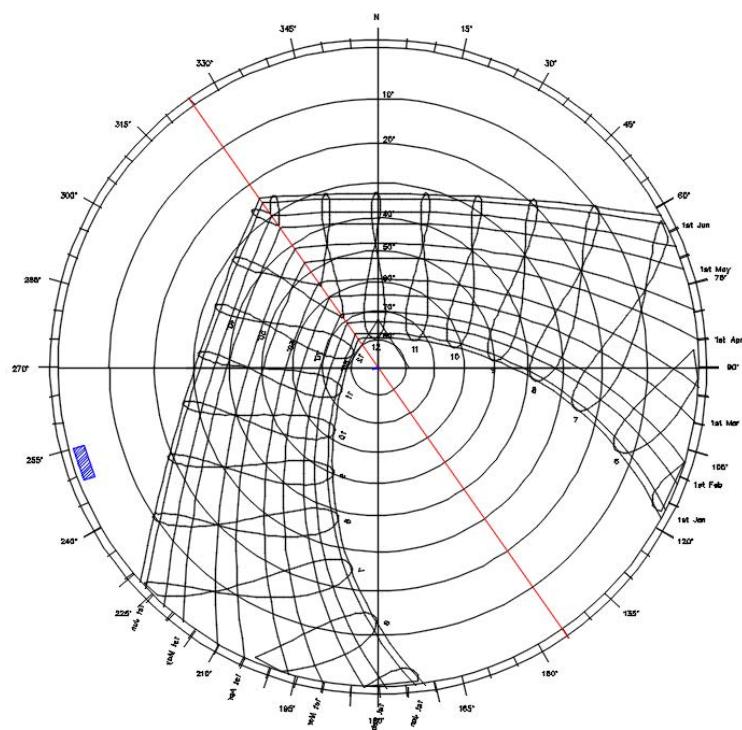
#### 4.4.1 Point 7 - Façade Aspect 55 -North-eastern glazed wall of Level 2 Multi-Purpose Hall

There is no risk of rogue reflections from this façade to this viewpoint.

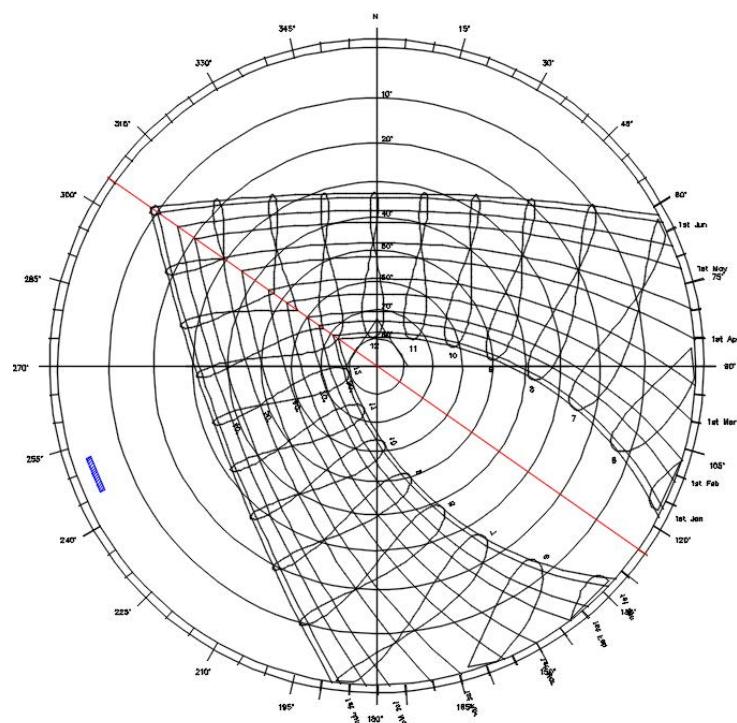
**4.4.2 Point 7 - Façade Aspect 35 - Northern wall of Entry Level of Entry Pavilion**

There is no risk of rogue reflections from this façade to this viewpoint.

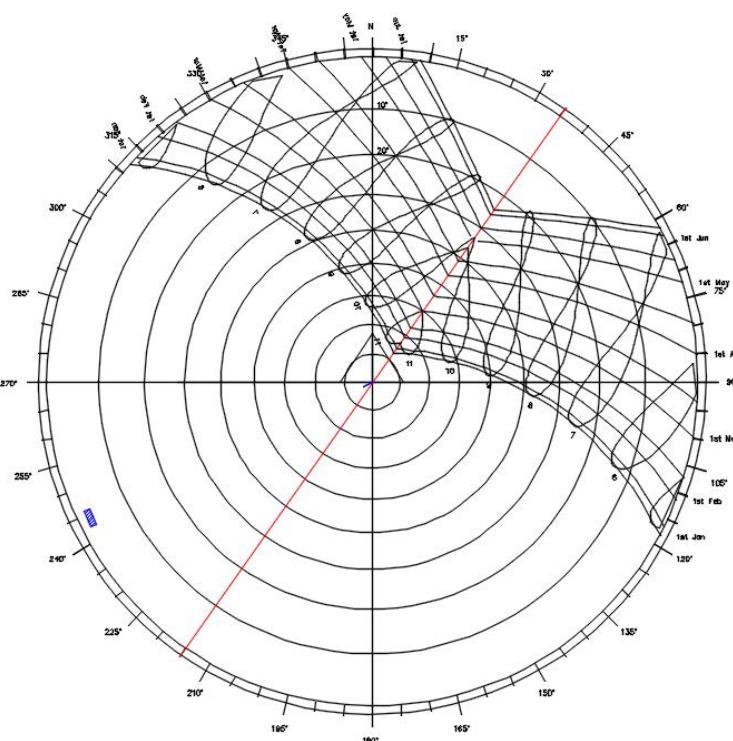
**4.4.3 Point 7- Façade Aspect 125 - Eastern wall of Entry Level of Entry Pavilion**

There is no risk of rogue reflections from this façade to this viewpoint.

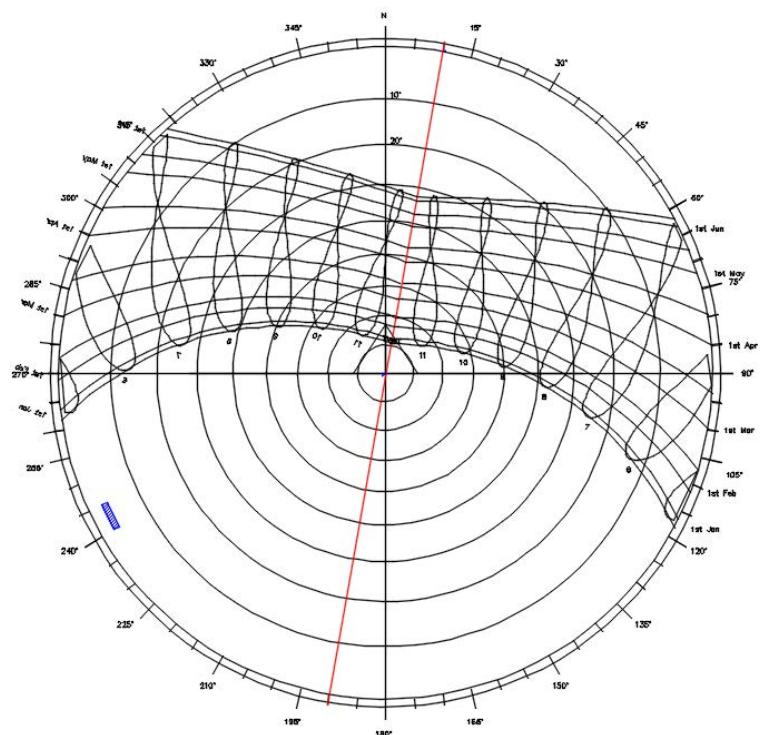
**4.4.4 Point 7 -Façade Aspect 100 - Eastern wall of Level 1 of café**

There is no risk of rogue reflections from this façade to this viewpoint.

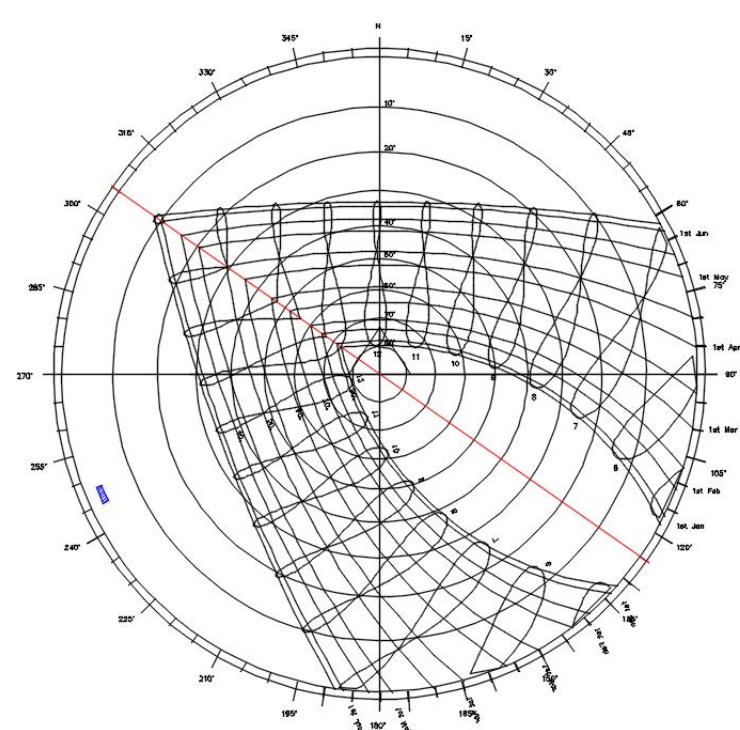
**4.4.5 Point 7- Façade Aspect 35 - Northern wall of Level 1 of café**

There is no risk of rogue reflections from this façade to this viewpoint.
