Richard Crookes Constructions – Jesse Moss

Unexpected Finds Procedure

Sydney Modern Gallery
Art Gallery Road, Sydney, NSW

15 October 2019

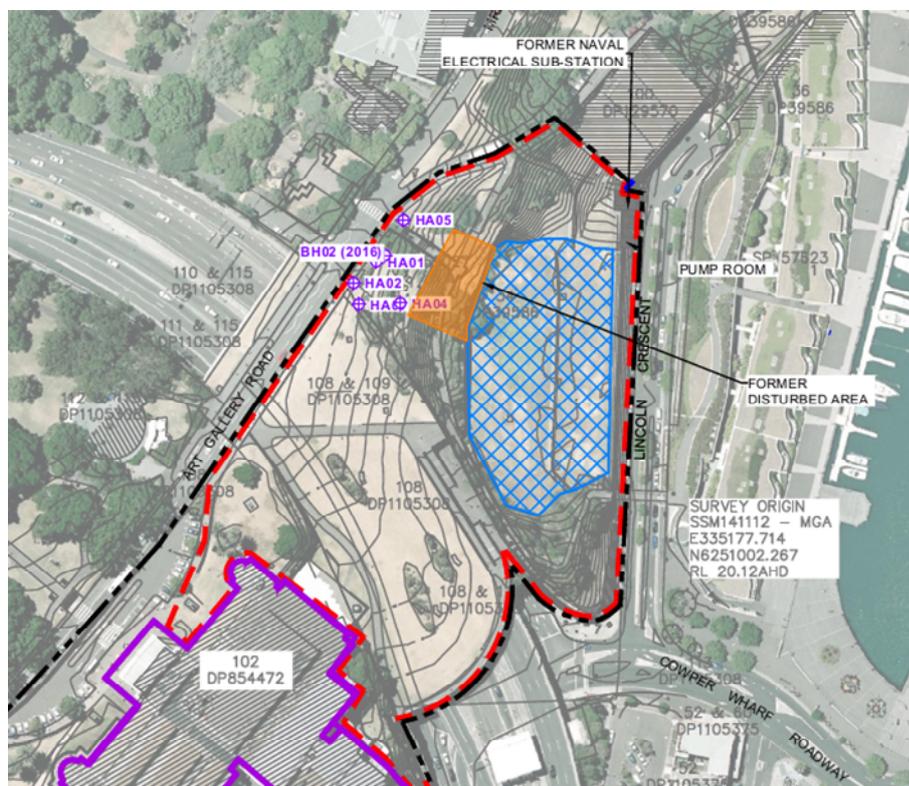
Figure 2 Area of Identified Contamination on the SMG Site

The location of identified contamination on the site is indicated in Figure 2.

Previous investigations identified TRH and PAH contamination and strong hydrocarbon odours in the part of the SMG site indicated in orange on Figure 2. The extent of the odorous contaminated soils is estimated to be 12m by 25m in area and is estimated to extend to the top of sandstone, which varies between 1.1m and 2.2m bgs.

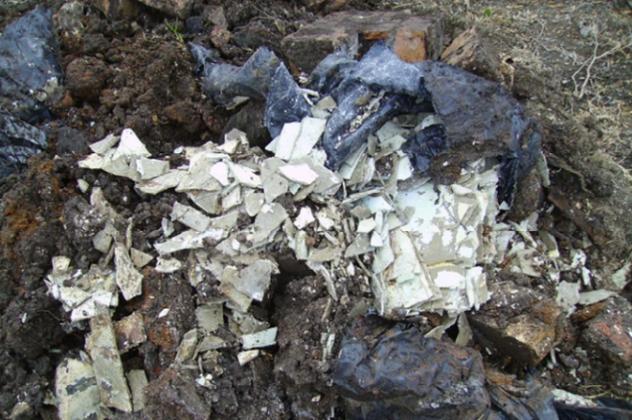
Potential Unexpected Find	Observed Characteristic	Typical Key Contaminant of Concern	Example of an unexpected find where applicable
Asbestos containing materials and/or buried asbestos pipes	<p>It is often very difficult to identify the presence of asbestos by sight. The only way to be certain is to have a sample of the material analysed by a laboratory. Cement bound asbestos (fibro cement sheet) may be present in building materials such as wall sheeting, pipes and roofing, backing of electrical switch boards, linoleum floor tiles etc and may be found as fragments of broken building materials (often found close to the building) and building wastes.</p> <p>Friable forms of asbestos including lagging and insulation may occur as fibrous material which flakes and powders easily. Textured coatings used to improve fire-resistance may also contain asbestos.</p>	Asbestos

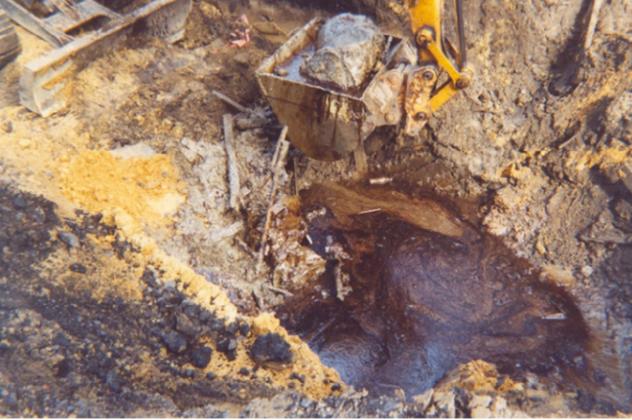
Buried waste materials	<p>May include a variety of waste materials, inclusive of waste oil drums, wood, plastic, metal fragments, building rubble (e.g. concrete, brick, asphalt, asbestos containing materials), lead paint. We do not consider that a trivial piece or fragment of foreign material constitutes as an unexpected find (e.g. a single brick).</p>	<p>Total Recoverable Hydrocarbons (TRH) Benzene, toluene, ethylbenzene, xylenes and naphthalene (BTEXN) Polycyclic Aromatic Hydrocarbons (PAHs)</p> <p>Volatile Halogenated Compounds (VHCs) Asbestos Heavy metals – usually arsenic, cadmium, chromium, copper lead, mercury, nickel and zinc</p>

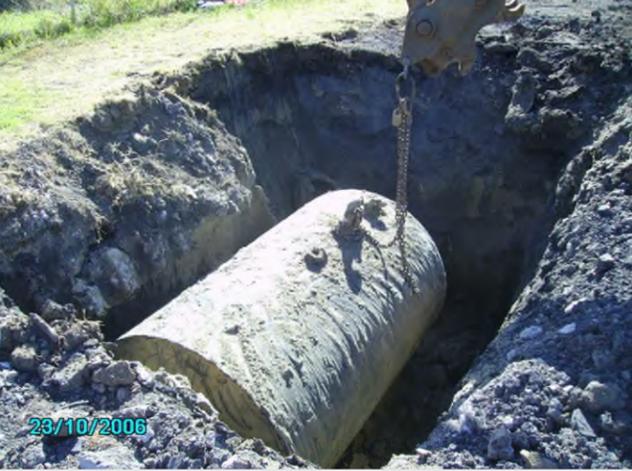
Underground storage tanks (USTs)	<p>Though unlikely but can be identified as follows:</p> <ul style="list-style-type: none"> • A buried steel underground tank; • Deeper sand fill is sometimes observed and / or hydrocarbon odours or staining. • Encountering relatively small concrete footings or steel pipelines, sometimes with observed hydrocarbon odours or staining. 	TRH, BTEXN, PAHs, VHCs, phenols, lead

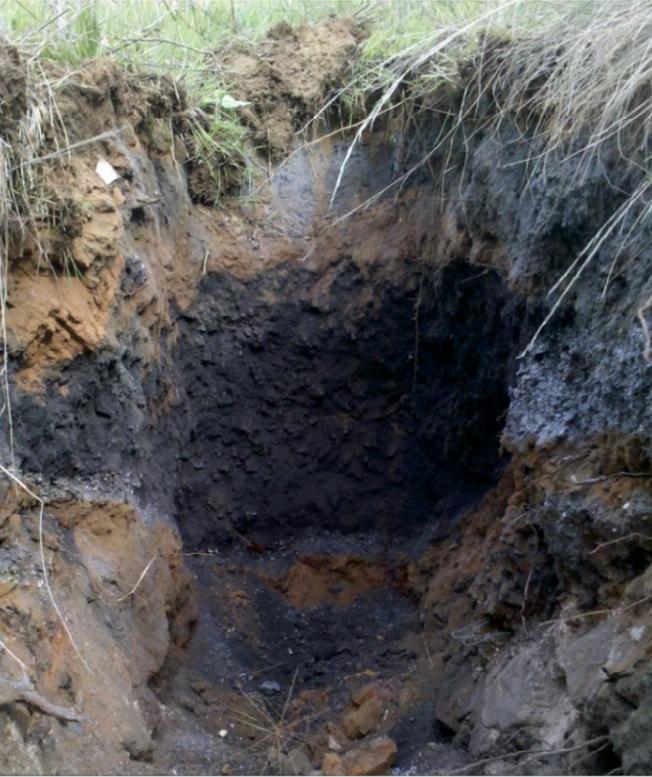
Potential Unexpected Find	Observed Characteristic	Typical Key Contaminant of Concern	Example of an unexpected find where applicable
Ash or slag deposits	<p>Ash materials typically light weight, grey and white gravel and sand sized (1mm to 10mm) particles (see photograph example).</p> <p>Slag materials can be varied in consistency and colour. Typically slags from steelmaking are pale grey to grey, however can be blue/green/grey, loose or cemented. Slag gravels can be very angular and appear to have a vesicular (i.e. 'honeycomb') shape.</p>	PAHs, heavy metals

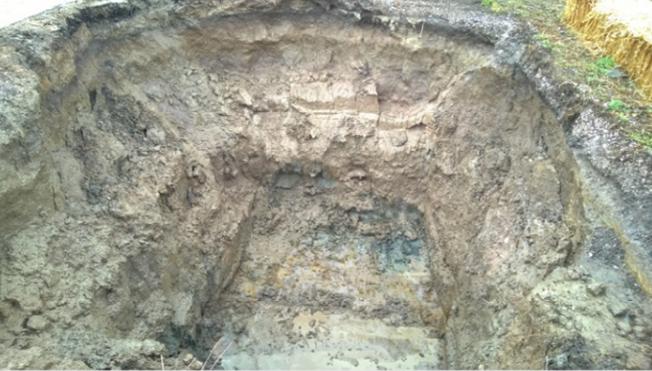
Hydrocarbon Compounds	<p>May be identified by a hydrocarbon (e.g. petrol, diesel or oil) odour which may vary in strength from possible (just detectable) to very strong (easily detectable at a distance from the source).</p> <p>The odour may or may not be accompanied by specific areas of dark staining (black-grey) or larger scale discolouration of strata from a previously identified 'natural colour' e.g. staining of orange and brown clay to dark grey and green.</p>	TRH, BTEXN, PAHs, lead

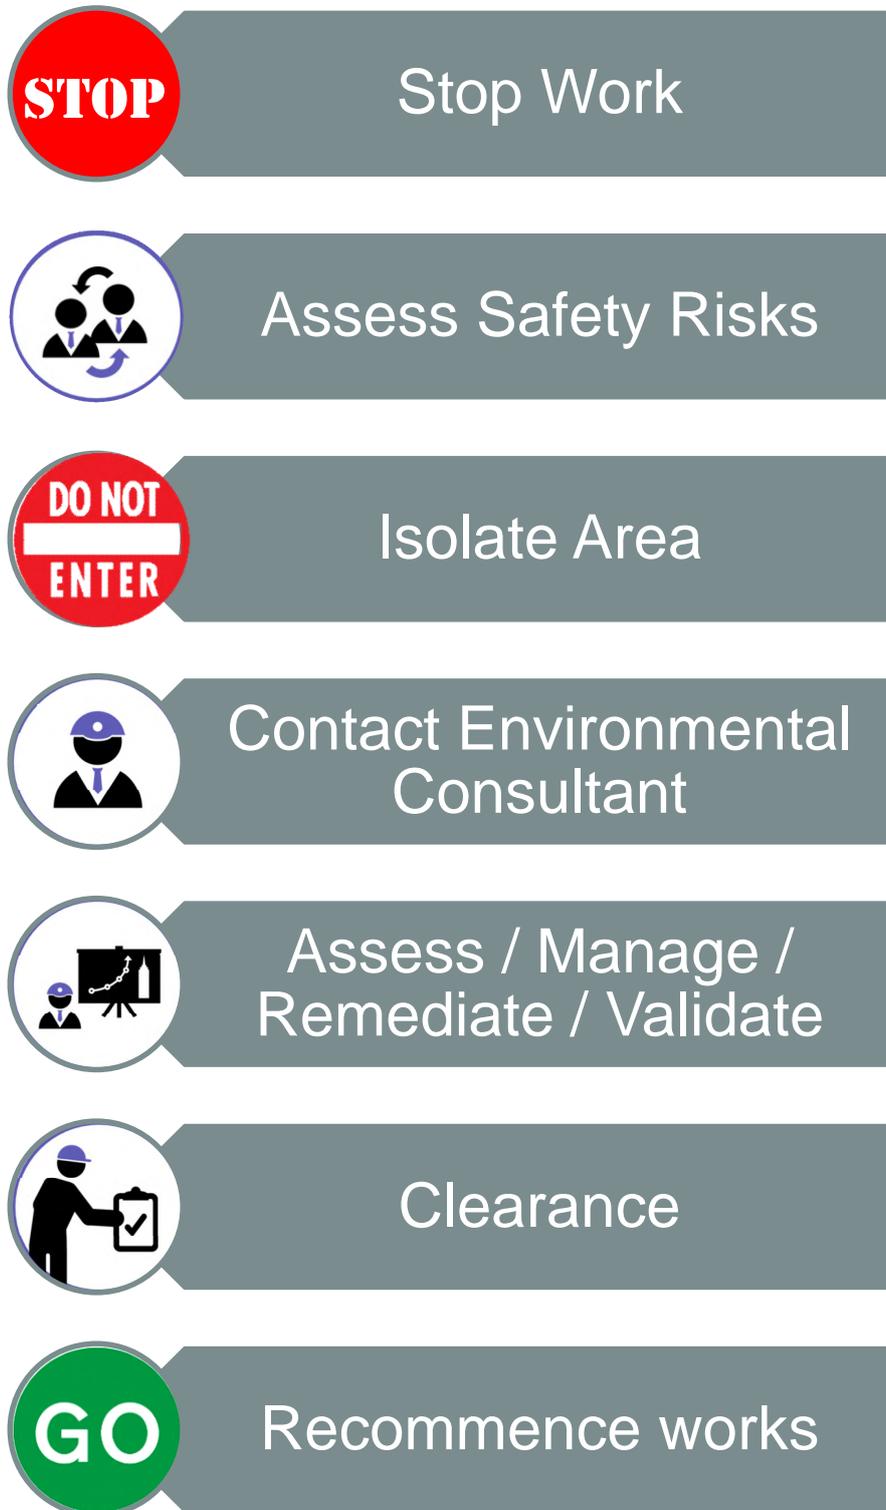
A simple one-page summary of the sequence of actions recommended in the UFP.

Below is a summary version of the **Unexpected Finds Procedure** and can be used as a handout:
