# **JEMALONG SOLAR STATION PRELIMINARY HAZARD ANALYSIS**

Document Reference: HL20160225A

Revision: 2.0 [25 February 2016]

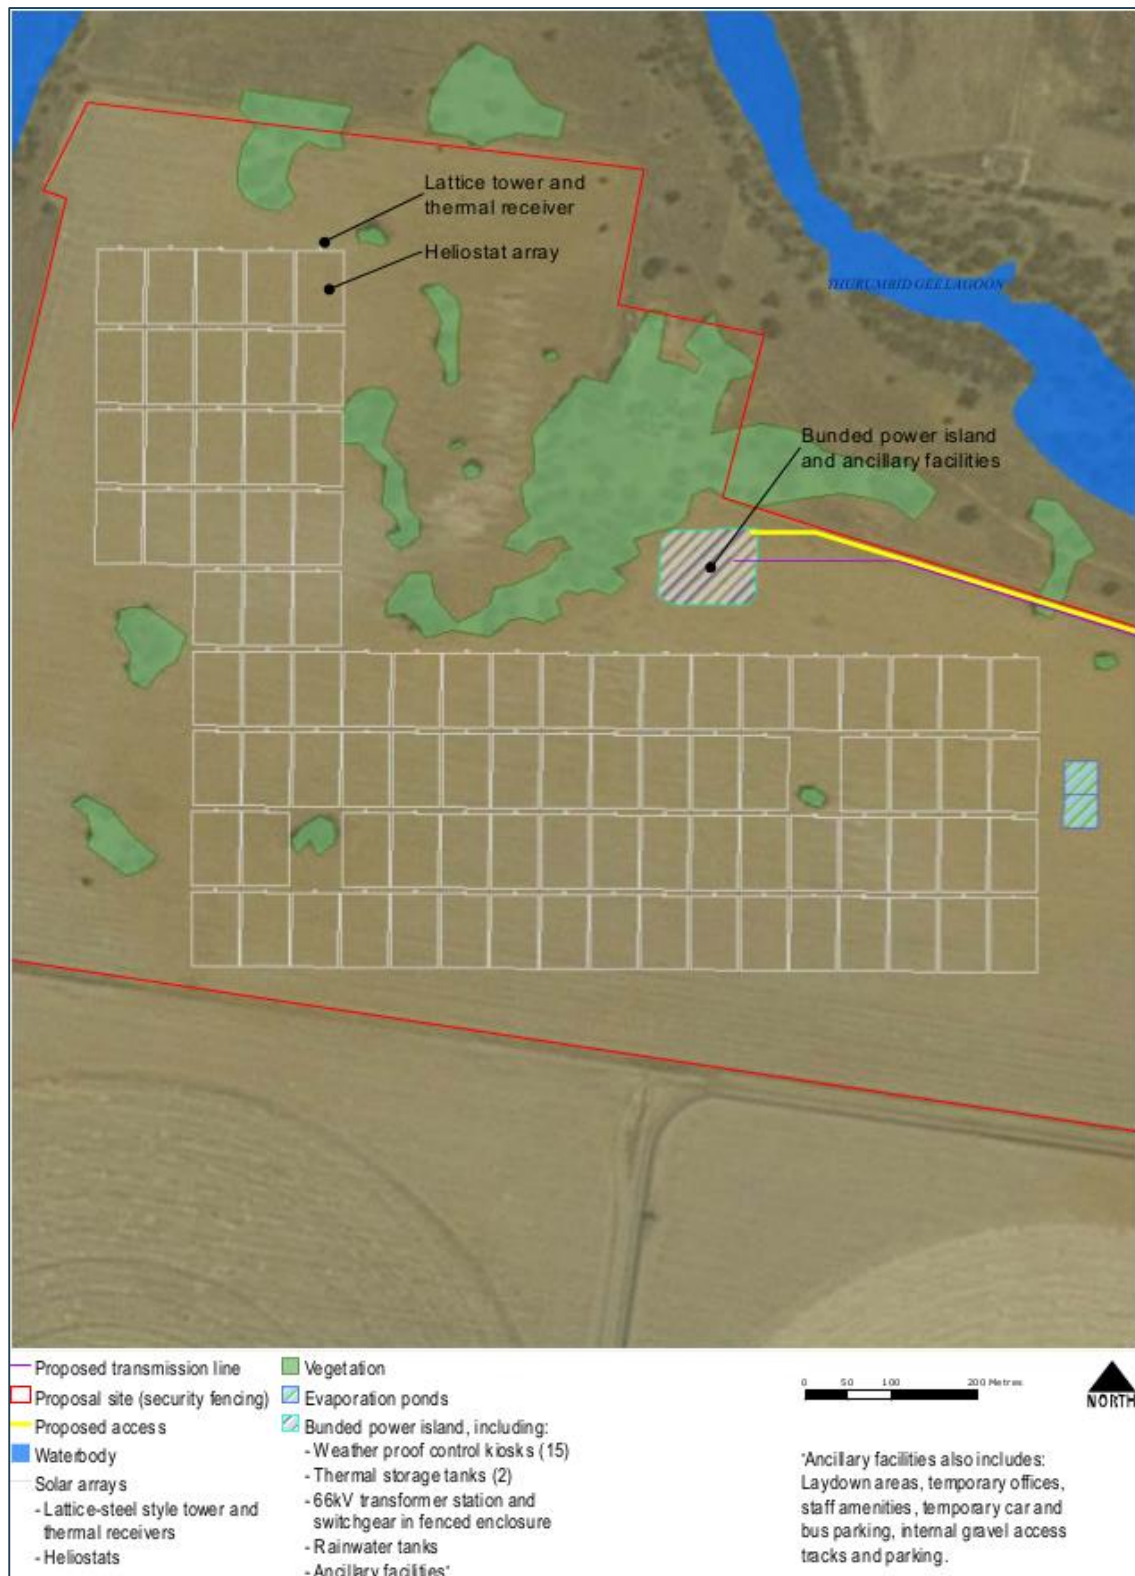
Figure 3: Layout of the infrastructure within the site

The general layout of the heliostat arrays and the location of other facilities are shown in Figure 3. Most processing and storage activities will occur within the bunded power island.

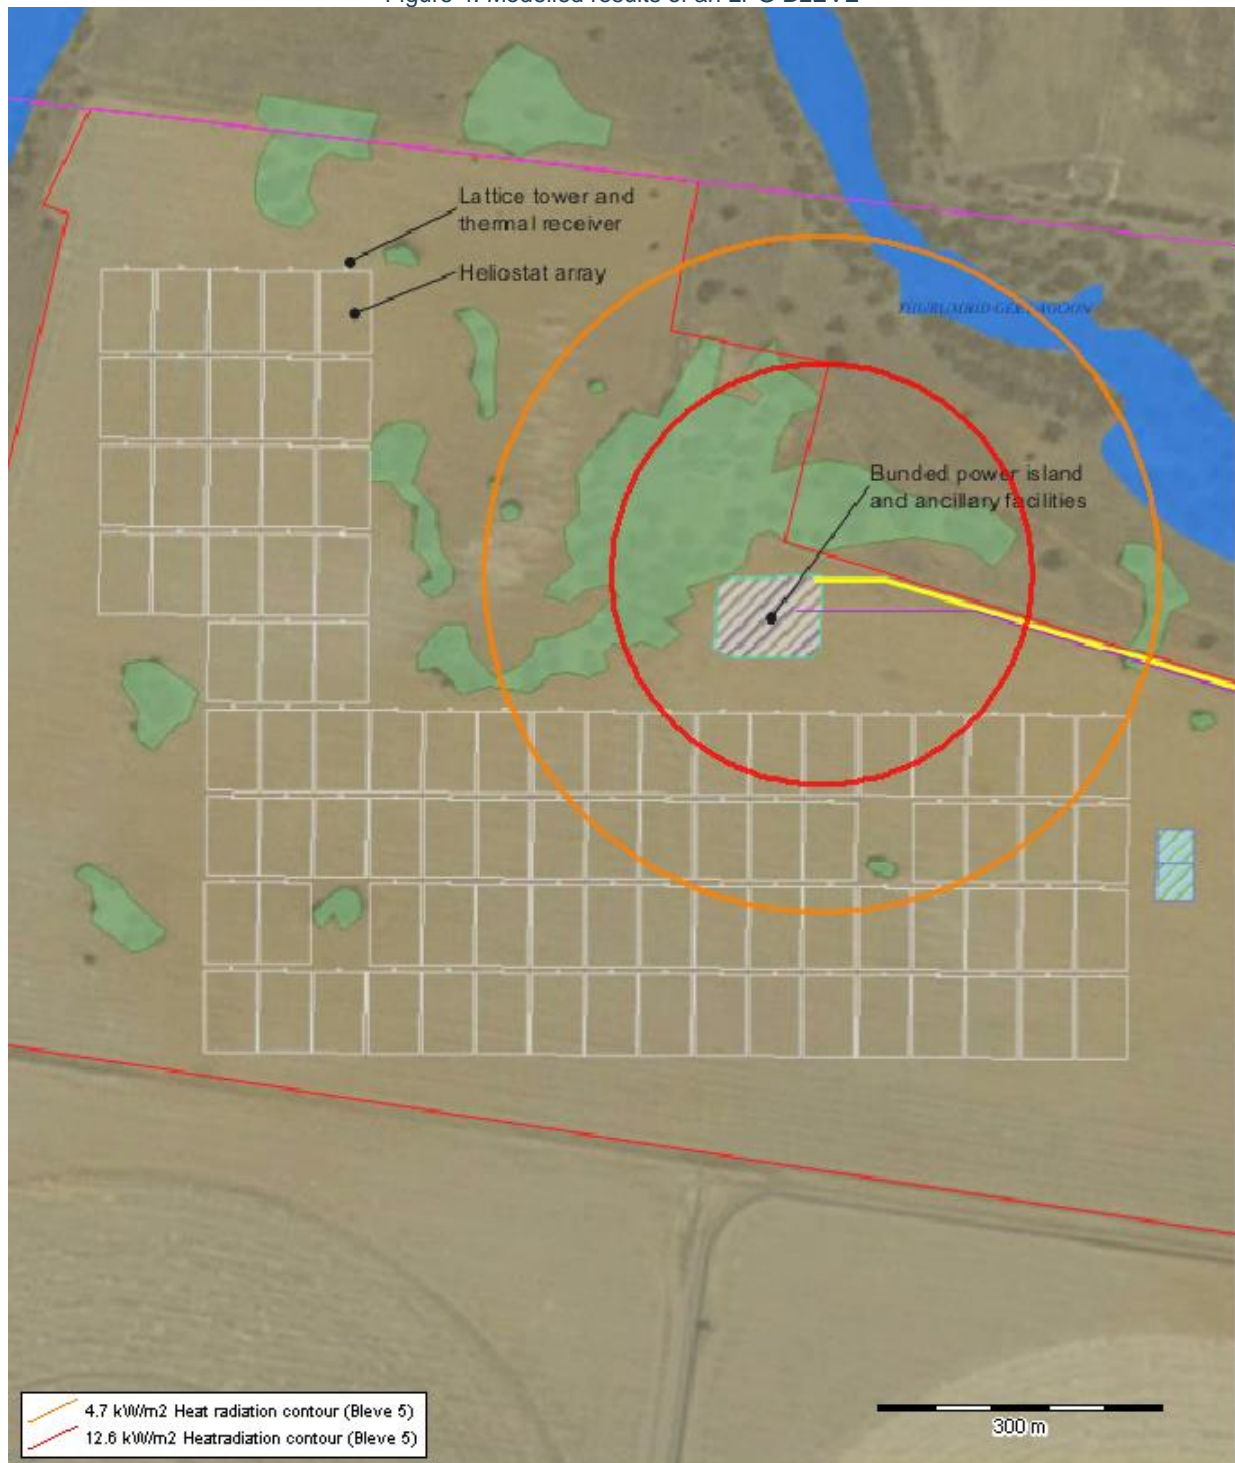
Figure 4: Modelled results of an LPG BLEVE

The results of a BLEVE are shown in Figure 4. The site boundary being used for the purpose of this study is that of the Jemalong Station which is shown by the pink line. The purple contour represents the extent of a BLEVE fireball, which would kill any person within it. The red contour represents the extent of heat radiation of  $12.6\text{kW/m}^2$  which would result in a significant chance of a fatality for extended exposure. The orange contour represents the extent of heat radiation of  $4.7\text{kW/m}^2$  which would result in injury after 30 seconds exposure.

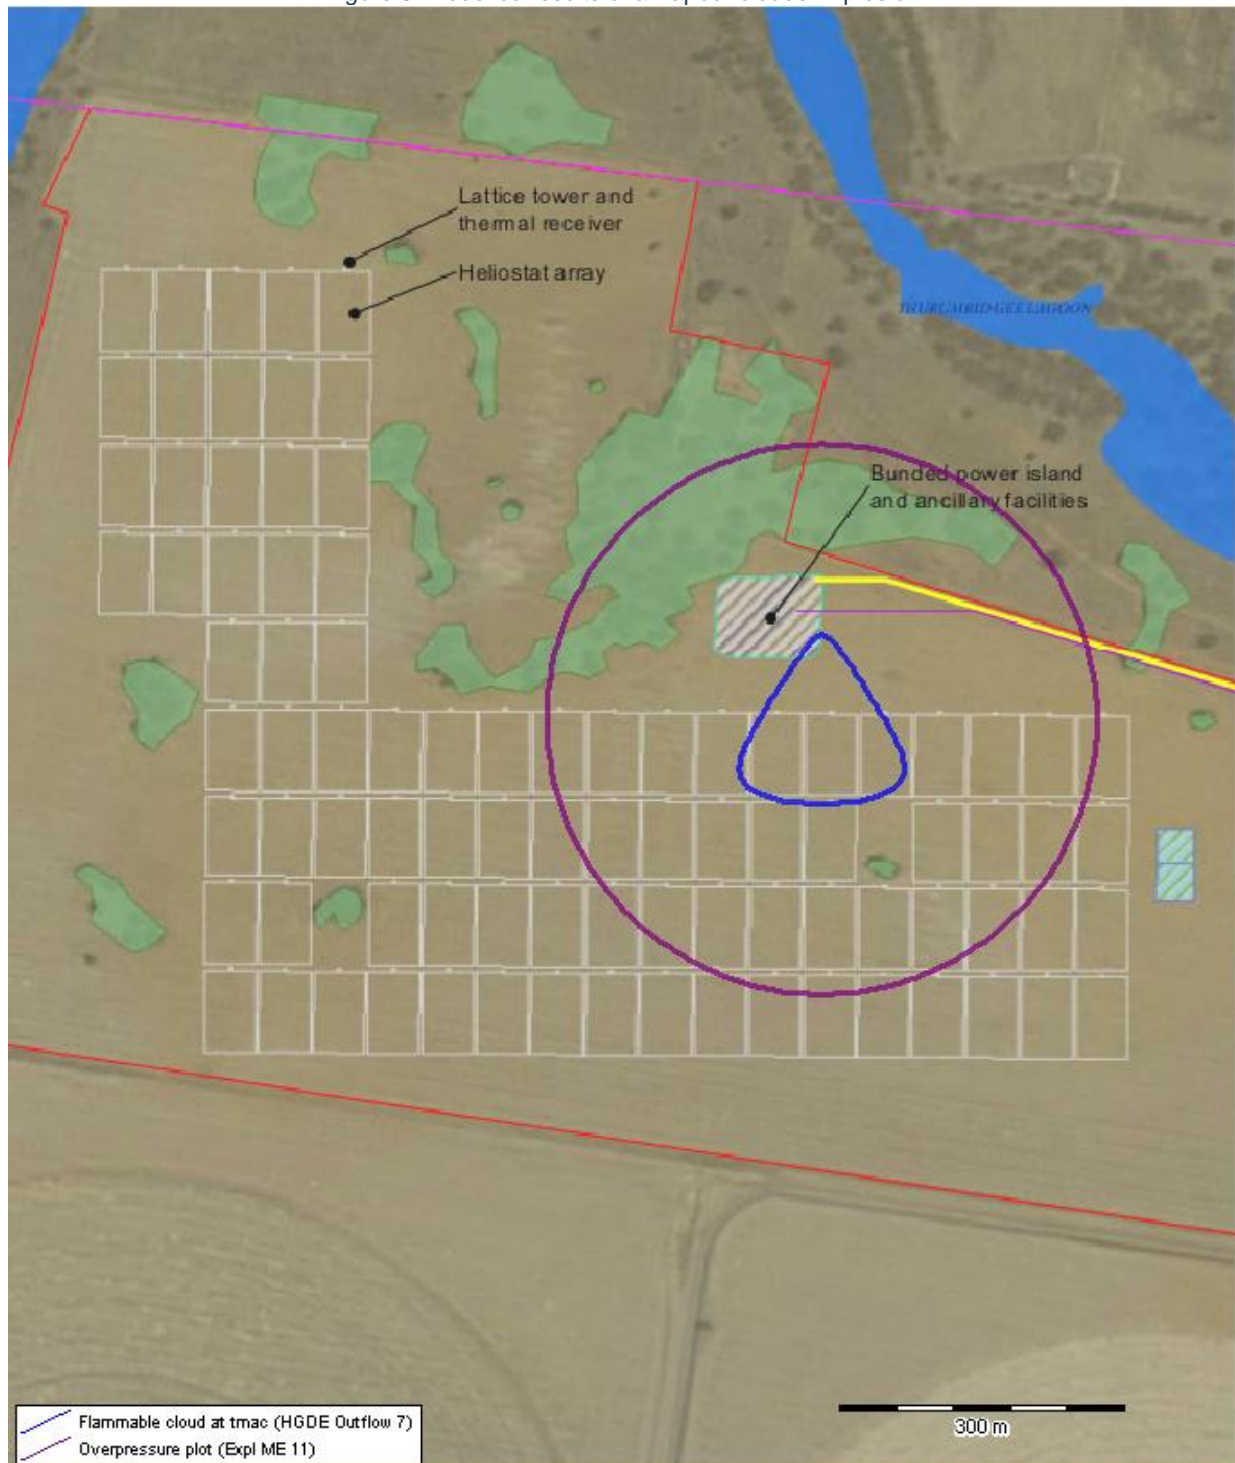
Figure 6: Modelled results of a Vapour cloud Explosion

The results of a VCE are shown in Figure 4. The site boundary being used for the purpose of this study is that of the Jemalong Station which is shown by the pink line. The blue contour represents the area of the LPG cloud prior to ignition. The purple contour represents the extent of overpressure of 7kPa from the explosion, which represents a 10% chance of injury to persons.

This contours are contained within the larger Jemalong Station.
