**Lend Lease (Millers Point) Pty Ltd**

## Barangaroo, Hickson Road

Specialist Geotechnical Desktop Report to  
Accompany Development Application SSD 6617-  
2014 for Hickson Road Remediation

5 November 2014

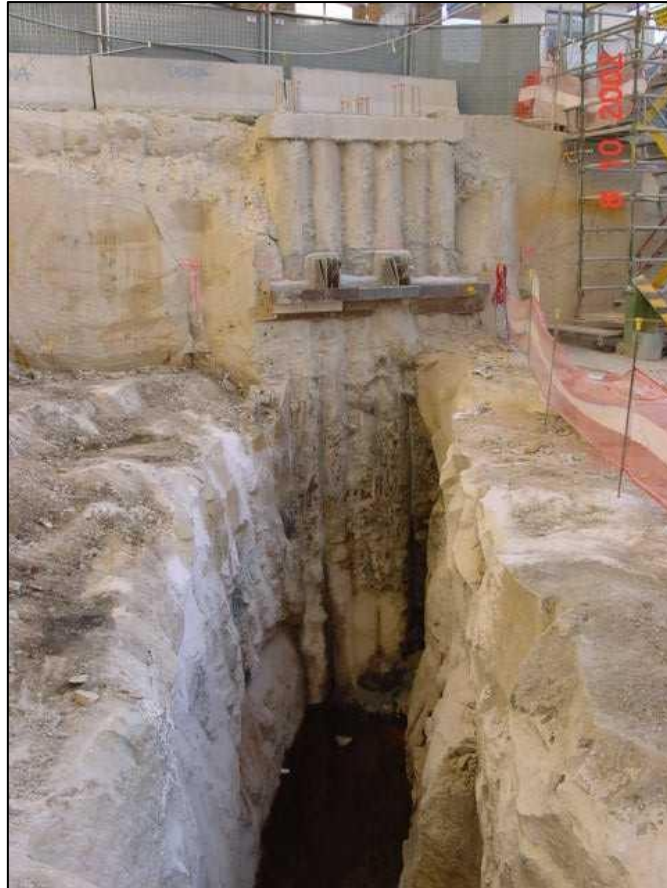
**Plate 7.1 Photograph showing main gas holder annulus, secant pile wall and upper waler beam and ground anchors (Source: Lend Lease)**

During excavation and construction of the basement to The Bond the former main gas holder annulus was intersected. The gas holder annulus was originally excavated as a trench into the sandstone bedrock approximately 1.5m wide to approximately -6.6m AHD. Where the basement wall intersected the annulus a series of secant piles with temporary ground anchors were installed. Two rows of ground anchors were installed at approximately 0.75m AHD and -2.70m AHD during bulk excavation of the annulus and surrounding rock. The following Plate 7.1 presents the position of the secant pile wall and the upper anchored waler beam within the annulus prior to bulk excavation of the building basement.
