# Kendall Bay Remediation Project

### Hydrological Assessment

Client: JBS&G Australia Pty Ltd

Reference: M&APA1848R002F1.0

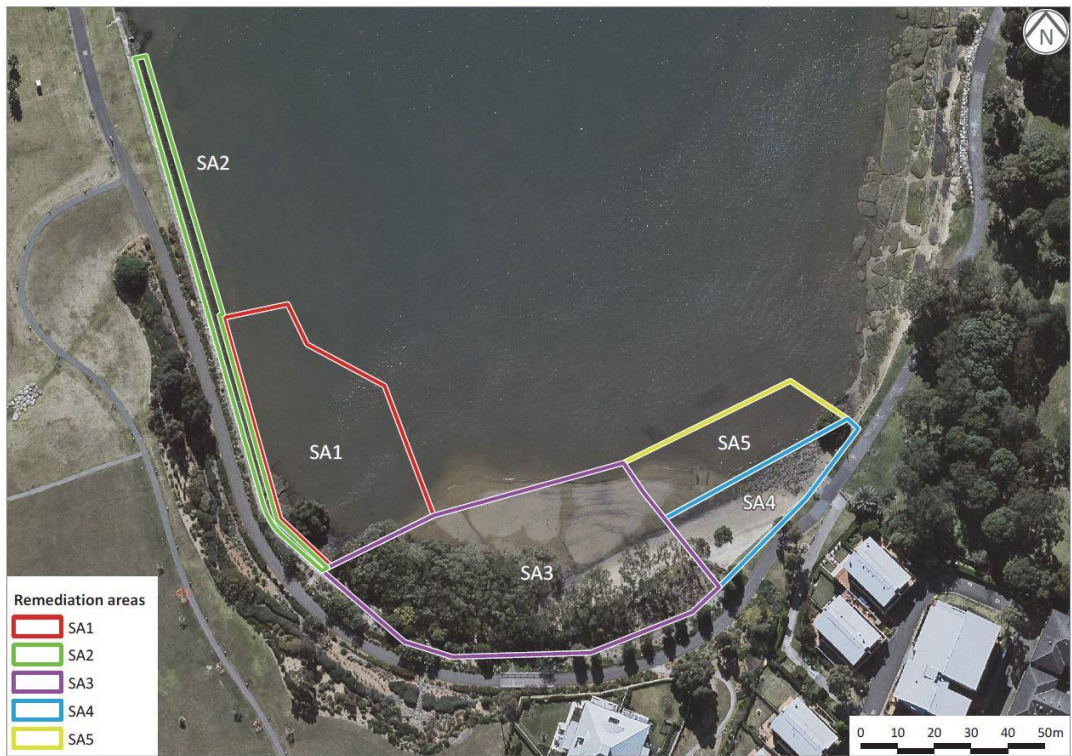
Figure 1: Southern Remediation Area (S&W, 2018)

The project will involve the remediation of contaminated sediments within two defined areas within Kendall Bay. The extent of the defined remediation areas at the head of the Bay, referred to herein as the 'Southern Remediation Area', are shown on **Figure 1**. The remediation areas located on the western side of the Bay in the vicinity of the former loading wharf, referred to herein as the 'Northern Remediation Area', are shown on **Figure 2**.

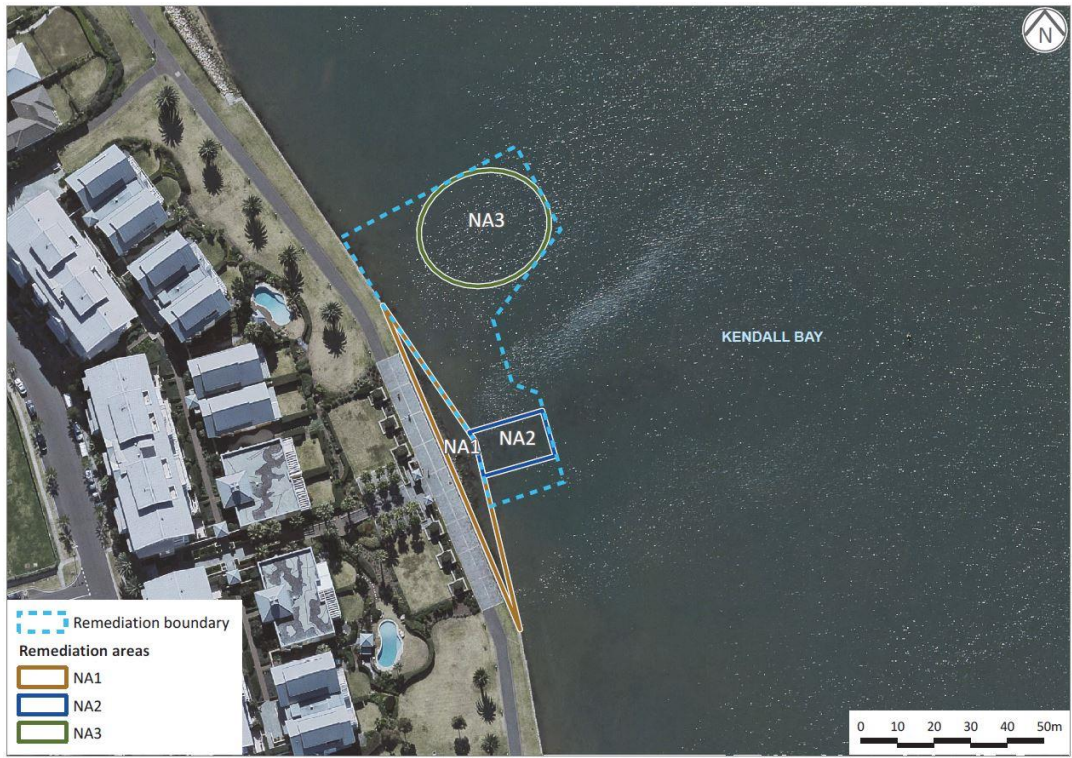
Figure 2: Northern Remediation Area (S&W, 2018)

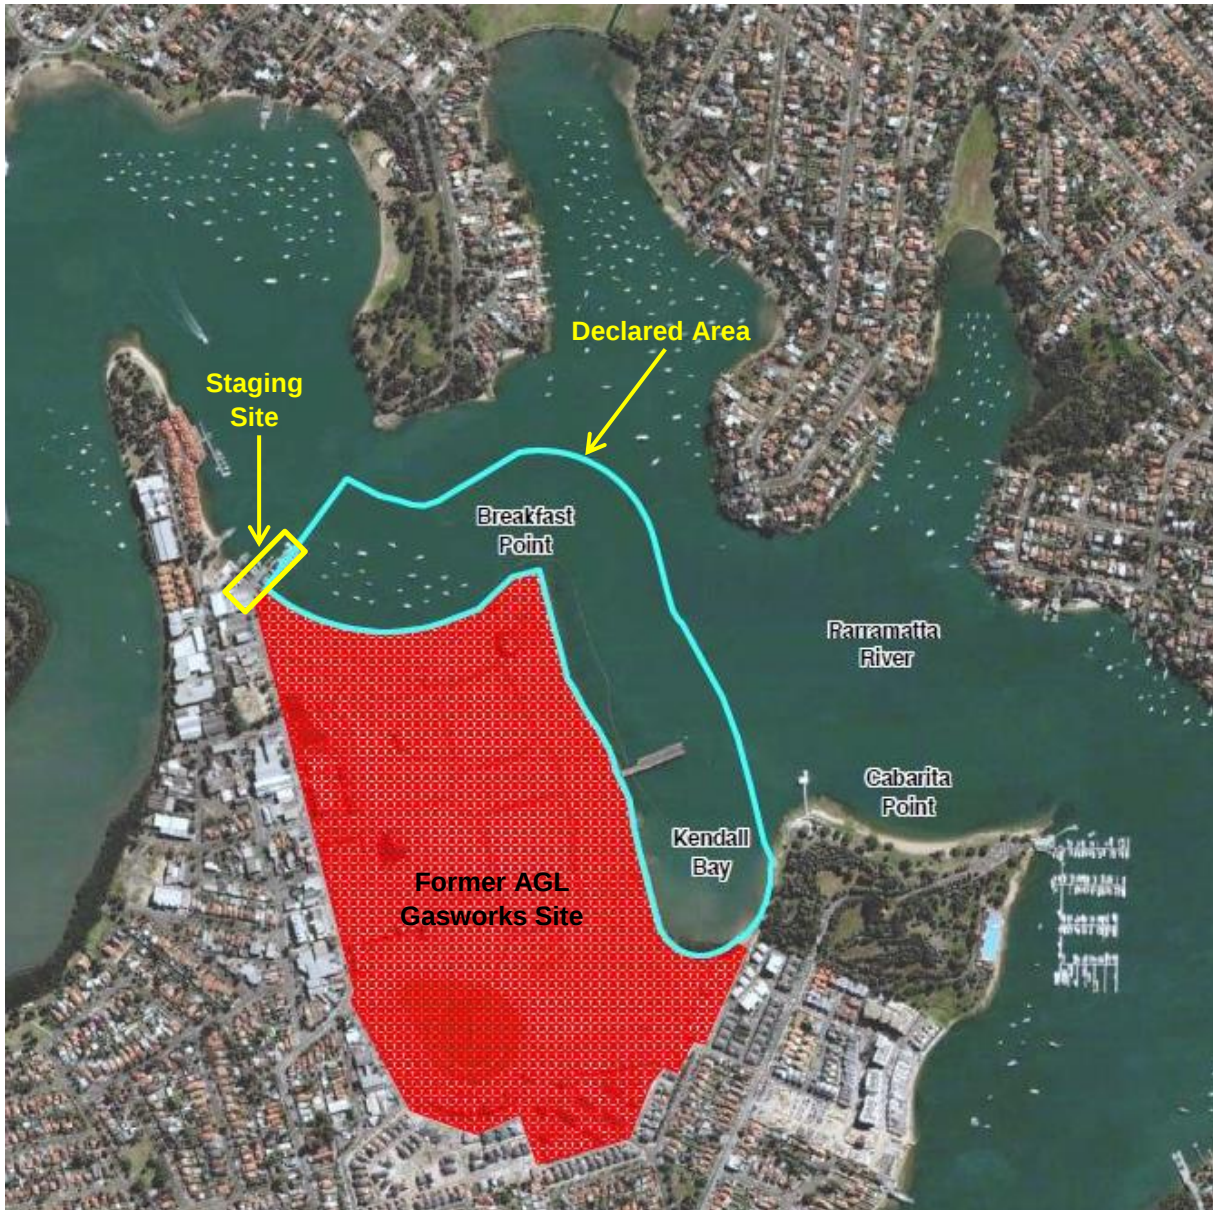
Figure 3: Staging Site and Declared Area (URS, 2007)

Treatment of contaminated sediment, if required, will occur at the Staging Site located at 140 Tennyson Road, Mortlake (refer **Figure 3**). The Staging Site provides direct access to Parramatta River, which is strategically important as it enables ready access to Kendall Bay, without the reliance on adjoining public or other land. All plant and equipment to be utilised as part of the project will be transported to and from the proposed Staging Site and subsequently from the Staging Site to and from the Remediation Areas.

The EPA Declared Area (refer **Figure 3**) will encompass the route vessels will take to facilitate the transport of sediments and other materials removed from the Remediation Areas to the Staging Site and solidification materials and clean sand and rocks to the site. Excavated materials will be transported via barges to the Staging Site for onshore transfer, treatment, storage and disposal, where required.

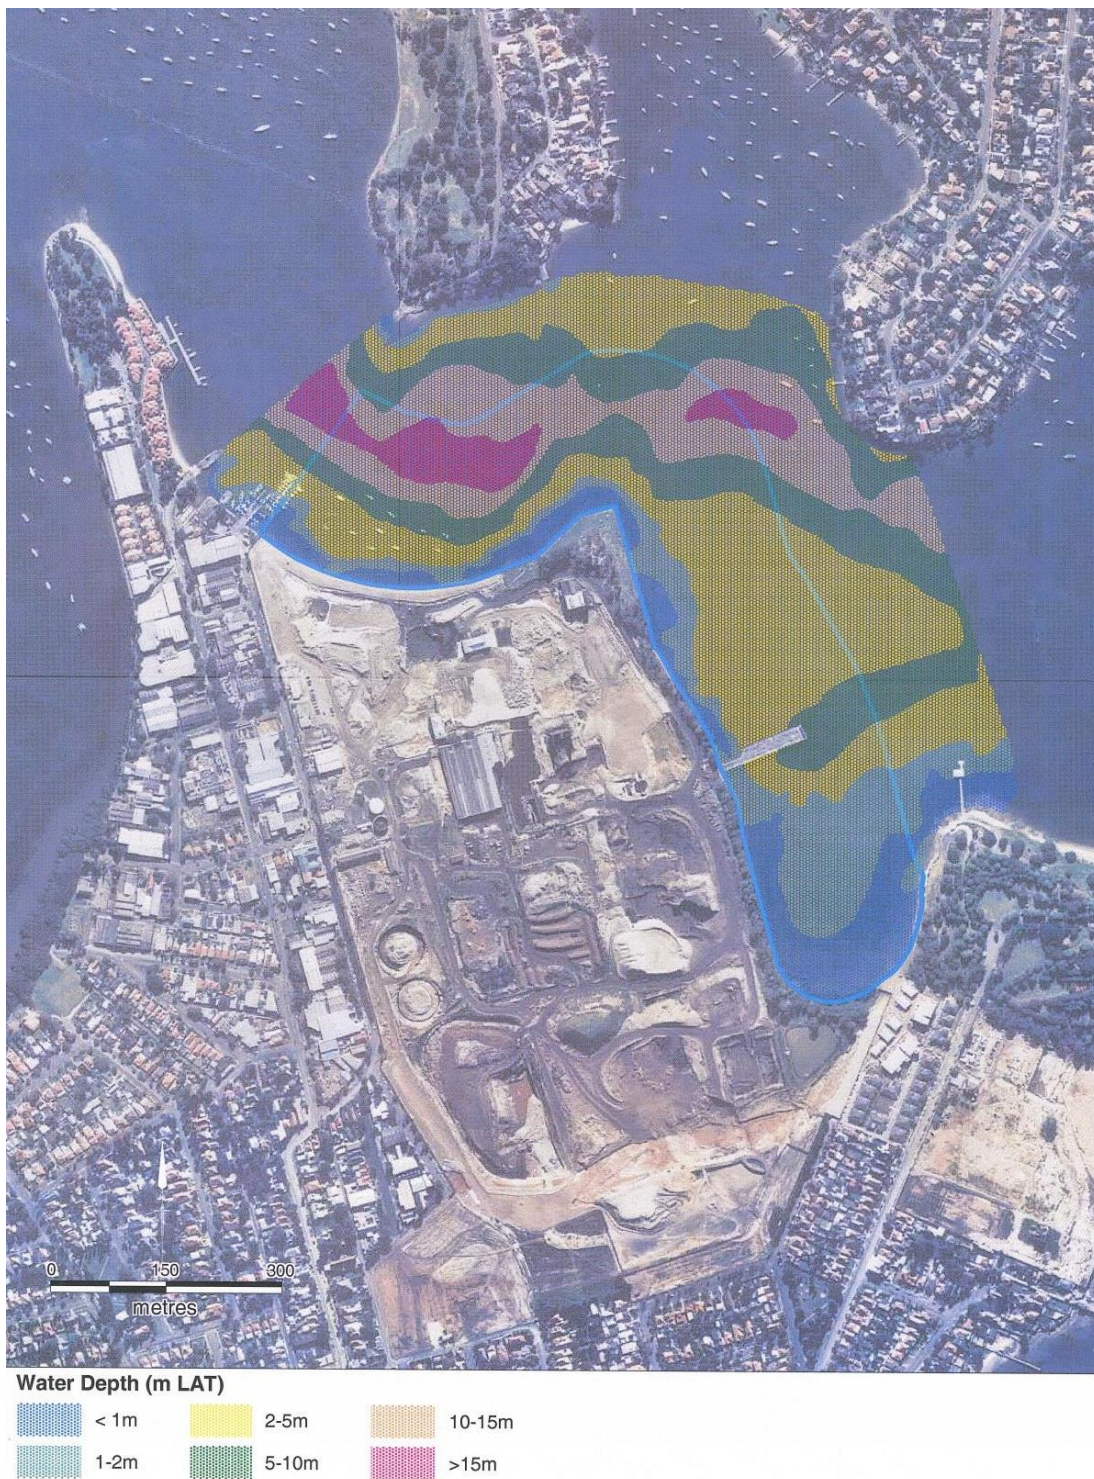
Figure 5: Historical aerial photograph and coarse bathymetry (URS, 2006)

Within Kendall Bay the bathymetric levels are typically less than -2m CD except in the vicinity of the former coal wharf on the western foreshore, where a channel and berthing areas were dredged to provide shipping access from the wharf (shown on the historical aerial photograph on **Figure 5**) to the main channel of the Parramatta River.

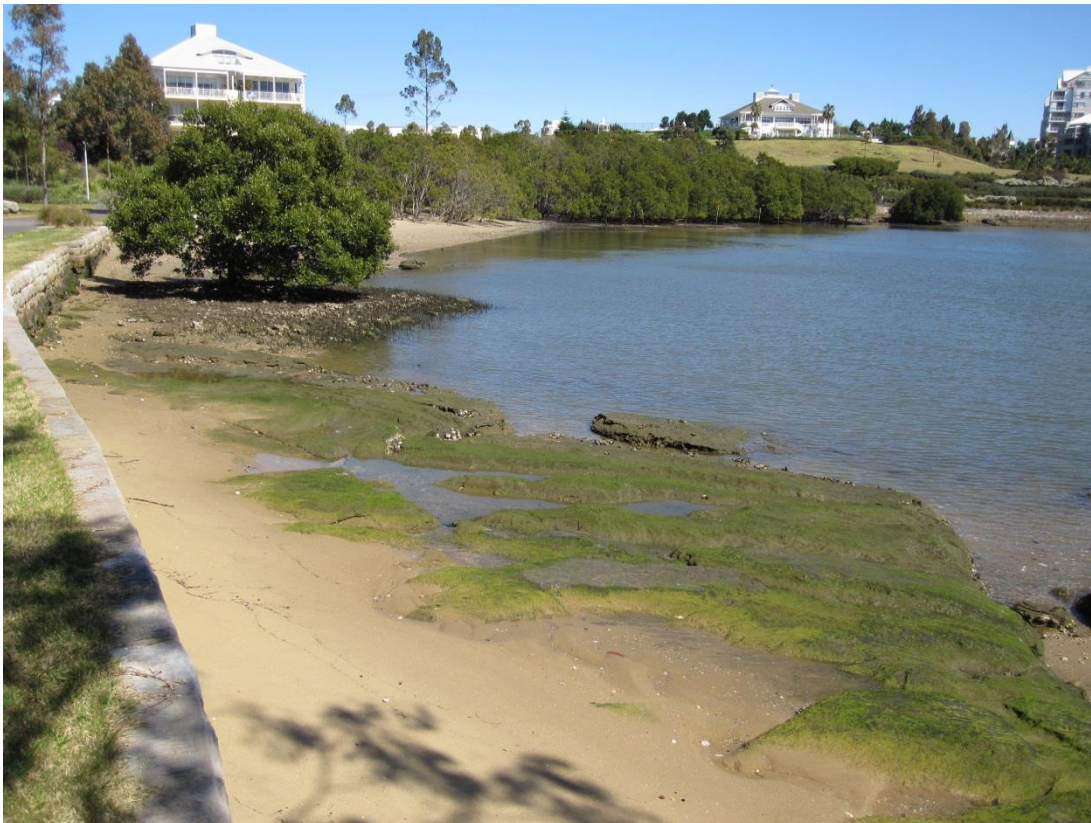
*Figure 8: View from the eastern foreshore to the head of Kendall Bay looking west*

A rock platform exists along the eastern side of Kendall Bay and is gradually covered with sandy sediments to the south, forming a shallow beach area in the south eastern corner of the bay. The nearshore beach slope at this location is around 1V:8H. The sandy sediments continue into the eastern side of the stand of mangroves at the head of the Bay. Within the mangroves area the bed transitions into silty sand with shell and gravel of coal and fill. **Figure 8** provides a view along the eastern foreshore towards the head of Kendall Bay.

Several foreshore protection structures exist behind the shallow intertidal area of Kendall Bay. A low-level sandstone block wall exists in the south-eastern corner of the bay (refer **Figure 8**) and acts as a retaining wall adjacent to the promenade along the foreshore. This structure is terminated by a concrete wall on the eastern side of the mangrove stand. Beyond this point the mangroves are backed by a 1V:1H revetment formed by a facing of mortared sandstone blocks (refer **Figure 9**). This revetment structure has been incorporated into the landscaped terracing up to the level of the adjacent foreshore promenade. The toe of the sandstone revetment appears to be protected by rip-rap generally less than 100mm in diameter, while bricks have been deposited along its base in the south-western corner of the bay.

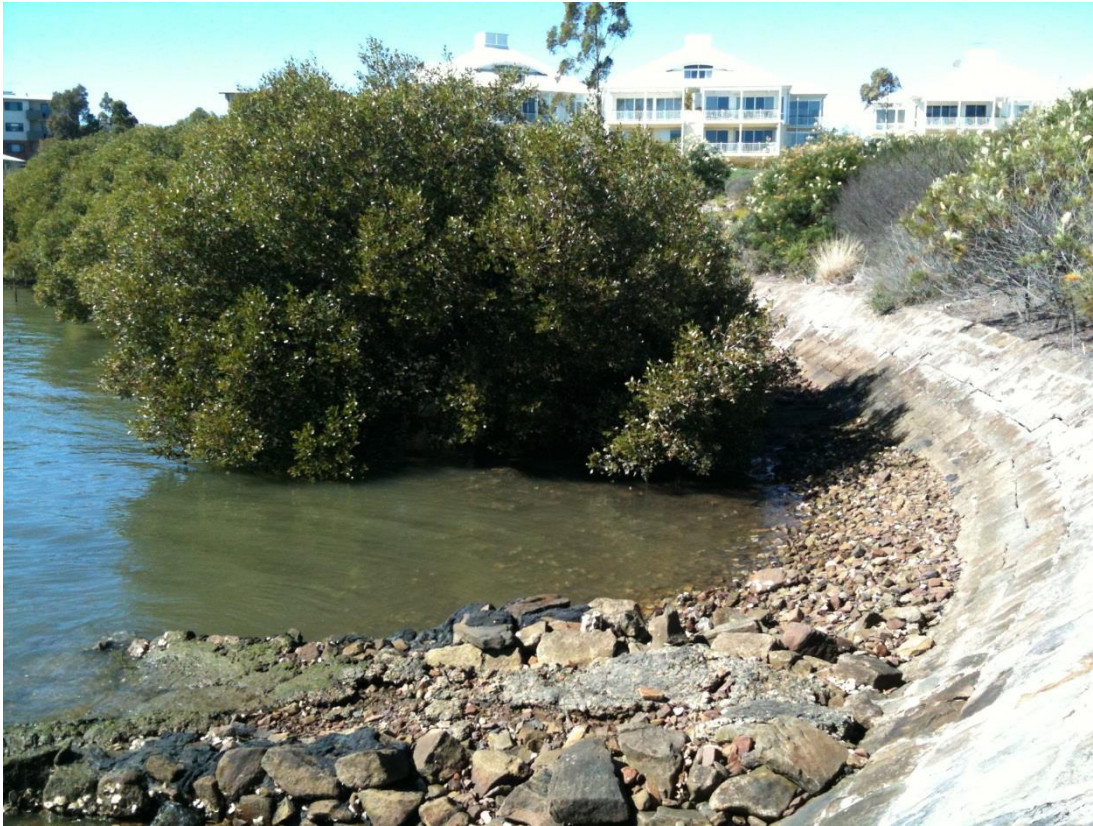
Figure 9: View of sloped revetment behind the mangrove stand

In remediation area SA1 the bed levels would be permanently lowered to LAT which would result in greater wave penetration into the south-western corner of the bay. Shoreline impacts would be mitigated by the existing seawall along the western side of the bay. However, the sand shoal forming substrate for mangroves growing at the head of the bay would be subject to increased wave action. Monitoring of the western area of mangroves should be undertaken to identify loss of sand from the shoal and/or undermining of mangroves. Protection of the batter slope from the mangrove area (SA3) to the depressed area of SA1 may be required to mitigate against erosion. It is noted that rip-rap already exists in the vicinity of this area at the toe of the seawall immediately adjacent to the mangroves (refer **Figure 9**).

The south-western corner of the bay contains coarse sediment including an area of cobbles in the intertidal zone (refer **Figure 9** and **Figure 21**). This area does not appear to support sediment deposition, probably due to the high wave energy and incident wave direction. The western shoreline is exposed to frequent ferry wake waves, which roll at an angle along the exposed face of the seawall and propagate into the south-western corner of the bay.

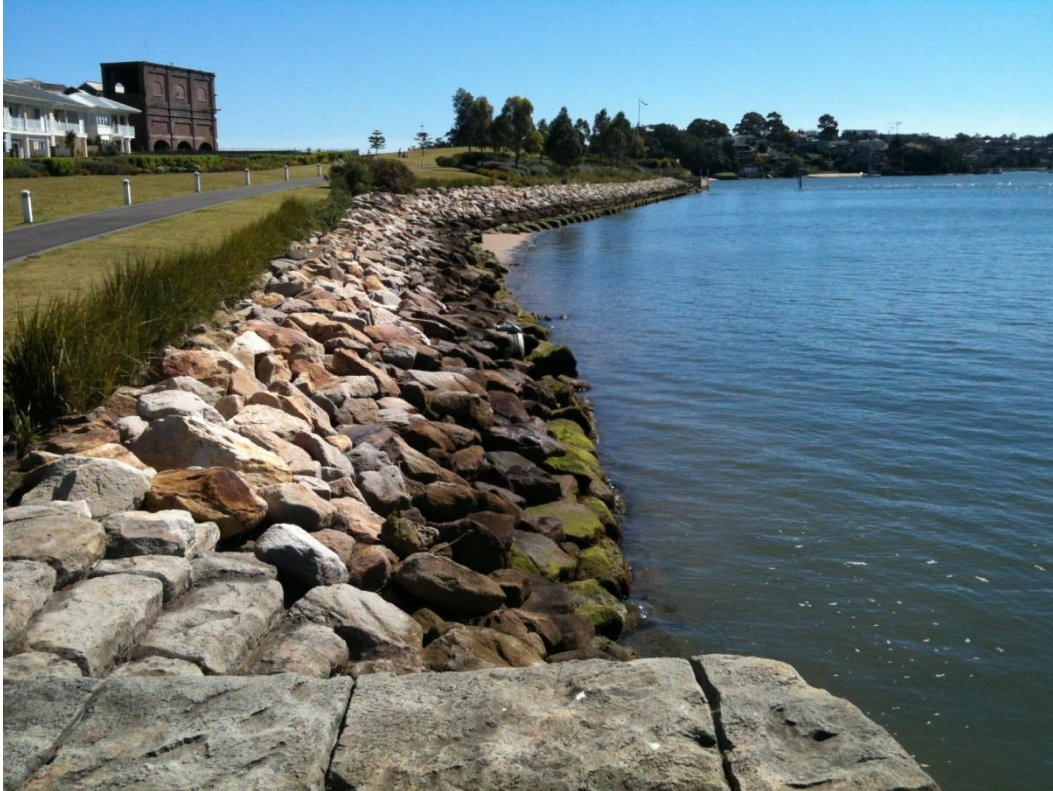
*Figure 12: Transition between sandstone block seawall and sloping rock revetment (looking towards Breakfast Point)*

The vertical seawall transitions into a sloped rock revetment of relatively recent construction approximately 250m south of the tip of Breakfast Point (refer **Figure 12**). At the tip of Breakfast Point a vertical blockwork seawall has been constructed to retain a terraced pedestrian walkway (refer **Figure 13**). This structure appears to be built on a foundation formed by a bedrock outcrop and continues around the tip of Breakfast Point before transitioning back to the same sloped rock revetment found on the western side of Kendall Bay.

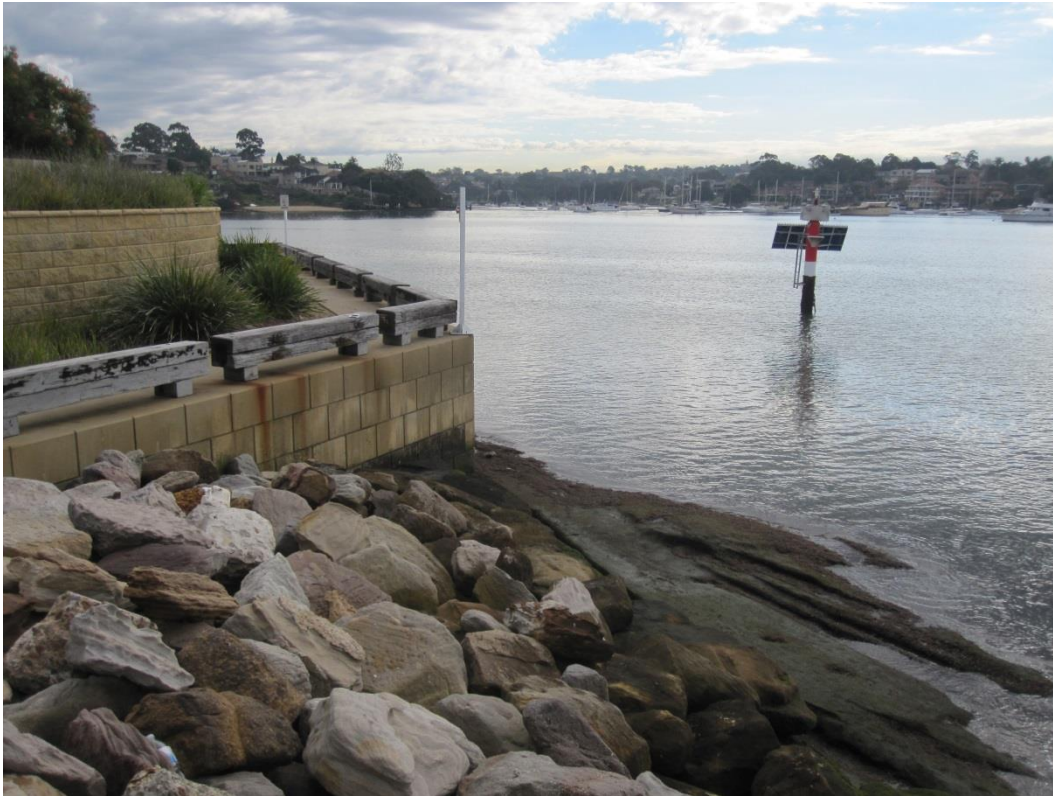
*Figure 13: Vertical block seawall at Breakfast Point*

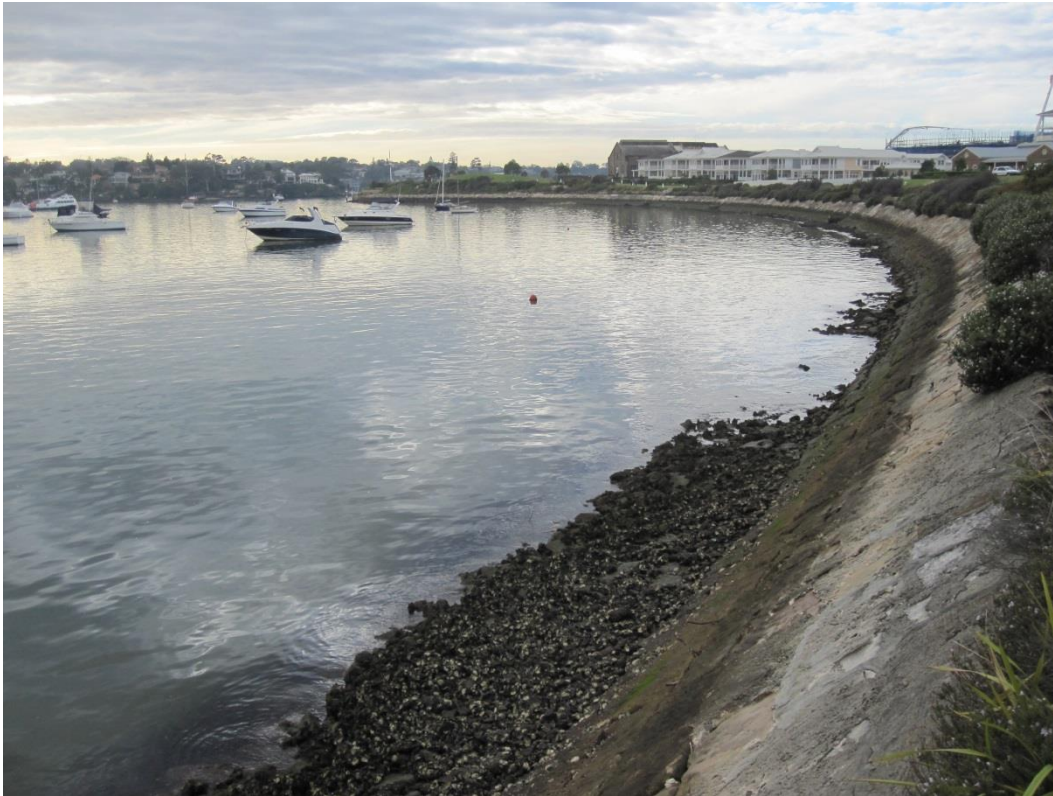
*Figure 14: Sloped revetment within Fairmile Cove (looking towards Breakfast Point)*

The sloped rock revetment extends around 100m along the foreshore of Fairmile Cove before a sloped revetment commences (refer **Figure 14**). This comprises a facing of mortared sandstone blocks with rock toe protection, which appears to be of similar construction to the older seawall structure found at the head of Kendall Bay. This sloped seawall structure continues to the waterfront of the proposed staging site (refer **Figure 15**).

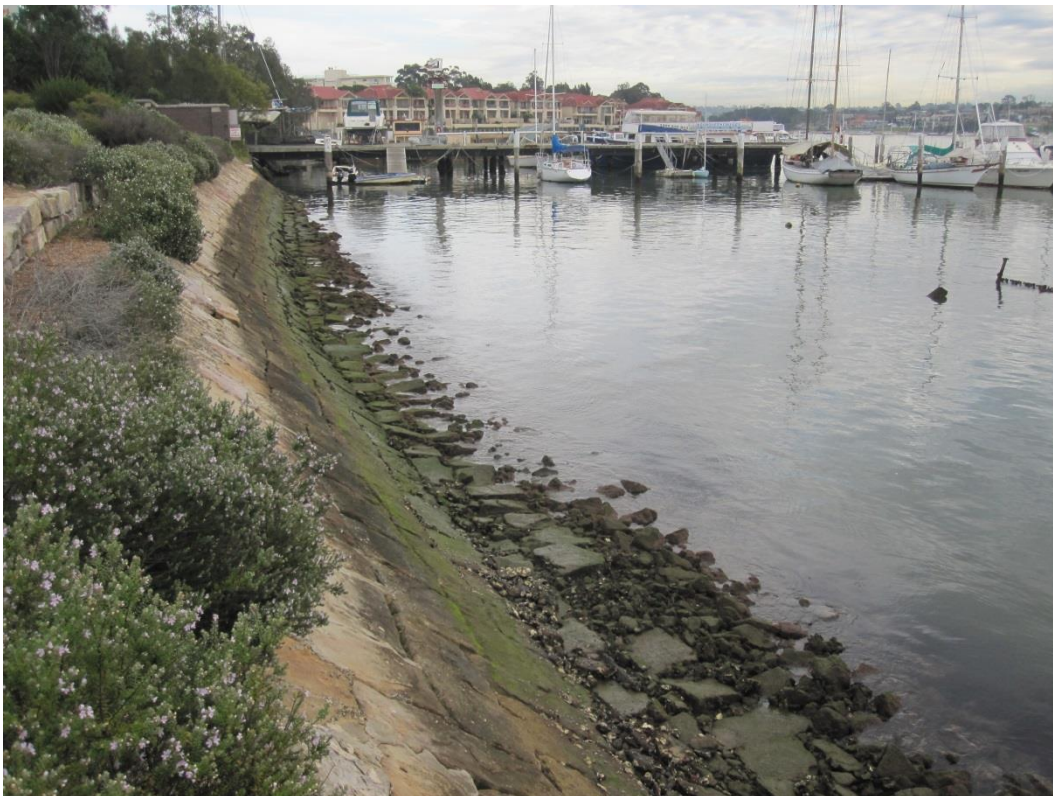
*Figure 15: Sloped revetment within Fairmile Cove (looking towards the Staging Site)*

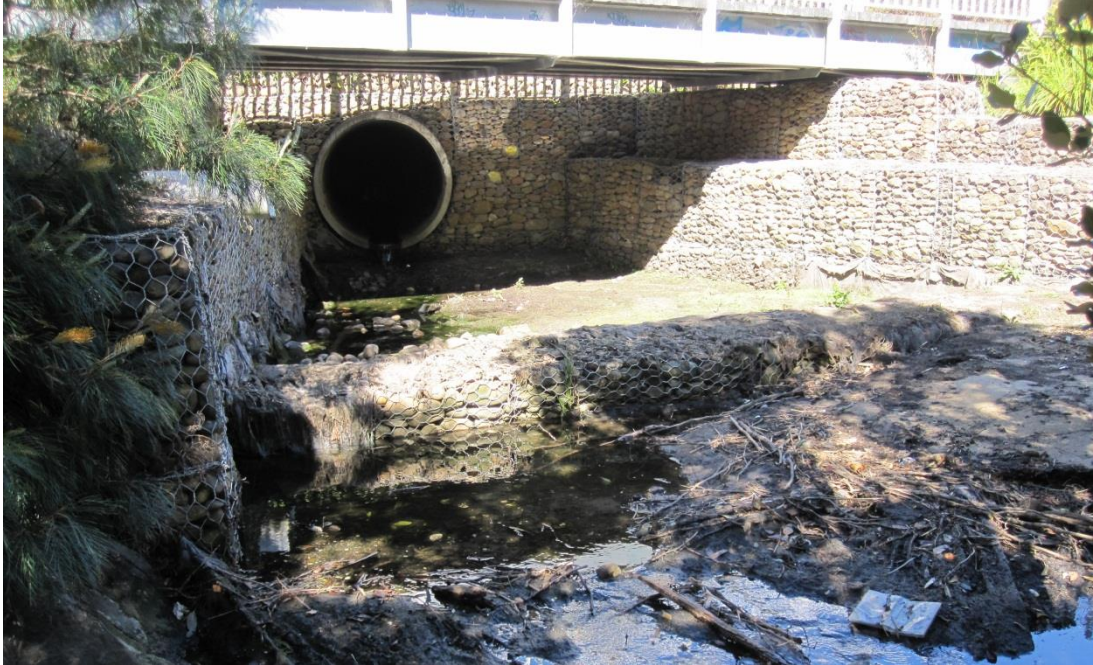
*Figure 17: 1650mm stormwater outlet at the head of Kendall Bay*

The main stormwater inflow is at the head of the Bay where a 1650mm diameter pipeline exists (refer **Figure 17**). However, this pipeline flows into a large basin constructed from gabion baskets which would act to dissipate the energy of stormwater flow. During the site inspection a shallow incised channel was

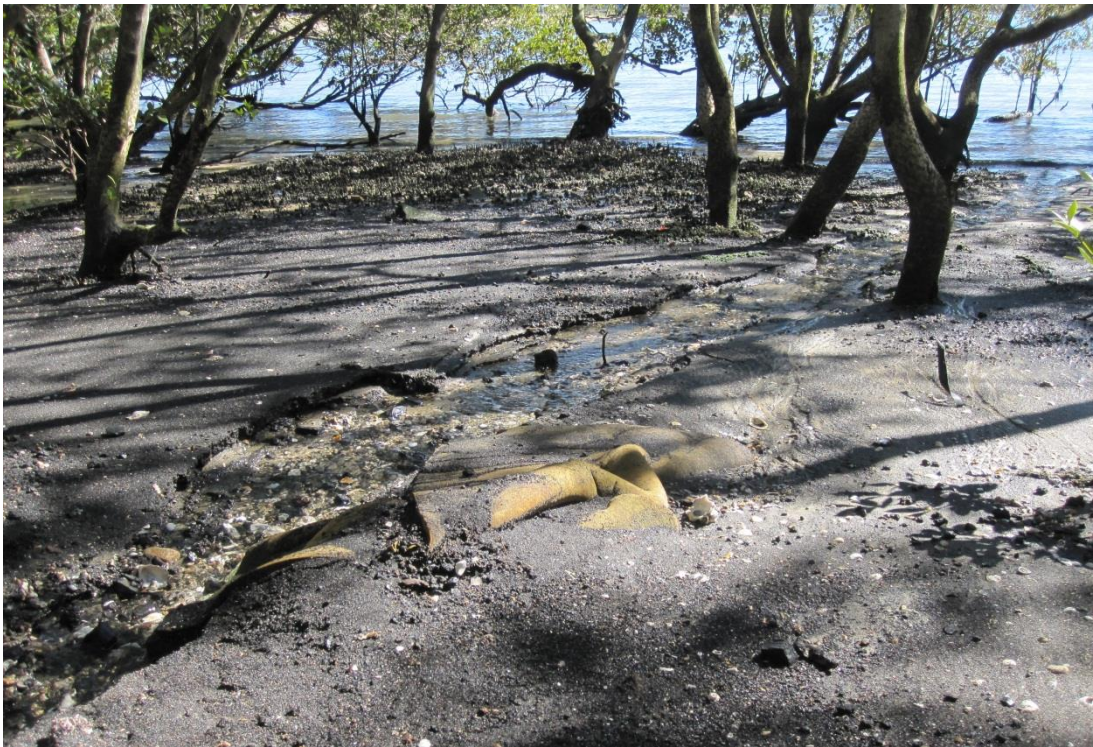
*Figure 18: Shallow channel leading from 1650mm stormwater outlet*

observed leading from the outlet through the sandy substrate within the mangrove stand under low flow conditions (refer **Figure 18**).

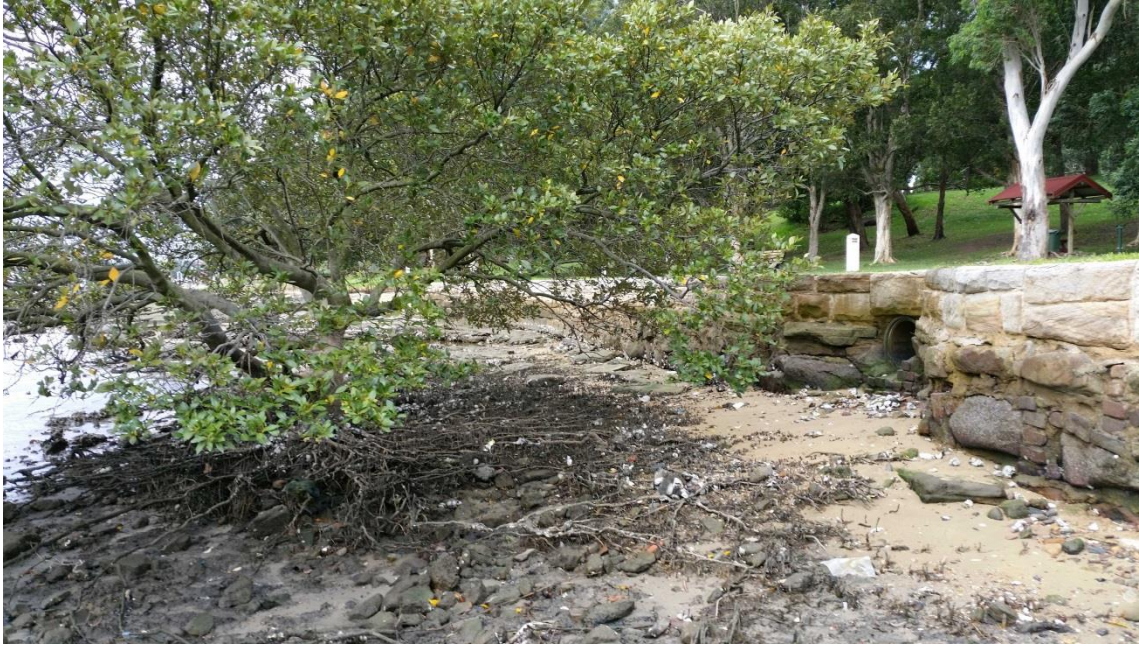
*Figure 19: 450mm diameter stormwater outlet within Remediation Area SA4*

outlet located towards the eastern end of the beach (refer **Figure 19**) and a 670mm diameter outlet located in the middle of the beach (refer **Figure 20**).

The existing 450mm outlet within remediation area SA4 is located immediately behind a mangrove tree (refer **Figure 19**), which has a root mass that would provide resistance against stormwater flows. The existing mangroves have proven to be resilient to stormwater flows, particularly in remediation area SA3 where the large 1650mm diameter outlet discharges through a stand of mangroves. It is considered that as the mangrove tree is not proposed to be removed as part of the remediation works, the outlet would not significantly impact on beach amenity if it was left in its current configuration at the eastern end of the beach area.

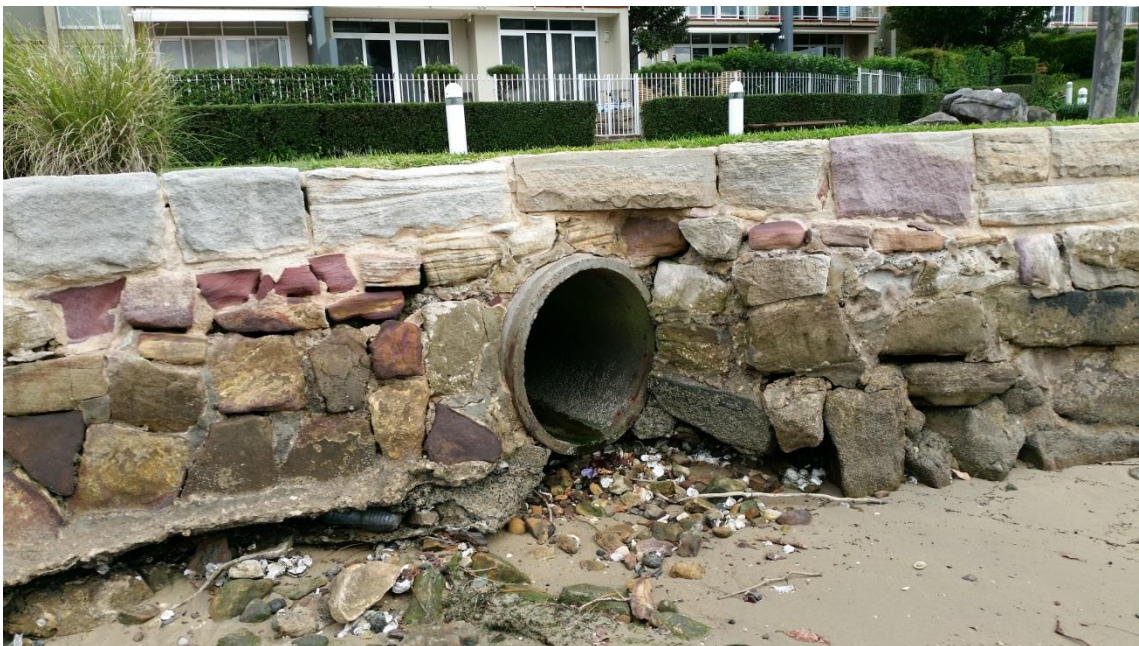
*Figure 20: 670mm diameter stormwater outlet within Remediation Area SA4*

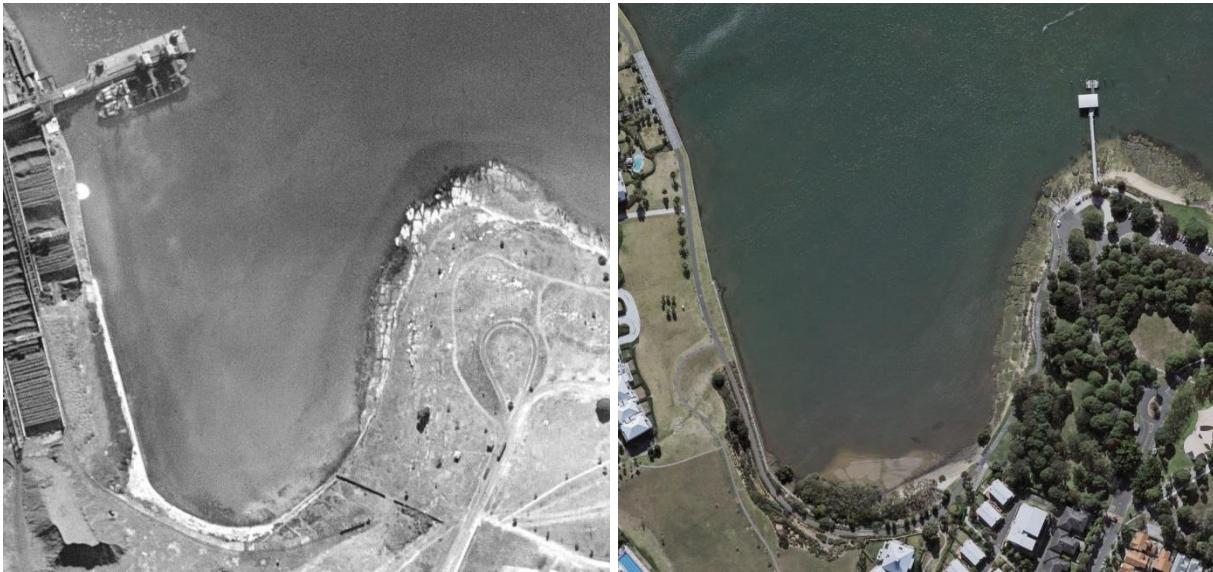
Figure 21: Aerial photographs of Kendall Bay in 1943 (left) and 2015 (right)
