Addendum – Response to Submissions and Heritage Impact Statement**Sumatran Tiger Adventure – Original / Early Pathway****Introduction**

An expanded Sumatran Tiger Exhibit is proposed at Taronga Zoo. Additional information was requested on 15 September by the Department of Planning and Environment regarding the removal of part of the early path alignment (item 99L) namely:

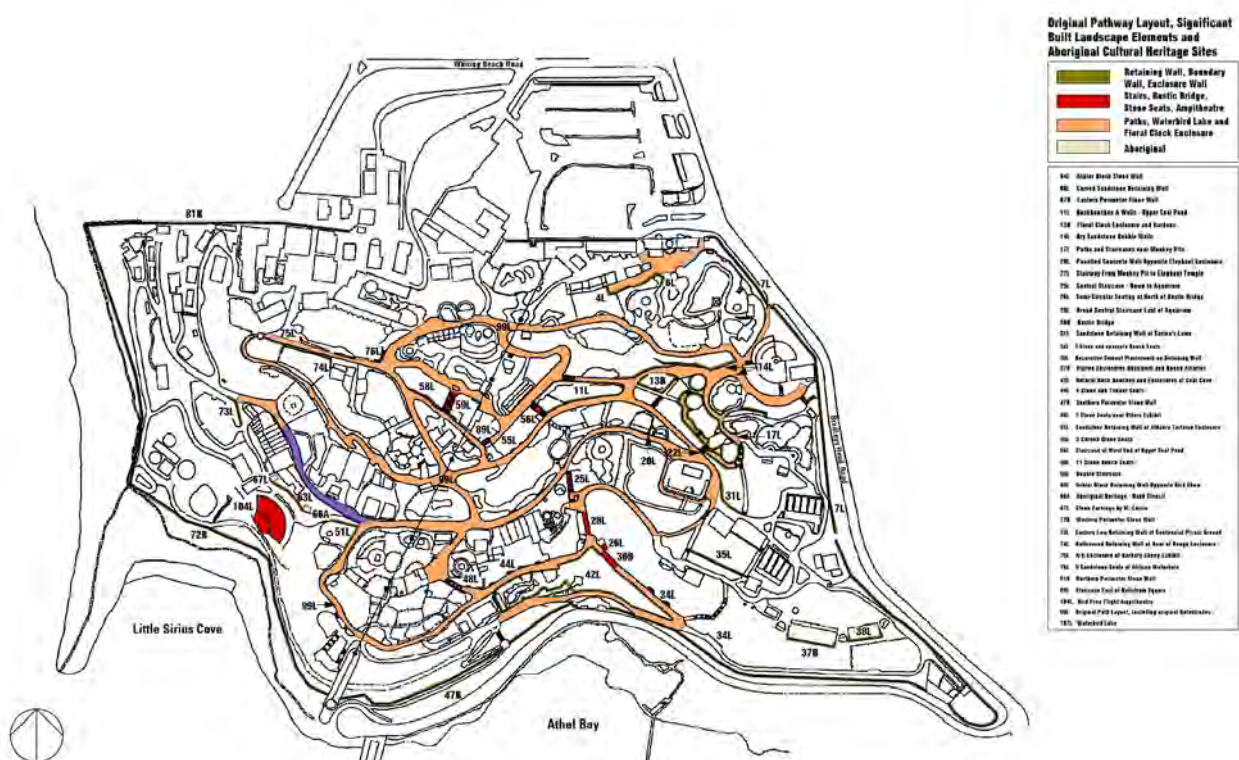
Figure 1 Original pathway layout plan prepared by GML, extracted from the Taronga Zoo Conservation Strategy 2002. The section of path affected by the proposal has been shaded purple. Some sections of the original pathway layout (elsewhere in the Zoo) have been altered since the preparation of this plan.

The layout of the original pathways (Fig. 1) shown in the Conservation Strategy prepared by GML in 2002 is based on the series of diagrams of the zoo layout prepared for visitors. The original path design took advantage of the existing topography and watercourses. No early accurate surveys of the Zoological Gardens from its opening in 1916 until the 1960s have been located that would have provided detailed information regarding the exact layout of the paths and the nature of their surface and any kerbing and guttering. The diagram of the significant path layout in the GML and subsequent studies has been taken from the sequence of diagrams in visitors guides. These diagrams are not to scale, the widths of the paths and the locations are approximate. Detailed surveys from the 1970s on show there was a hierarchy of paths, with main paths to key exhibits and smaller paths to individual buildings such as toilet blocks.

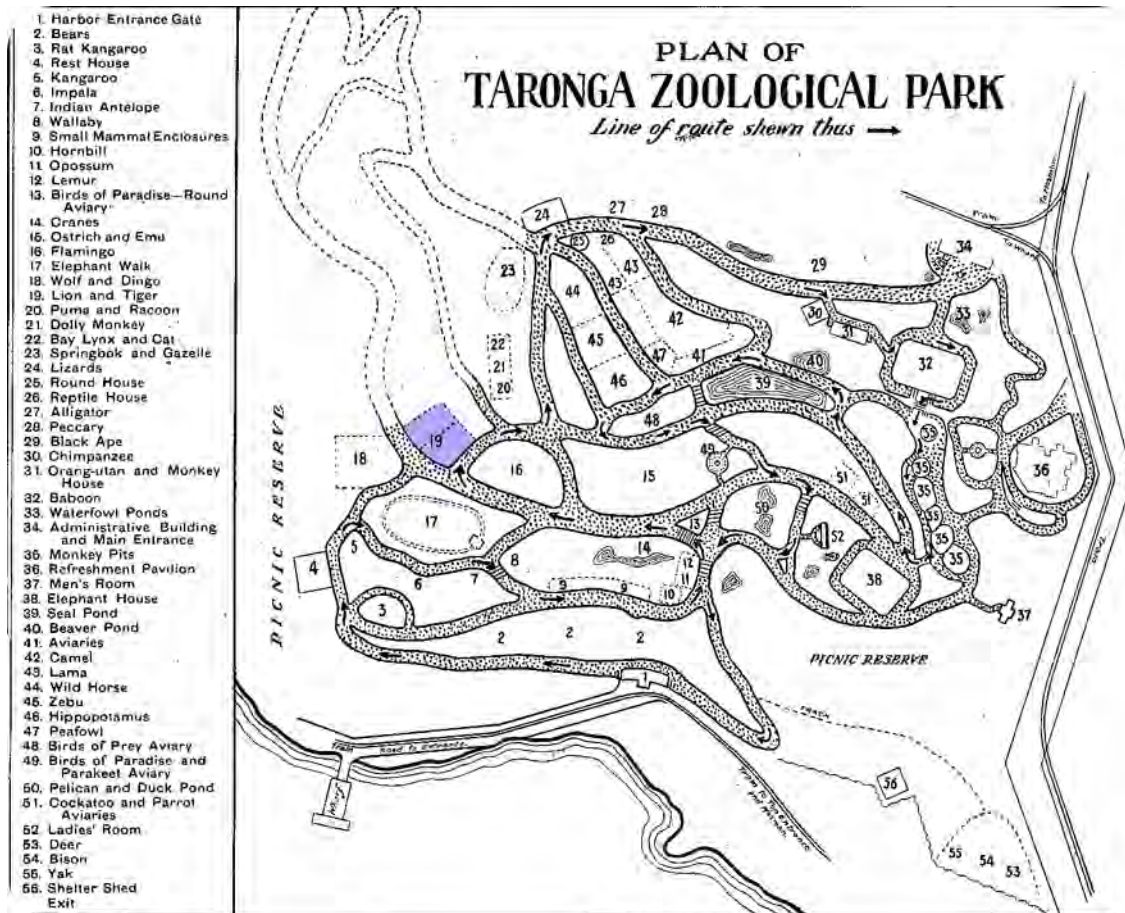
Figure 2 Diagram from 1920 guide showing the location of the exhibits at Taronga Zoo. The original section of path affected by this proposal is associated with enclosure 19 (Lion and Tiger) (now Sun Bears). This enclosure has been shaded. Beyond that the path was not formalised. The wolf and dingo exhibit (18) is opposite. Source: Taronga Zoo archives

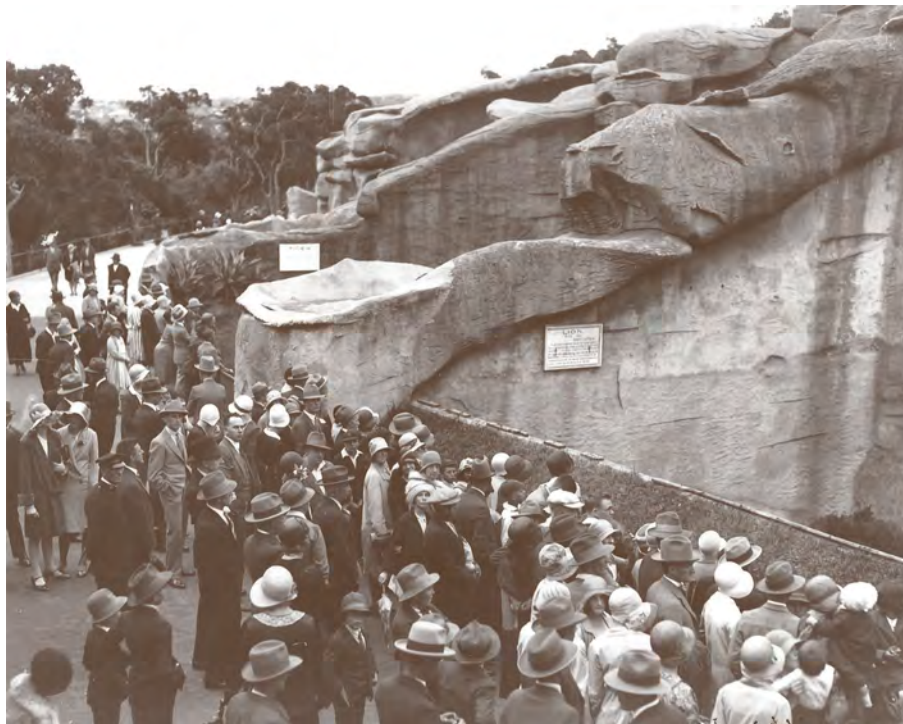
Figure 3 Crowds at the row of lions and tigers dens looking west, March 1930. The two initial dens (now Sun Bears) are in the foreground and the three later dens in the background. Note the lighter coloured second stage of the path in the background with a kerb and fence on the outer edge. Source: ML GPO 1 still 22157.

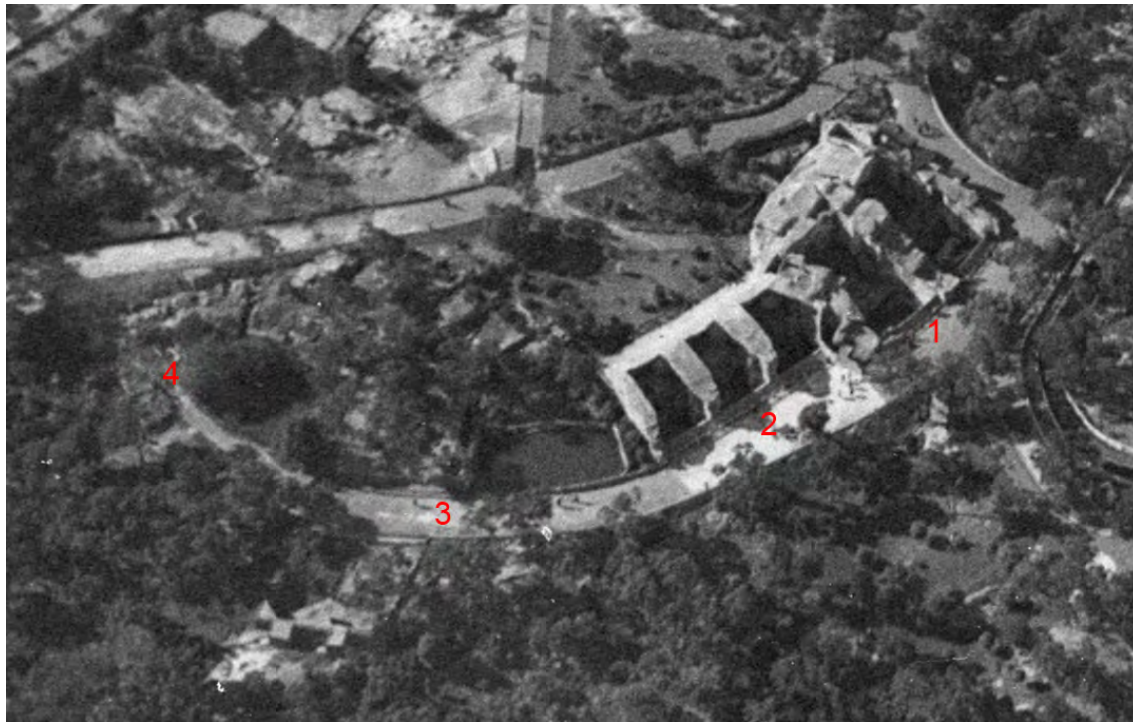
Figure 4 Undated aerial by Hall & Co of the Zoological Gardens, thought to date from the early 1930s. Note the lighter coloured second stage of the path (numbered 2). The surface of section 3 of the path varies and may have been unmade at this time. It leads past a new duck pond to the wild dog exhibit recently move further along the path. Source: ML GPO 1 still 07335.

One of the 1930s Hall & Co aerial photos (Fig. 4) of Taronga Park shows this area in detail, showing the original section of path built in conjunction with the first two carnivora pits (1), the lighter coloured (possibly concrete) extension to the additional three carnivora pits (which included a retaining wall on the south side of the path) (2) and the second extension to a new exhibit to the west (3). Tahr mountain and the stair to connect with the upper path was not constructed (4). There appears to be a barrier halfway between the numbers 3 & 4 on the photo just past the dingo exhibit. The connecting stairway can be seen on the 1943 aerial (SoHI Fig 2.15) and corresponds with the construction of Tahr Mountain in the 1930s. Later diagrams of the layout of the exhibits show the location of Tahr Mountain, erected to the west, and the additional carnivora pits built to the north and above of the three existing pits.

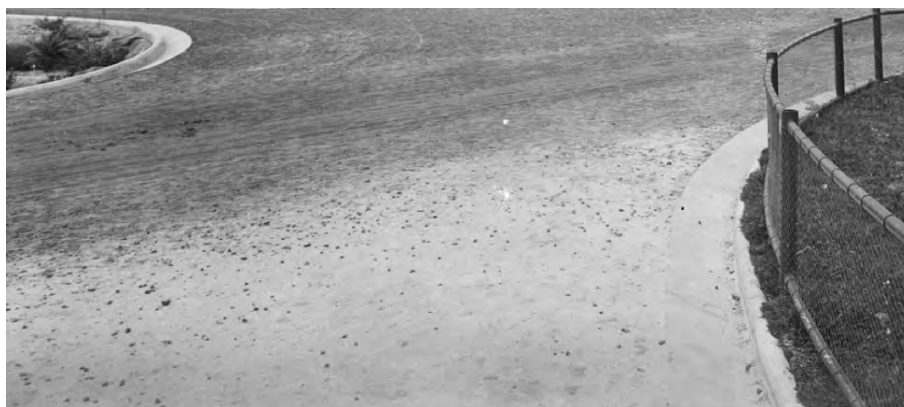
Figure 5 Detail of a view of the path at the main entrance to the Zoological Gardens, undated but likely to have been around the time that the Zoo first opened to the public. Note the curved top of the kerb and the steep angle of the gutter running down to the kerb. Source: ML A E Foster Series 08 Sydney monuments.

Unlike other portions of the Zoological Gardens, no detailed photographs have been located showing the section of path to the west of the carnivore pits. Early photographs of other parts of the Zoological gardens show the paths to have been gravel with a camber and a formed kerb and gutter. The profile of the gutter has a distinct slope to the kerb, which has a curved top.

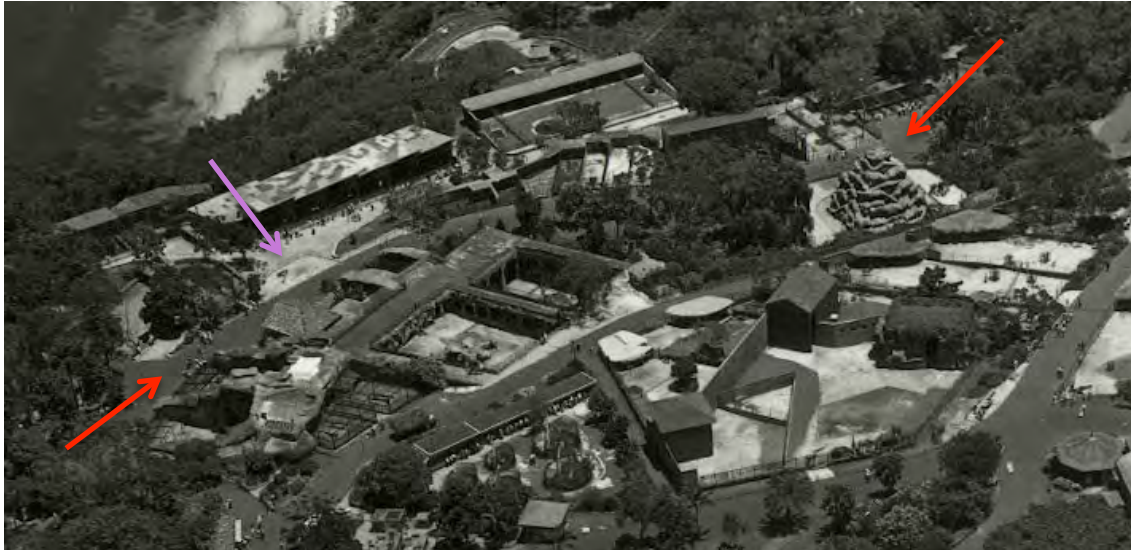
Figure 6 Detail of circa 1962 aerial photo showing the area of the proposal viewed from the northeast. The section of pathway discussed in this report is arrowed red. The path can be seen extending right of Tahr Mountain. Additional exhibits lower down the hill (top of photo) were added in the mid 1950s along with a new road and a lookout above, arrowed purple).

In the absence of detailed information the above photos and following plans have been analysed to better understand the construction of the path, subject of this report, and changes to it. The 1962 photos show additional exhibits developed below the road and the new road and exhibits further down the hill. The path appears to be bitumen in the 1960s and subsequently except for the lookout area and ramp which is lighter coloured, the same as the new road below. It may have been concrete or other material. There is generally a kerb with a fence, about a metre high, along the south side of the road. This fence does not remain. On the other side the area between tahr and the lions is a grassed picnic area which may have had an informal edge initially, though a kerb is indicated by 1986.

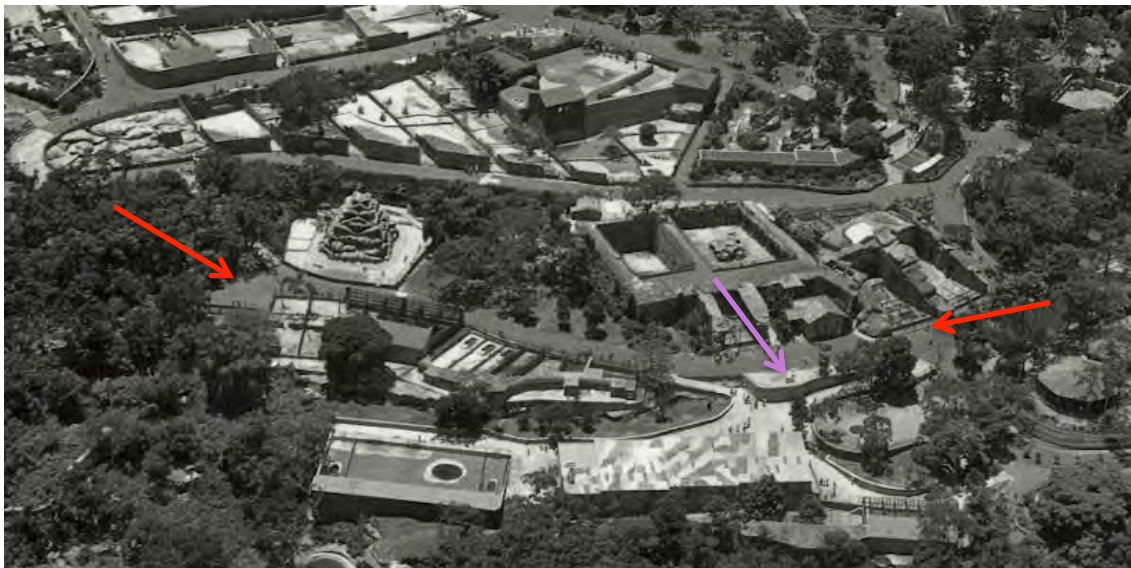
Figure 7 Detail of circa 1962 aerial photo showing the area of the proposal viewed from the south. The section of pathway discussed in this report, Dog Road, is arrowed red. The 1950s exhibits are in the foreground. The lookout (arrowed Purple) and adjacent ramp between Dog Road and the new lower level was probably also built in the 1950s. Note the new small exhibits on the south side of Dog Road. The high fence opposite Tahr Mountain is a monkey exhibit.

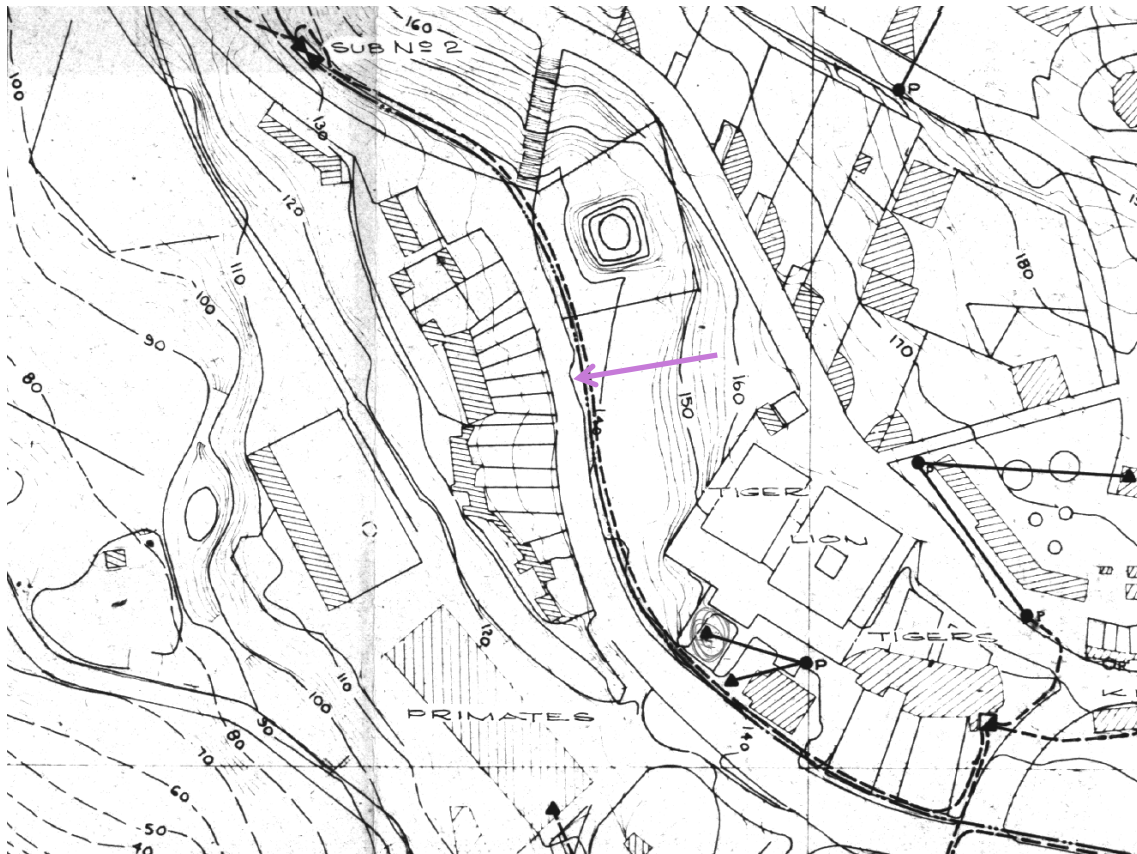
Figure 8 This detail of a Zoo plan prepared by PWD is signed by the chief engineer in 1973. It shows the high and low voltage underground electricity installation on the upper side of Dog Road. The drawing accurately shows the exhibits, ramp and lookout area on the lower side of Dog Road. Note the uneven path edge (arrowed) on the upper side. PWD plan

Major underground services have been installed under and across the road shown in 1970s plans and include high and low voltage power, polluted stormwater and fire hydrant lines. The form of the path today resulted from another series of changes to paths in association with the 1989 construction of the Snow Leopard exhibit, alterations to the lion and tiger pits in 1991-93 and the 1999-2000 alterations to the original lion and tiger pits for the Sun Bear exhibit. There are areas of brick paving, kerbs and low walls and areas of concrete paving in front of the Sun Bears and concrete kerbs on the south of the path.

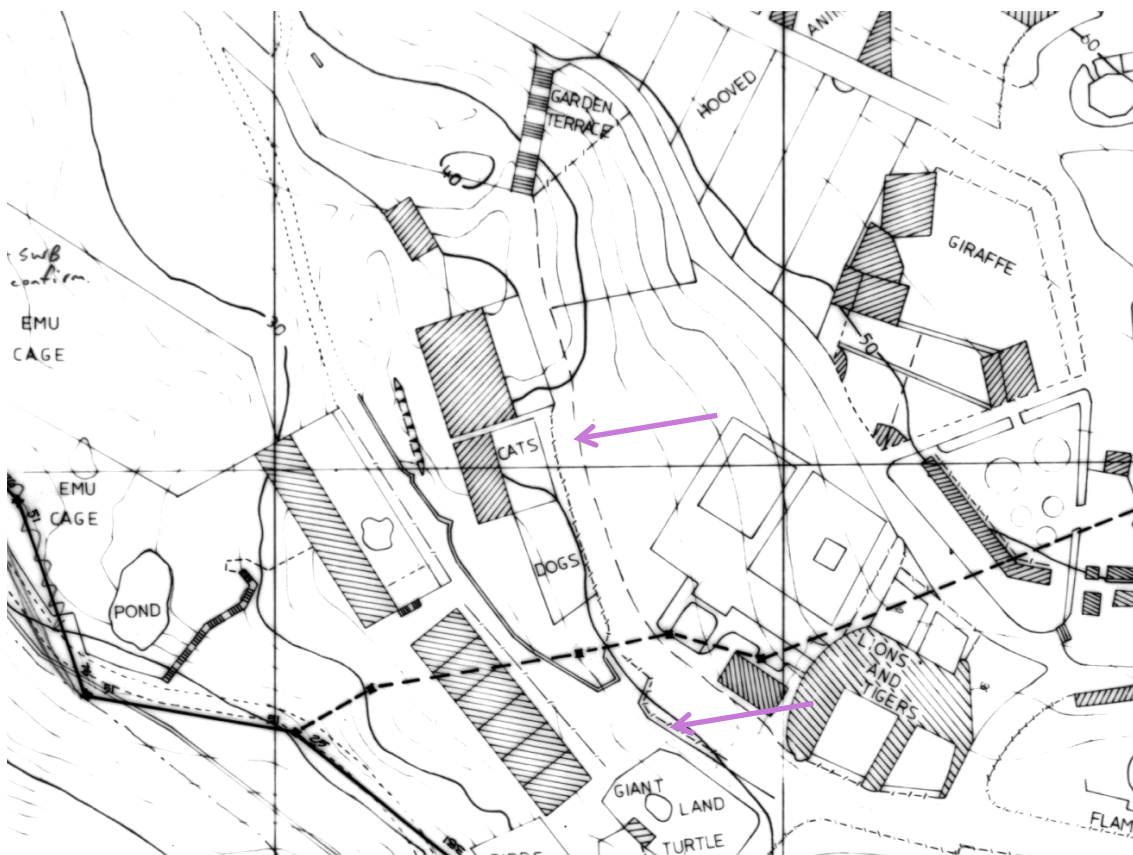
Figure 9 This PWD plan shows a main sewerage line on a survey dated 1975. The drawing does not accurately show the exhibits (eg. Tahr Mountain is missing) but shows fencing along the edge of the lookout and in front of the cat and dog exhibits. The same symbol is also used for the lions and tigers fencing. The opposite side of the road is dashed (not kerbed??). PWD plan
