Marulan South Limestone Mine | SSD 7009

## REHABILITATION STRATEGY

Prepared for Boral Cement Limited | 30 August 2022

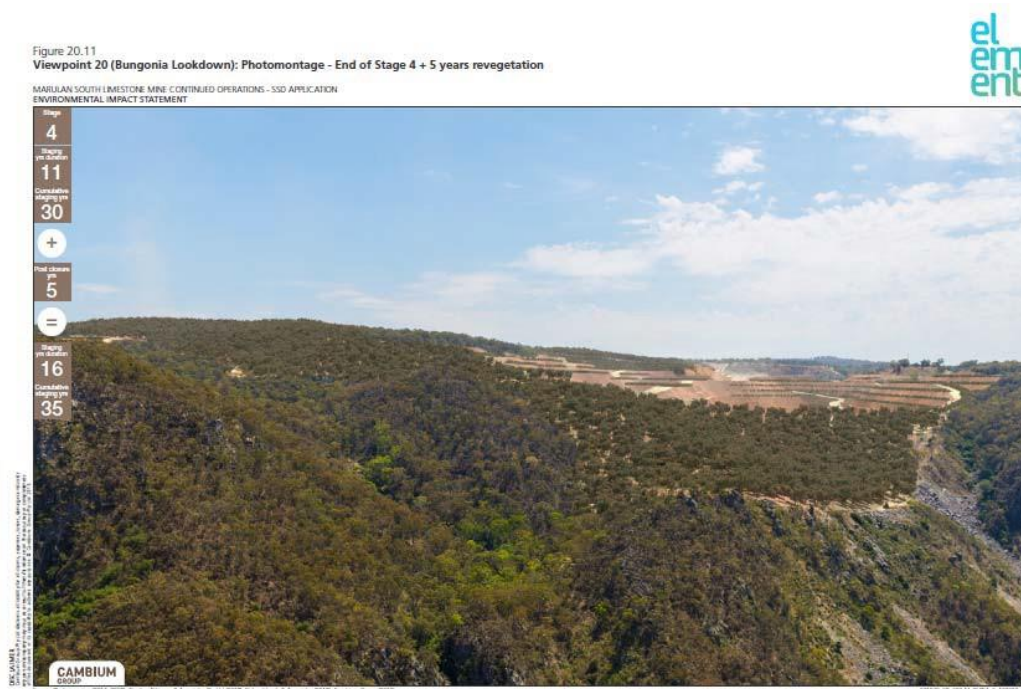
**Figure 3 Conceptual 30-year Final Landform Design with Rehabilitation after 5 years**

**Figure 3** as viewed from the Bungonia Lookdown.

- improved visual amenity in particular from the Bungonia Lookdown as visualised in Figure 3. Backfilling of the southern end of the south pit, landform rehabilitation and revegetation with native woodland is a significant component of this RS.

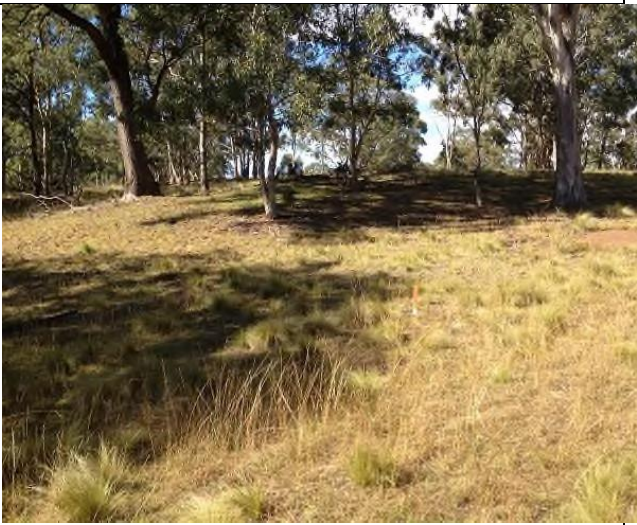
| Soil Unit: Sodosol, Red/ Brown | | |
|---|---|---|
| Typical Soil Profile | A1: 0-11 – Very dark grey loam, very weak angular-blocky, rough-faced, peds 30-40mm, moist, nil gravel | |
| | B2: 21-95 – Light olive brown heavy clay, apedal massive, moist, increasing weathered bedrock fragments | |

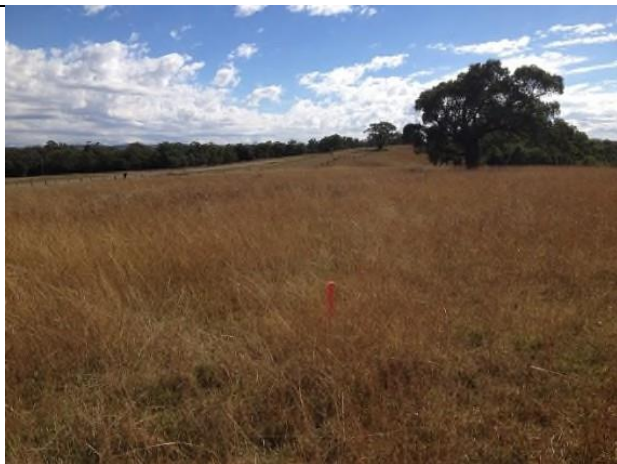
| Soil Unit: Tenosol, Bleached-Orthic / Brown-Orthic | | |
|---|---|---|
| Typical Soil Profile | A1: 0-11 – Dark brown sandy loam, weak angular-blocky, rough-faced, peds 10-30mm, moist, 0-10% gravel | |
| | B2: 11-60 – Yellowish brown heavy clay, apedal massive | |

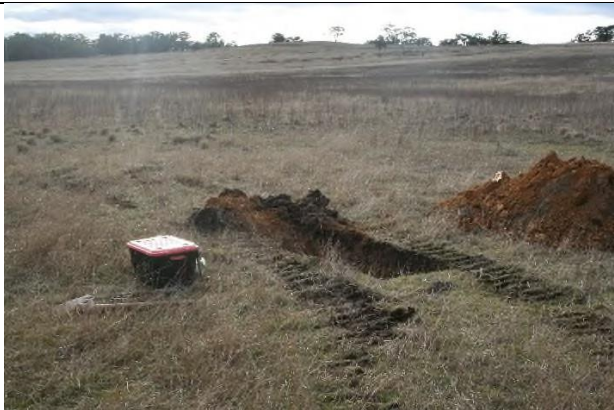
| Soil Unit: Kurosol, Brown | | |
|---|---|---|
| Typical Soil Profile | A1: 0-12 – Dark greyish brown sandy loam, weak polyhedral, rough-faced, peds 10-20mm, moist, nil gravel | |
| | A2: 12-44 – Light yellowish brown, sandy clay loam, weak polyhedral, rough faced peds, 20-30mm, moist, 20% ironstone nodules | |
| | B/C: 65- >110 – weathered bedrock | |

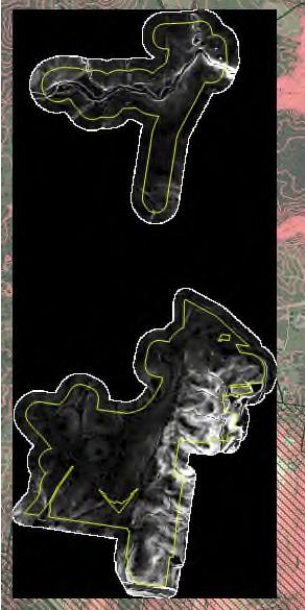
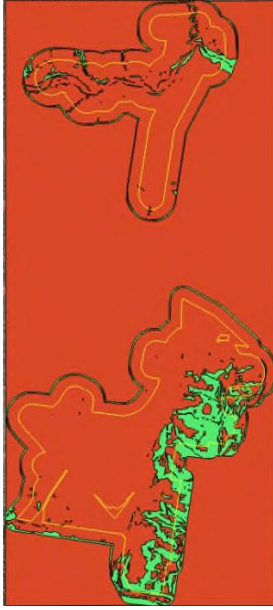
An analysis of terrain within the BSAL assessment areas was undertaken to identify slope gradient greater than ten percent (10%), and exclude those areas from further assessment. LIDAR imagery of the assessment areas was collected in November 2014, and processed using QGIS as described below.

| Step 1 | Step 2 | Step 3 | Step 4 | Step 5 |
|---|---|---|---|---|
| LIDAR imagery of Project area displayed as raster layer in QGIS, with vector polygons of BSAL assessment areas shown in yellow. | LIDAR image clipped to 100m buffer around BSAL assessment areas and analysed for slope using QGIS <i>Terrain Analysis</i> , giving a range of 0-25% slope within the area. | QGIS <i>Raster Calculator</i> used to identify areas of slope greater than 10% (white areas). | Raster image converted to vector polygons, with brown areas representing slope less than 10%, and green showing areas greater than 10% slope. | Polygons clipped to BSAL assessment areas, with purple polygons representing those areas with slope greater than 10%. |
