Doc Ref: WC510-06F02(rev1)- WS Memo

**RE: CAMPBELL'S STORES, SYDNEY HARBOUR
PEDESTRIAN WIND STATEMENT MEMO**

This technical memo comments on the latest design changes to Bay 12 of the Campbell's Store development, located in Sydney Harbour. A desktop pedestrian wind environment statement has previously been completed for the subject redevelopment by Windtech Consultants Pty Ltd; report reference WC510-04F02(rev0) dated 23rd October, 2015, for the latest architectural drawing set at the time. A glass block structure was proposed to be erected on the site of Bay 12 and a series of in-principle treatments were recommended within the report to ensure the wind conditions within the outdoor trafficable areas to be acceptable for its intended uses.

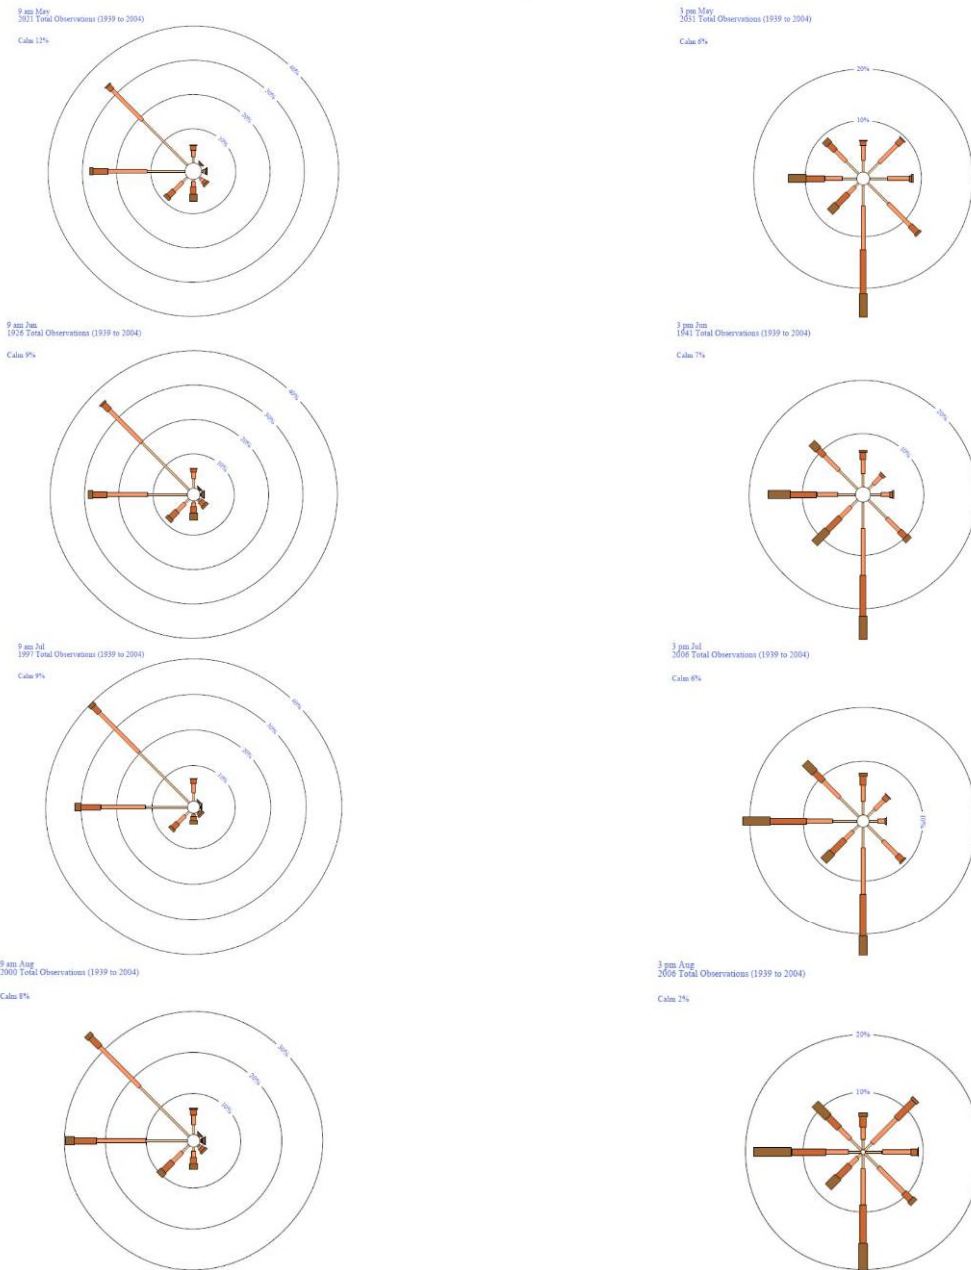
WIND FREQUENCY ANALYSIS (in km/h)
SYDNEY AIRPORT AMO STATION NUMBER 066037
Latitude: -33.94 ° Longitude: 151.17 °

Wind directions are divided into eight compass directions. Calm has no direction.
 An asterisk (*) indicates that calm is less than 1% .
 An observed wind speed which falls precisely on the boundary between two divisions (eg 10km/h) will be included in the lower range (eg 1-10 km/h). Only quality controlled data have been used.
