Australia Sydney One Project

Environmental Phase 1 Site Assessment

Prepared for
Wanda One Sydney Pty Ltd
Australia Sydney One Project - Environmental Phase 1 Site Assessment

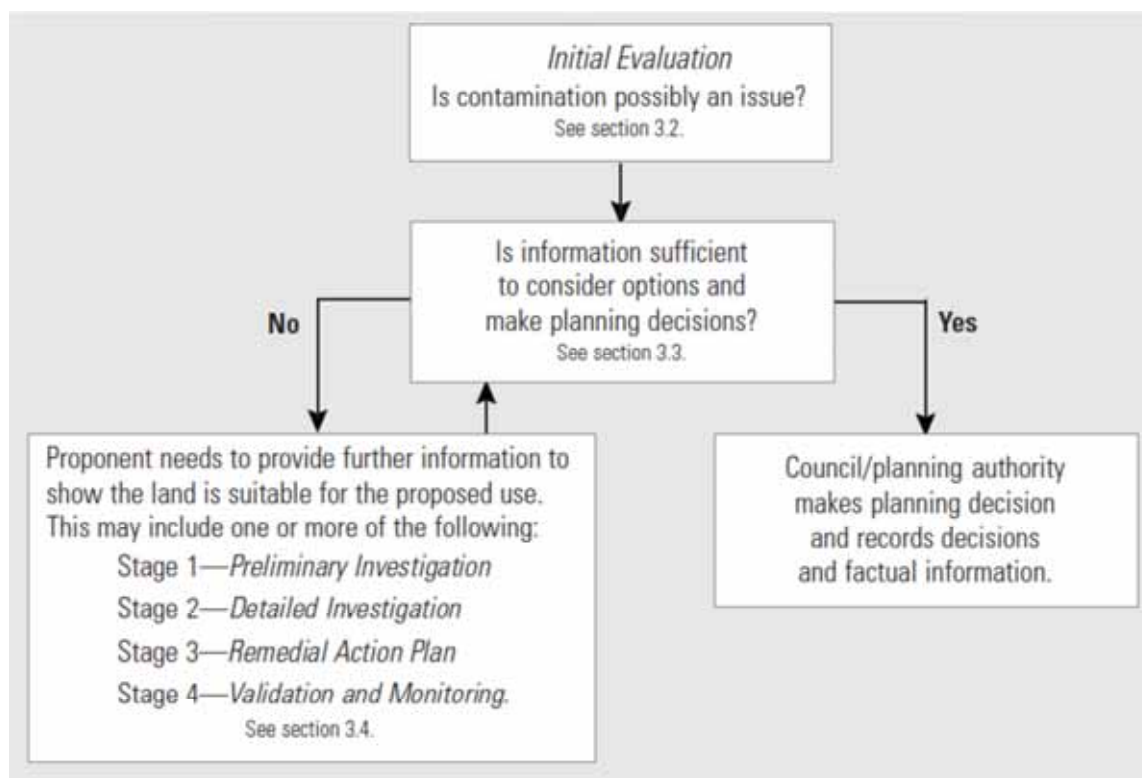
Figure 6.1: Decision Process for Assessment of Site Suitability (source: DUAP, 1998)

Assessment of the suitability of the site for the proposed redevelopment was carried out with reference to the decision making process presented as Figure 1 in Section 3 of *Managing Land Contamination, Planning Guidelines: SEPP 55 – Remediation of Land* (DUAP, 1998), which has been reproduced herein as Figure 6.1.

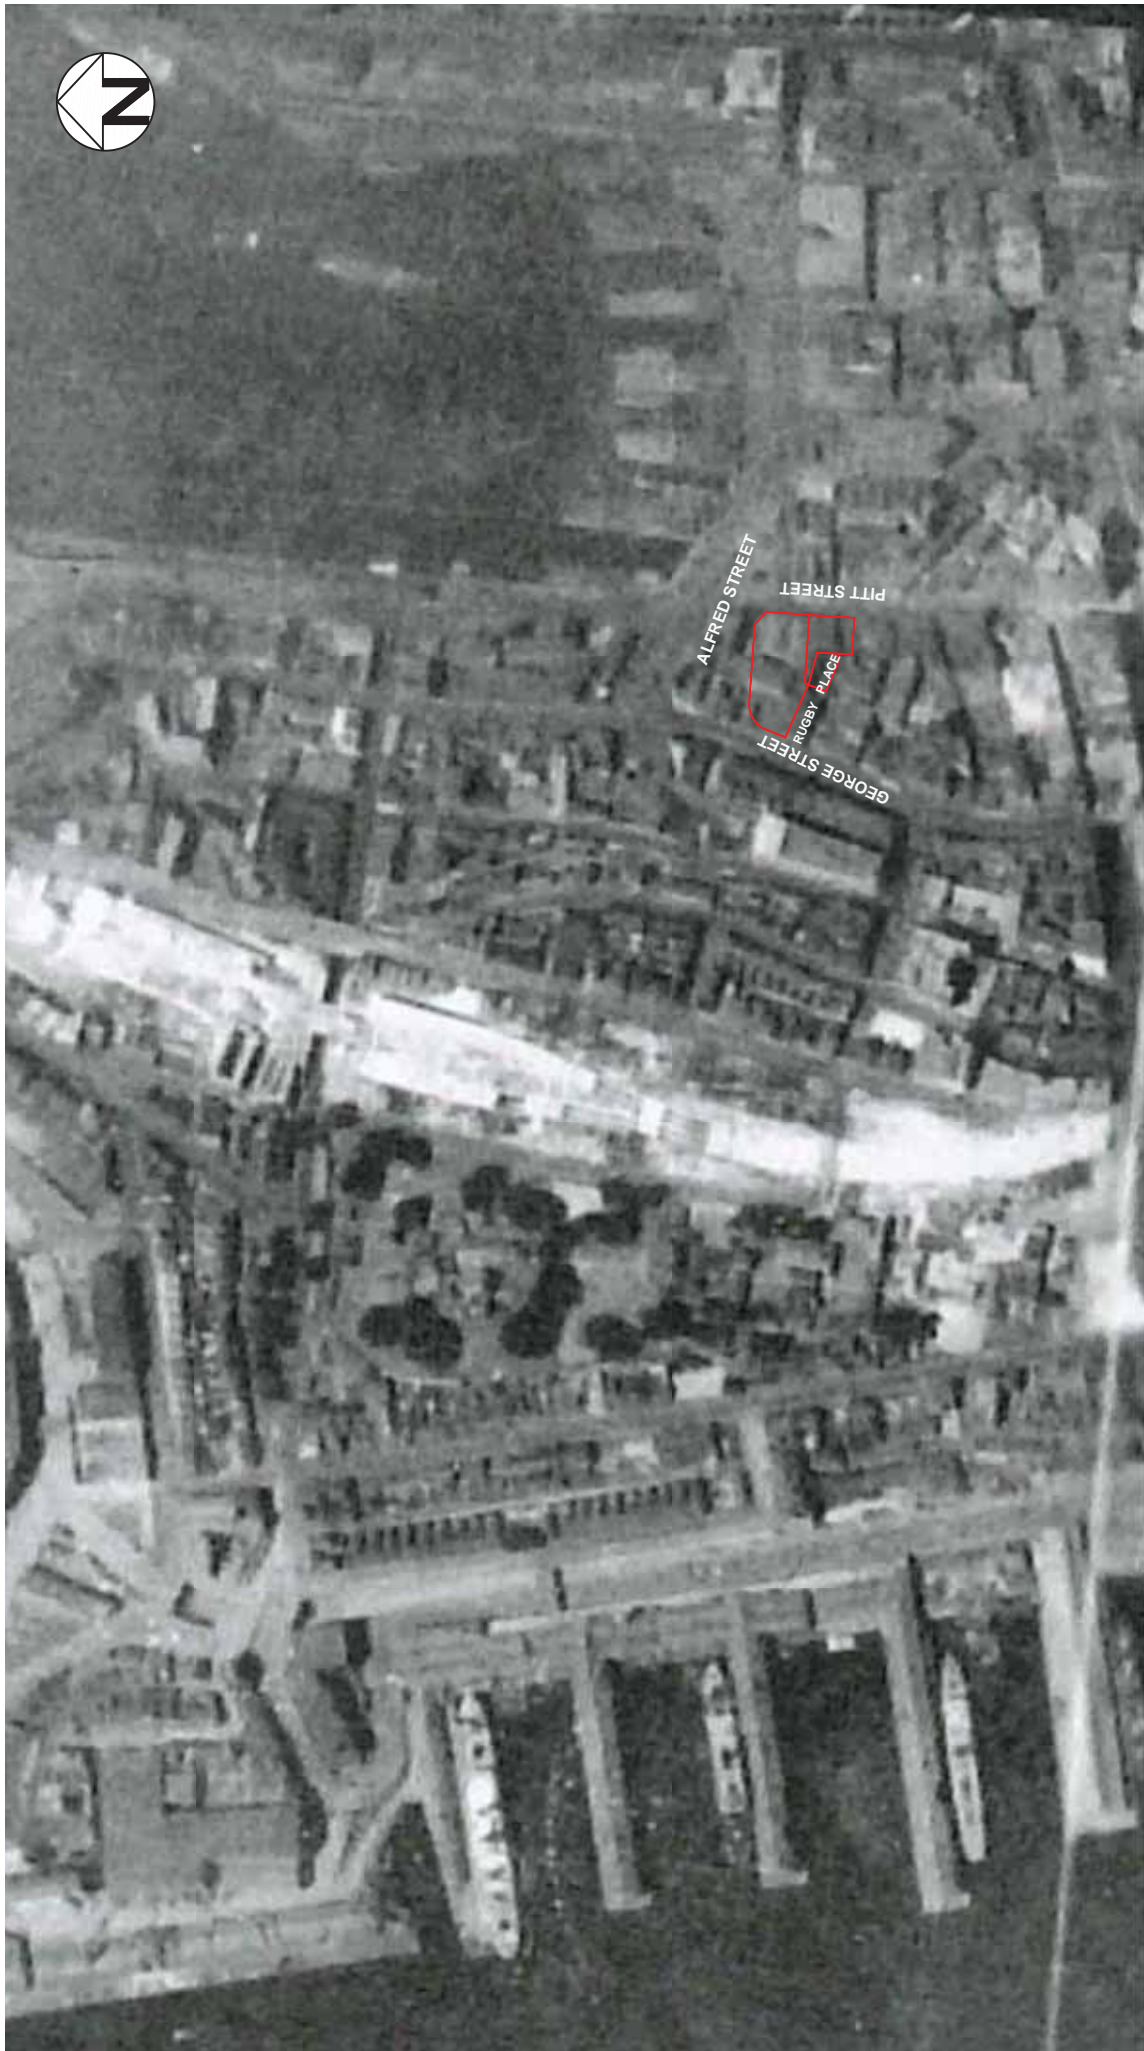
client:	WANDA ONE SYDNEY PTY LTD
project:	AUSTRALIA SYDNEY ONE PROJECT ENVIRONMENTAL PHASE 1 SITE ASSESSMENT 1 ALFRED STREET, SYDNEY, NSW
title:	AERIAL PHOTOGRAPH - 1930
project no:	GEOTLCOV/24001AD-AB
figure no:	FIGURE 3
rev:	A

<p>1930</p> <p><u>LEGEND</u></p> <p>— APPROXIMATE SITE BOUNDARY</p>
--

Current and historical aerial photographs of the site were obtained from the Land and Property Information Division of the NSW Department of Finance and Services, and online mapping tools. A summary of the historic land uses identified from the aerial photographs reviewed are summarised in Table 4.1. Historical aerial photographs are reproduced in Figures 3 to 10.

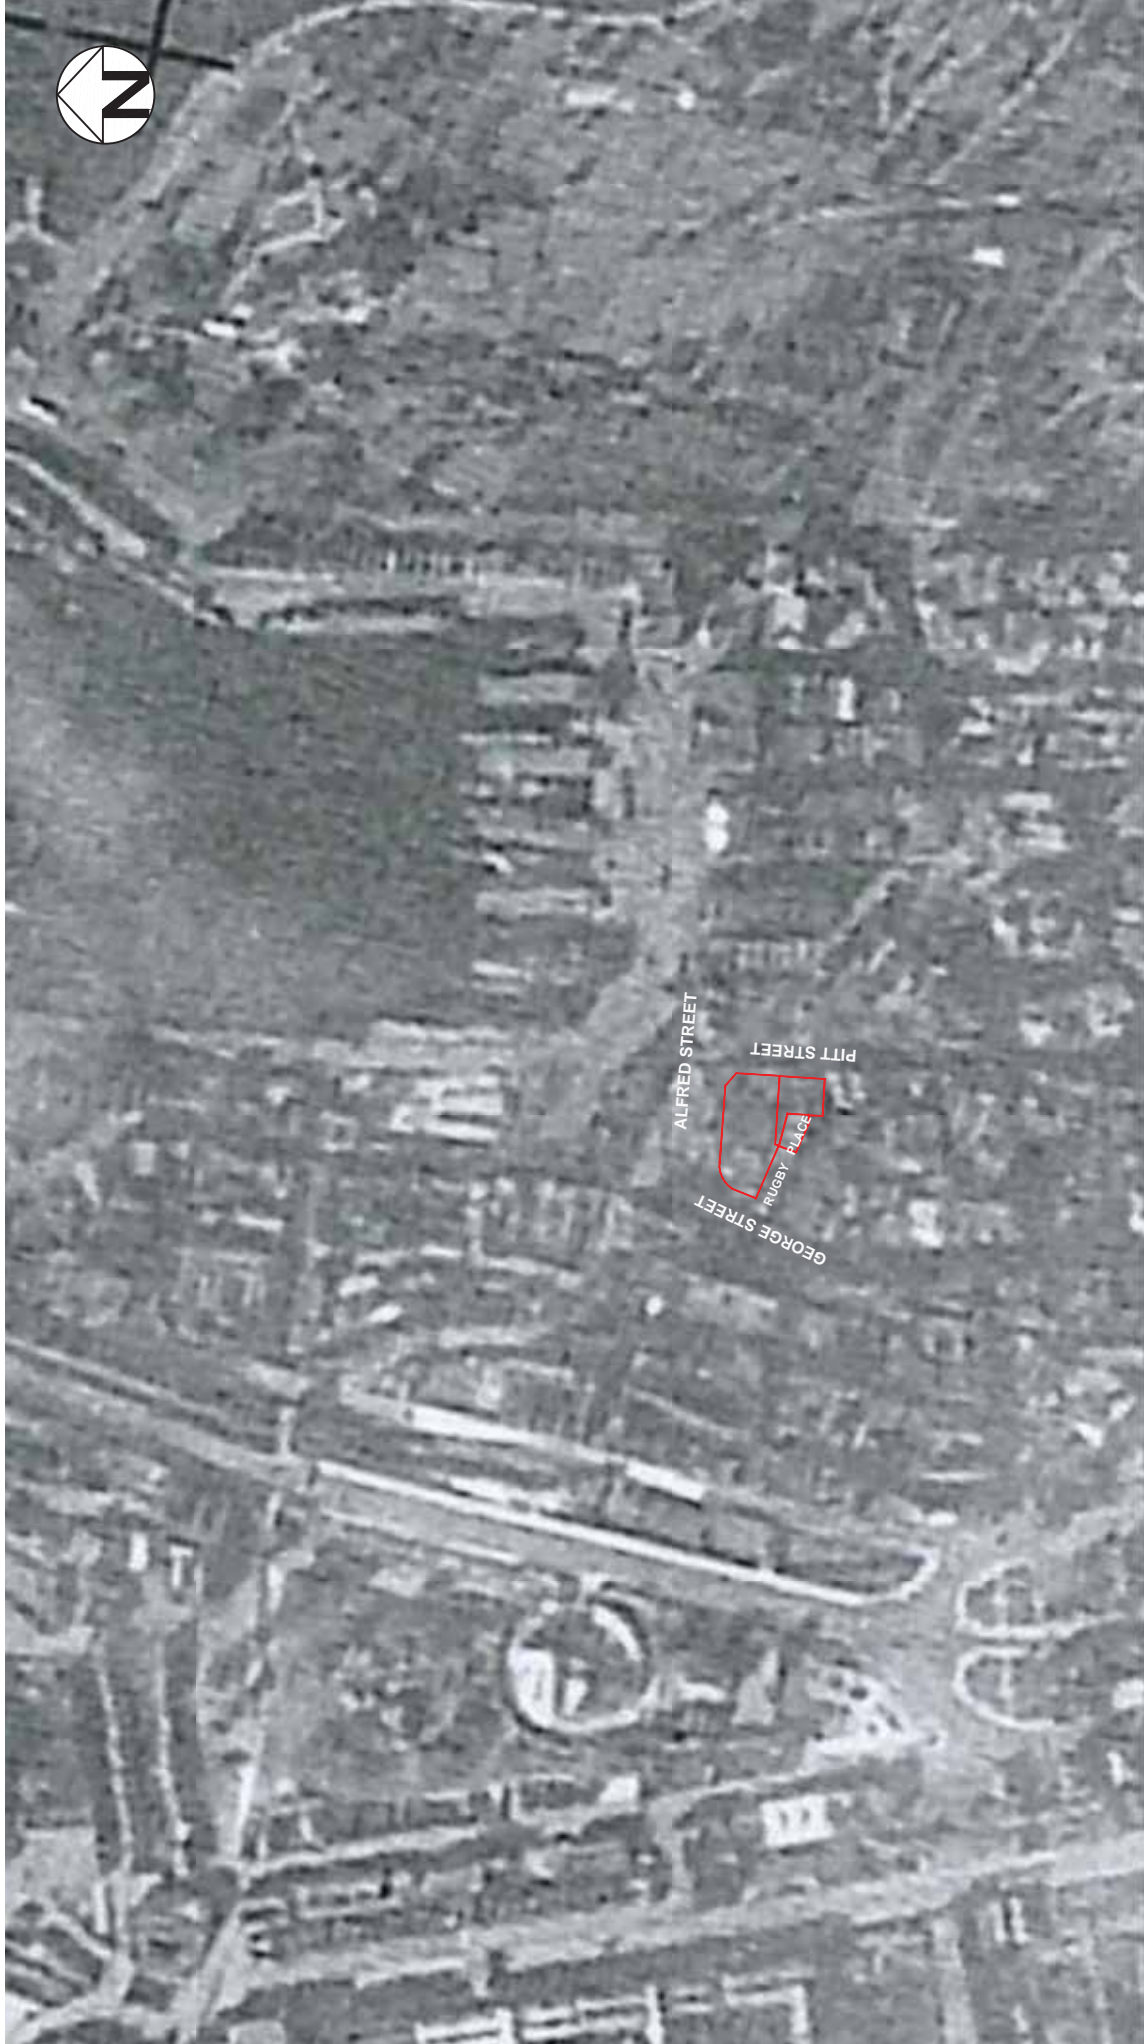
<p>1942</p> <p>LEGEND</p> <p>— APPROXIMATE SITE BOUNDARY</p>		drawn	MV

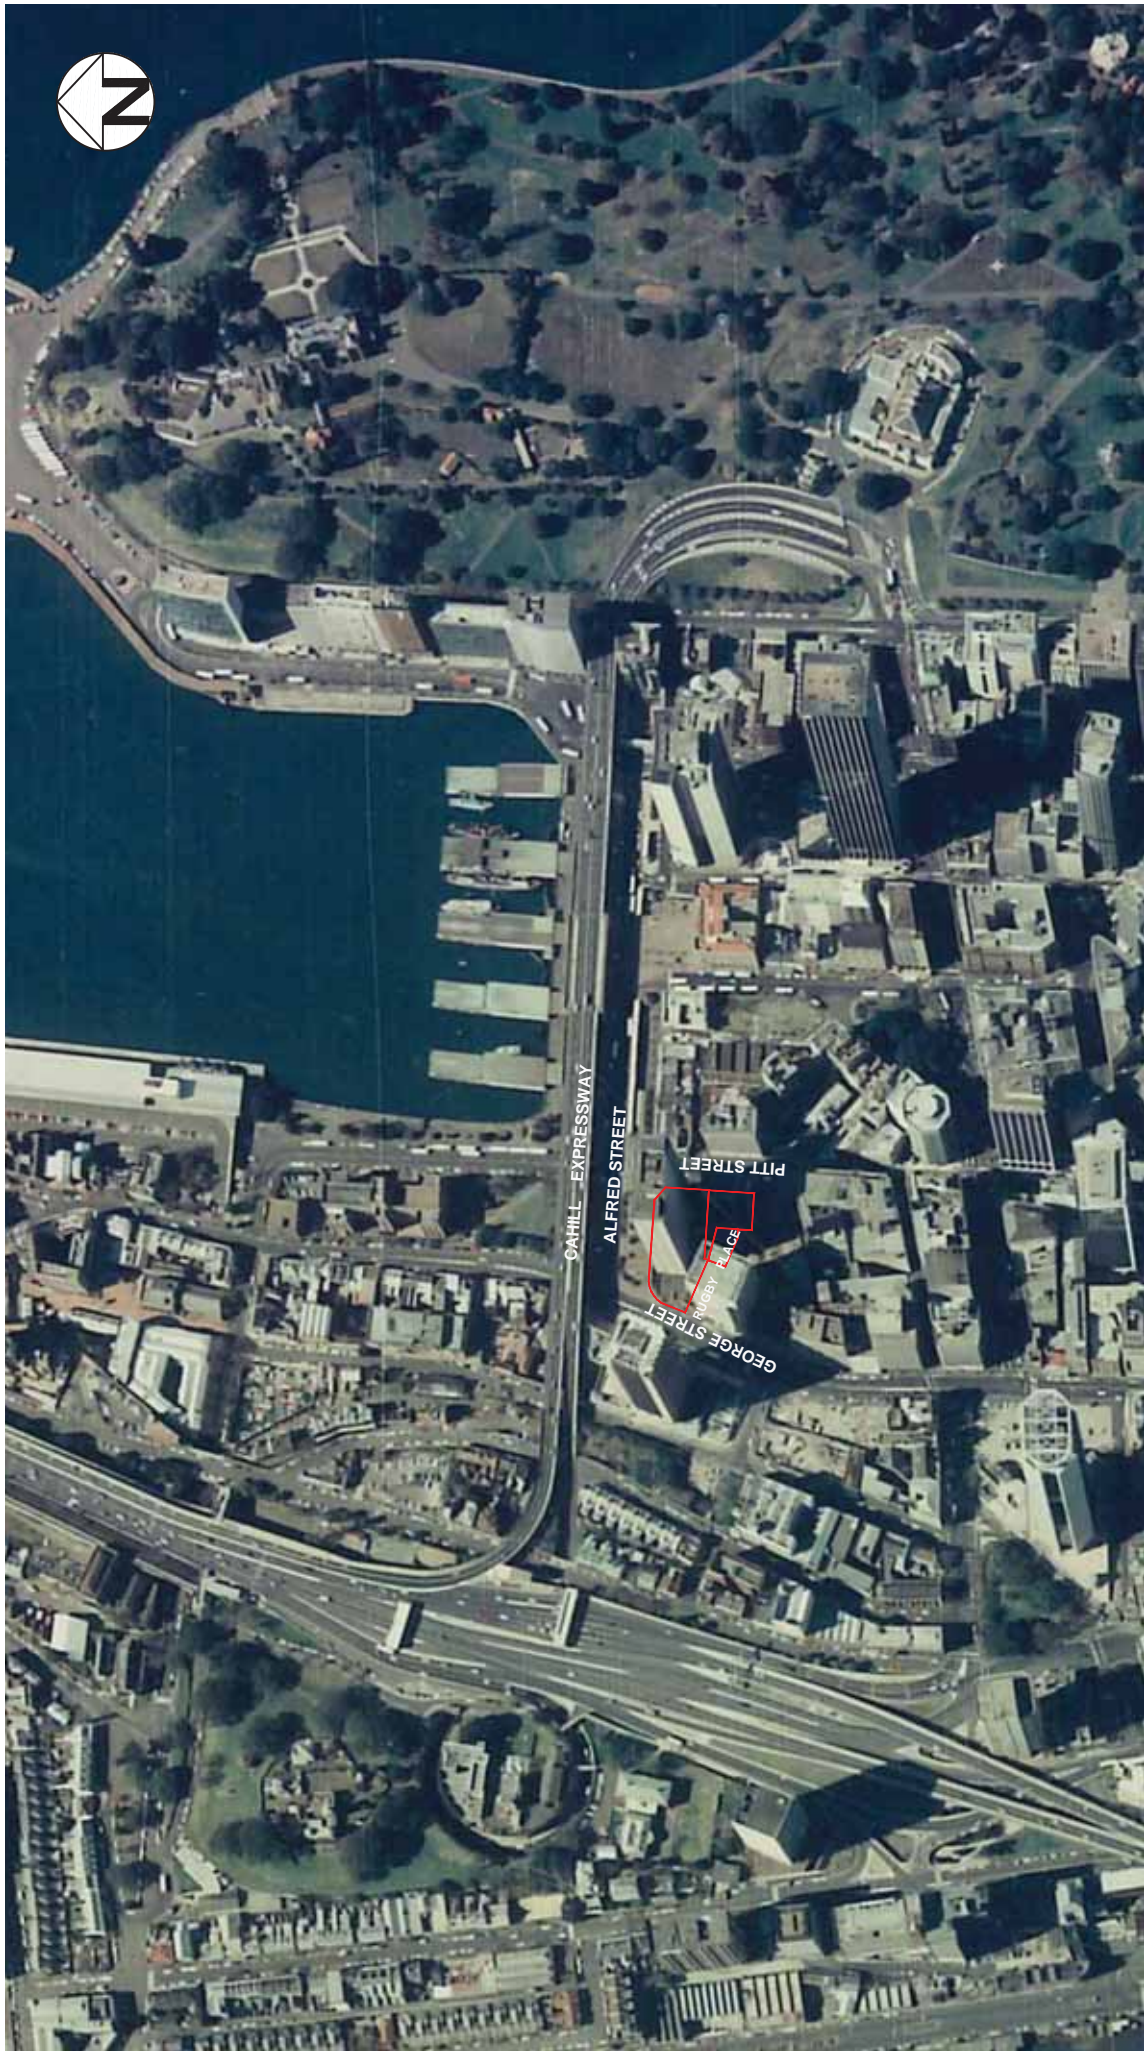
client:	WANDA ONE SYDNEY PTY LTD
project:	AUSTRALIA SYDNEY ONE PROJECT ENVIRONMENTAL PHASE 1 SITE ASSESSMENT 1 ALFRED STREET, SYDNEY, NSW
title:	AERIAL PHOTOGRAPH - 1982
project no:	GEOTLCOV24001AD-AB
figure no:	FIGURE 6
rev:	A

1982
LEGEND
— APPROXIMATE SITE BOUNDARY

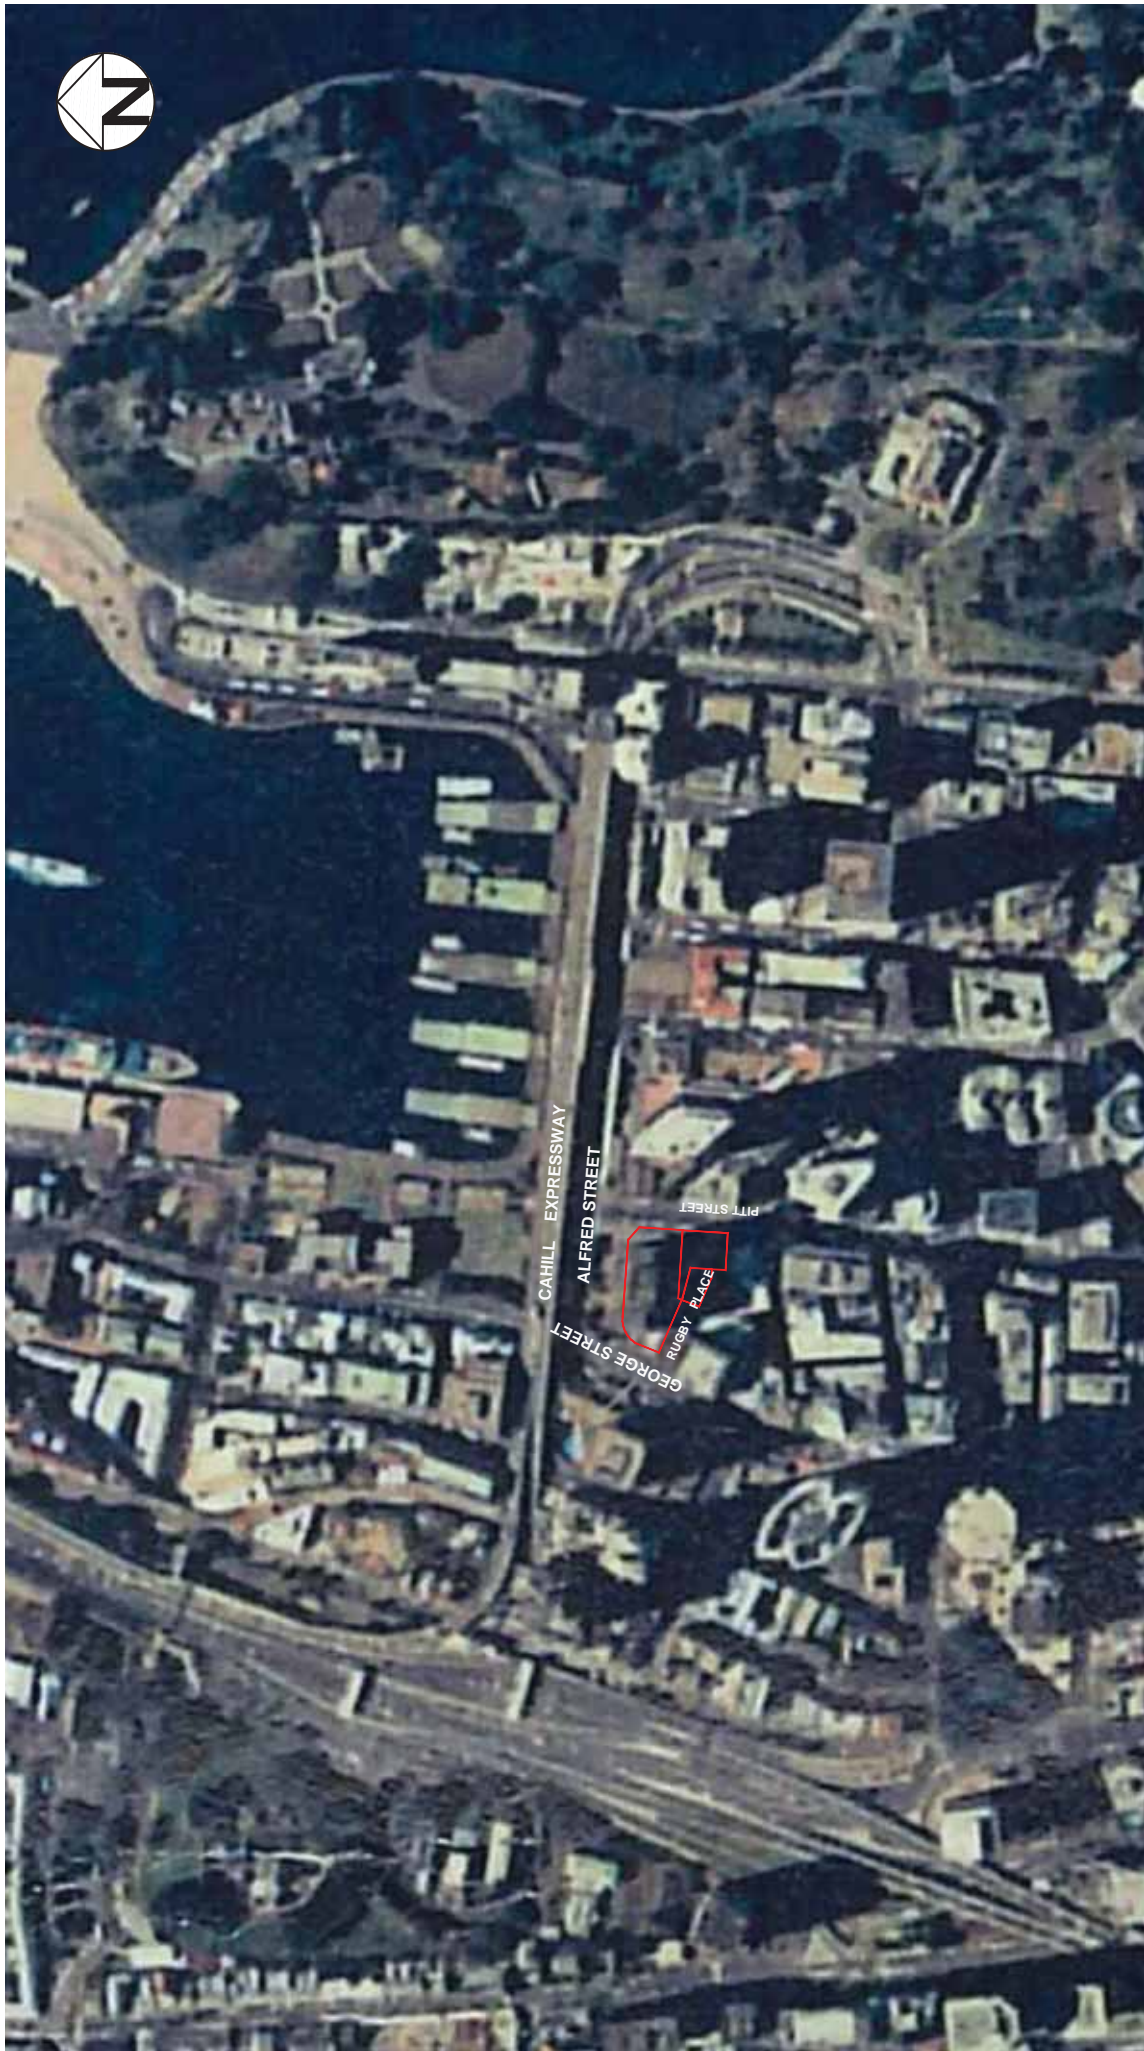
client:	WANDA ONE SYDNEY PTY LTD
project:	AUSTRALIA SYDNEY ONE PROJECT ENVIRONMENTAL PHASE 1 SITE ASSESSMENT 1 ALFRED STREET, SYDNEY, NSW
title:	AERIAL PHOTOGRAPH - 1991
project no:	GEOTLCOV/24001AD-AB
figure no:	FIGURE 7
rev:	A

1991
LEGEND
— APPROXIMATE SITE BOUNDARY

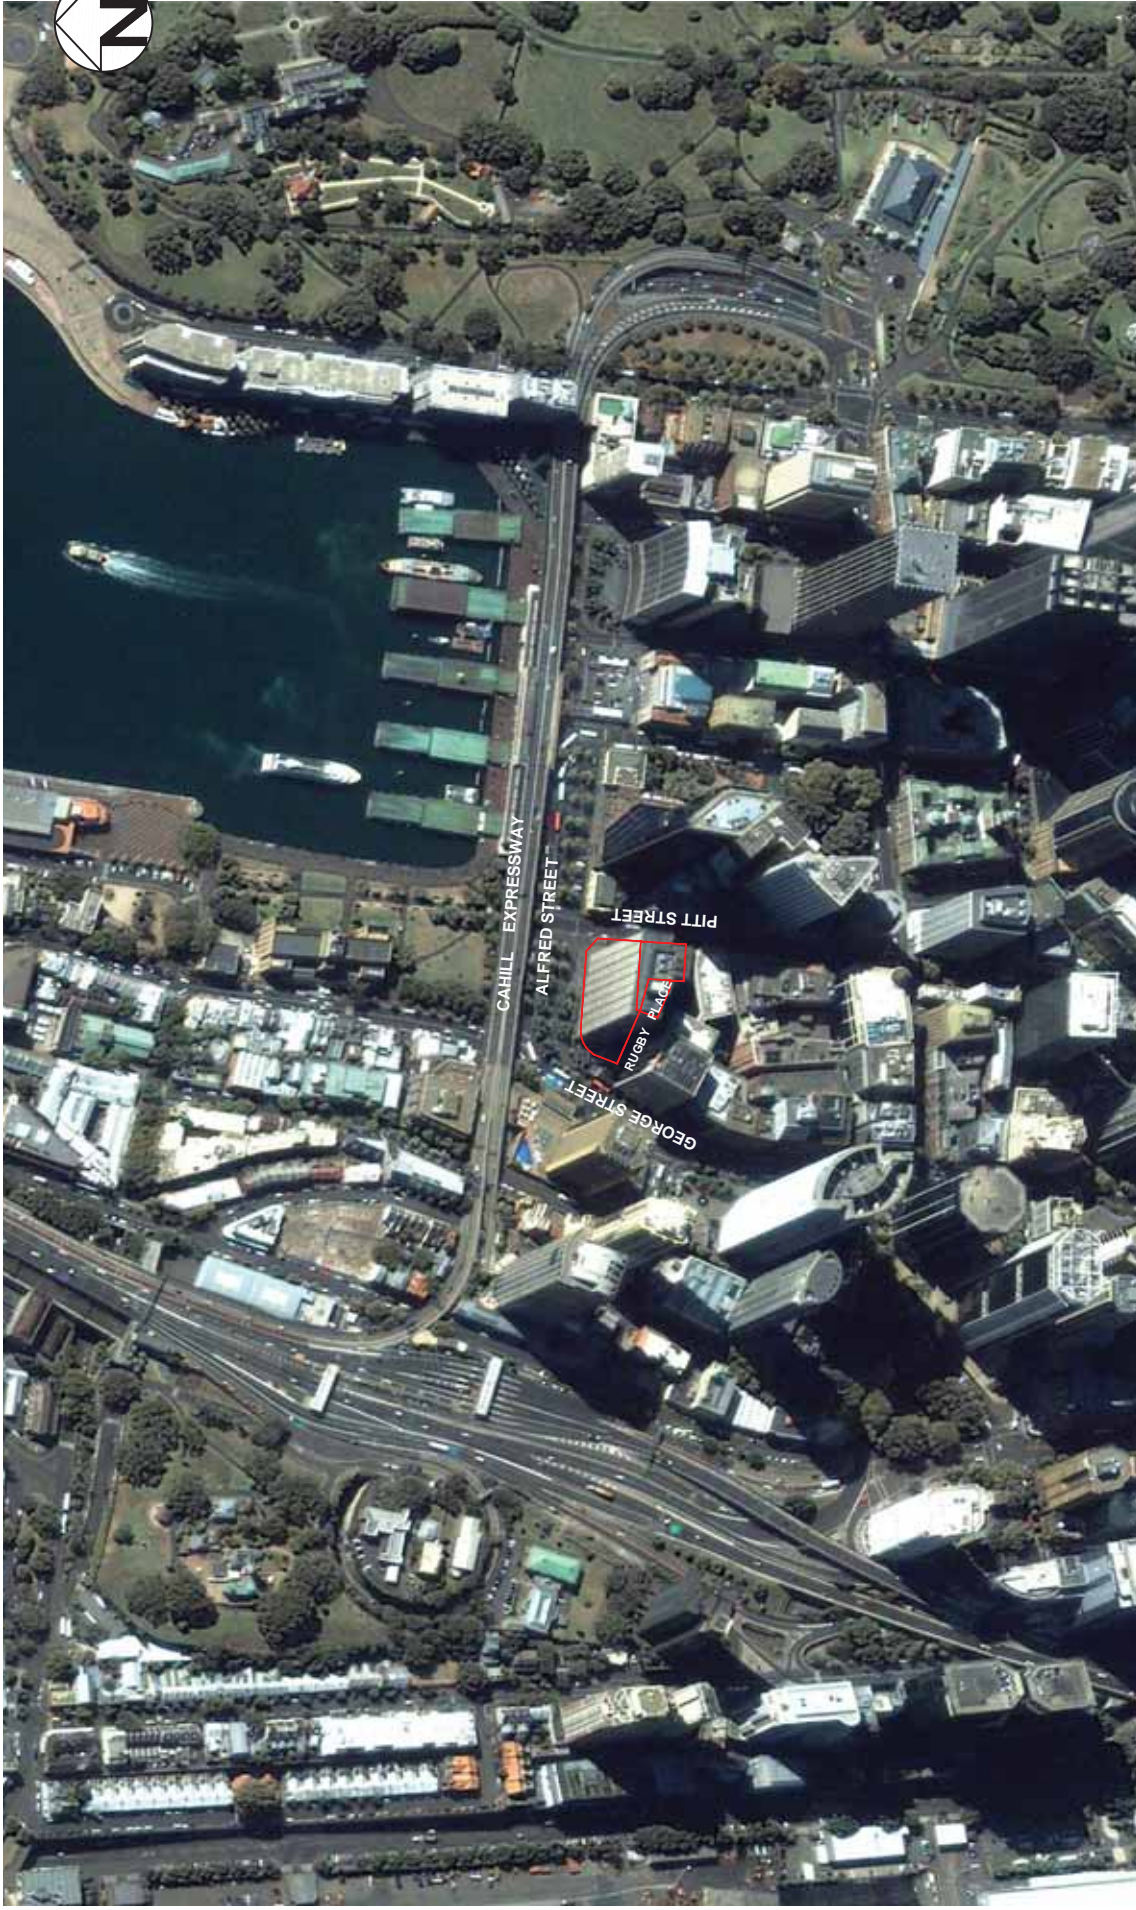
client:	WANDA ONE SYDNEY PTY LTD
		approved	PD			project:	AUSTRALIA SYDNEY ONE PROJECT ENVIRONMENTAL PHASE 1 SITE ASSESSMENT 1 ALFRED STREET, SYDNEY, NSW
date	04 / 06 / 15	title:	AERIAL PHOTOGRAPH - 2005				
scale	NTS	project no:	GEOTLCOV24001AD-AB				
original size	A4	figure no:	FIGURE 9	rev:	A

<p>2005</p> <p>LEGEND</p> <p>— APPROXIMATE SITE BOUNDARY</p>		drawn	MV
