## **Reflectivity Report**

**ATP**

**Mirvac**

**Prepared for**  
Mirvac

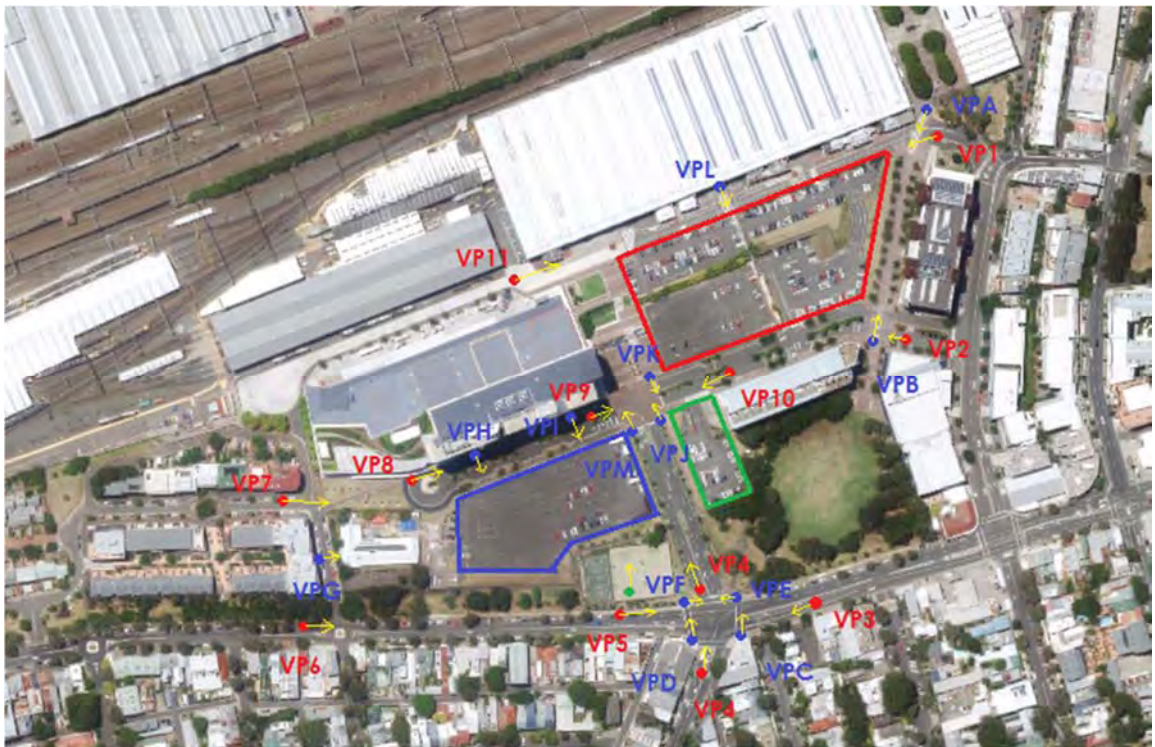
Figure 3 - Satellite Image with Viewpoints<sup>1</sup>

The site has been assessed to determine appropriate viewpoints where drivers (red), and pedestrians when they are crossing the road (blue), are able to see the building façade in their direct line of vision.

- o Crossing south at Locomotive Street (VPA and VPL)
- o Crossing north at Central Avenue (VPB, VPJ and VPM)
- o Crossing at the pedestrian crossings at Henderson and Davy Road (VPC, VPD, VPE and VPF)
- o Crossing east at Alexander Street (VPG)
- o Crossing south at Central Avenue (VPH, VPI and VPK)

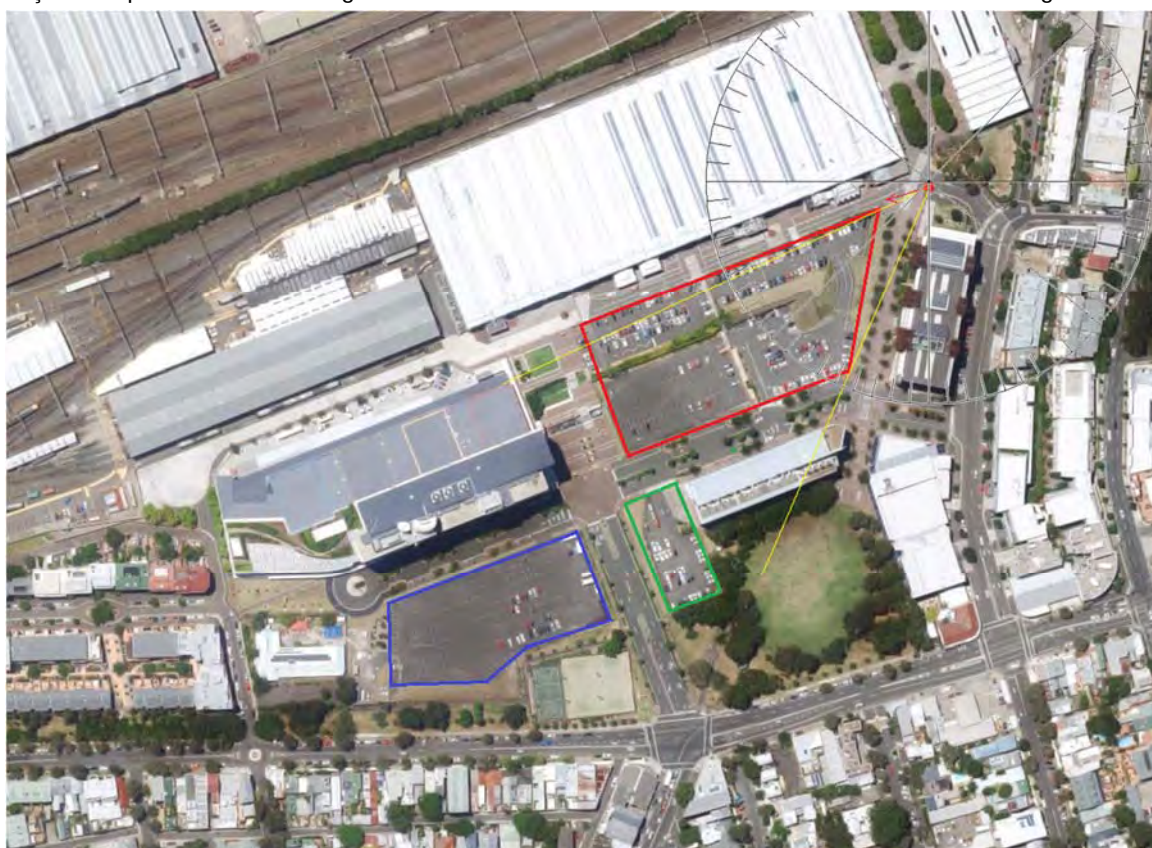
**Figure 10 – Viewpoint 1 horizontal bearing angles**

Viewpoint 1 has been taken at a distance of 37m from the north-east apex of Building 2.

On Figure 10 below yellow lines have been drawn to represent the bearing angles to the one visible façade aspect of the building. The red arrow indicated the direction of travel and viewing.

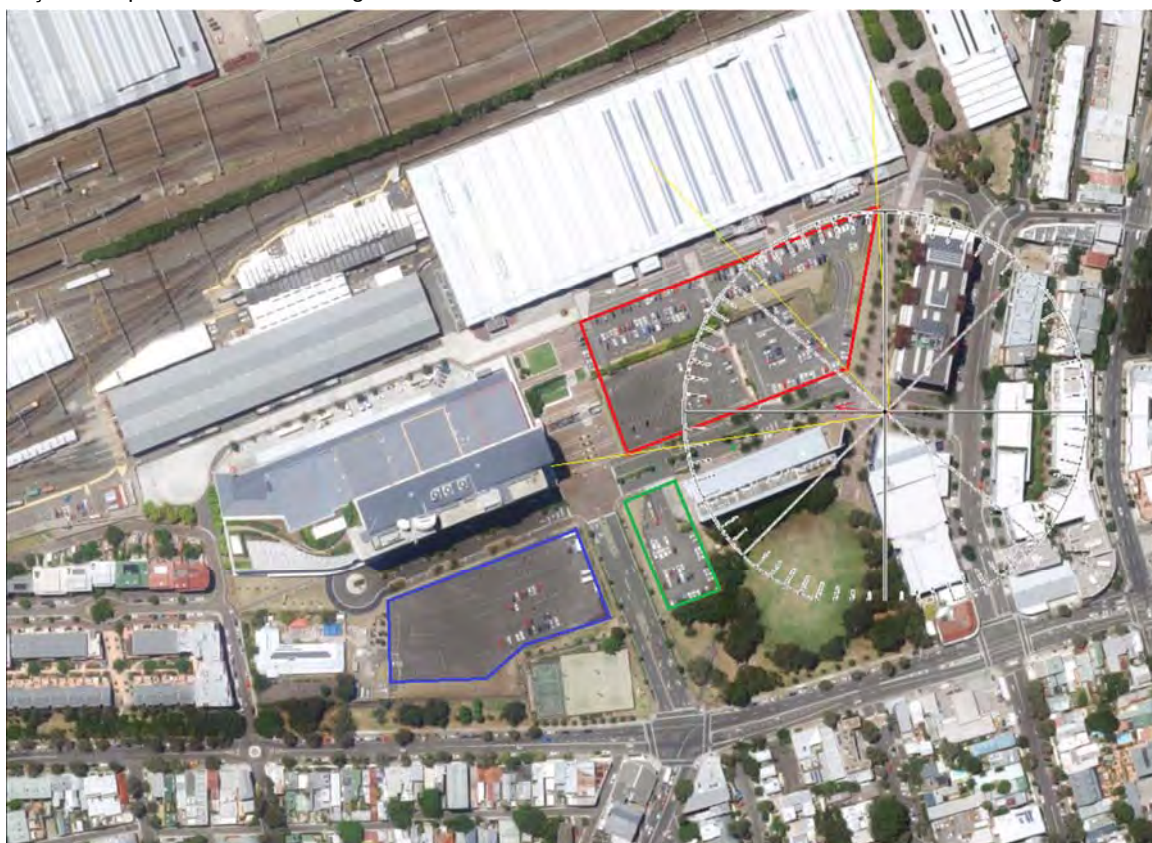
**Figure 12 – Viewpoint 2 horizontal bearing angles**

Viewpoint 2 has been taken at a distance of 33m from the south-east apex of Building 2.

On Figure 12 below yellow lines have been drawn to represent the bearing angles to the two visible façade aspects of the building. The red arrow indicated the direction of travel and viewing.

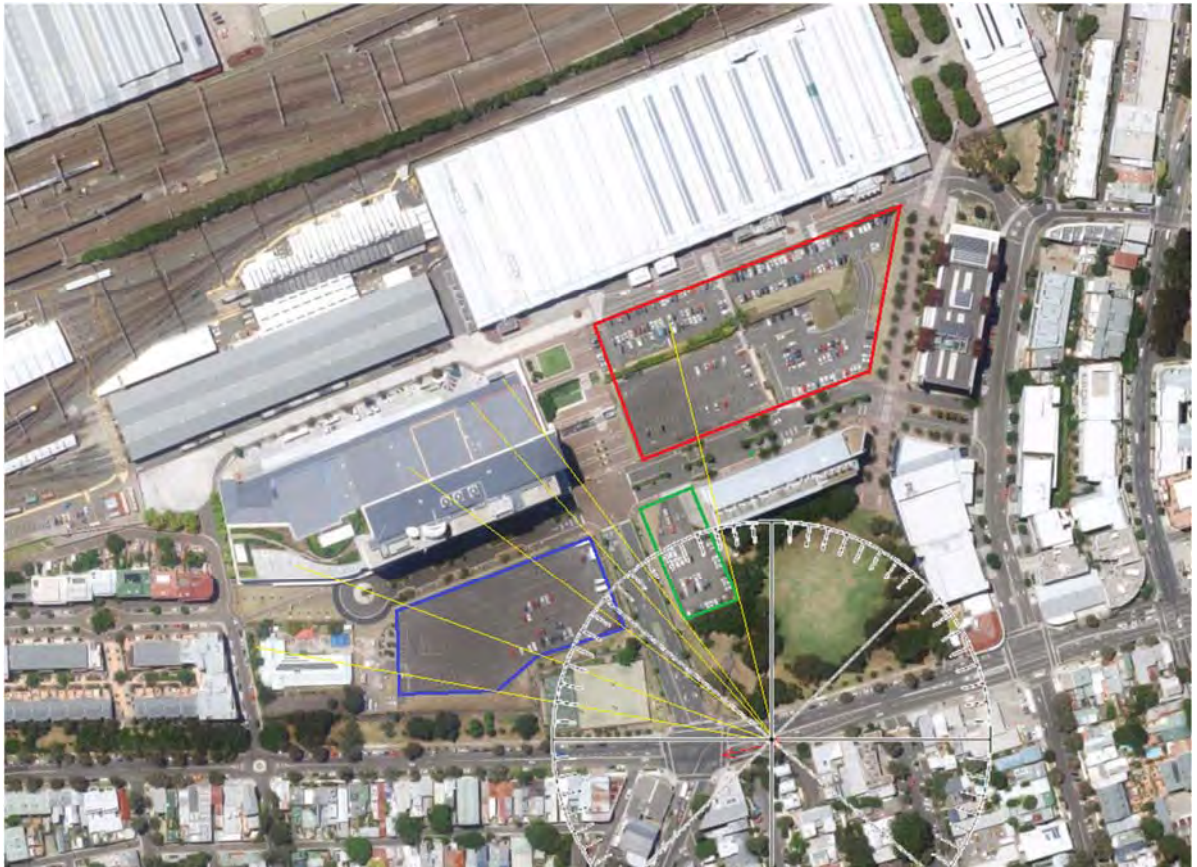
**Figure 15 – Viewpoint 3 horizontal bearing angles**

Viewpoint 3 has been taken at a distance of 105m from the south-east apex of Building 1.

On Figure 15 below yellow lines have been drawn to represent the bearing angles to the two visible façade aspects of the building. The red arrow indicated the direction of travel and viewing.

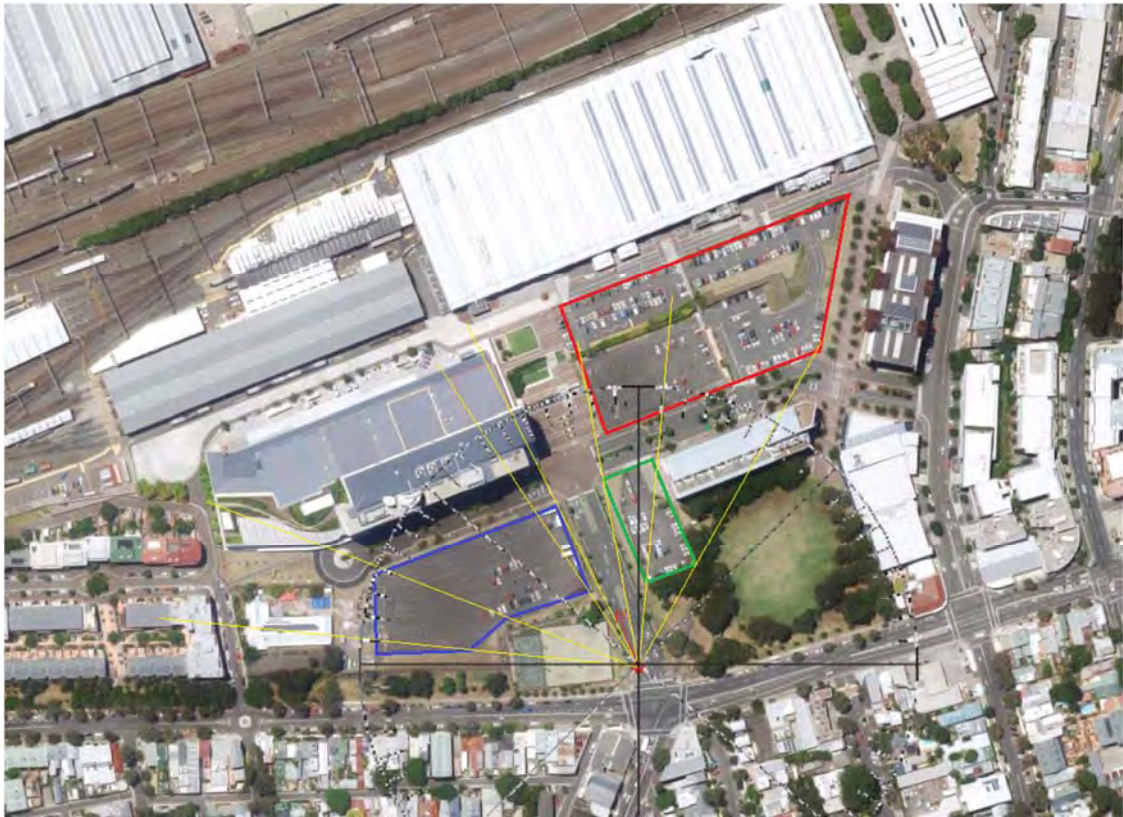
**Figure 20 – Viewpoint 4 horizontal bearing angles**

Viewpoint 4 has been taken at a distance of 65m from the south-east apex of Building 1.

On Figure 20 below yellow lines have been drawn to represent the bearing angles to the two visible façade aspects of the building. The red arrow indicated the direction of travel and viewing.

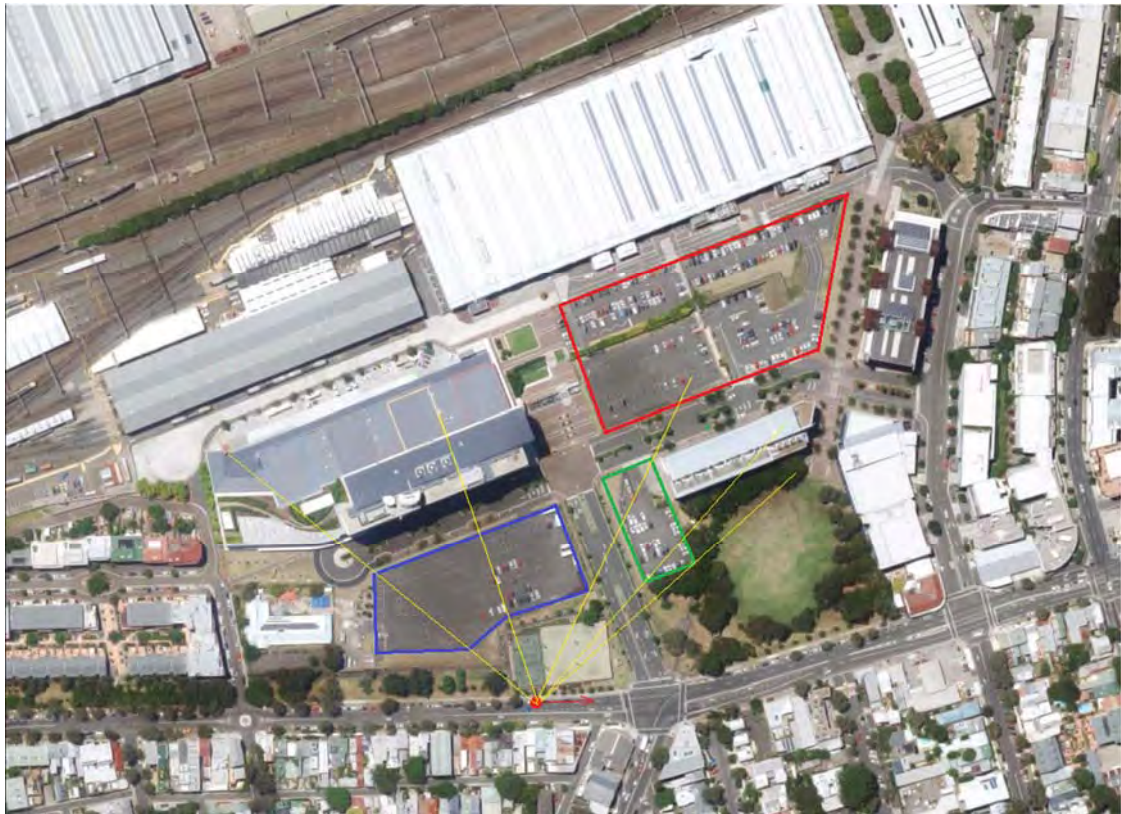
**Figure 26 – Viewpoint 5 horizontal bearing angles**

Viewpoint 5 has been taken at a distance of 60m from the south-east apex of Building 1.

On Figure 26 below yellow lines have been drawn to represent the bearing angles to the two visible façade aspects of the building. The red arrow indicated the direction of travel and viewing.

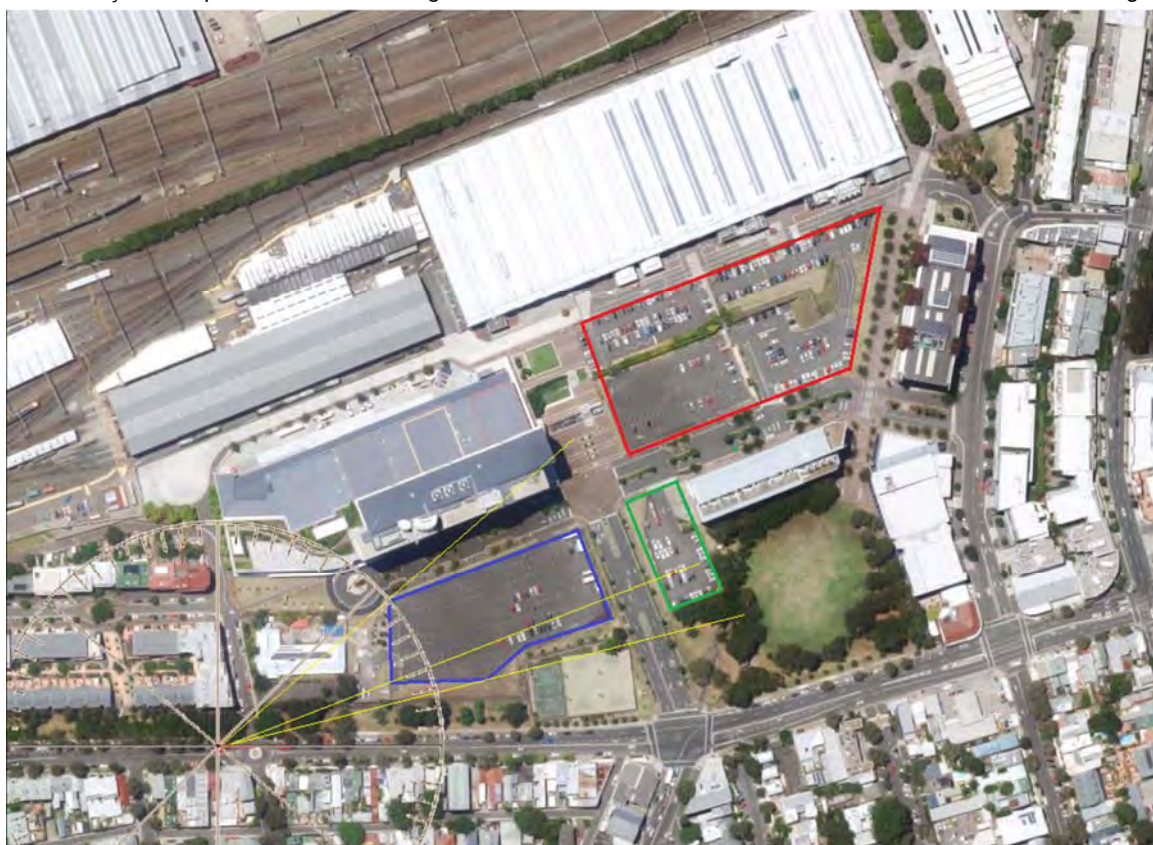
**Figure 30 – Viewpoint 6 horizontal bearing angles**

Viewpoint 6 has been taken at a distance of 95m from the south-west apex of Building 1.

On Figure 30 below yellow lines have been drawn to represent the bearing angles to the two visible façade aspects of the building. The red arrow indicated the direction of travel and viewing.

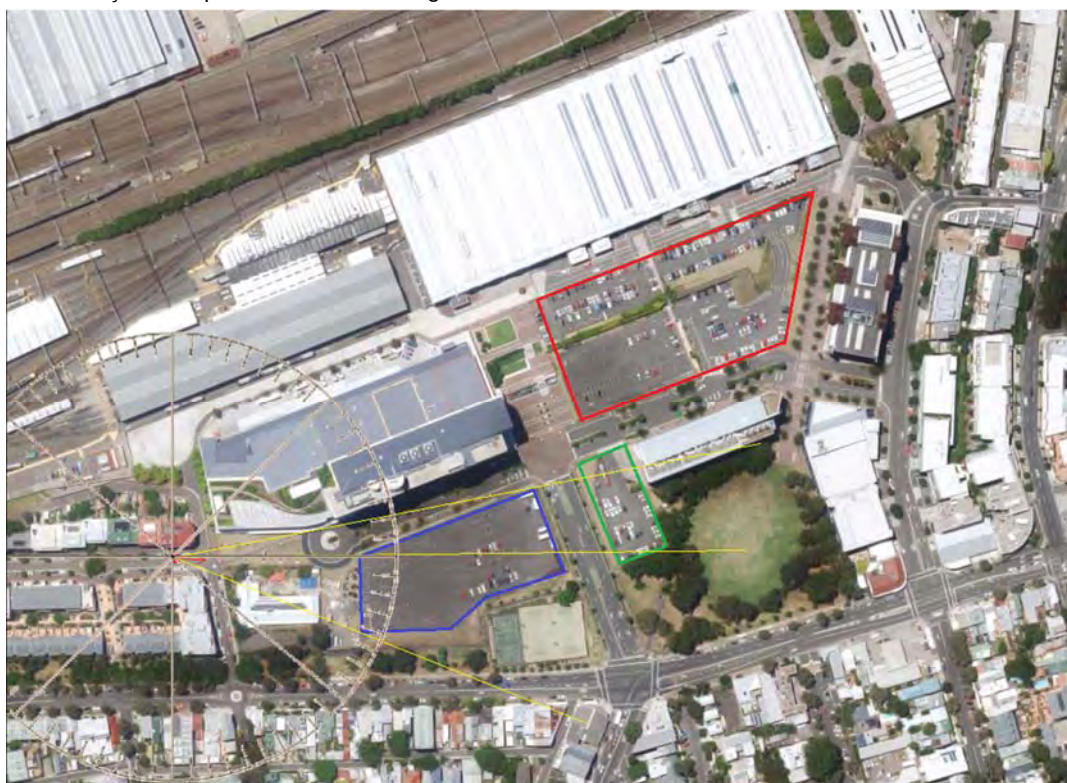
**Figure 33 – Viewpoint 7 horizontal bearing angles**

On Figure 33 below yellow lines have been drawn to represent the bearing angles to the two visible façade aspects of the building. The red arrow indicated the direction of travel and viewing.

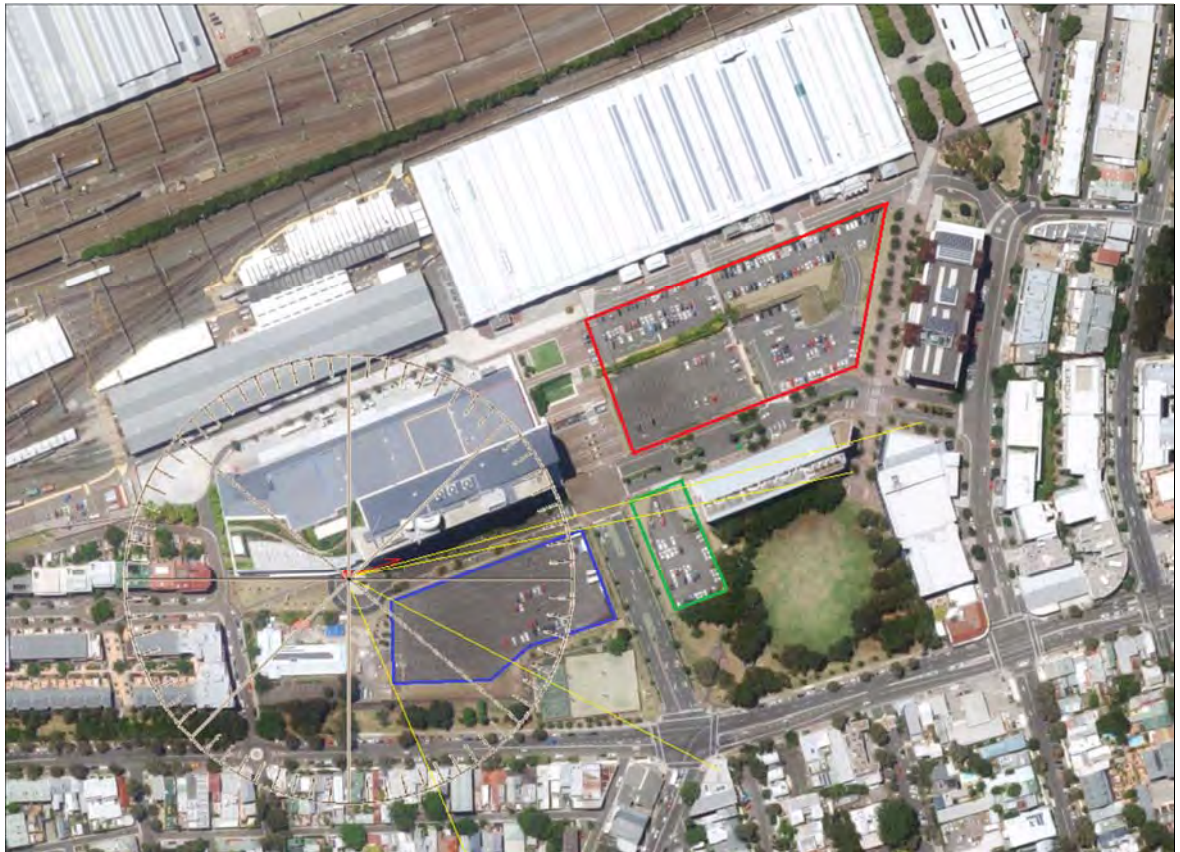
**Figure 36 – Viewpoint 8 horizontal bearing angles**

On Figure 36 below yellow lines have been drawn to represent the bearing angles to the two visible façade aspects of the building. The red arrow indicated the direction of travel and viewing.

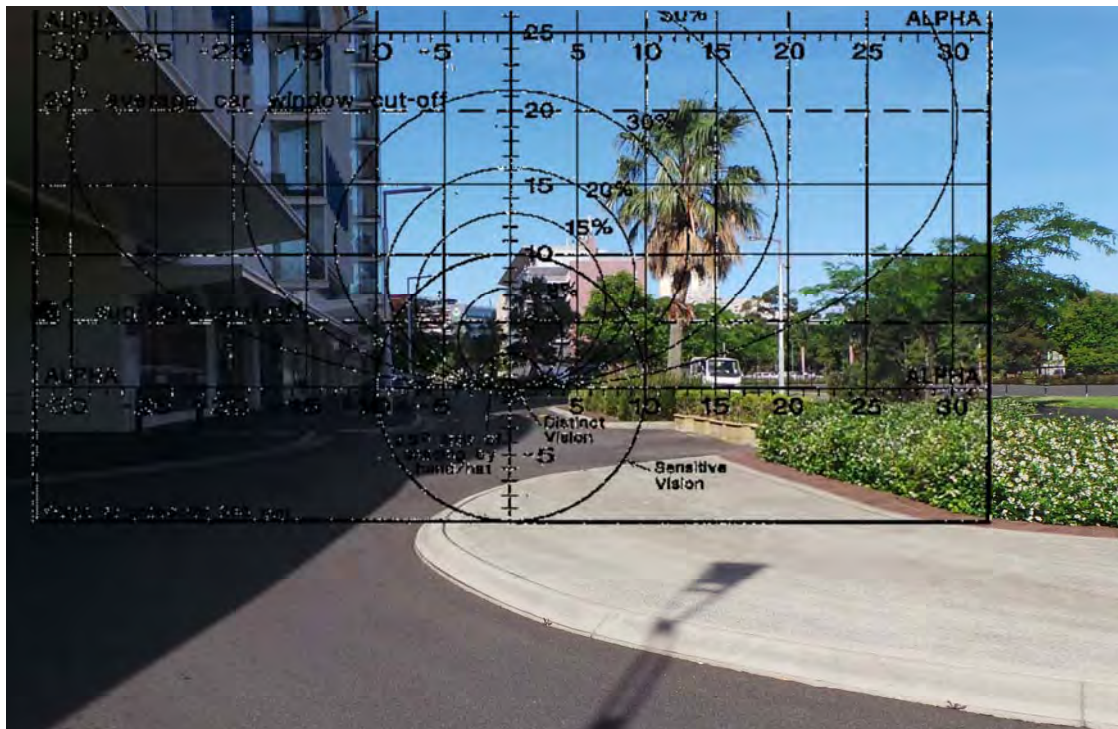
There is a reflected image from the northern end of façade aspect 253 of the Community Building between 6pm and 7pm from November to February. In order to assess the façade a photo has been taken and the glare protractor has been applied at scale; where the 40m high TOP Education Institute building is 200m distant.

Further assessment and treatment of the façade to manage reflections is required.

It is anticipated that Building 1 will provide shadowing to the Community building during these times; this can be confirmed with a sun study.

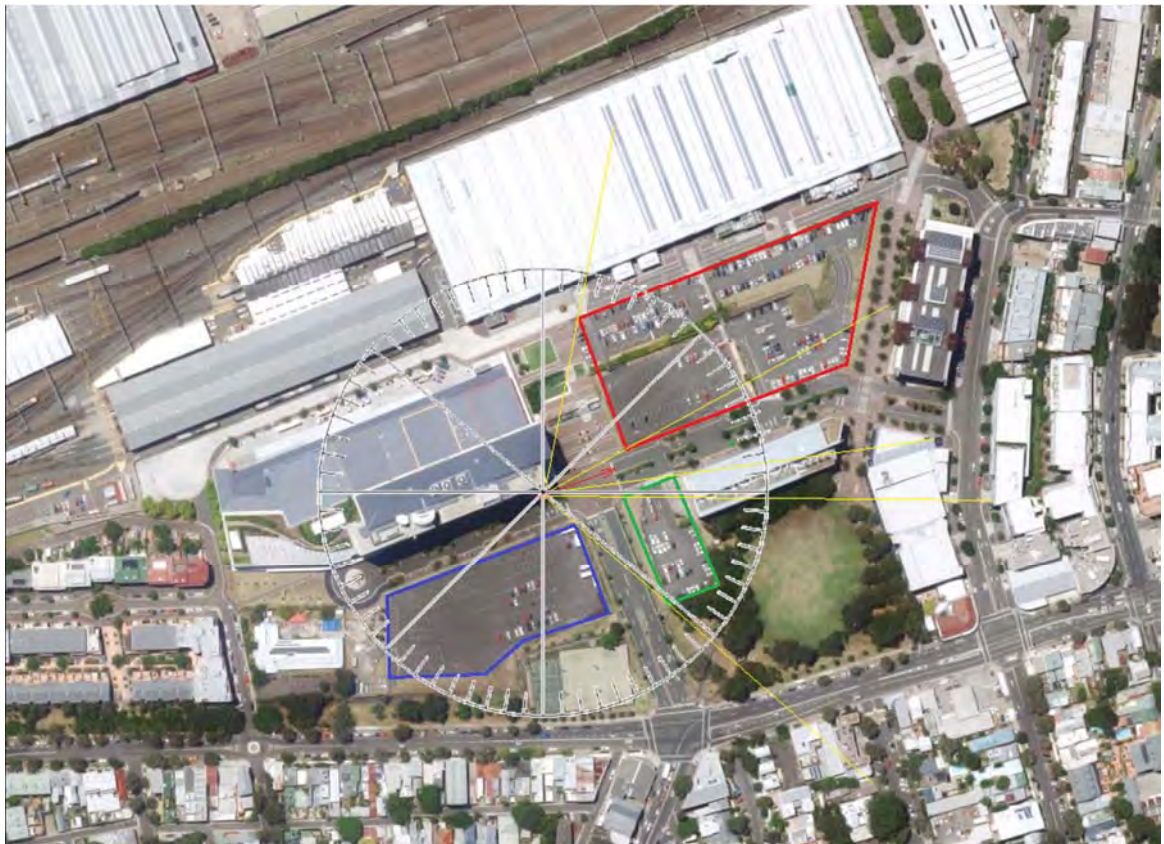
**Figure 40 – Viewpoint 9 horizontal bearing angles**

On Figure 40 below yellow lines have been drawn to represent the bearing angles to the two visible façade aspects of the building. The red arrow indicated the direction of travel and viewing.

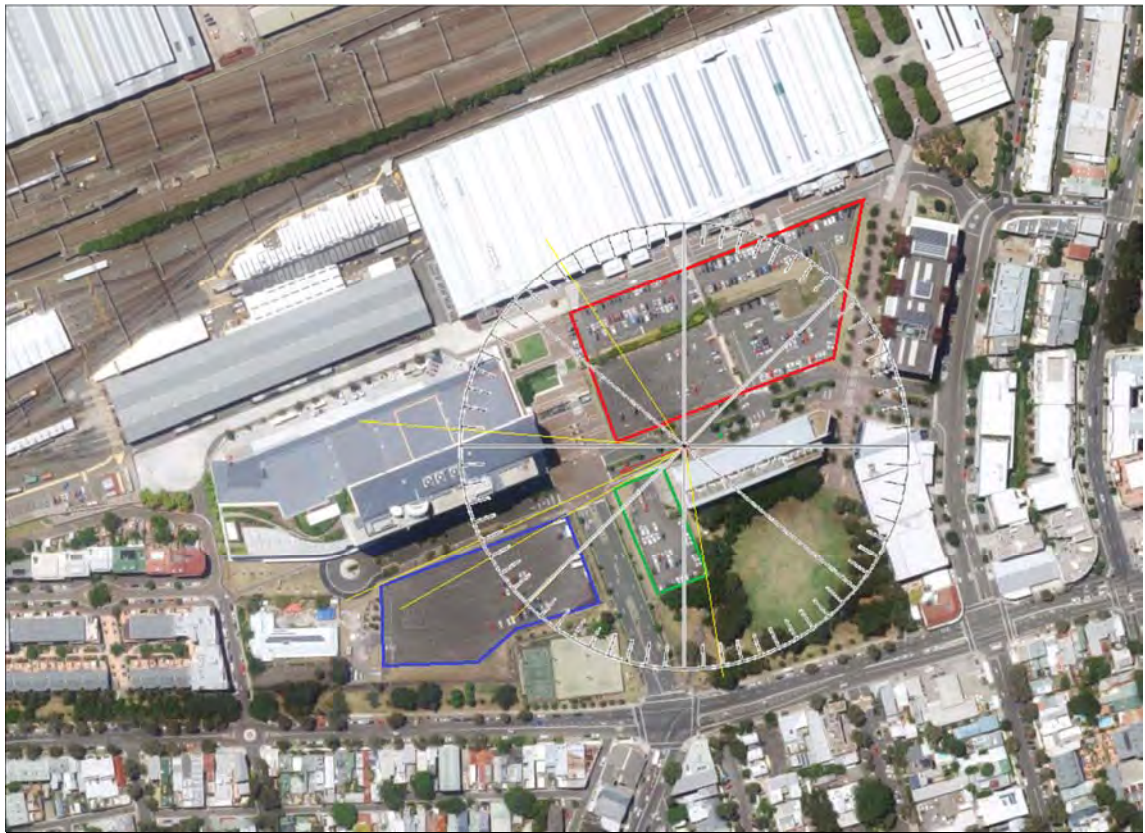
**Figure 44 – Viewpoint 10 horizontal bearing angles**

On Figure 44 below yellow lines have been drawn to represent the bearing angles to the two visible façade aspects of the building. The red arrow indicated the direction of travel and viewing.

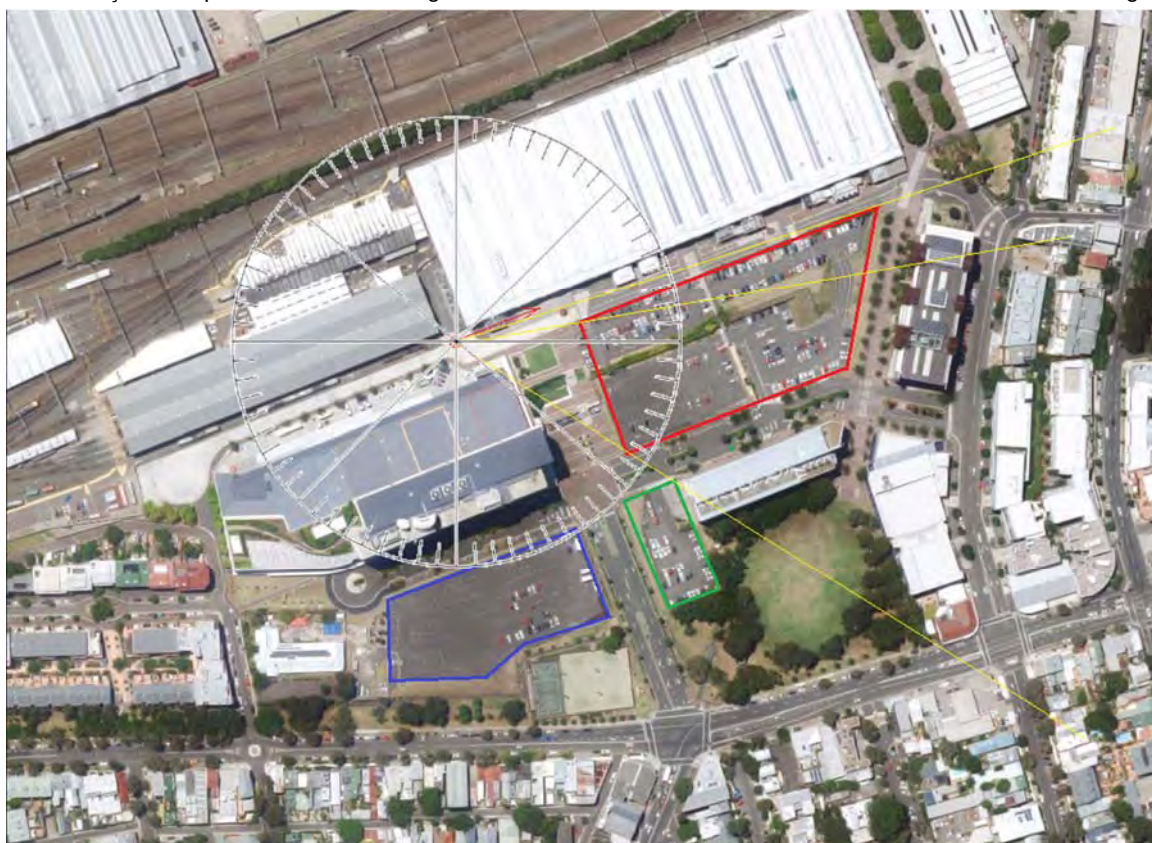
**Figure 48 – Viewpoint 11 horizontal bearing angles**

On Figure 48 below yellow lines have been drawn to represent the bearing angles to the two visible façade aspects of the building. The red arrow indicated the direction of travel and viewing.

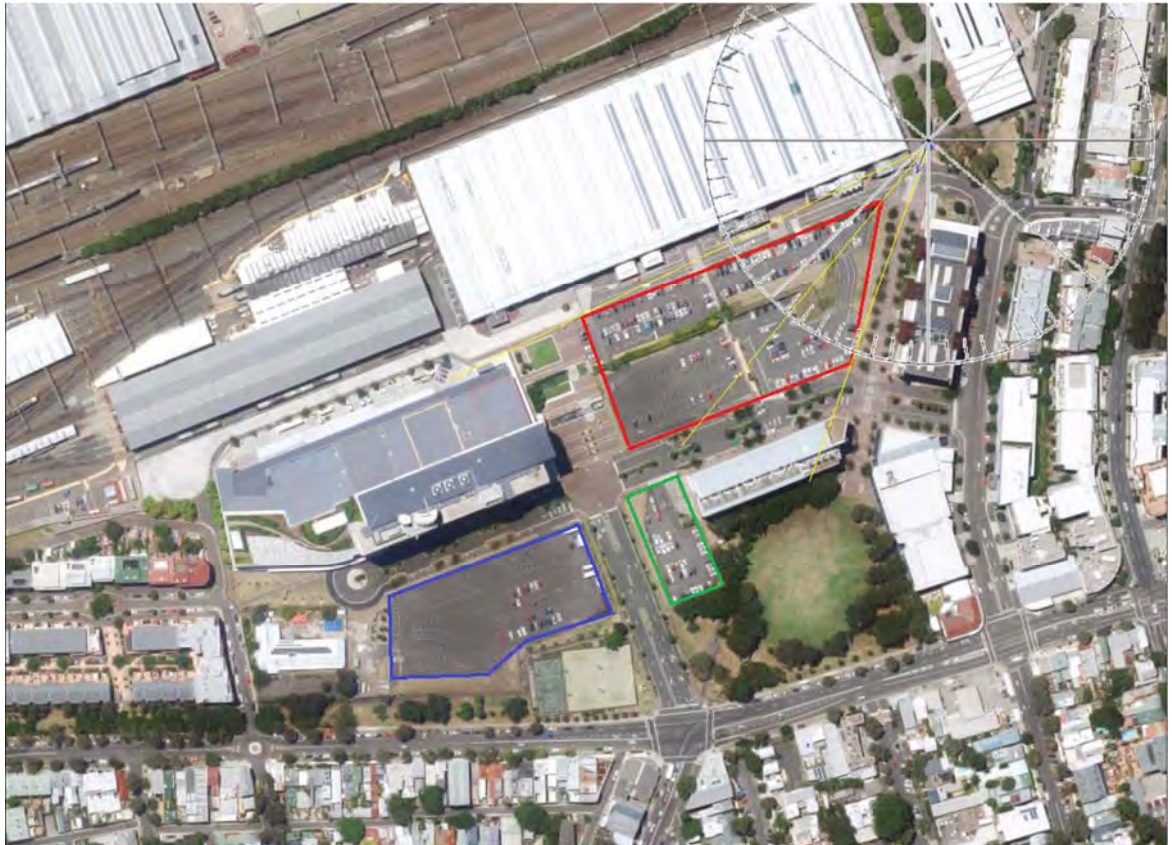
**Figure 51 – Viewpoint 5 horizontal bearing angles**

On Figure 51 below yellow lines have been drawn to represent the bearing angles to the two visible façade aspects of the building. The blue arrow indicated the direction of travel and viewing.

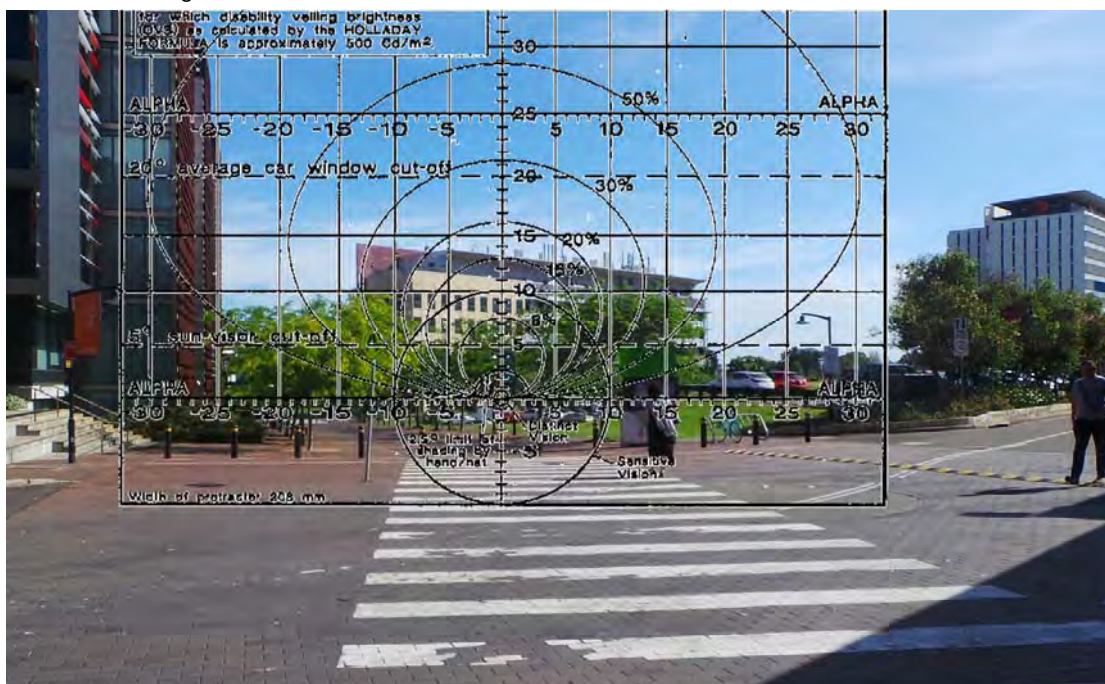
There is a reflected image of the sun that reaches Viewpoint A from Façade Aspect 343 of Building 2 after 6pm from April to May and August to October. In order to assess the façade a photo has been taken and the glare protractor has been applied at scale; where the 40m high TOP Education Institute building is 160m distant.

Further assessment and treatment of the façade to manage reflections is required.

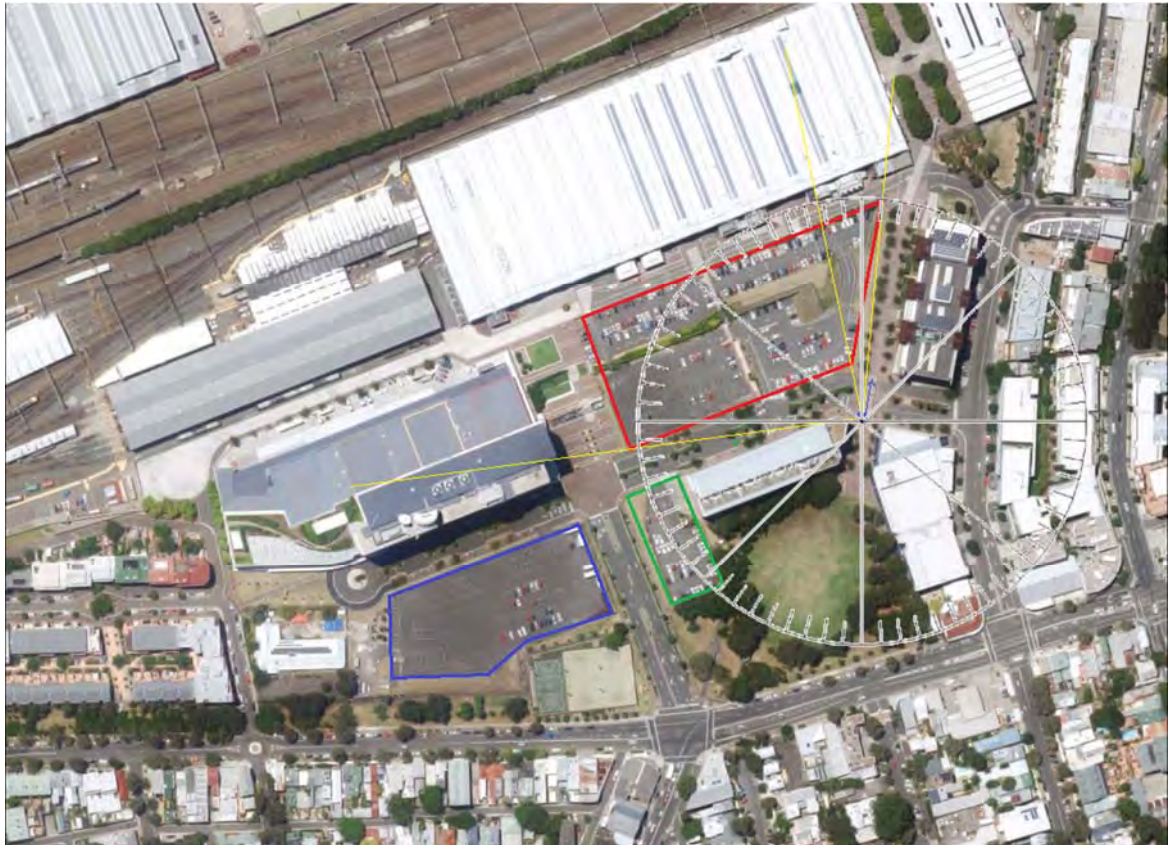
**Figure 54 – Viewpoint 5 horizontal bearing angles**

On Figure 54 below yellow lines have been drawn to represent the bearing angles to the two visible façade aspects of the building. The blue arrow indicated the direction of travel and viewing.

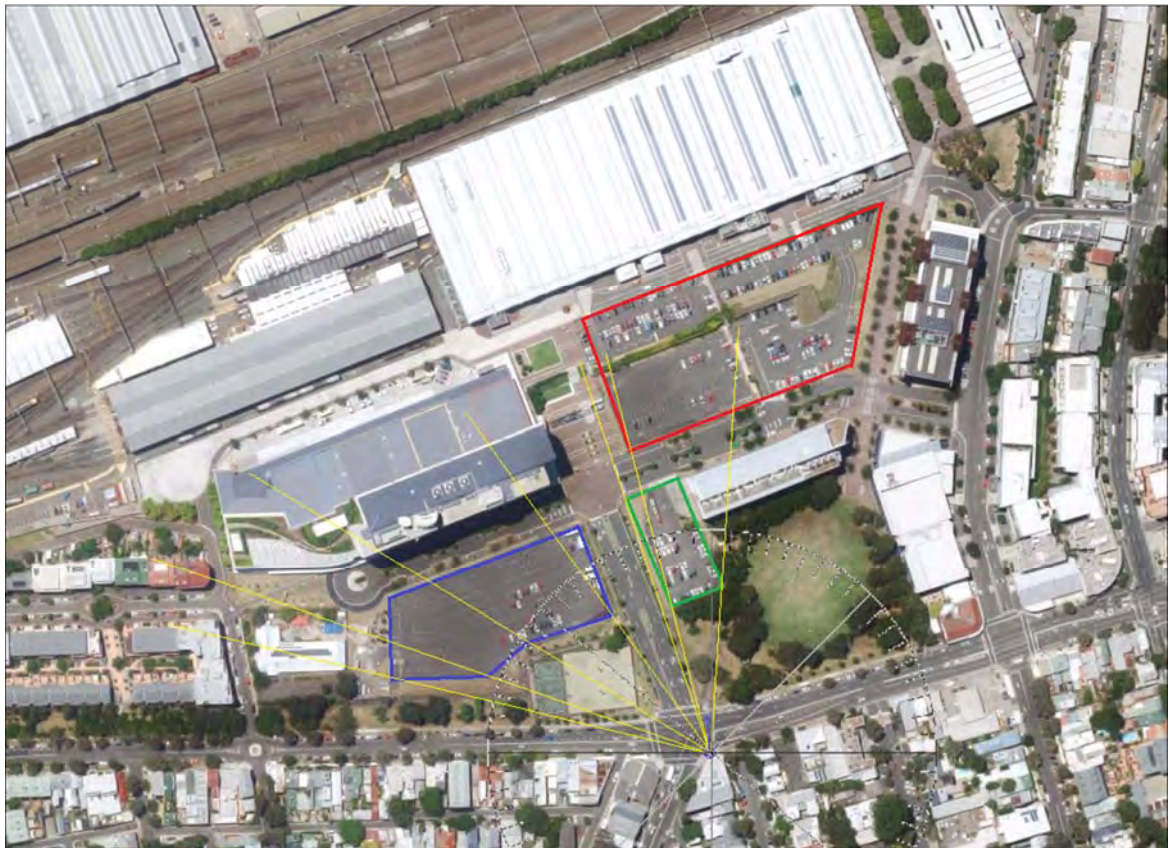
**Figure 57 – Viewpoint C horizontal bearing angles**

On Figure 57 below yellow lines have been drawn to represent the bearing angles to the two visible façade aspects of the building. The blue arrow indicated the direction of travel and viewing.

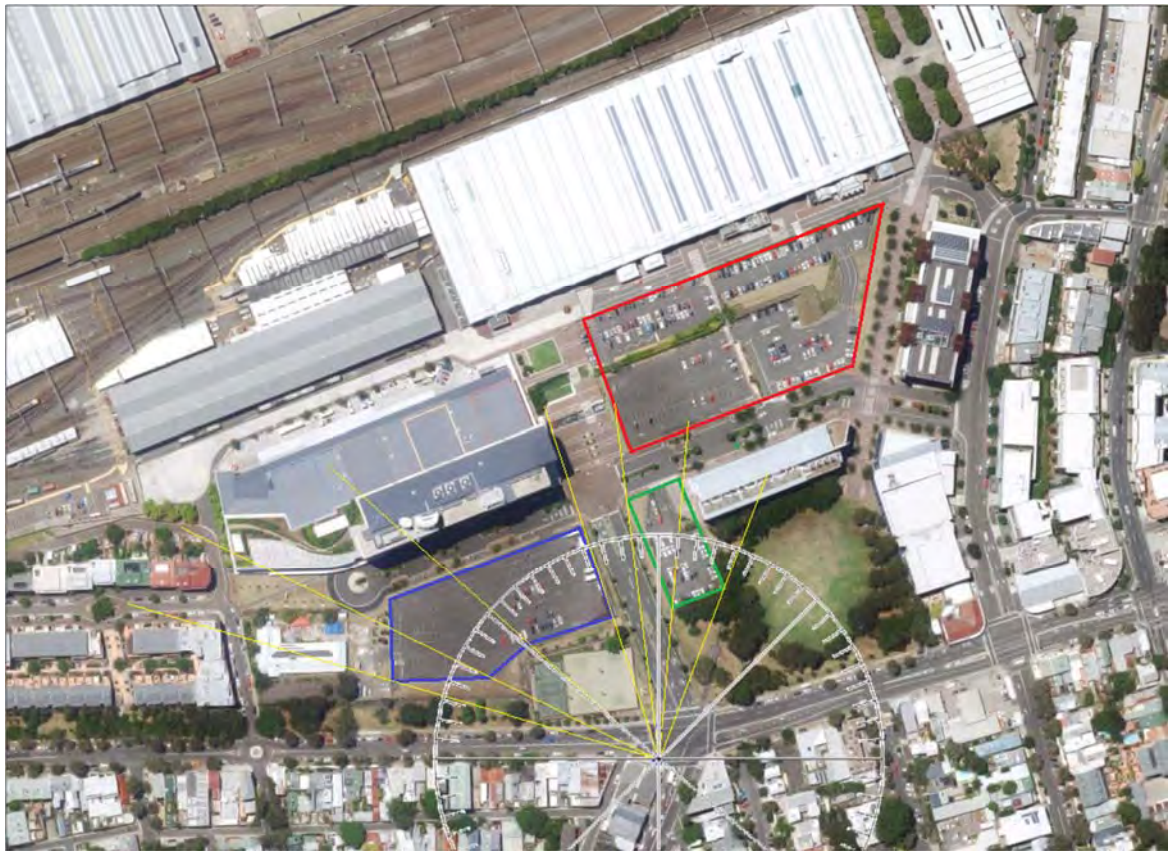
**Figure 63 – Viewpoint 5 horizontal bearing angles**

On Figure 63 below yellow lines have been drawn to represent the bearing angles to the two visible façade aspects of the building. The blue arrow indicated the direction of travel and viewing.

The vertical bearing angles have been calculated for each building that is visible from Viewpoint 5.

$$\begin{aligned}\beta_{\text{Community}} &= \tan^{-1}(16\text{m} \div 70\text{m}) \\ &= 12.9^\circ\end{aligned}$$

$$\begin{aligned}\beta_{\text{Building 1}} &= \tan^{-1}(31.6\text{m} \div 90\text{m}) \\ &= 19.3^\circ\end{aligned}$$

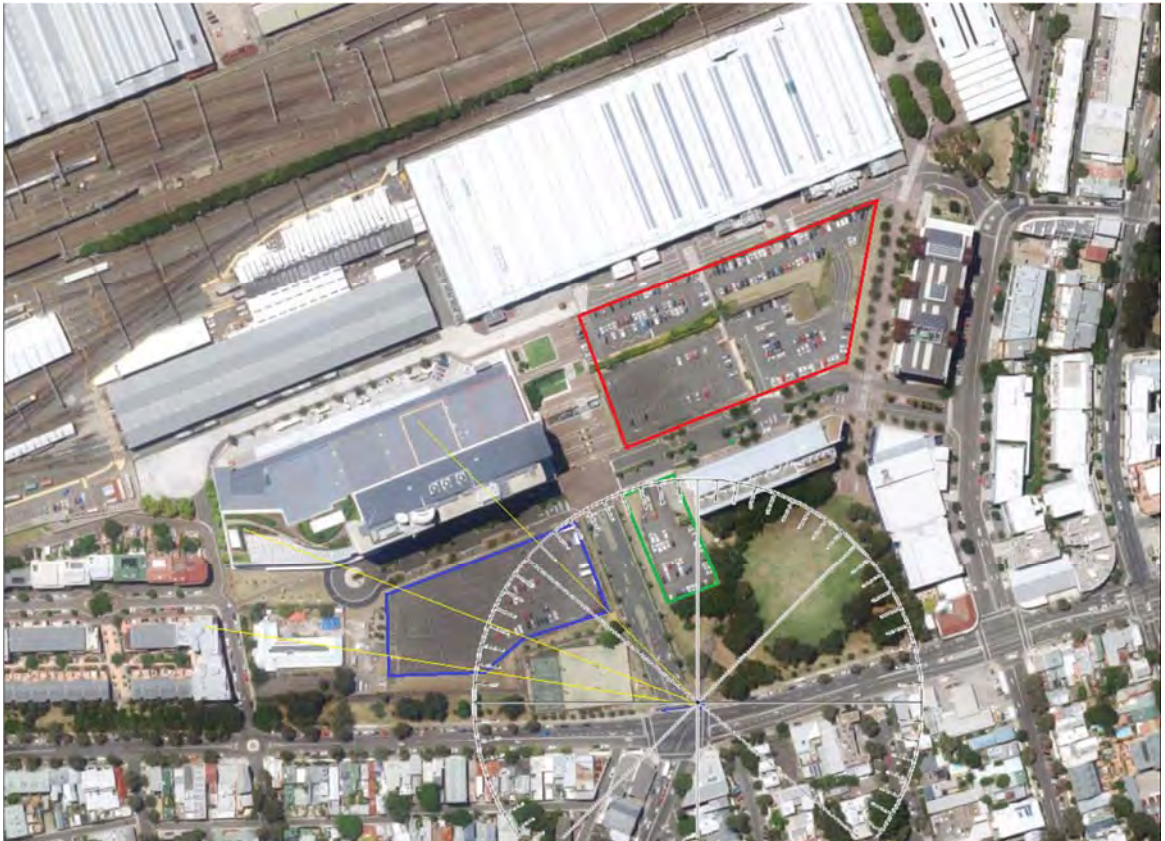
**Figure 69 – Viewpoint E horizontal bearing angles**

On Figure 69 below yellow lines have been drawn to represent the bearing angles to the two visible façade aspects of the building. The blue arrow indicated the direction of travel and viewing.

The vertical bearing angles have been calculated for each building that is visible from Viewpoint 5.

$$\begin{aligned}\beta_{\text{Building 1}} &= \tan^{-1}(31.6\text{m} \div 90\text{m}) \\ &= 19.3^\circ\end{aligned}$$

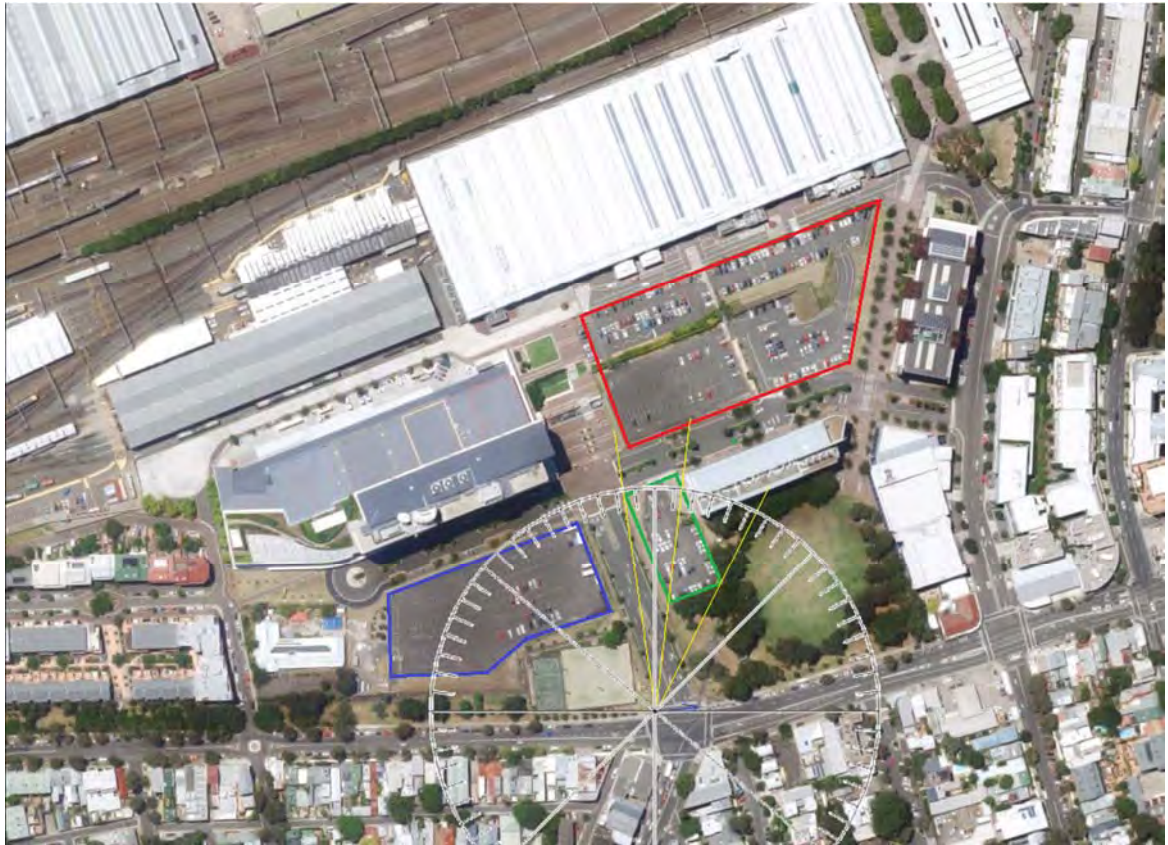
**Figure 72 – Viewpoint 5 horizontal bearing angles**

On Figure 72 below yellow lines have been drawn to represent the bearing angles to the two visible façade aspects of the building. The blue arrow indicated the direction of travel and viewing.

The vertical bearing angles have been calculated for each building that is visible from Viewpoint 5.

$$\begin{aligned}\beta_{\text{Community}} &= \tan^{-1}(16\text{m} \div 70\text{m}) \\ &= 12.9^\circ\end{aligned}$$

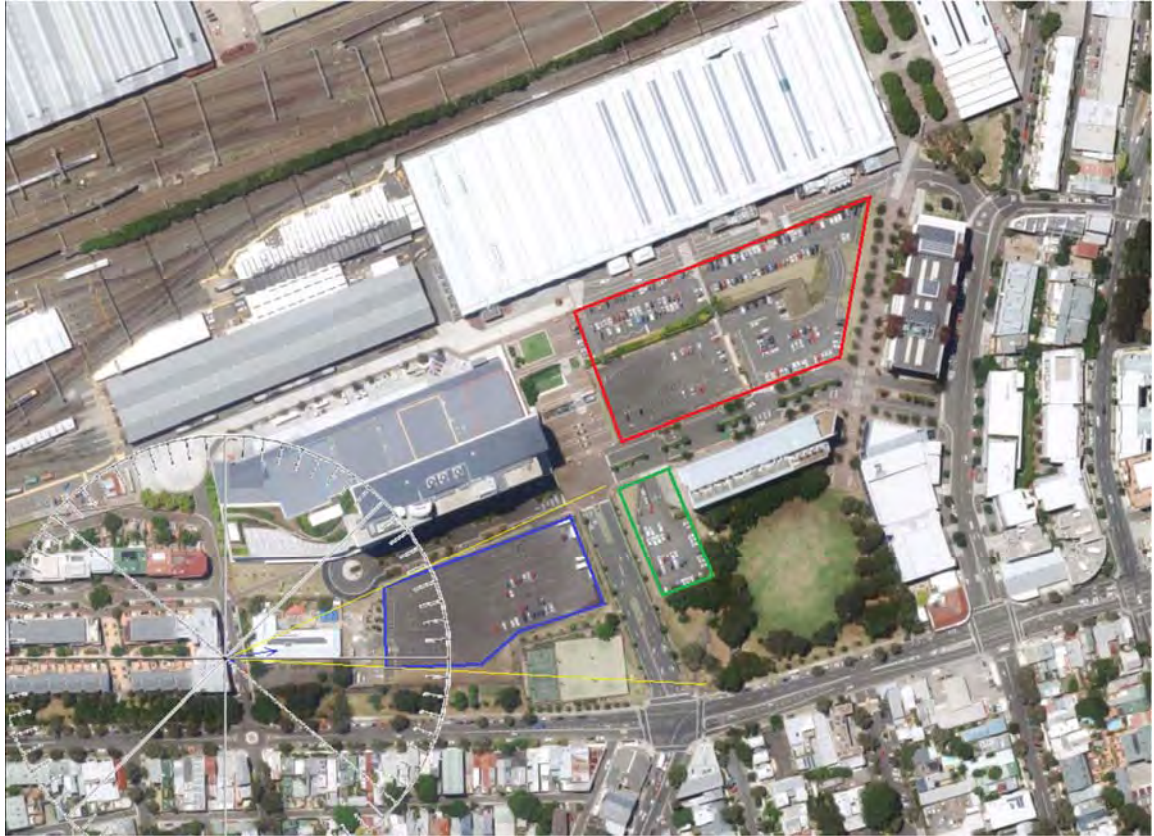
**Figure 75 – Viewpoint G horizontal bearing angles**

On Figure 75 below yellow lines have been drawn to represent the bearing angles to the two visible façade aspects of the building. The blue arrow indicated the direction of travel and viewing.

The vertical bearing angles have been calculated for each building that is visible from Viewpoint 5.

$$\begin{aligned}\beta_{\text{Building 1}} &= \tan^{-1}(31.6\text{m} \div 95\text{m}) \\ &= 18.4^\circ\end{aligned}$$

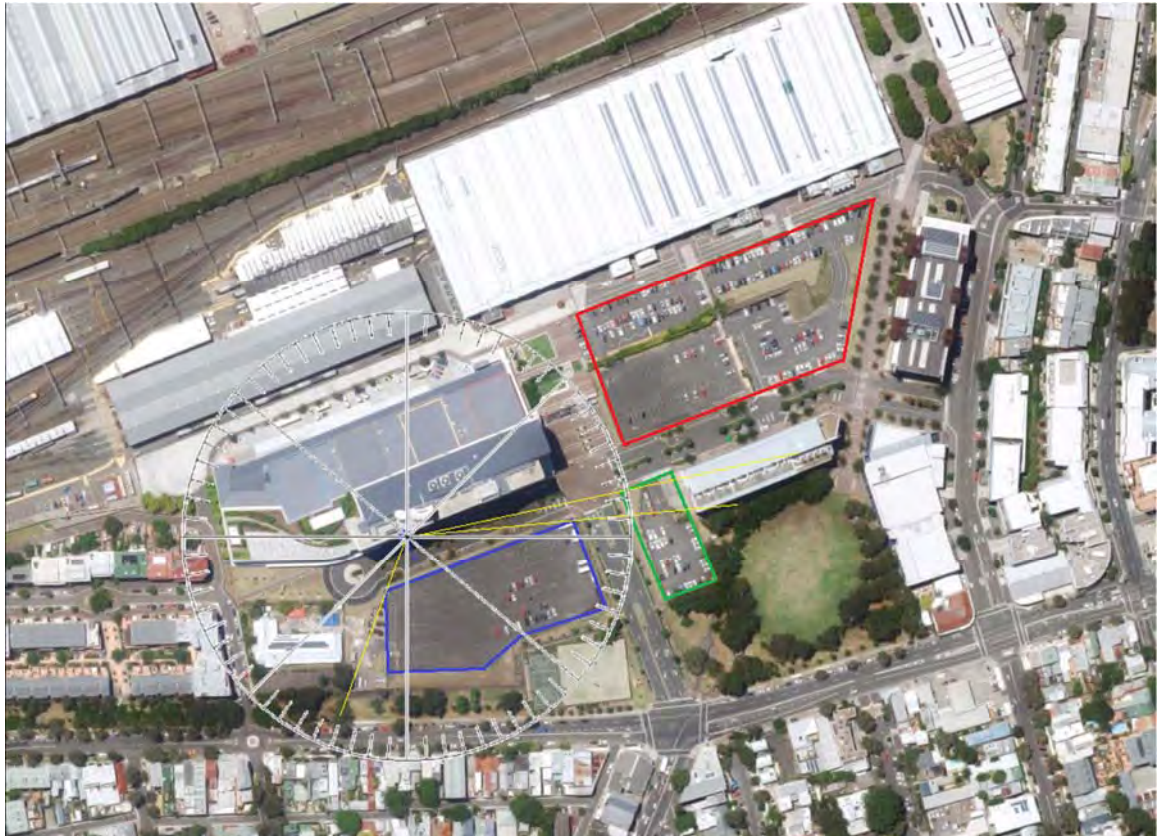
**Figure 77 – Viewpoint H horizontal bearing angles**

On Figure 77 below yellow lines have been drawn to represent the bearing angles to the two visible façade aspects of the building. The blue arrow indicated the direction of travel and viewing.

The vertical bearing angles have been calculated for each building that is visible from Viewpoint H.

$$\begin{aligned}\beta_{\text{Community}} &= \tan^{-1}(16\text{m} \div 130\text{m}) \\ &= 7.0^\circ\end{aligned}$$

$$\begin{aligned}\beta_{\text{Building 1}} &= \tan^{-1}(31.6\text{m} \div 28\text{m}) \\ &= 48.5^\circ\end{aligned}$$
