## **Reflectivity Report**

**ATP**

**Mirvac**

**Prepared for**  
Mirvac

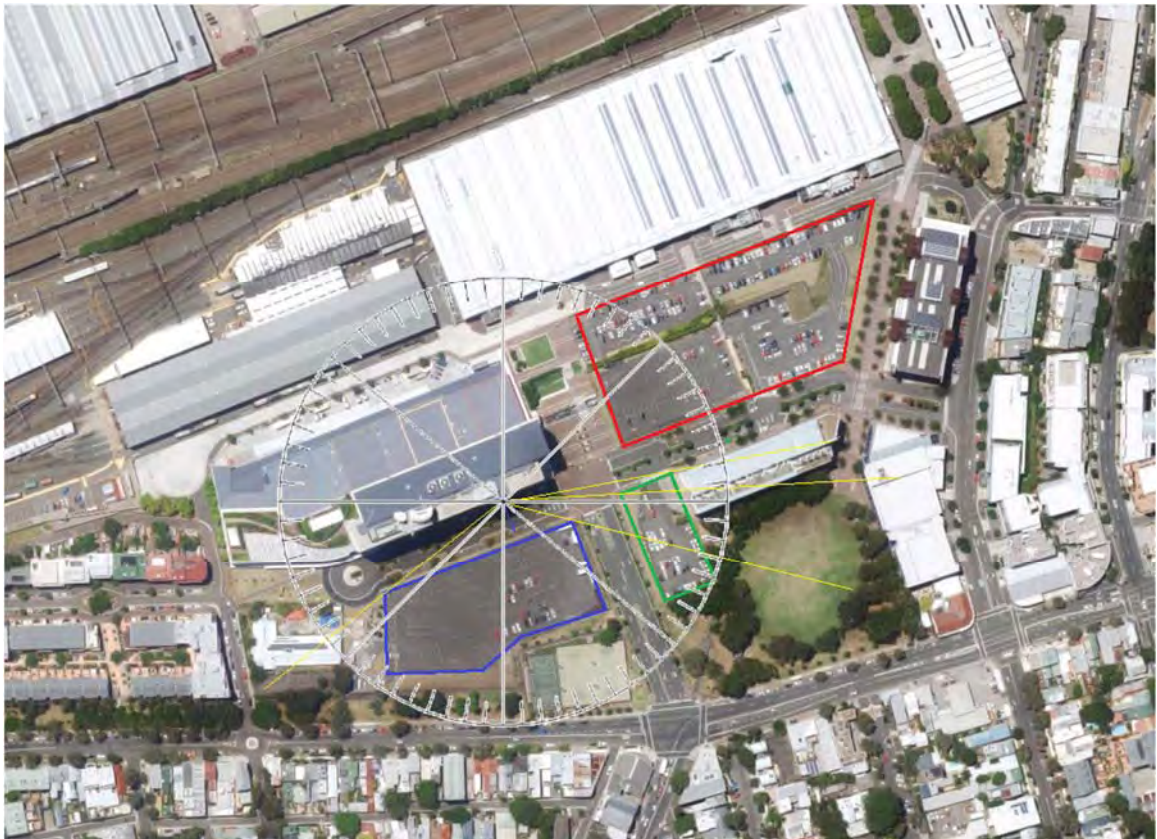
**Figure 80 – Viewpoint 5 horizontal bearing angles**

Viewpoint I has been taken at a distance of 20m perpendicular to Façade Aspect 342 of Building 1. On below below yellow lines have been drawn to represent the bearing angles to the two visible façade aspects of the building. The blue arrow indicated the direction of travel and viewing.

The vertical bearing angles have been calculated for each building that is visible from Viewpoint 5.

$$\begin{aligned}\beta_{\text{Community}} &= \tan^{-1}(16\text{m} \div 70\text{m}) \\ &= 12.9^\circ\end{aligned}$$

$$\begin{aligned}\beta_{\text{Building 1}} &= \tan^{-1}(31.6\text{m} \div 20\text{m}) \\ &= 57.7^\circ\end{aligned}$$

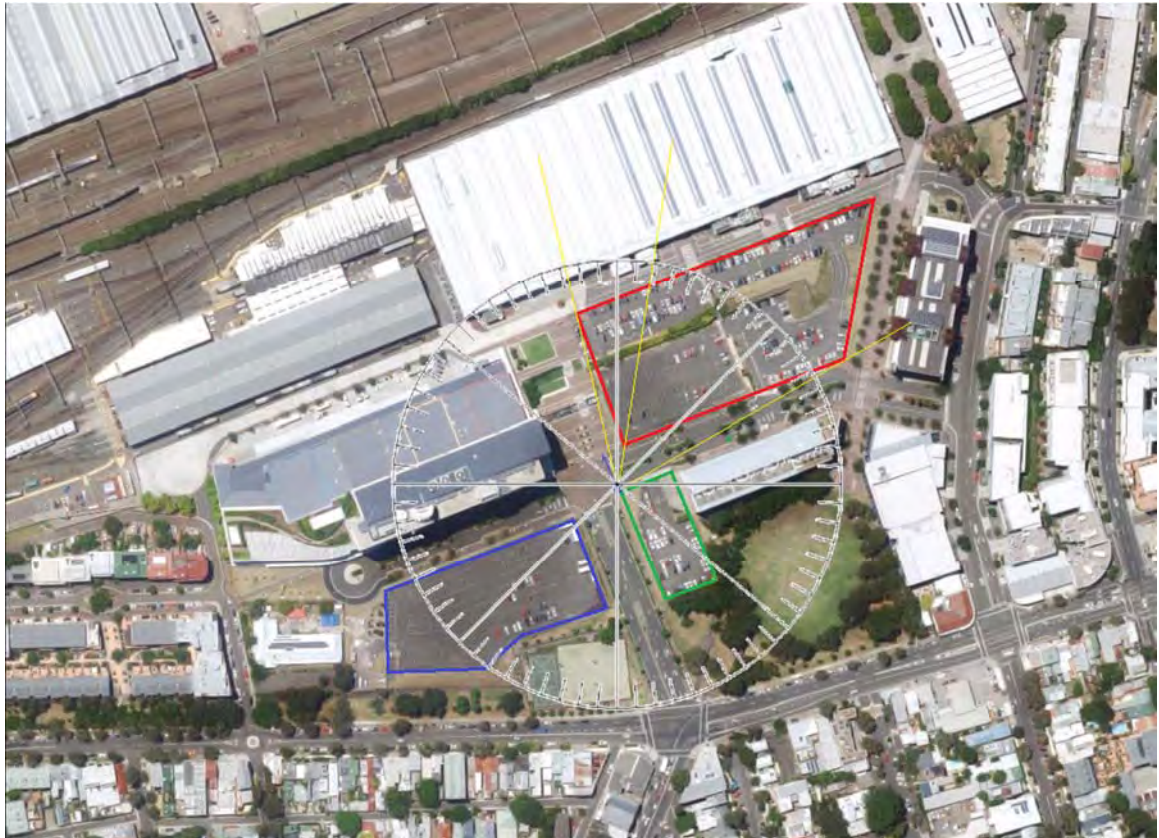
**Figure 83 – Viewpoint 5 horizontal bearing angles**

On Figure 83 below yellow lines have been drawn to represent the bearing angles to the two visible façade aspects of the building. The blue arrow indicated the direction of travel and viewing.

The vertical bearing angles have been calculated for each building that is visible from Viewpoint 5.

$$\begin{aligned}\beta_{\text{Building 2}} &= \tan^{-1}(33.7\text{m} \div 27\text{m}) \\ &= 51.3^\circ\end{aligned}$$

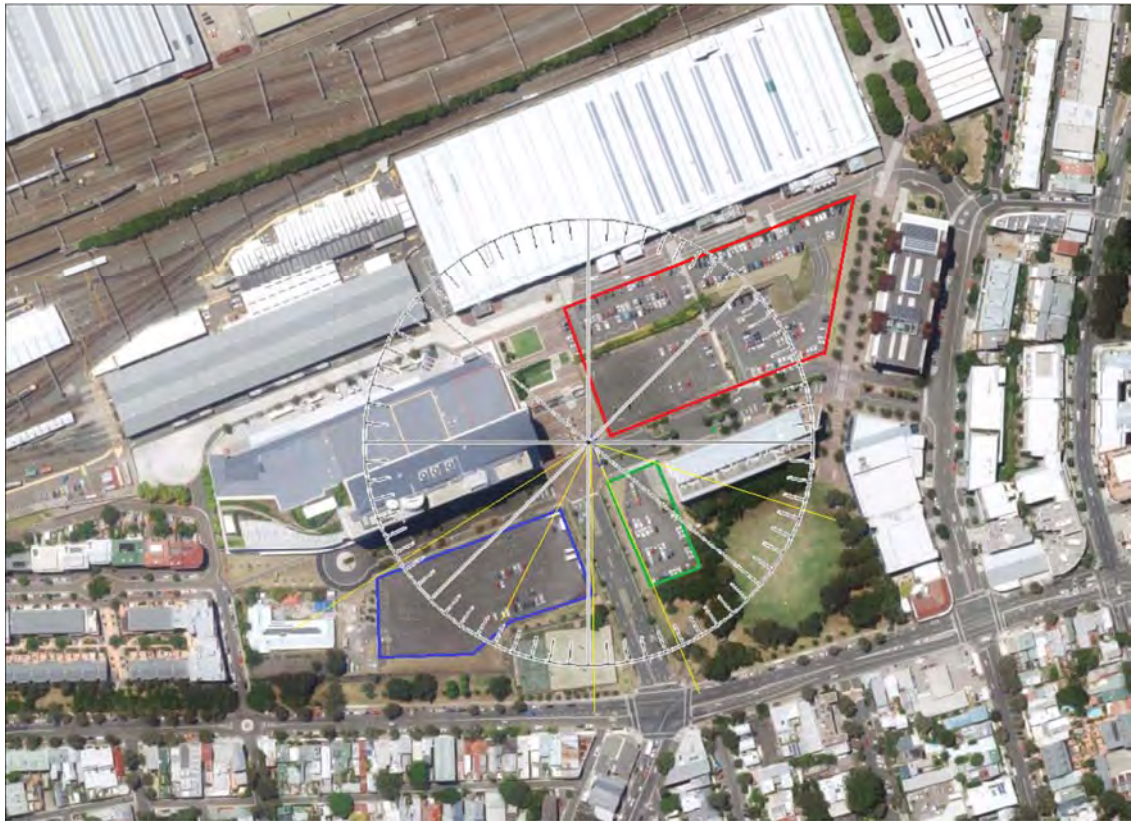
**Figure 86 – Viewpoint 5 horizontal bearing angles**

On Figure 86 below yellow lines have been drawn to represent the bearing angles to the two visible façade aspects of the building. The blue arrow indicated the direction of travel and viewing.

The vertical bearing angles have been calculated for each building that is visible from Viewpoint 5.

$$\begin{aligned}\beta_{\text{Community}} &= \tan^{-1}(16\text{m} \div 28\text{m}) \\ &= 29.7^\circ\end{aligned}$$

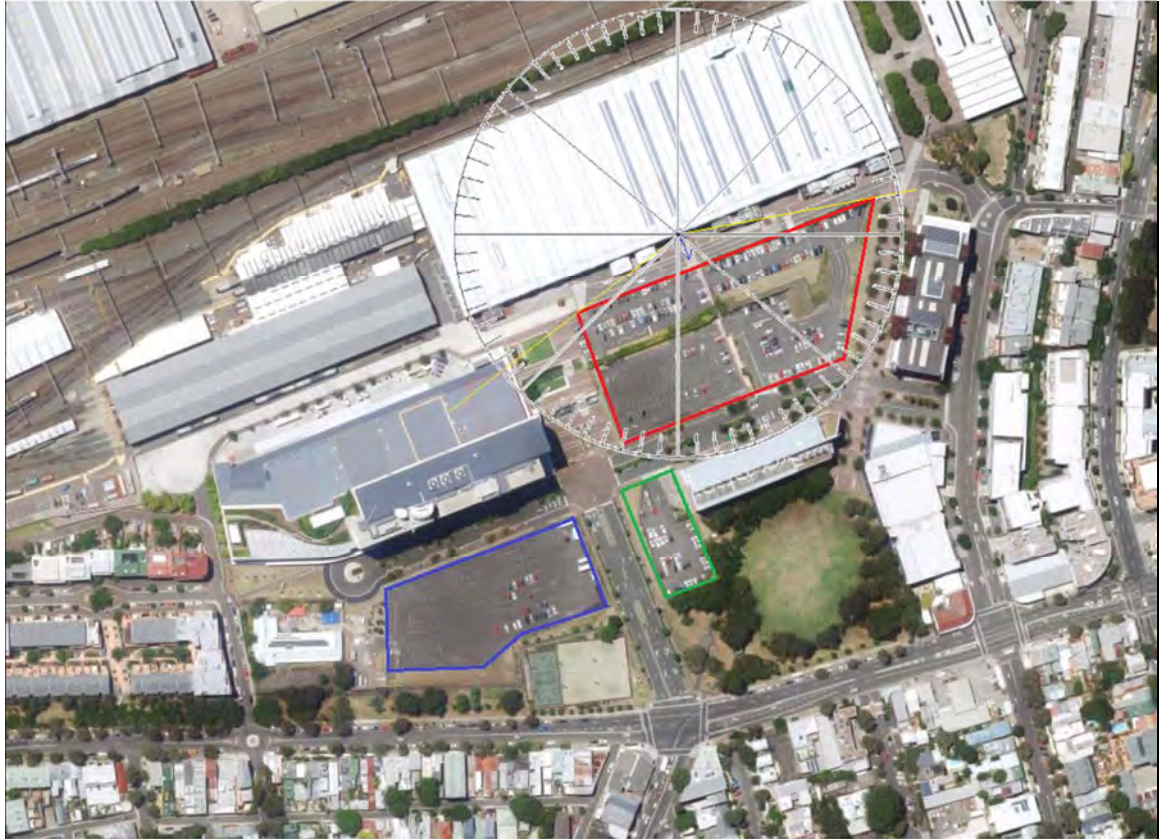
**Figure 89 – Viewpoint 5 horizontal bearing angles**

On Figure 89 below yellow lines have been drawn to represent the bearing angles to the two visible façade aspects of the building. The blue arrow indicated the direction of travel and viewing.

The vertical bearing angles have been calculated for each building that is visible from Viewpoint 5.

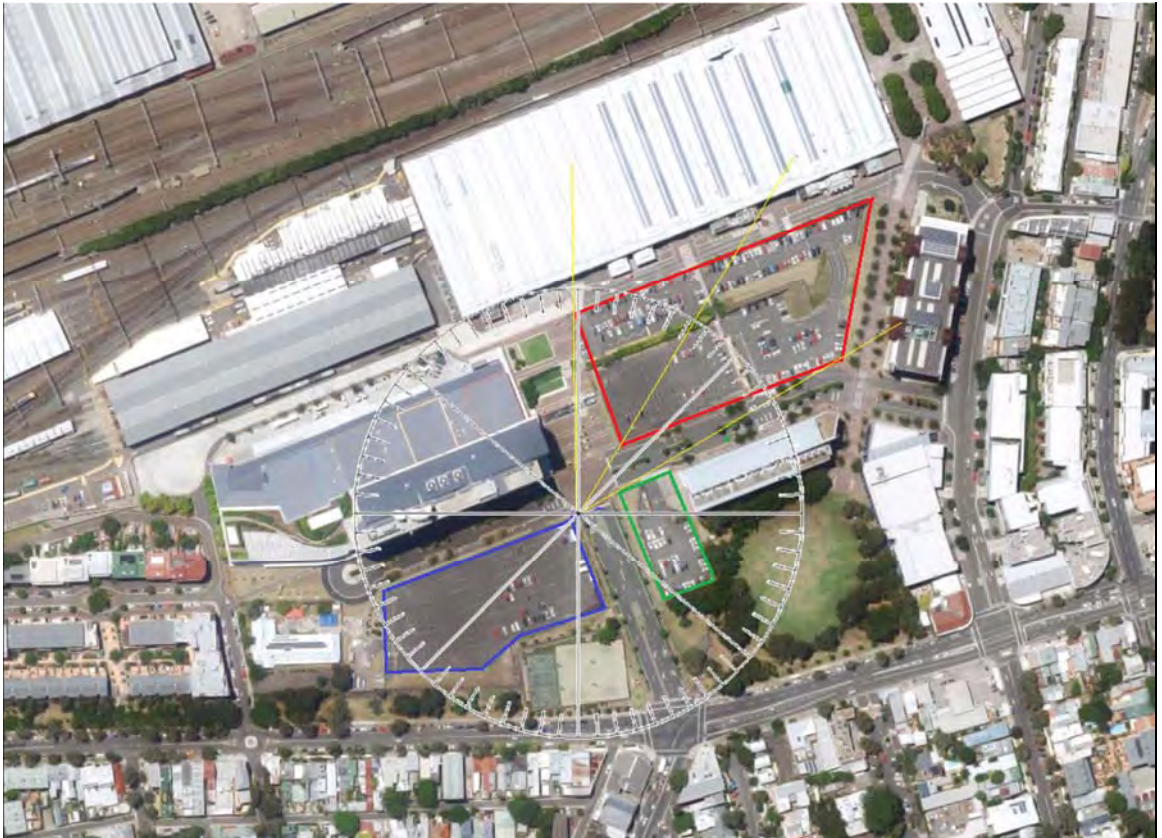
**Figure 91 – Viewpoint 5 horizontal bearing angles**

On Figure 91 below yellow lines have been drawn to represent the bearing angles to the two visible façade aspects of the building. The blue arrow indicated the direction of travel and viewing.

The vertical bearing angles have been calculated for each building that is visible from Viewpoint 5.
