Riverside Theatre Redevelopment – Structural Design Statement for SSDA

NCC Compliance Approach – Structure

Purpose of this Report

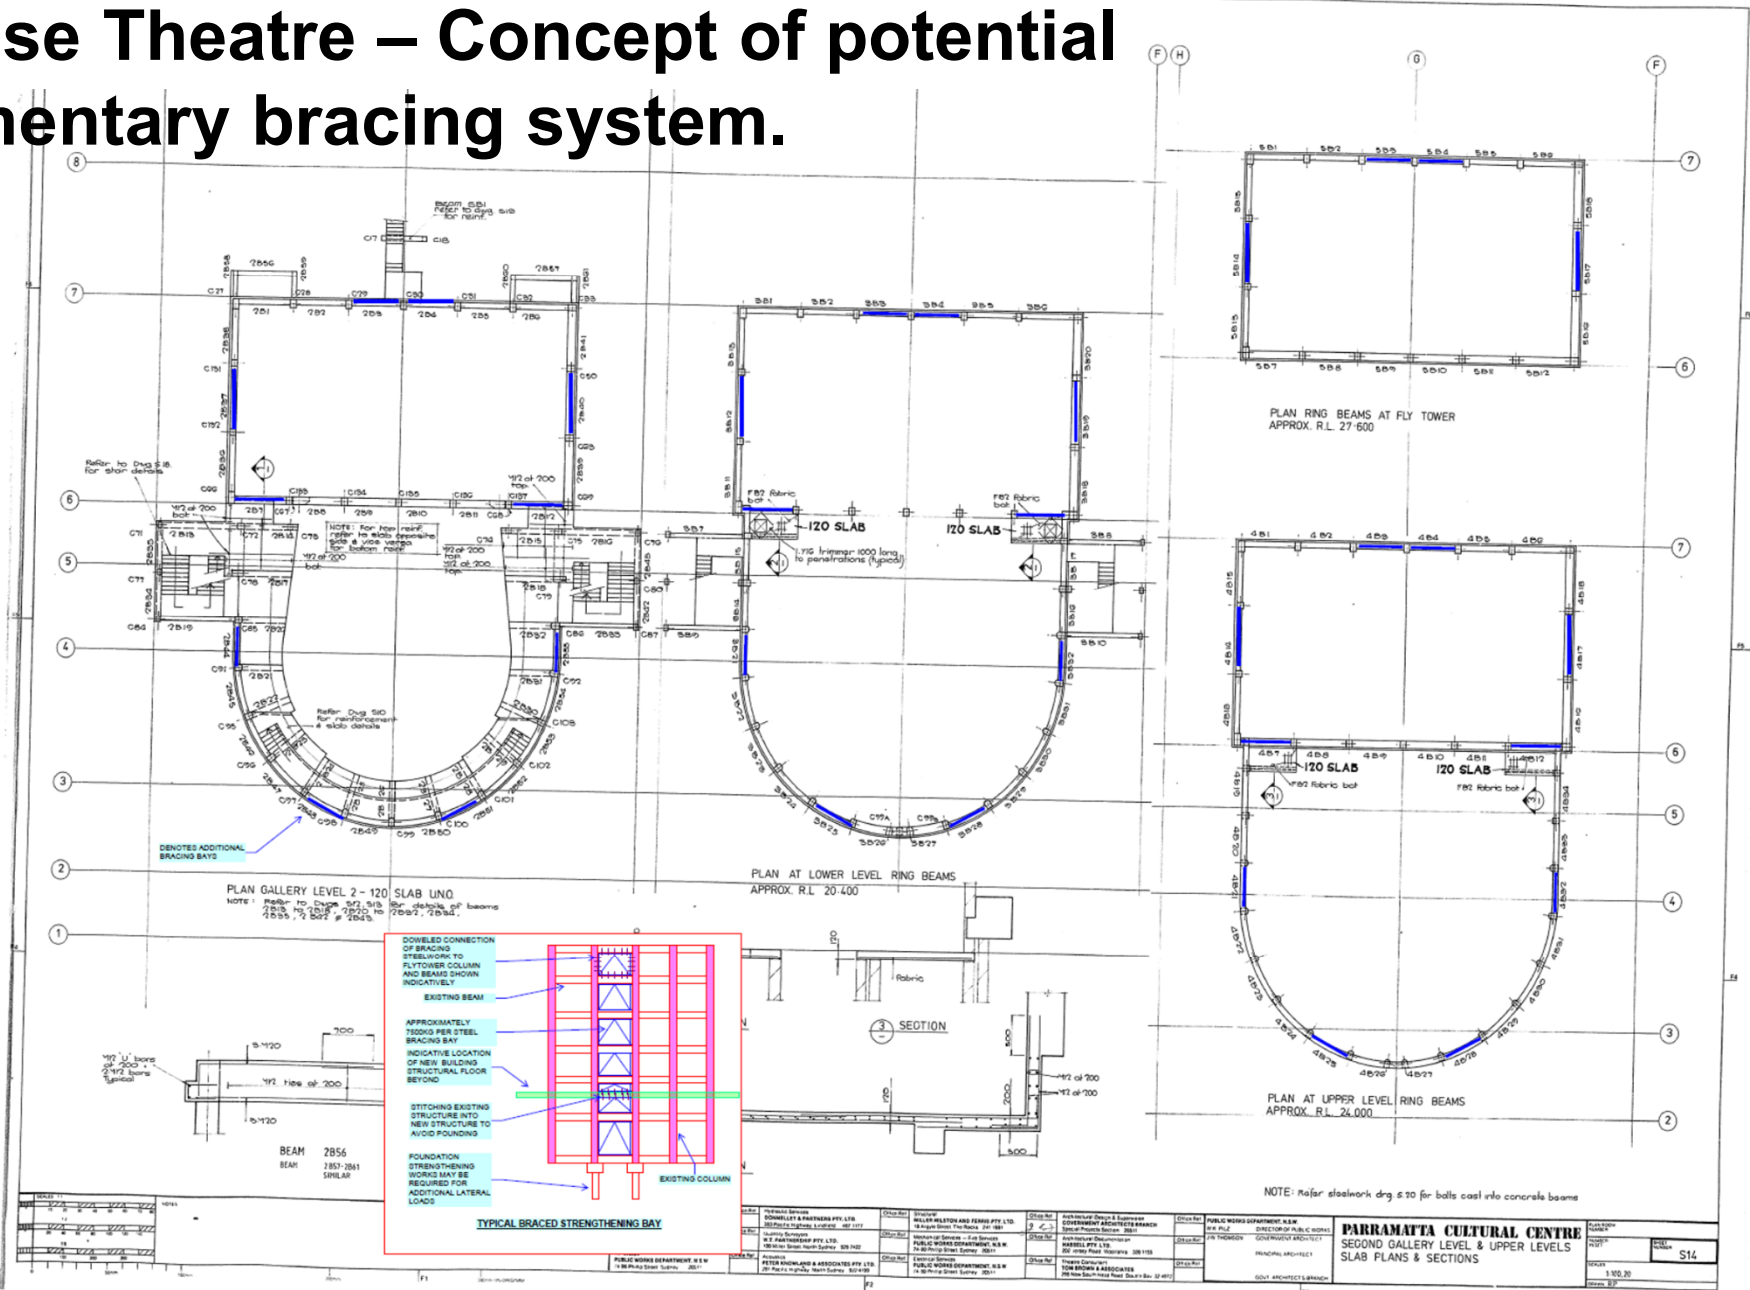
Playhouse Theatre – Concept of potential supplementary bracing system.

The new bracing will be tied into the new building structure and its stability system. This approach maintains the project design intent to retain the existing playhouse theatre. A concept sketch indicating a potential bracing system is shown on the following page.
