# Demolition

## Heritage lanterns

SP-AR-E-MAKE-SK0114 [A]

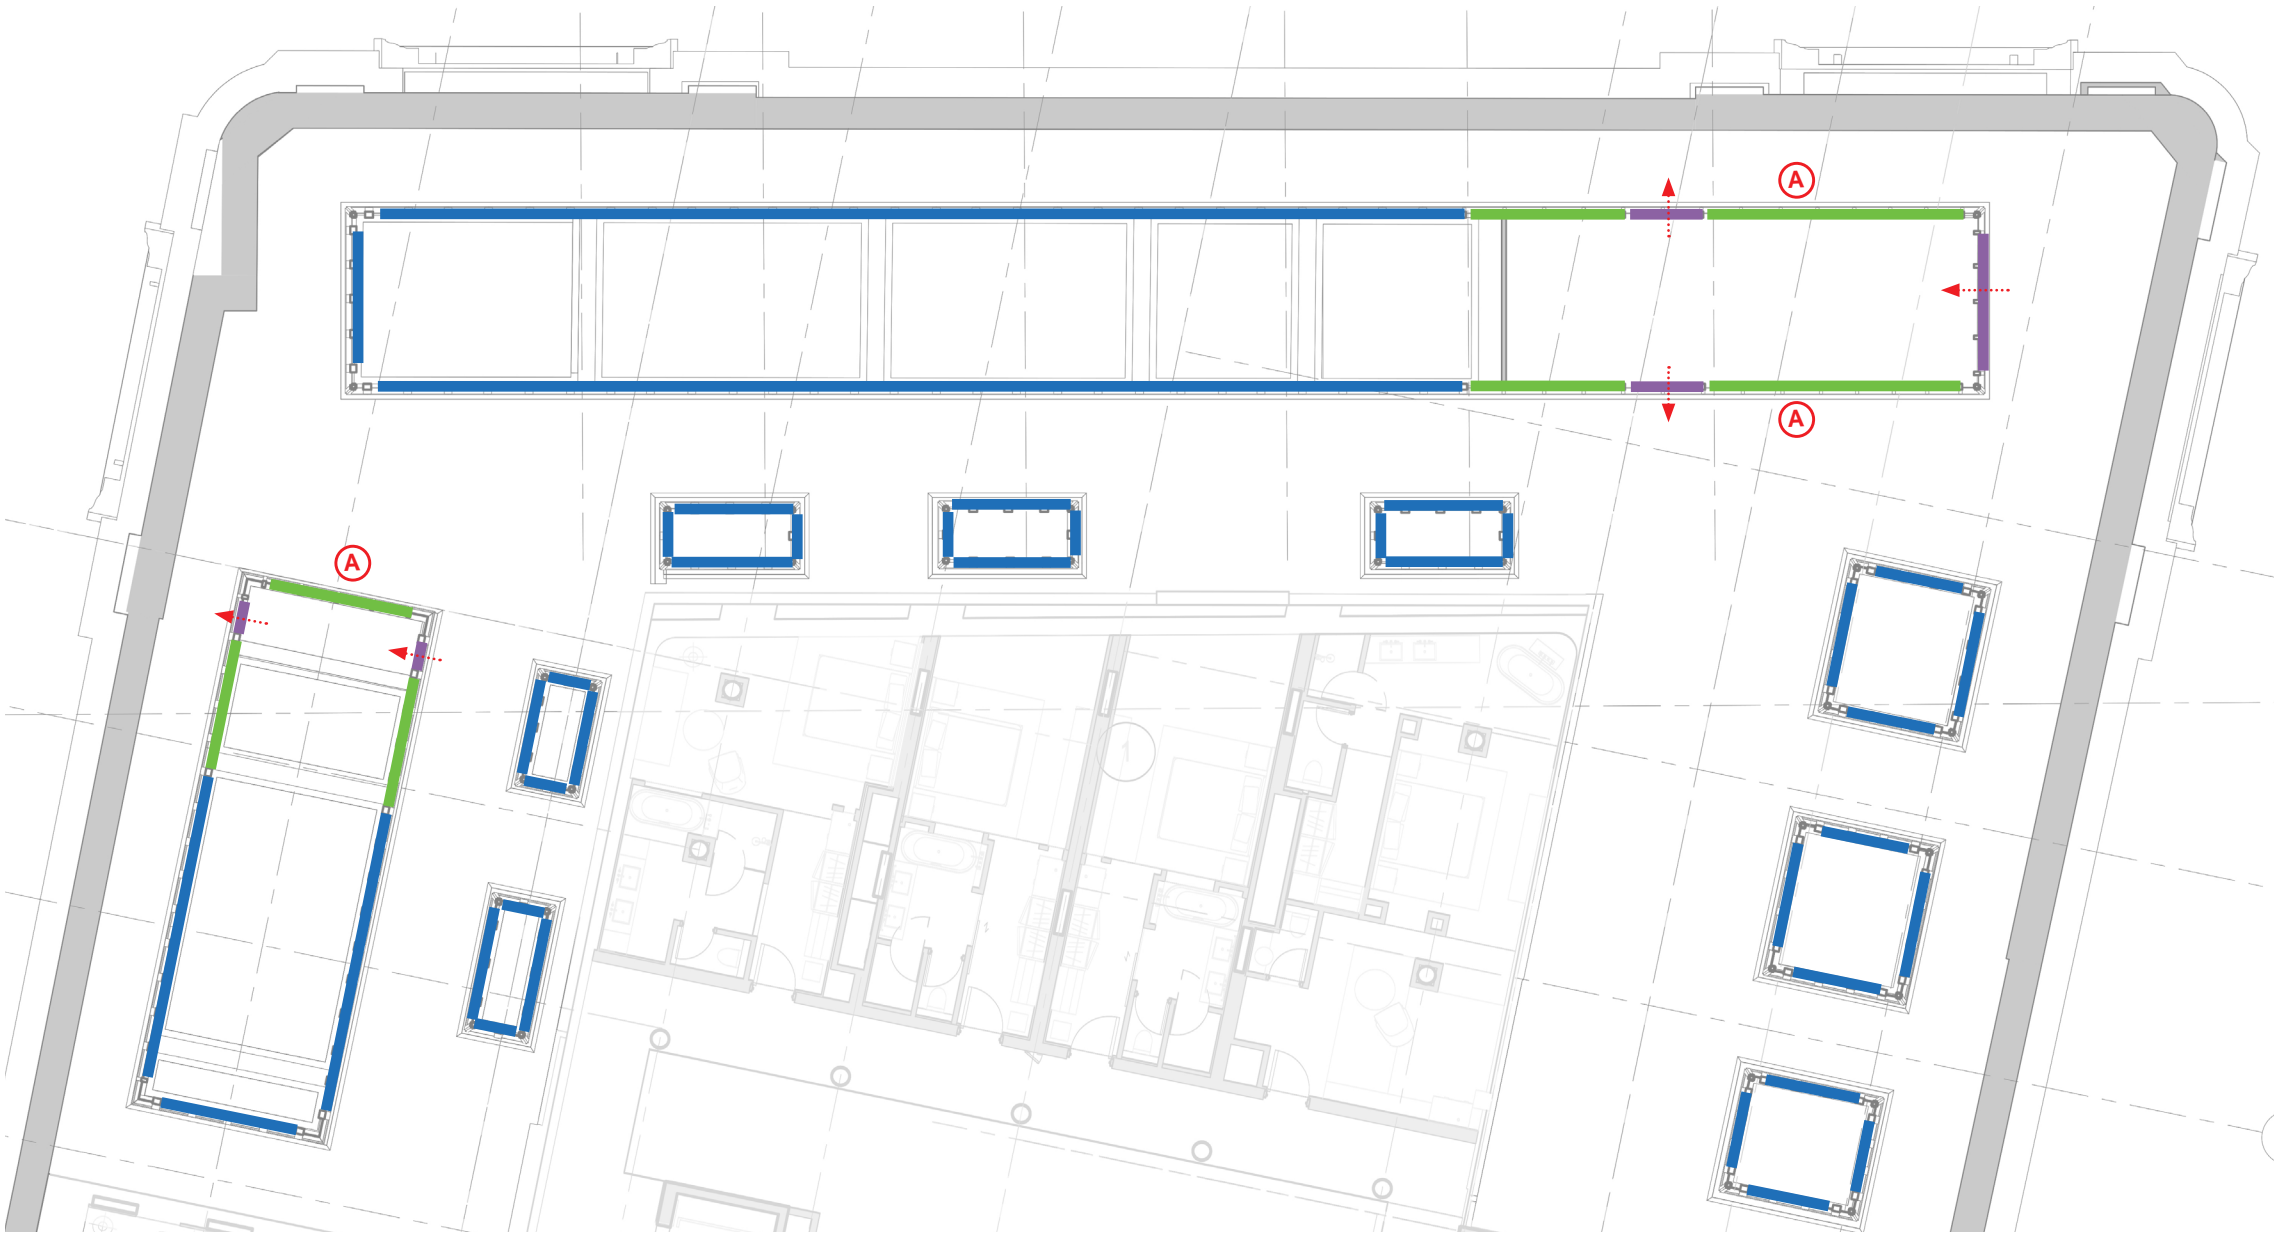
SP-AR-E-MAKE-SK0115 [A]

- TTW Façades’ recommendation is to install DGUs to all roof lanterns (Gym, pool and spa). Refer to Aconex correspondence TTWNSW-GCOR-000713 and TTWNSW-ADVICE-000185
- TTW Façades have advised the gym and spa areas should not have the same humidity as the pool so the risk of condensation on the glazing is reduced but not totally eliminated. TTW recommend the use of the same glazing and details for these areas as the pool.

- Proposed timber framed DGU's to replace existing (fixed glazing). Angle of window to match existing. Refer to next pages for more detail.
- Proposed location of timber infill panels to match existing. Angle of new panel to match existing. Built/ TTW façades to further advise on condition of existing and whether replacement is required
- Proposed location of timber louvred panels to accommodate mechanical requirements. Louvred panels to match existing. Angle of new panel to match existing
- Ⓐ Proposed location of access panels to provide access to mechanical plant room. Refer to proposed lantern elevations for more detail
- ◀ Outside air intake or exhaust air extract

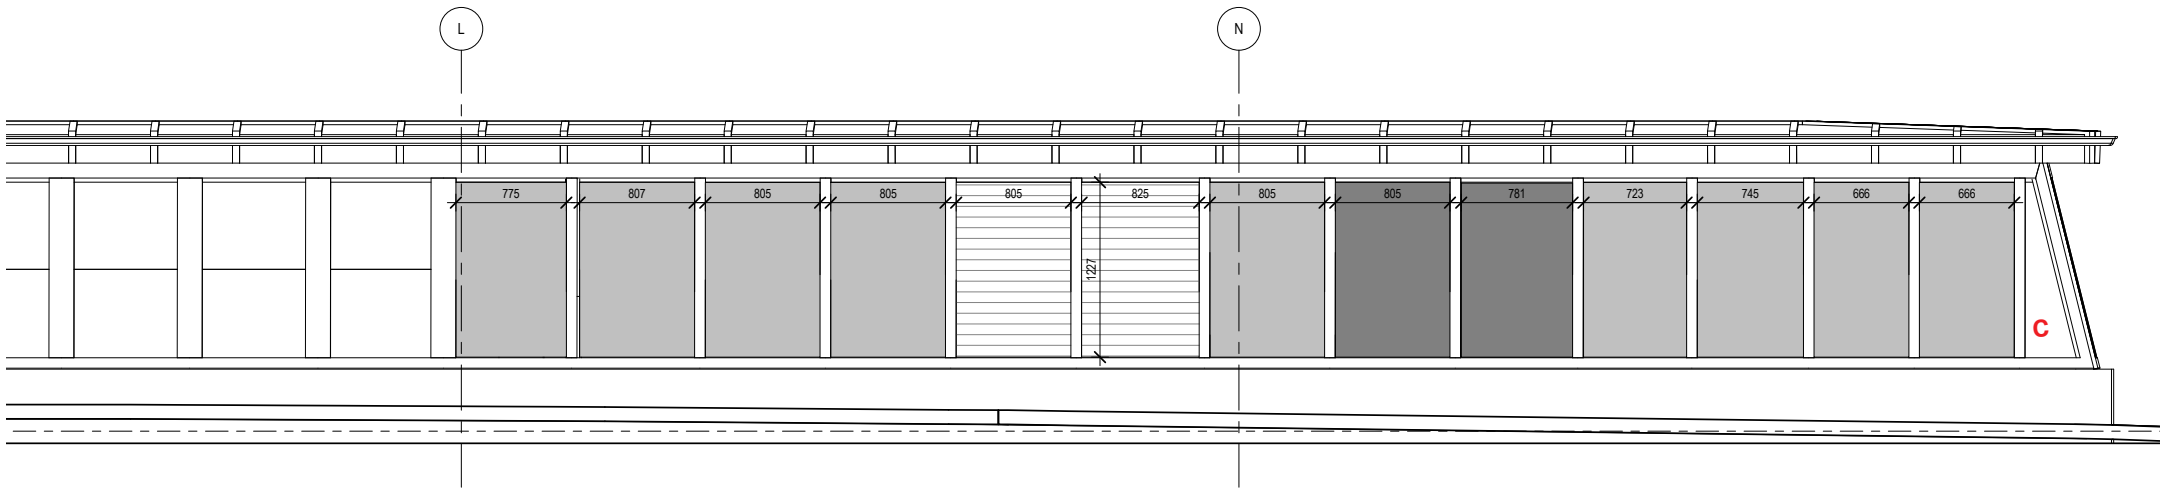
- Notes
- Proposed location of timber infill panels to match existing. Angle of new panel to match existing. Built/ TTW façades to further advise on condition of existing and whether replacement is required
  - Proposed location of timber louvred panels to accommodate mechanical requirements. Louvred panels to match existing. Angle of new panel to match existing
  - Proposed location of access panels to provide access to mechanical plant room. Refer to proposed lantern elevations for more detail. Final door hardware to be discreet and submitted to Make and Urbis for approval
  - Proposed timber framed DGU's to replace existing (fixed glazing)
  - C

**Pool lantern: South elevation**  
Backgrounds taken from Ridley revit model

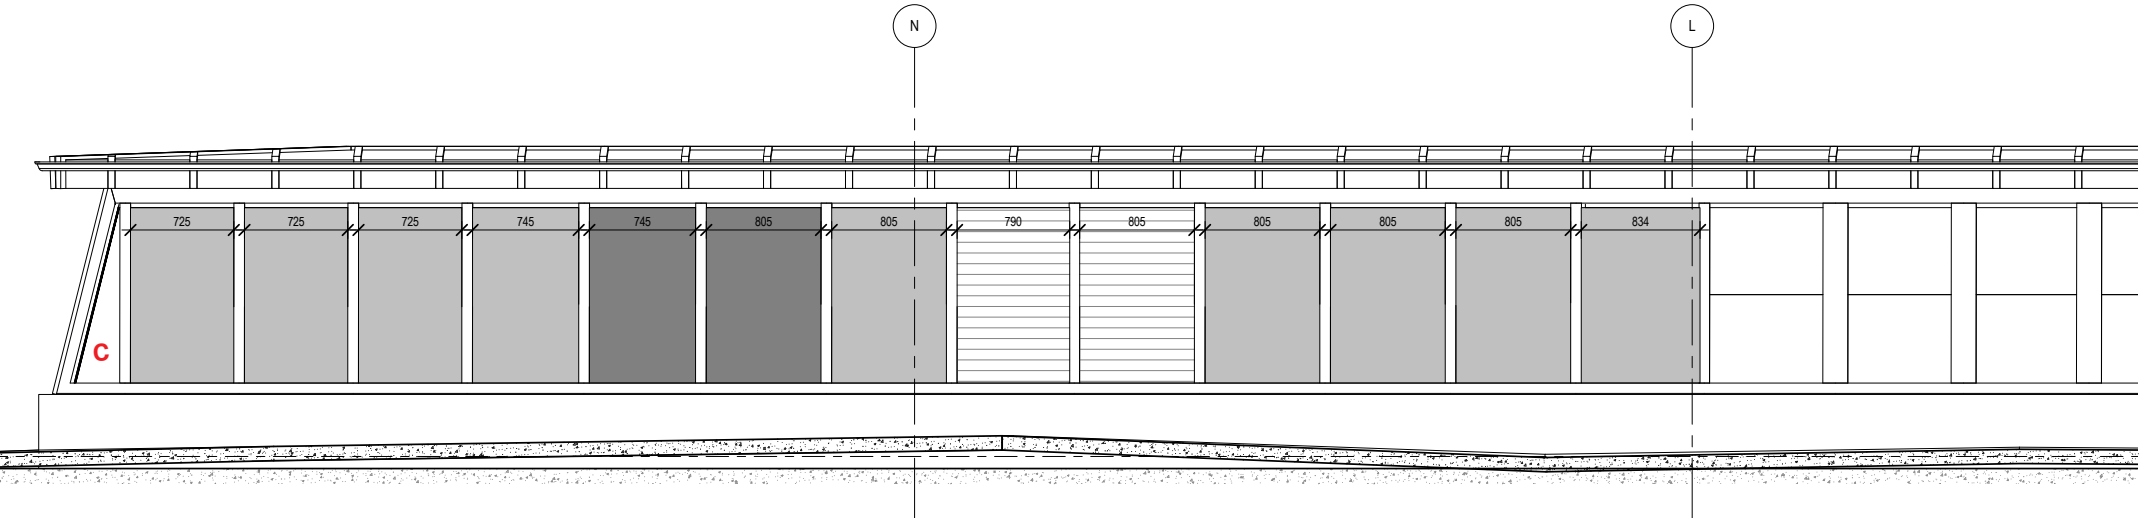
**Pool lantern: North elevation**  
Backgrounds taken from Ridley revit model

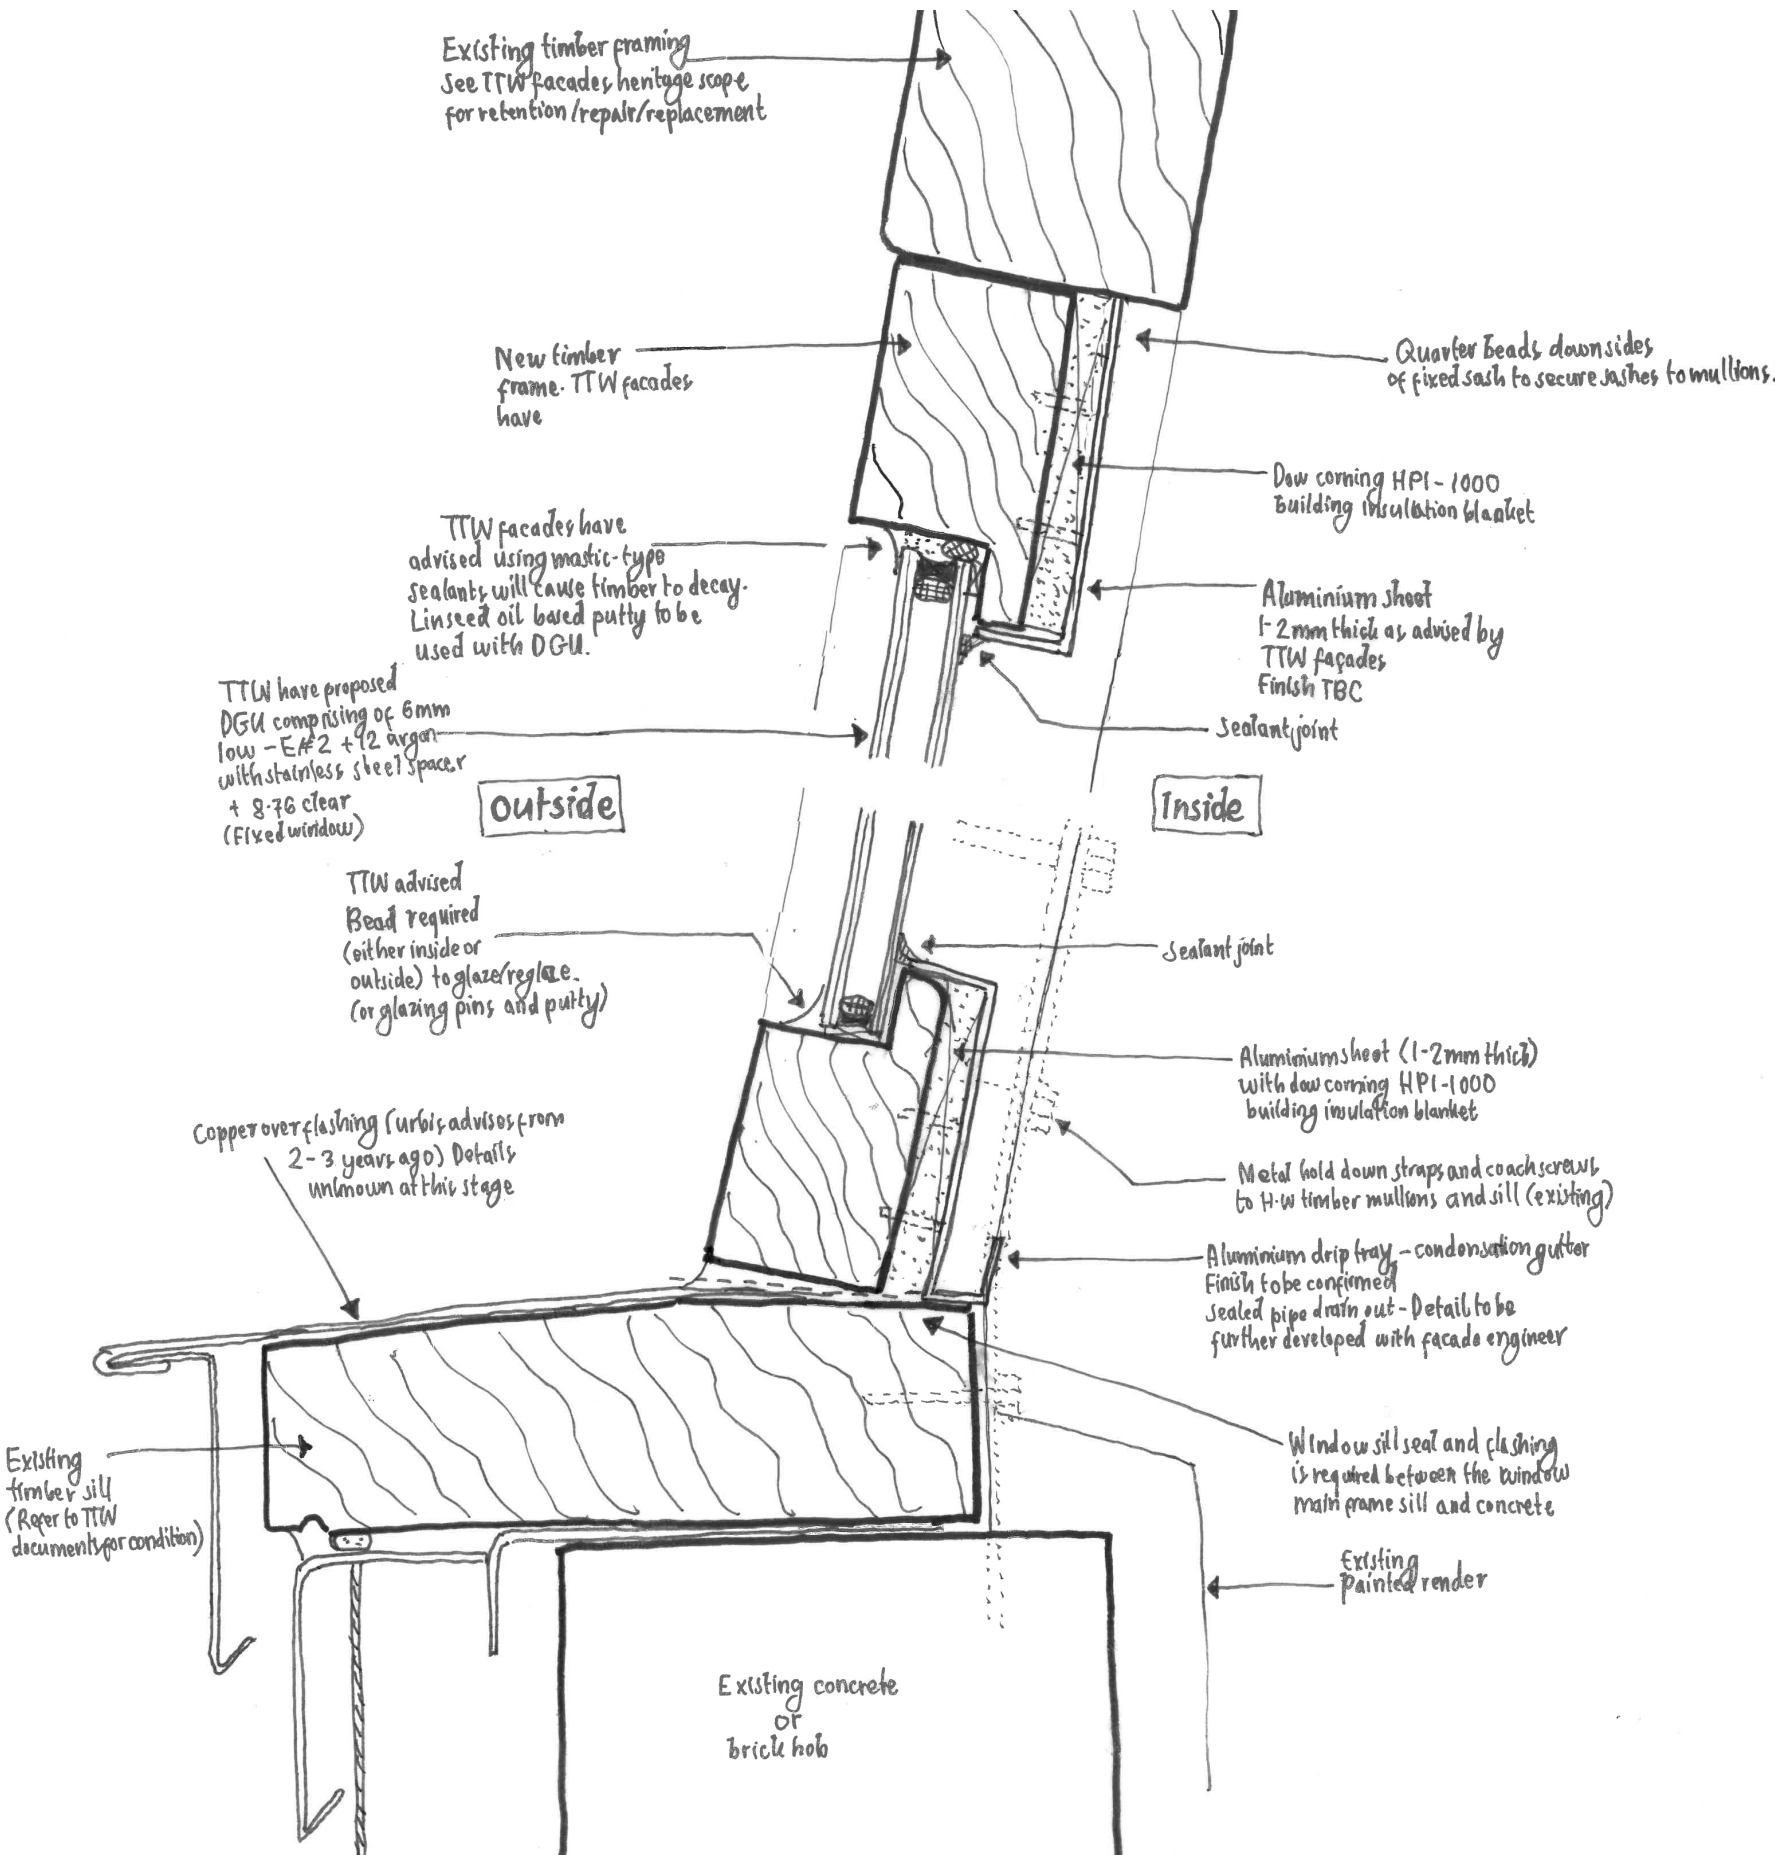
SP-AR-E-MAKE-SK0118 [A]

Work in progress detail coordinated with TTW façades, Built. Refer to Aconex mail correspondence MKRD-MM-000031. Detail of condensation gutter, sealed pipe drain out and waterproofing to be further developed with facade engineer.

- TTW have recommended new DGU's to replace the existing pool windows due to the high humidity of the pool space below. Warm air is also provided by the mechanical systems to this glazing.

- TTW advised that the risk of condensation is mainly from midnight to 6am when temperatures are at their minimum (and mechanical systems are throttled back to save energy potentially resulting in lower internal and higher dew point temperatures). The proposed drip trays will catch any condensation running down the glass and divert it outside.

- TTW have advised that an aluminium sheet is required to cover the top and bottom section of each glazing panel. The high conductivity of the aluminium will allow heat to transfer from the metal to the glass, reducing the condensation risk.

- The DGU keeps the external cold outside, and the aluminium attracts heat from the internal environment.
- The gym and spa areas should not have the same humidity as the pool so the risk of condensation on the glazing is reduced but not totally eliminated. It will not be necessary to provide heating to the glazing as per the pool.

- TTW have advised Timber inspections Report 1127-Nov-18 states that the original frames are western red cedar.
- TTW recommend that for durability, availability and heritage reasons, that western red cedar be used again for the new frames
- Western red cedar is corrosive to copper to a degree (corrodes out copper nails), therefore new timber should be primed as a minimum before installation, to isolate timber from copper sills

- The existing metal ties could be retained, however it may be difficult to paint without removing it entirely (including the turn-buckles). TTW to advise on the appropriate strategy if these are removed and replaced with new ties, or kept in place and carefully upgraded.

- New windows are not operable
- TTW and Built advised maintenance could be done from below, using a long pole from within the pool or surrounding edges, and that this is common practice in Australia.
