international  
**conservation**  
services

# Plaster Cornice Removal Methodology

Former Department of Lands Building  
22-23 Bridge Street, Sydney

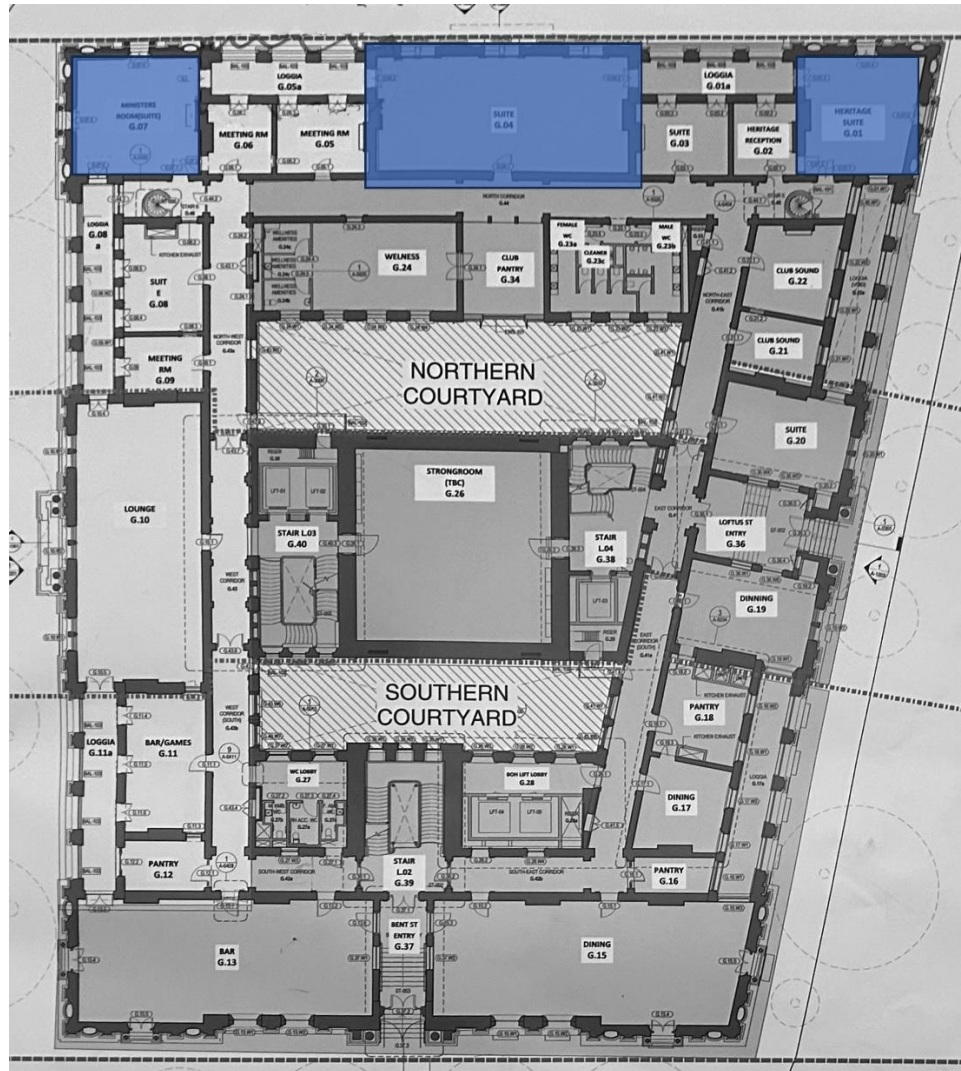
Figure 1: Ground floor plan denoting G.01, 04 and 07

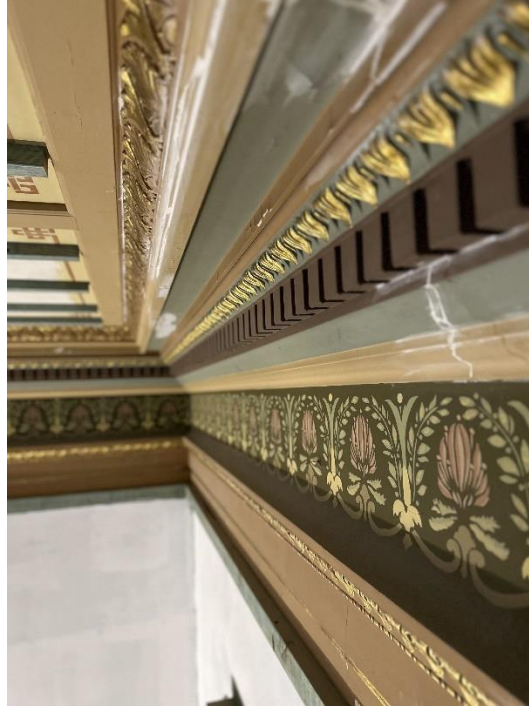
Plate 1: Detailed image of the ornate plaster cornice and string moulding in G.07

The elaborate plaster and lath cornice was constructed using a combination of insitu 'run' sections of plasterwork that would have involved using a sliding form to create an extruded shape using wet plaster. Due to the height and depth of the cornice this would have been undertaken in up to three separate 'runs' to create the final profile.

The 'run' sections of the cornice were then embellished with the addition of cast decorative plaster elements.

The structure of the cornice is founded on timber brackets that were fixed perpendicular to the wall or beam at approximately 350-450mm centres. The brackets were fixed laterally to timber plugs that were set into the walls and to the underside of the timber ceiling joists. Split timber laths were then fixed to the leading edge of the brackets to provide the support for the run sections of the plaster cornice.

Below the cornice is a separate plaster string moulding that would have been run insitu.
