## 6 Results – Masterplan

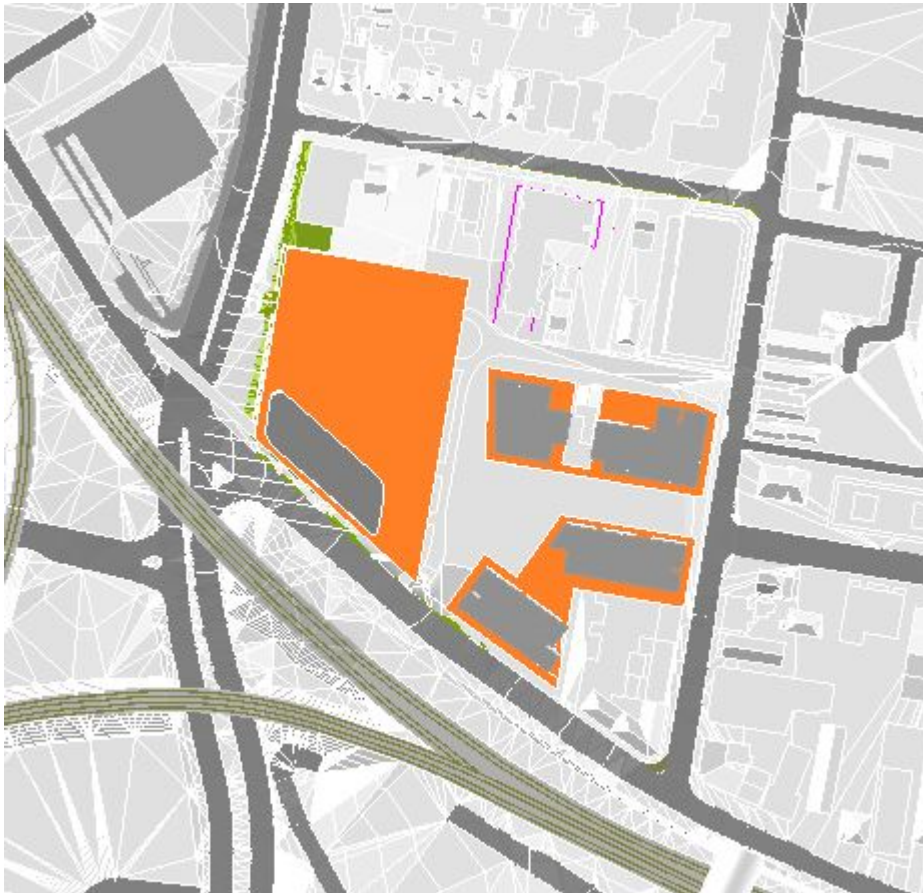
The assessment was also carried out with the new masterplan buildings as shown below to highlight any impacts on the proposed club design in the future and to highlight critical wind issues to be addressed in the future. Please note the images have been taken 2m above the entrance level and it has not been updated to reflect the latest club design.
