## Dilapidation Report - 2-4 Larkin Street & 1,3,5 Pockley Avenue, Roseville

### **PROJECT NUMBER. V260255**

Reference: V260255\_A - Dilapidation Report

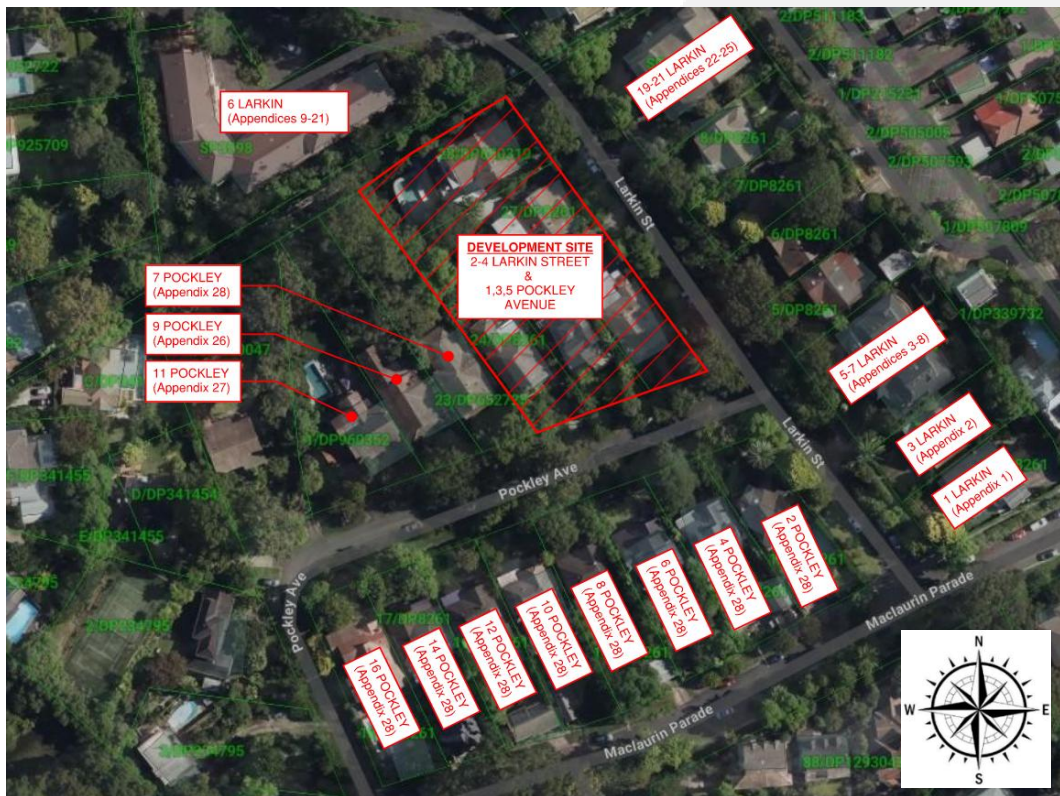
Figure 1 – Site Overview Map (Neighbouring Properties)

Refer to Figure 1 and Figure 2 for a site overview of the inspected areas - neighbouring properties and public infrastructure, respectively.

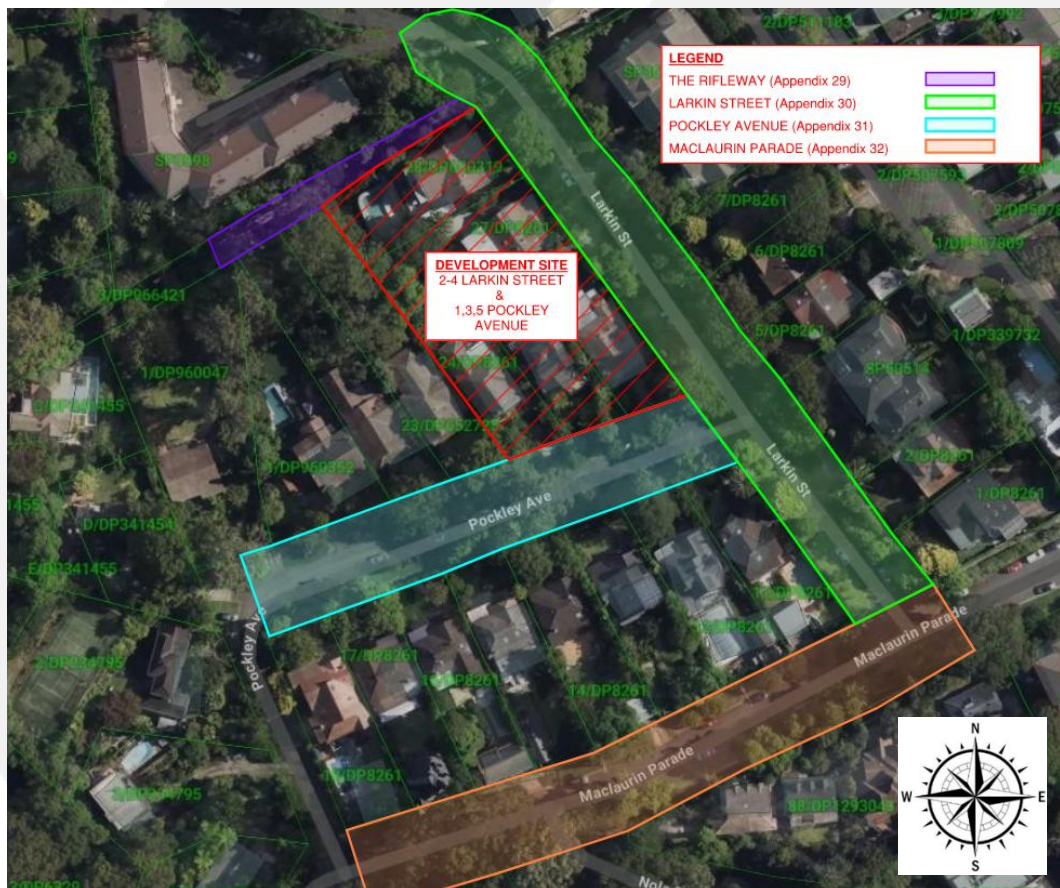
Figure 2 – Site Overview Map (Public Infrastructure)
