## Geotechnical Investigation Report 59-63 Trafalgar Avenue & 1A/B Valley Road, Lindfield NSW

Prepared for: Castle Hill No.8 Pty Ltd

Reference: P3444\_01 Rev1

Morrow Geotechnics Pty Ltd has undertaken a geotechnical investigation to provide geotechnical advice and recommendations for the proposed development at 59-63 Trafalgar Avenue & 1A/B Valley Road, Lindfield NSW (the site).

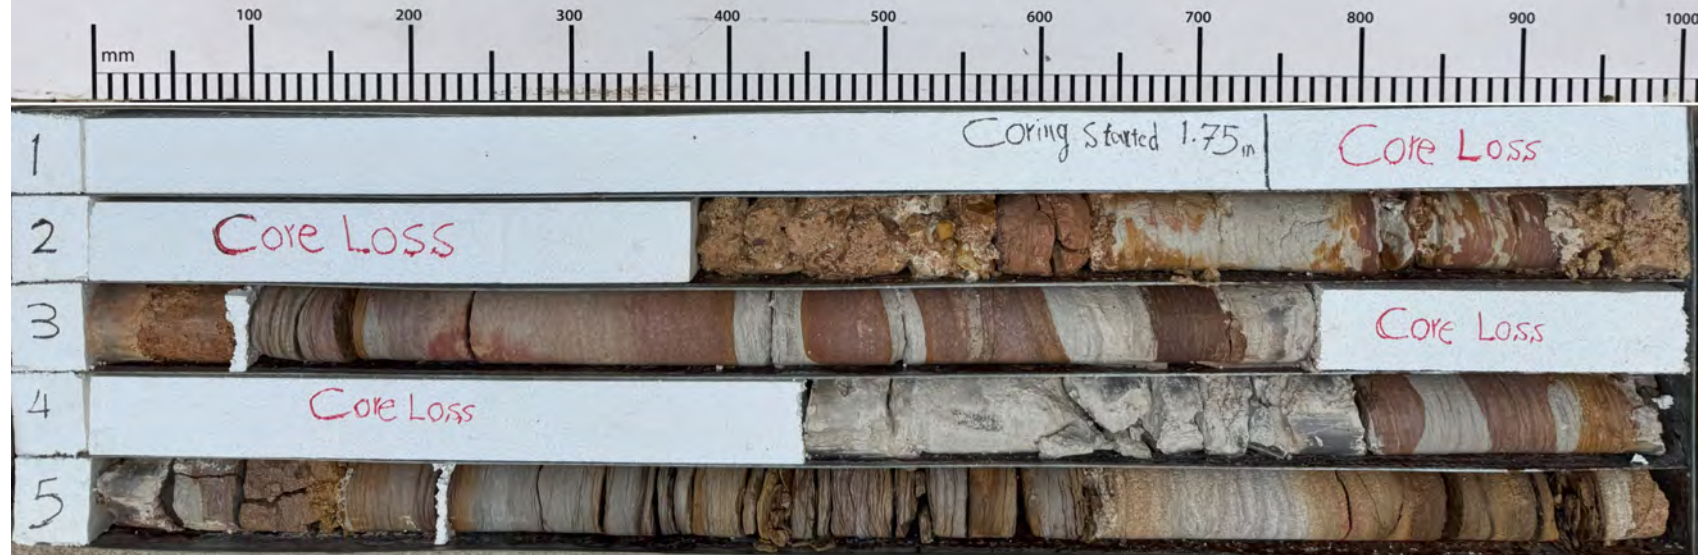
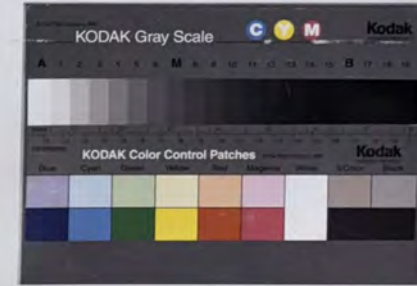
BOREHOLE ID: BH2  
 DEPTH: 1.75 to 6.0 m  
 CORE TRAY NO: Box 1 of 4  
 DATE: 14,2,2025

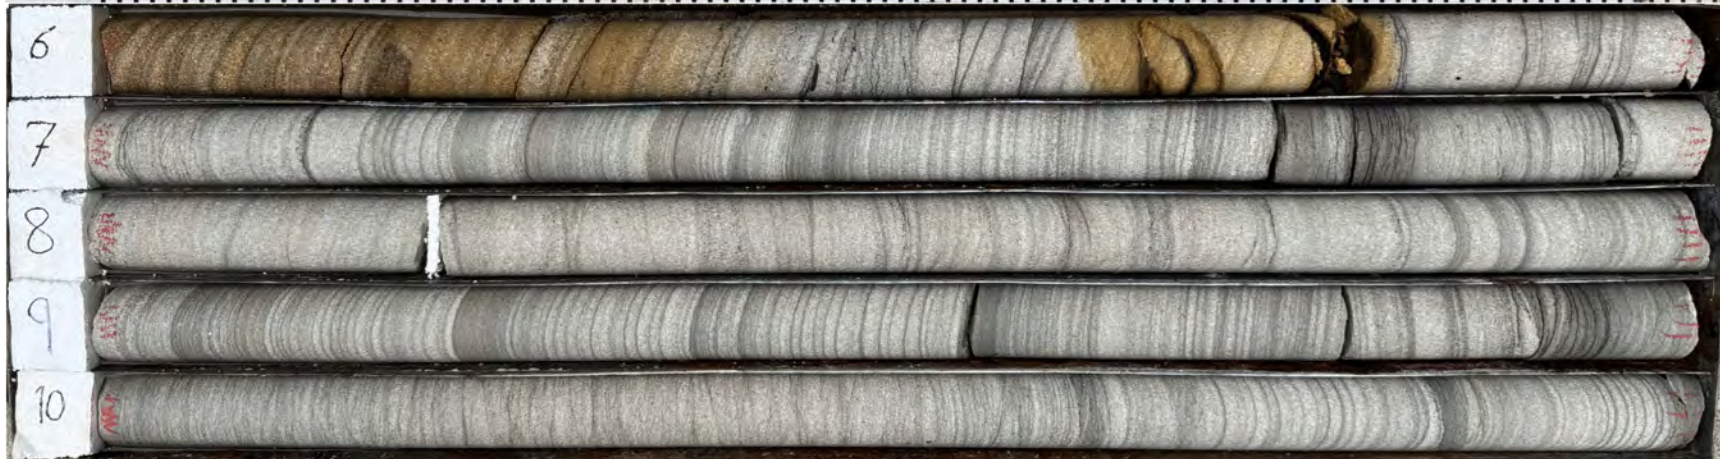
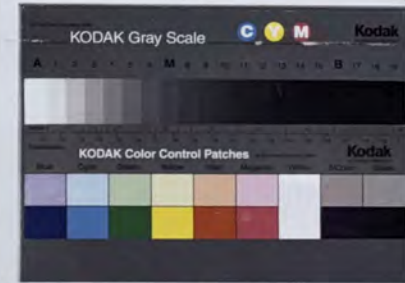
BOREHOLE ID: BH2  
DEPTH: 6.0 to 11.0 m  
CORE TRAY NO: Box 2 of 4  
DATE: 14,2,2025

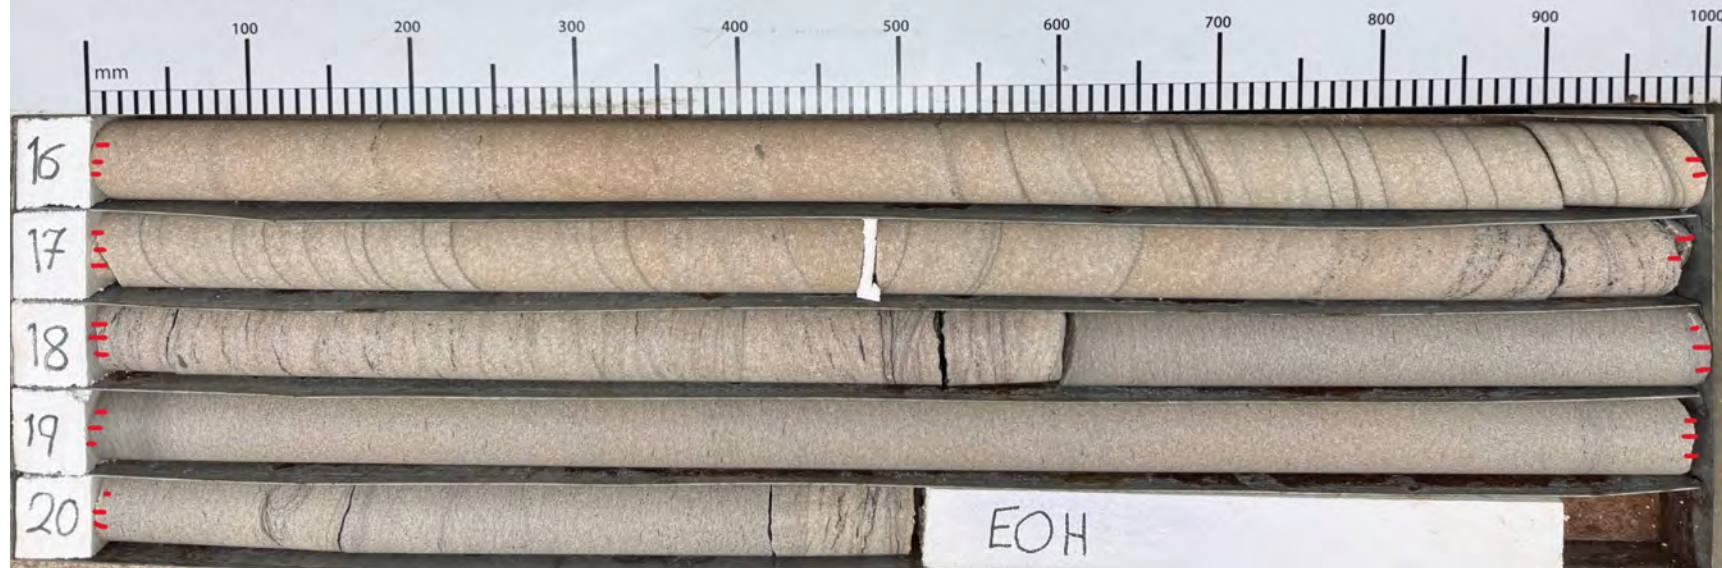
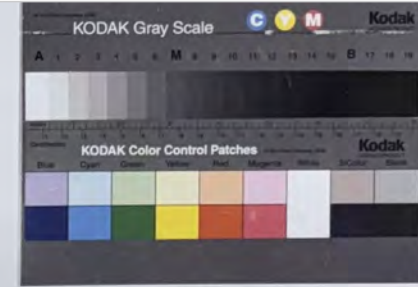
BOREHOLE ID: BH2  
DEPTH: 16.0 to 20.52 m  
CORE TRAY NO: Box 4 of 4  
DATE: 14, 2, 2025

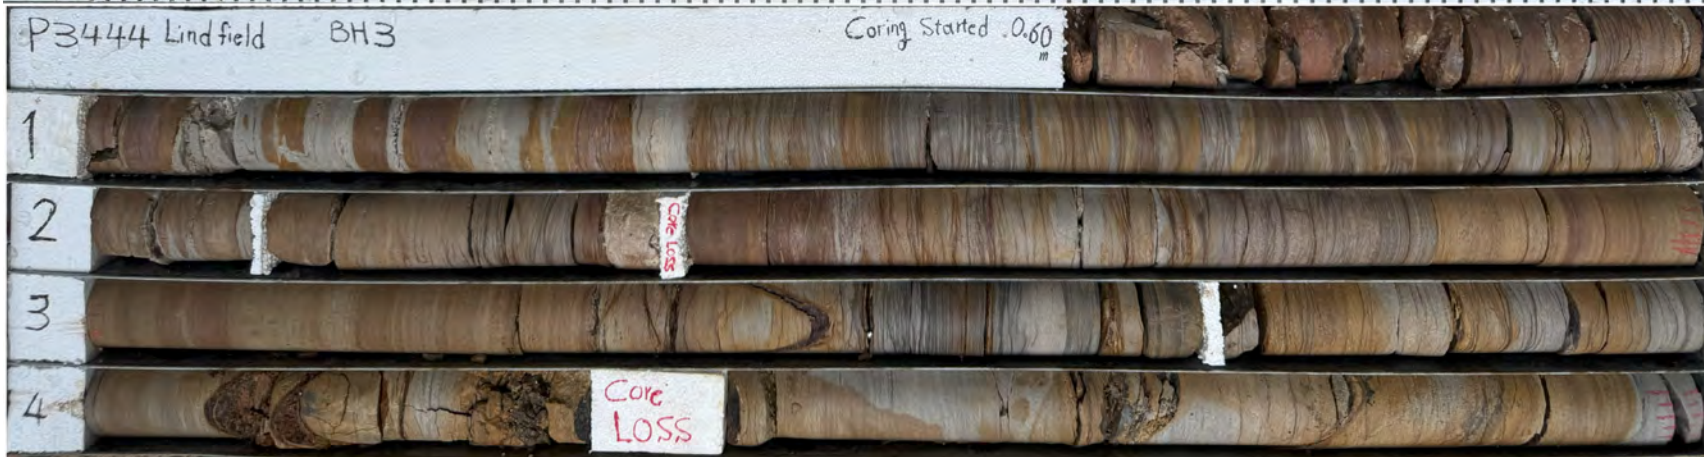
BOREHOLE ID: BH3  
 DEPTH: 0.6 to 5.0m  
 CORE TRAY NO: Box 1 of 4  
 DATE: 11, 2, 25

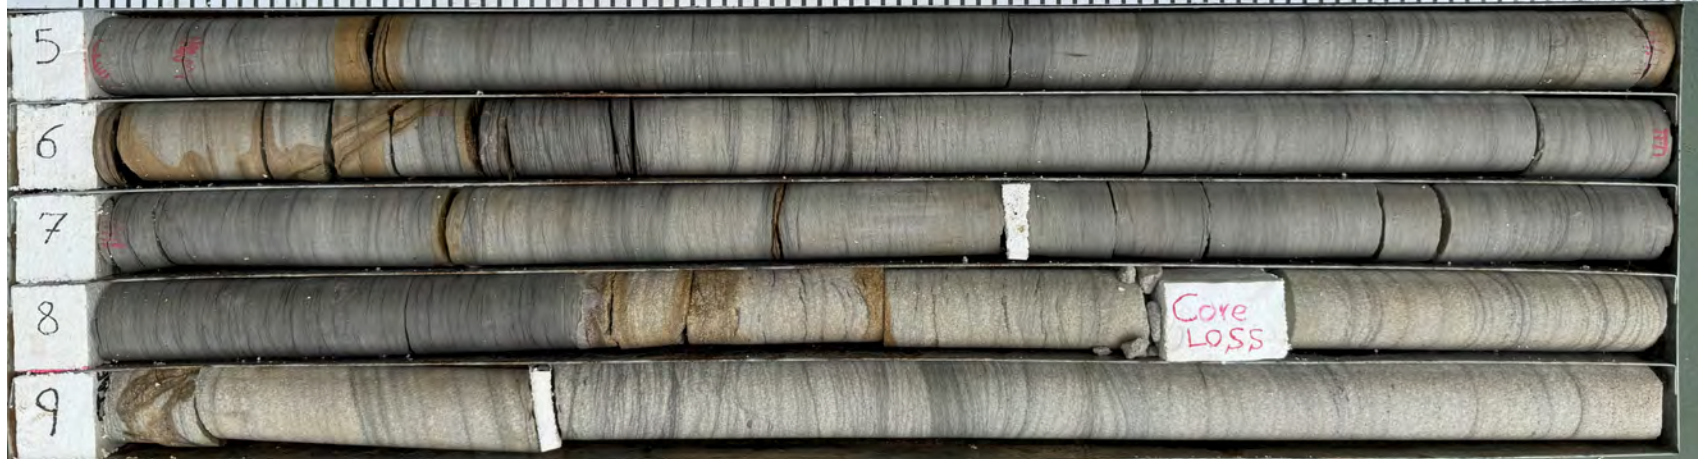
BOREHOLE ID: BH3  
DEPTH: 50 to 10.0m  
CORE TRAY N: Box 2 of 4  
DATE: 11, 2, 25

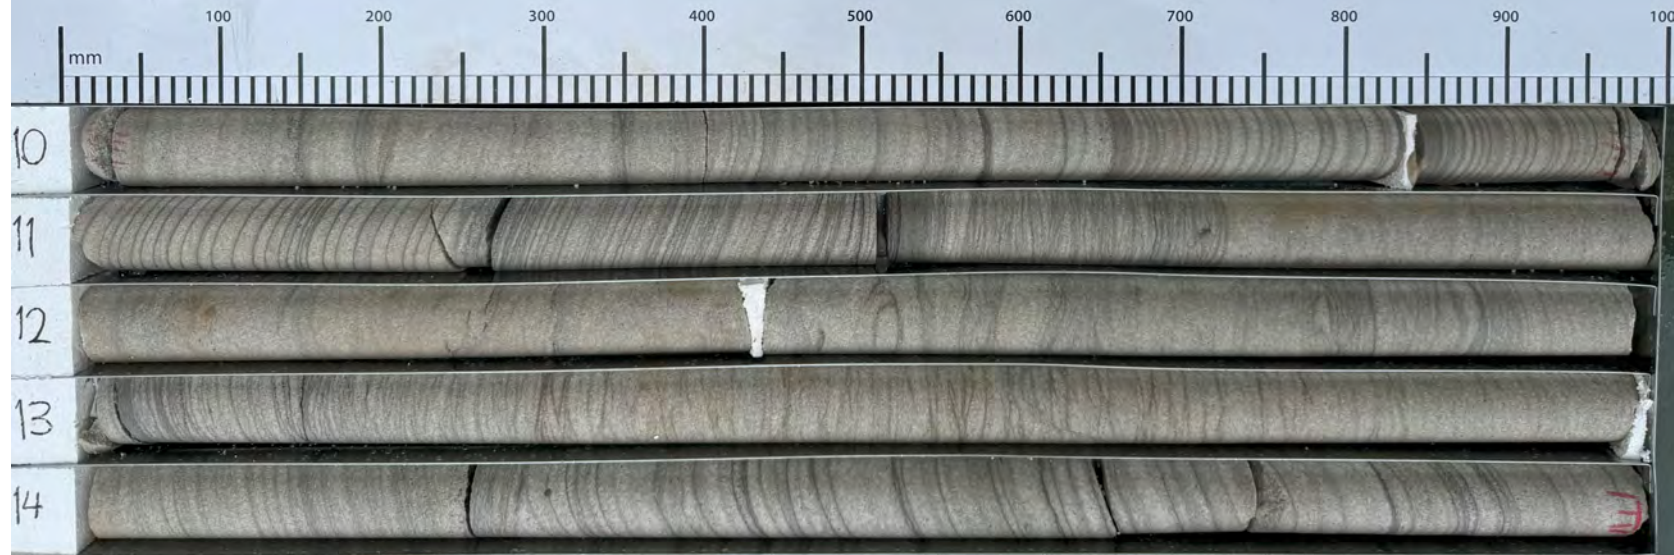
BOREHOLE ID: BH3  
DEPTH: 10.0 to 15.0m  
CORE TRAY N: Box 3 of 4  
DATE: 11, 2, 25

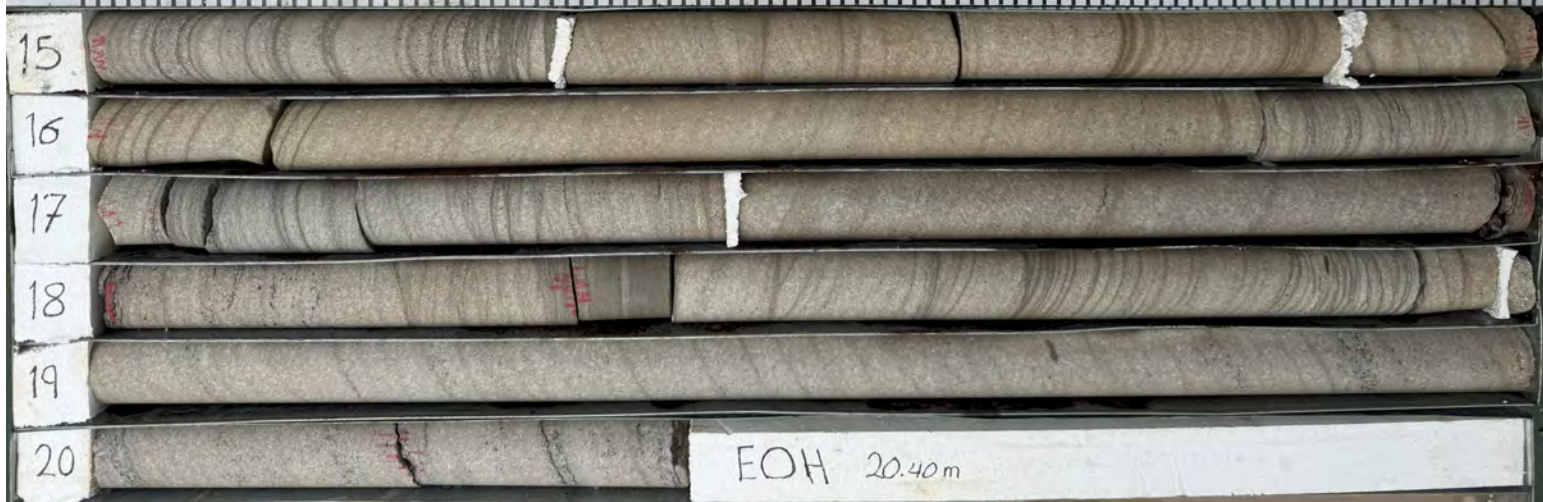
BOREHOLE ID: BH3  
DEPTH: 15.0 to 20.4m  
CORE TRAY N: Box 4 of 4  
DATE: 12, 2, 25
