# **Site Hydrogeology Report 59-63 Trafalgar Avenue & 1A/B Valley Road, Lindfield NSW**

**Reference: P3444\_06**

**Date: 22 April 2026**

## **Morrow Geotechnics Pty Ltd**

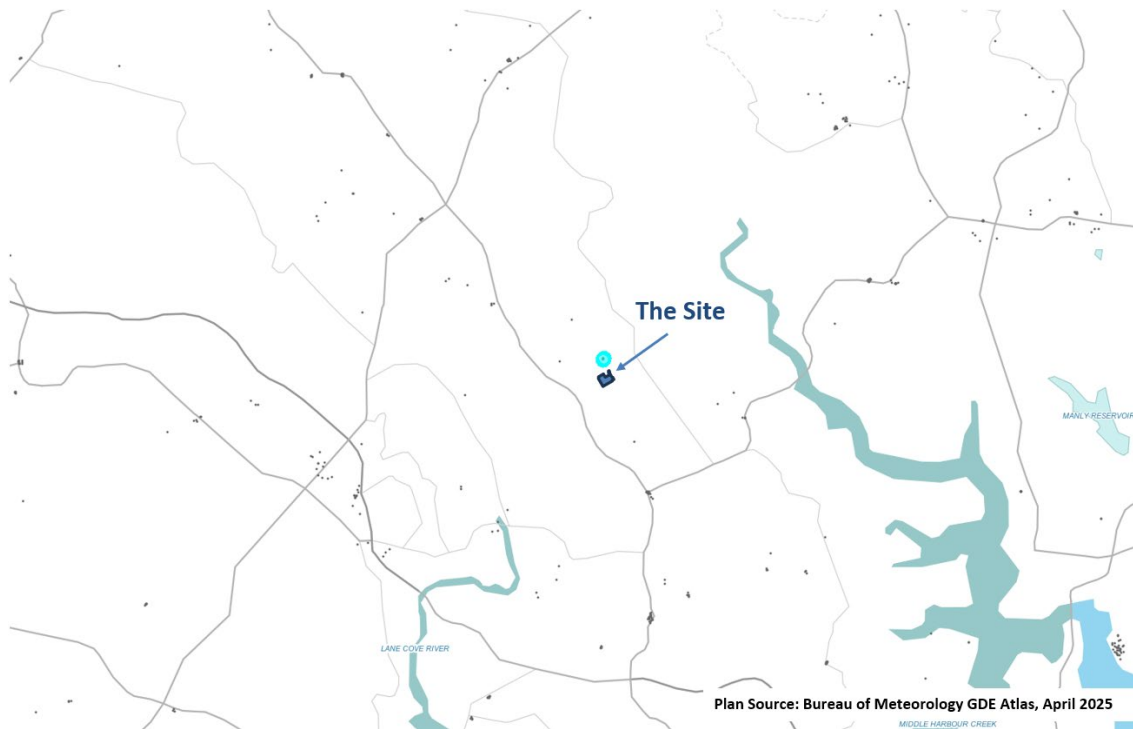
According to the Bureau of Meteorology (BOM) Australian Groundwater Explorer no water supply bores are located with 500m of the site, bore locations are shown on **Figure 1** below.

**Figure 1:** Water Supply Works Monitoring Bores

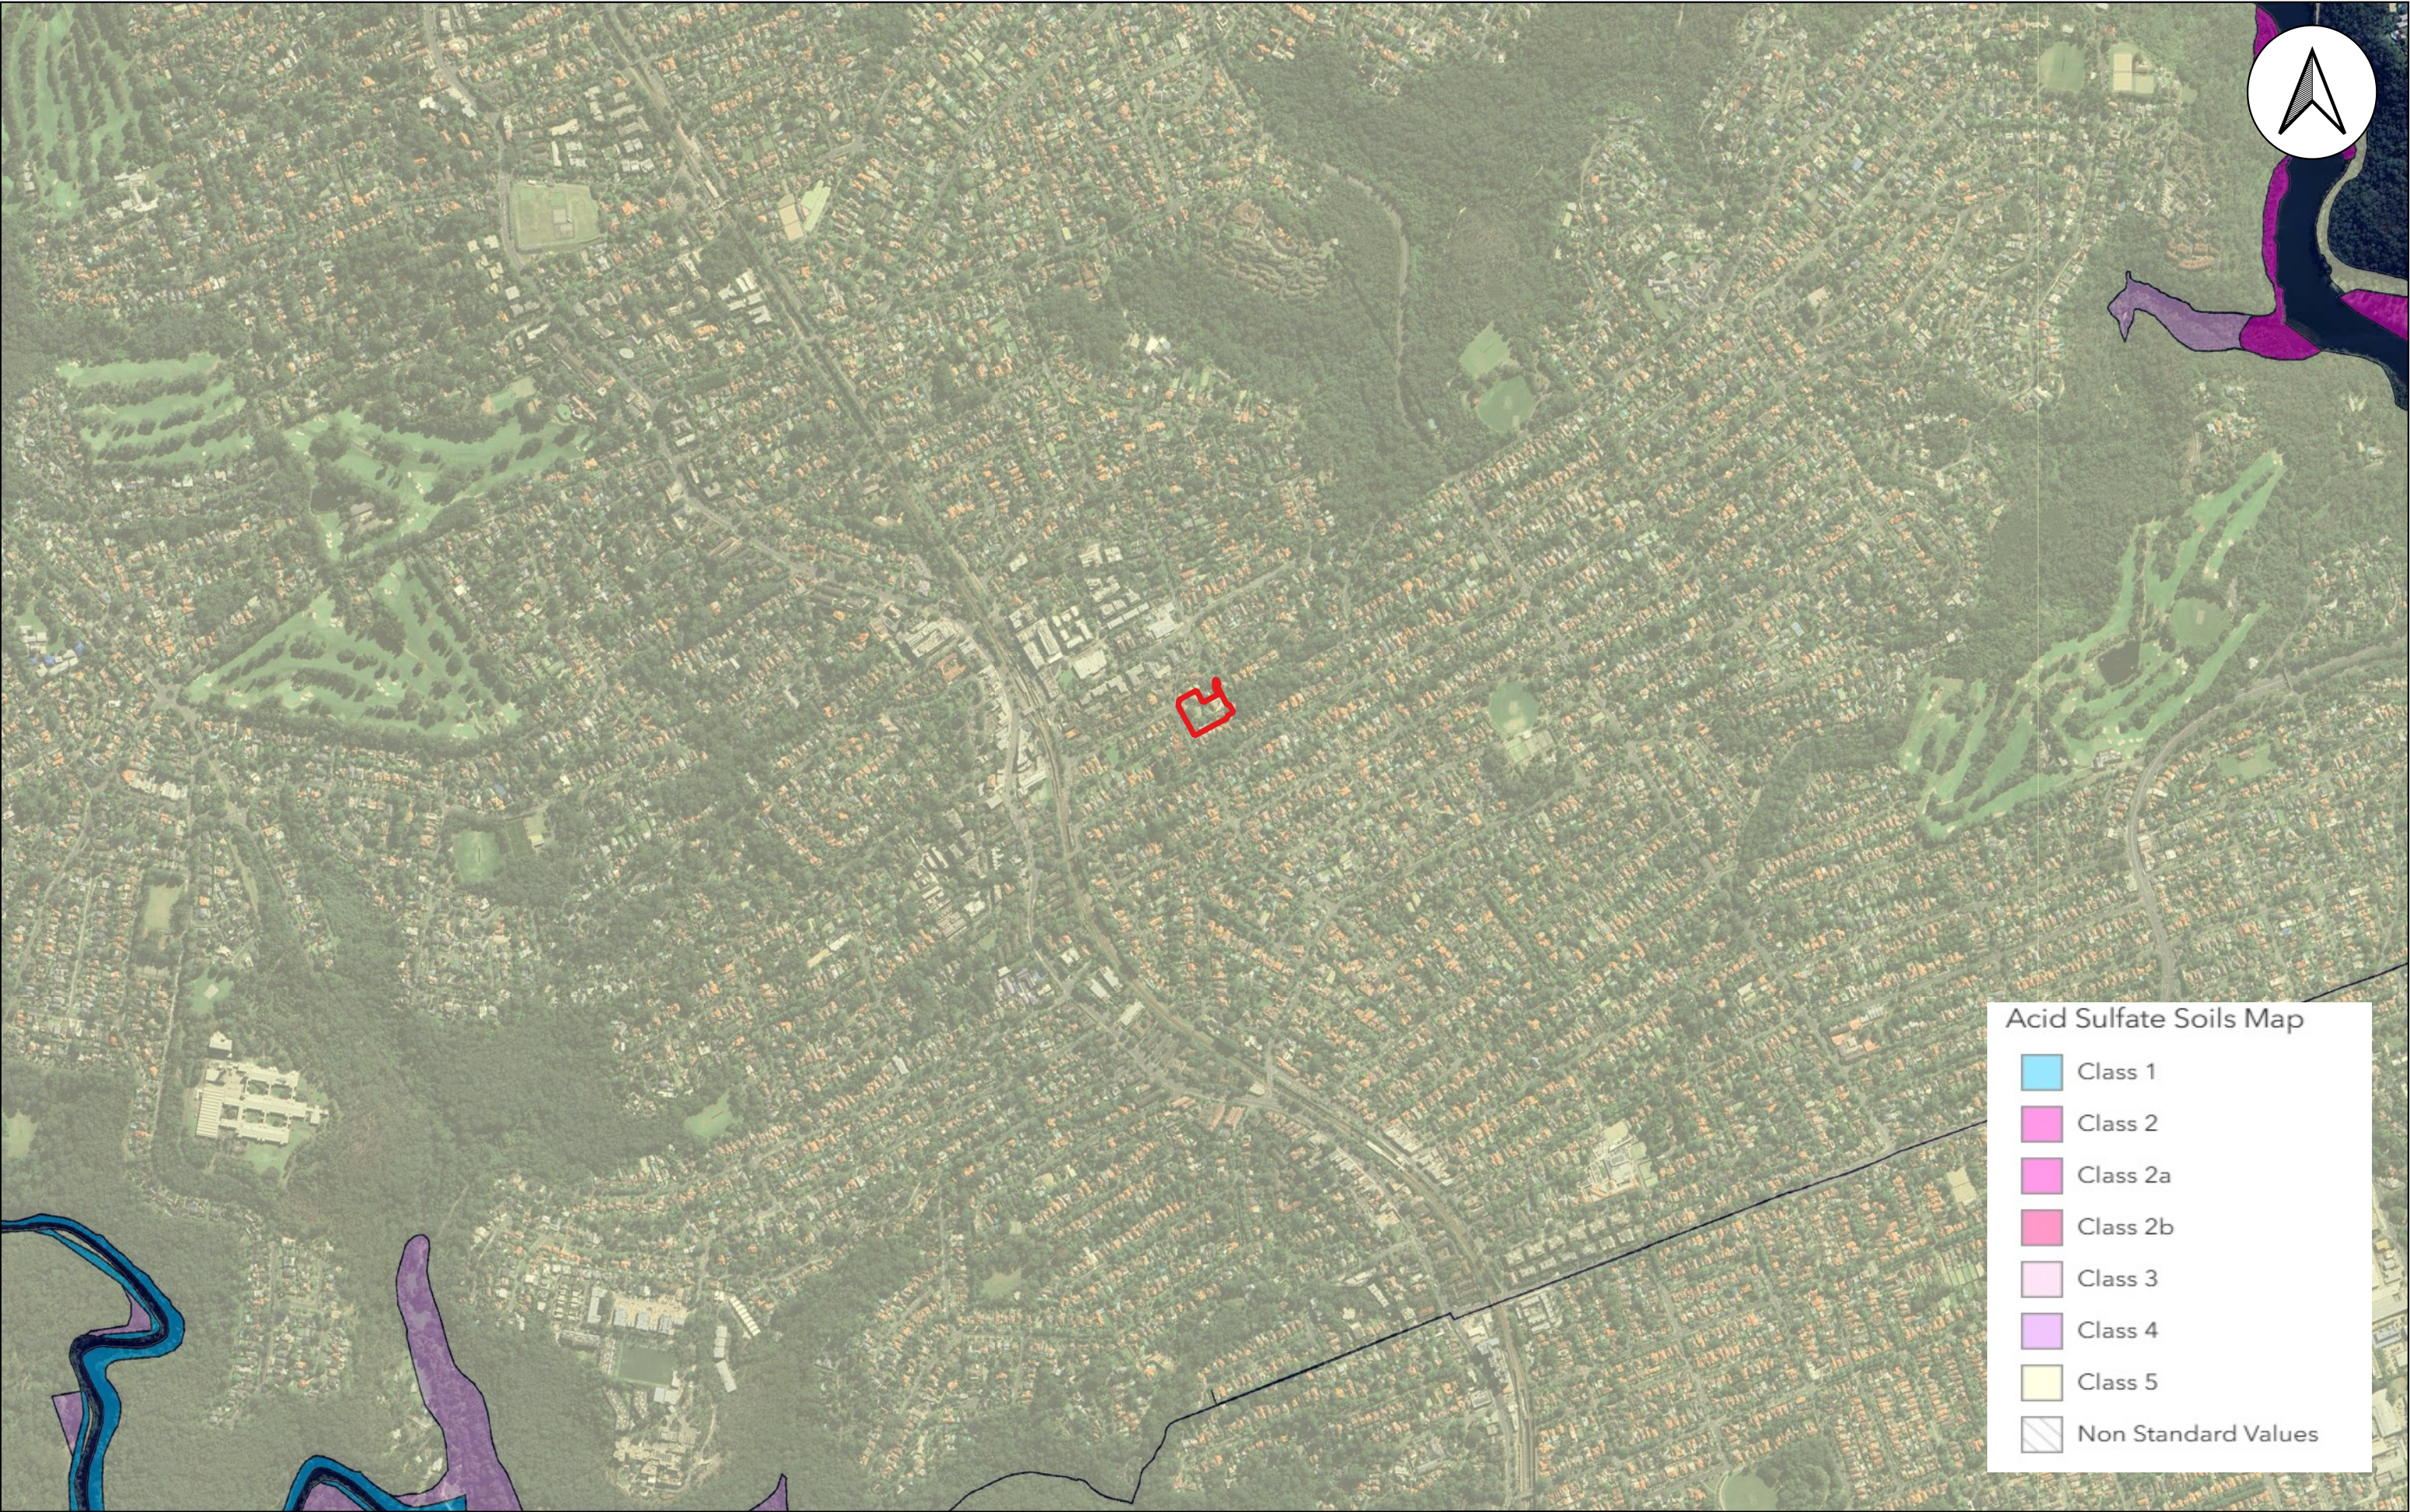
NOTE:  
1. Drawing projection in GDA2020 / MGA zone 56, adapted from aerial imagery from "SIX Maps", accessed 16/09/2025.  
2. Acid Sulfate Soils data obtained from Ku-ring-gai Council, accessed on 17/04/2026

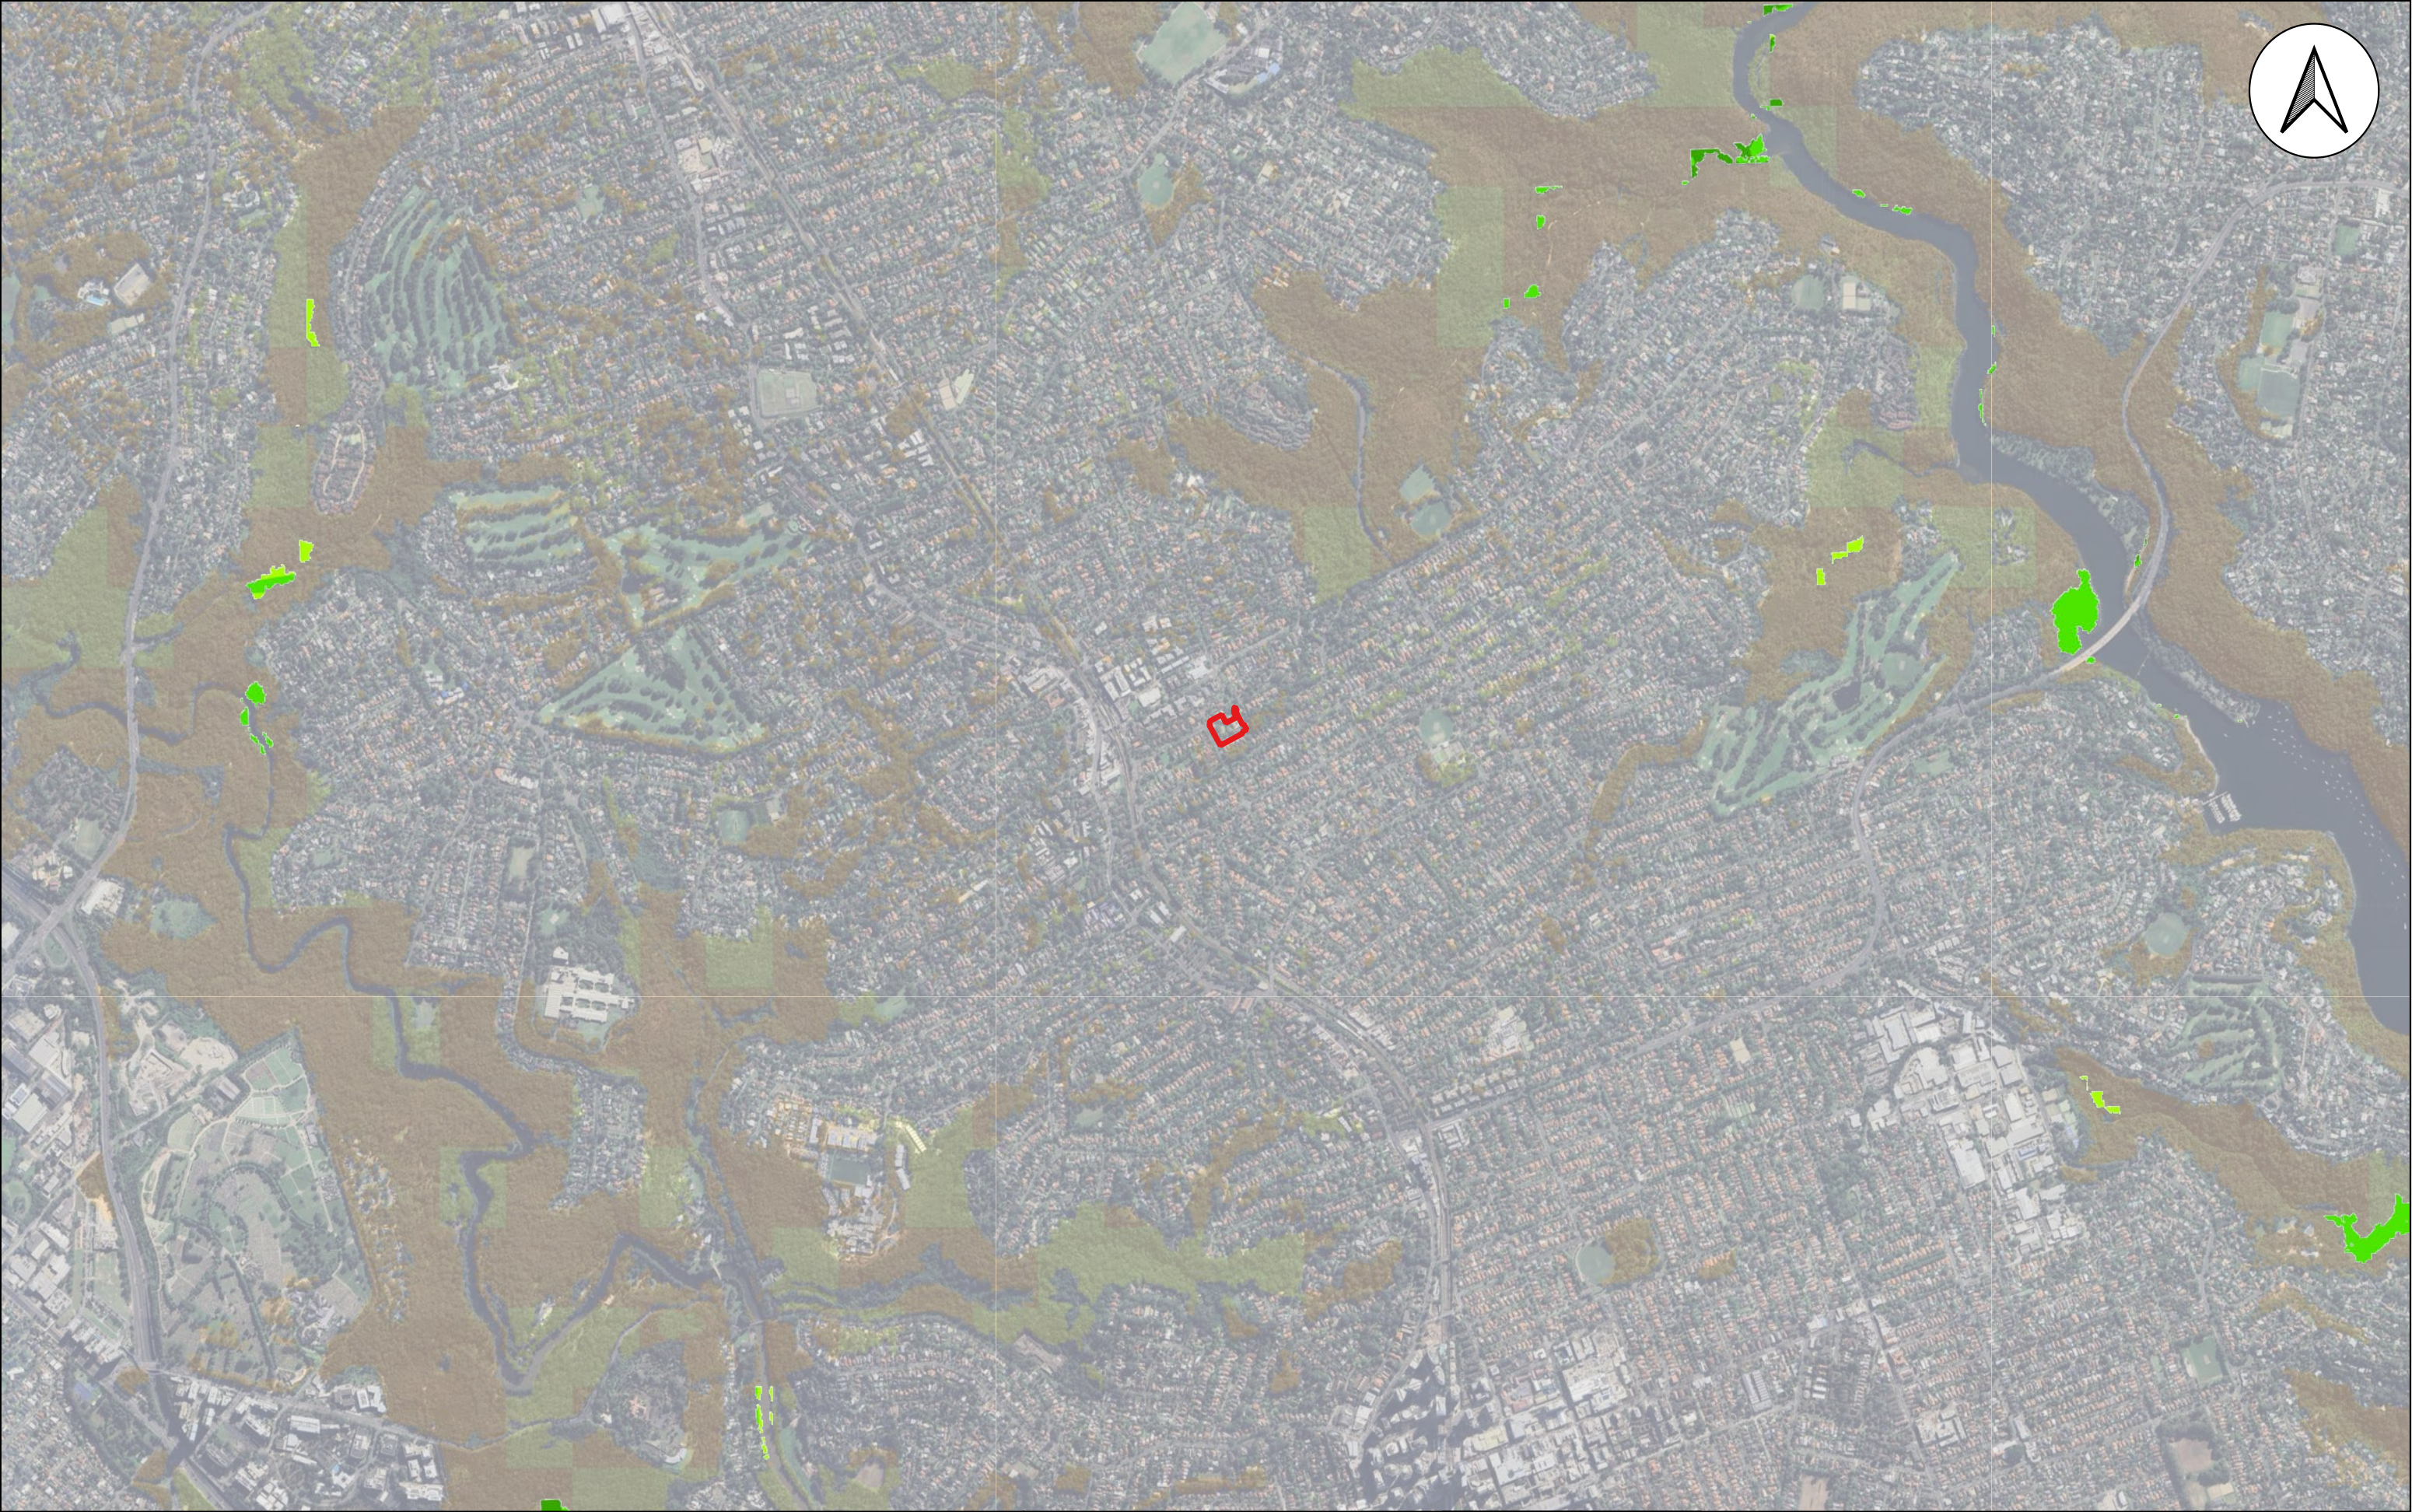
NOTE:  
1. Drawing projection in GDA2020 / MGA zone 56, adapted from aerial imagery from "SIX Maps", accessed 16/09/2025.  
2. GDE data obtained from eSPADE, accessed on 17/04/2026
