**University of Sydney Health Precinct
Blackburn Building (D06), Dangerous Goods
Store (D15) and Proposed Shared Pedestrian
& Vehicular Pathway
Camperdown, NSW**

Geotechnical Investigation

20 January 2017

Geotechnical Investigation – USYD Health Precinct, Blackburn Building (D06), Dangerous Goods Store (D15) and Proposed Shared Pedestrian Pathway, Camperdown, NSW

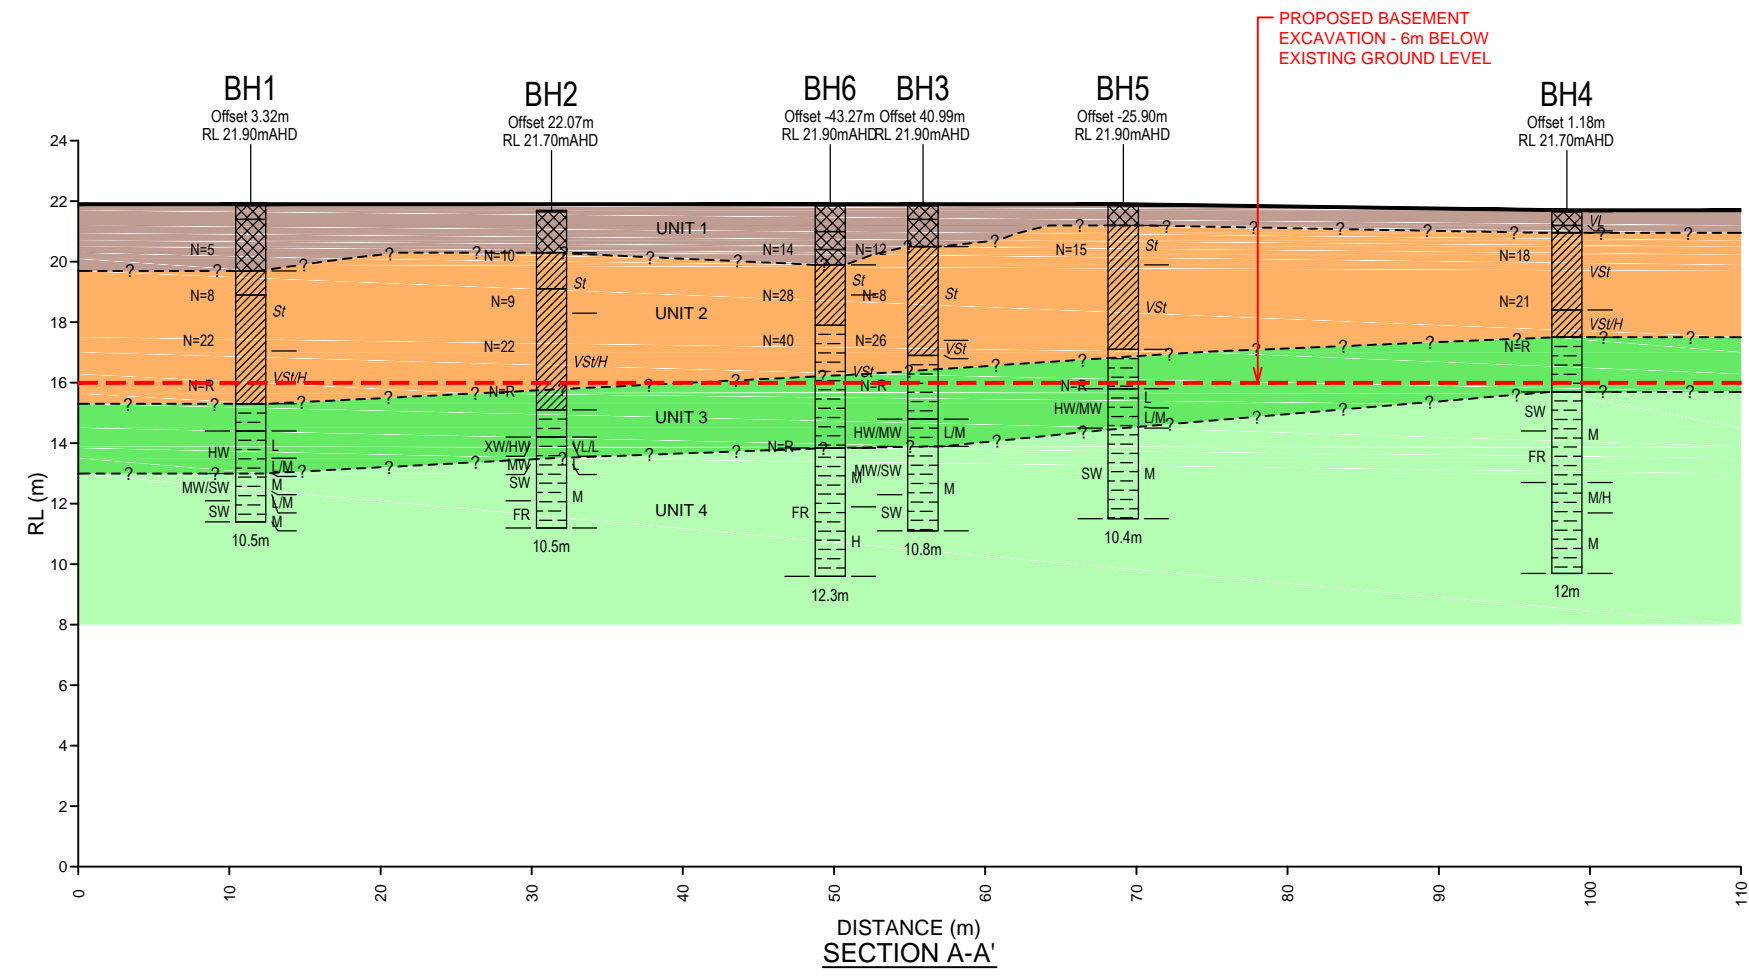
client:	LEND LEASE BUILDING PTY LTD		
project:	USYD HEALTH PRECINCT UNIVERSITY OF SYDNEY - CAMPERDOWN CAMPUS CAMPERDOWN, NSW		
title:	SECTION A-A'		
project no:	GEO\TCOV25283AF-AD	figure no:	FIGURE 2
rev:	A

The Coffey engineering borehole logs and rock core photographs are presented in Appendix A, together with explanation sheets which describe the terms and symbols used in the logs. An interpreted cross sections on a north-west to south-east diagonal through the site is presented in Figure 2.

The geotechnical section in Figure 2 suggests a general fall in Units 3 and 4 to the north-west at about 2%.

Figure 2 – Section A-A'

As the rock profile slopes down to the northwest, the base of the proposed 6 m excavation will expose either Unit 2 Residual Soil on the northwest side and Unit 3 Class V/IV Shale to the northeast, south and southwest. For the building loads expected, we recommend that the structures be supported on the same Unit to reduce differential settlement. Whilst parameters are provided for Unit 3 Shale, this material may deteriorate due to exposure during construction and the presence of groundwater. In our view the building should be founded on Unit 4 Shale.
