GROUNDWATER IMPACT ASSESSMENT

Project Title – 215, 229-239 Pitt St, Merrylands

Project Type – Proposed Multistorey Development

Project No. – GR24220-1Arev01

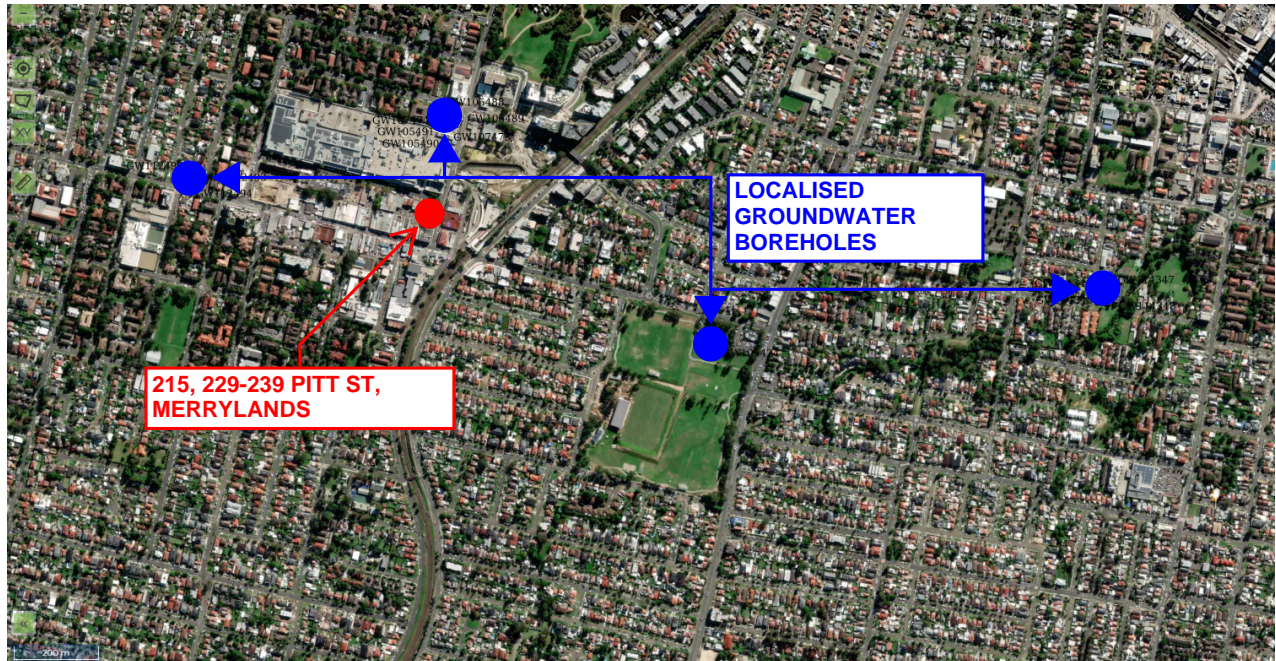
Figure 6: Localised Groundwater Boreholes from the Site

An aerial view of the site as shown in Figure 6, demonstrates 14 Local groundwater wells with an approximate depth ranging from 3.5-11.5m exist approximately 240-580m North-West and 740-1600m South-East as shown in Figure 6. These groundwater wells from the North-West region consist of a standing water level of 2.3m BGL. Additionally, the groundwater wells from the South-East region

consist of a standing water level ranging from 3.6m to 5.5m BGL and an average yield of 0.410 (L/s). Based on the data collected from these wells, it can be noticed that the groundwater level is sloping down from North-West to South-East.

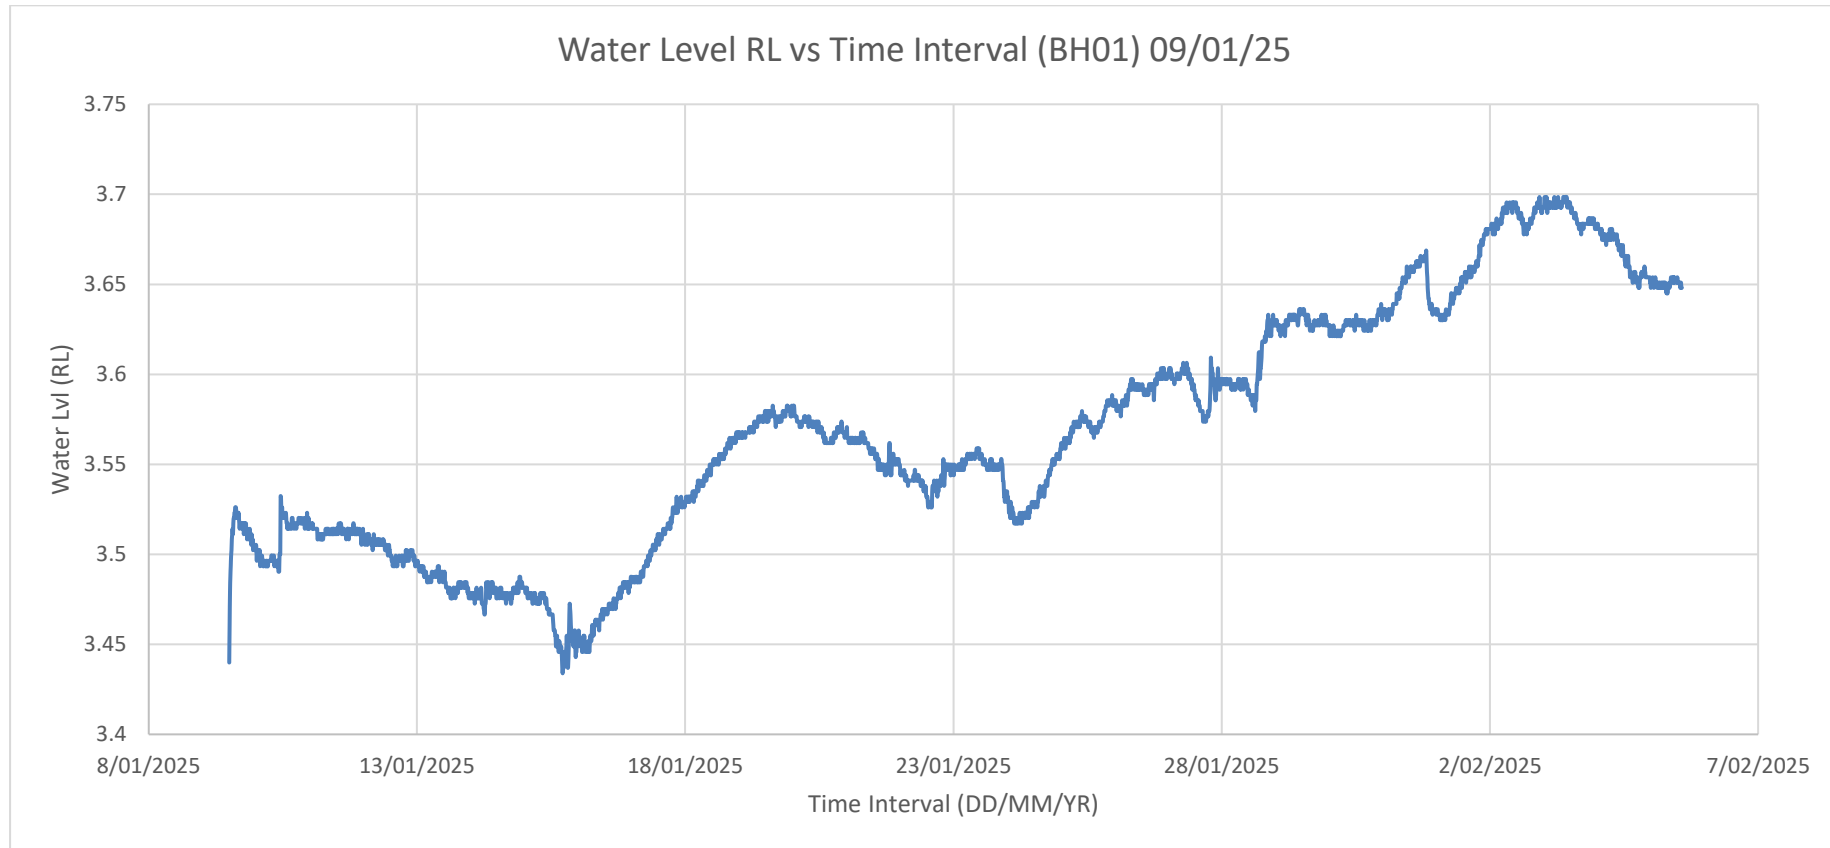
Figure 7: Groundwater Level Monitoring Results for BH01, 09/01/25

The following Tables demonstrate the observed and calculated groundwater levels and hydraulic conductivity based on previous results, whilst the following Figures show the groundwater level monitoring results. Based on the observed and statistical analysis of the groundwater levels, the minimum, maximum and average groundwater level are approximately RL 2.25, RL 4.04 and RL 3.69.

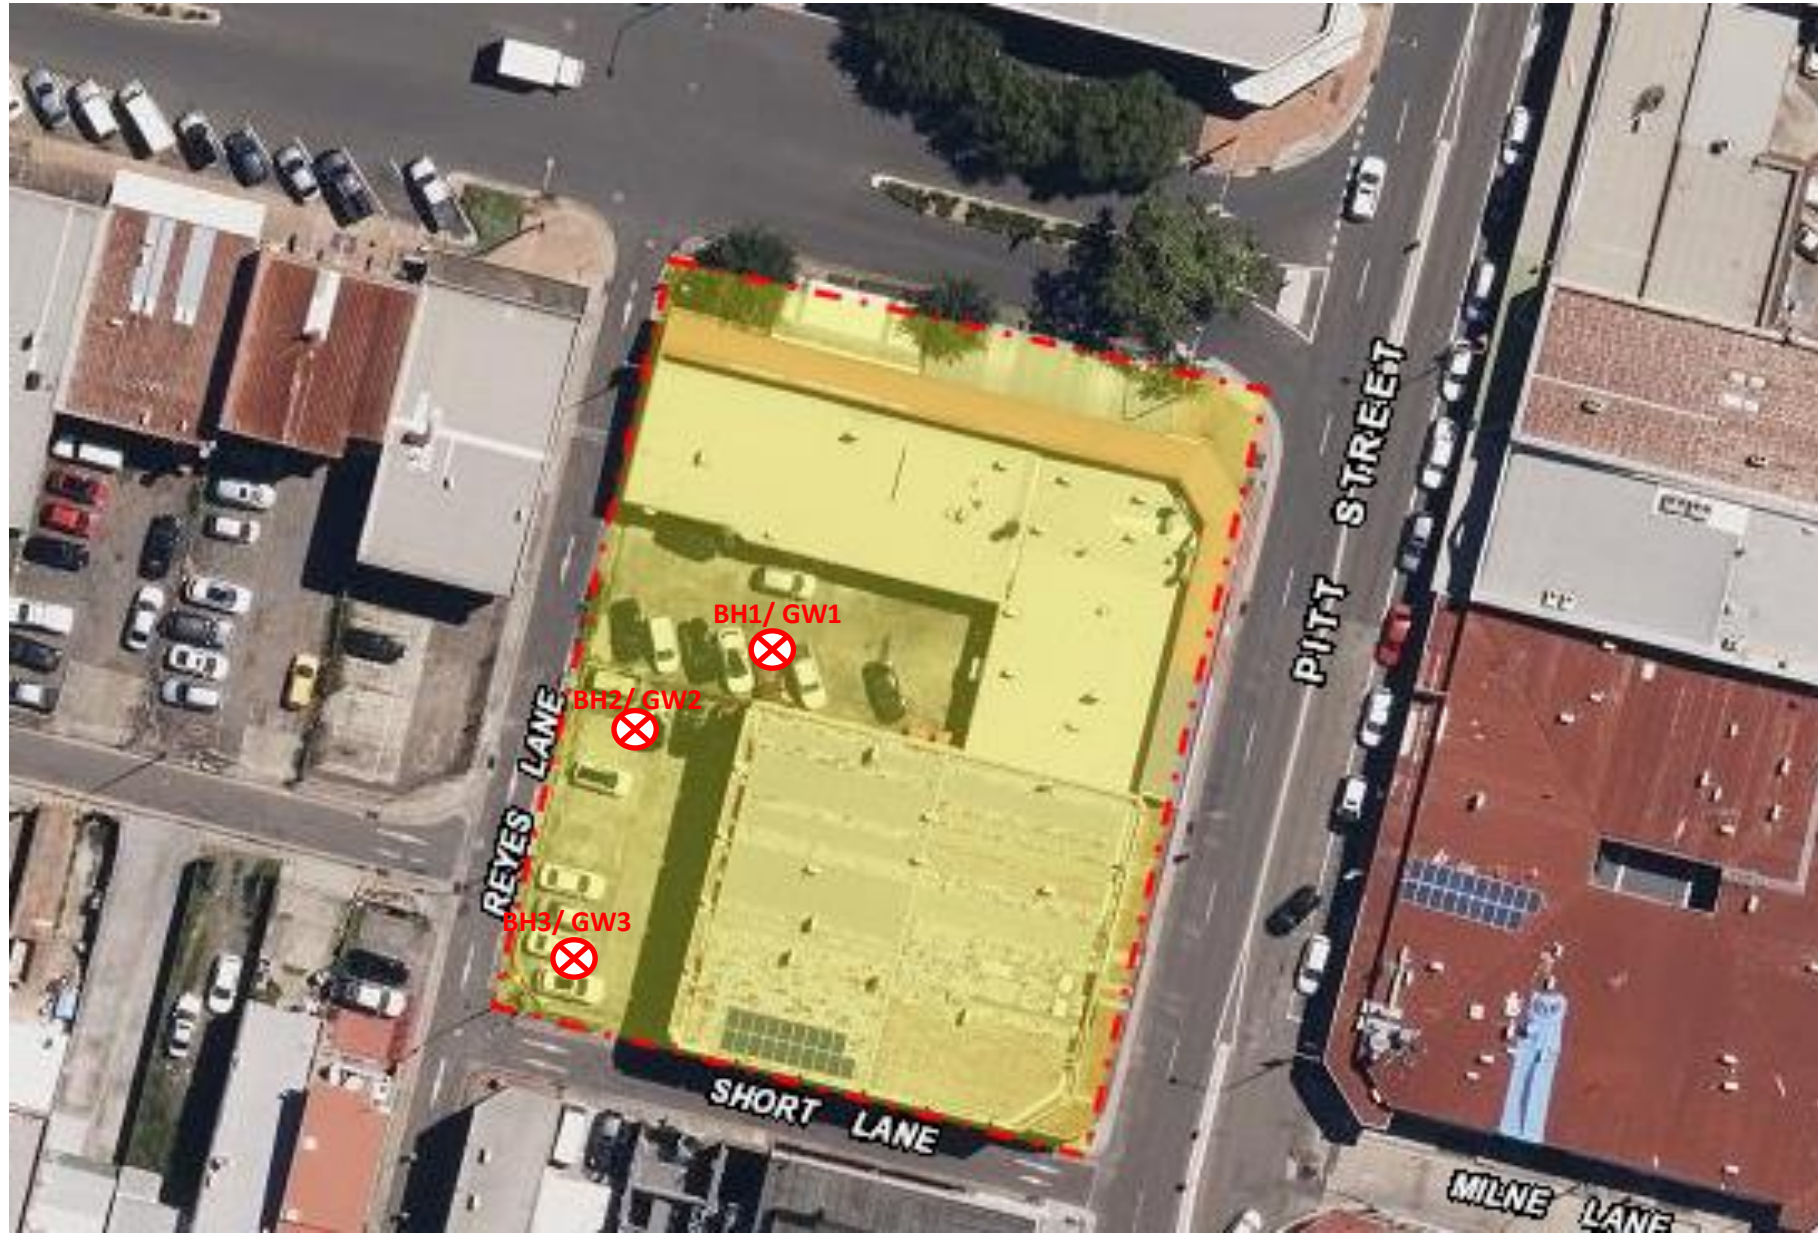
Drawn	AS	CLIENT: ANGLICARE SITE ADDRESS: 215, 229-239 PITT ST, MERRYLANDS	Figure	1
Checked	AE		Title	Site Plan
Date	22/01/2025		Job No	GR24220
Scale @ A3	NTS

The results of the investigation indicate that the subsurface profile comprises Silty CLAY underlain by SHALE BEDROCK. Based on the borehole information, a summary of subsurface conditions is presented below. The location of each borehole can be found in Appendix A and more detailed logs can be found in Appendix B.

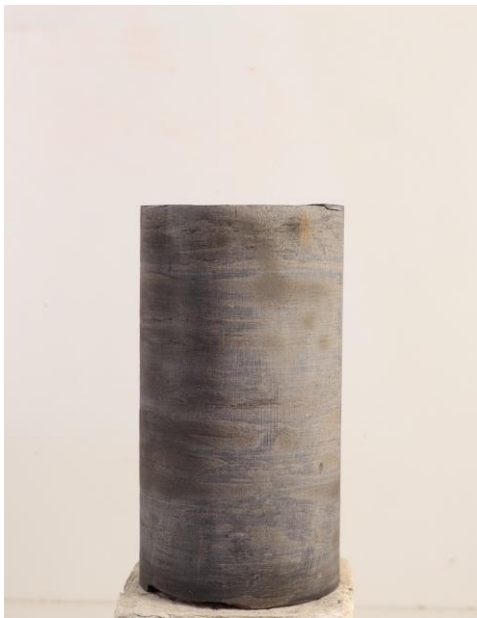
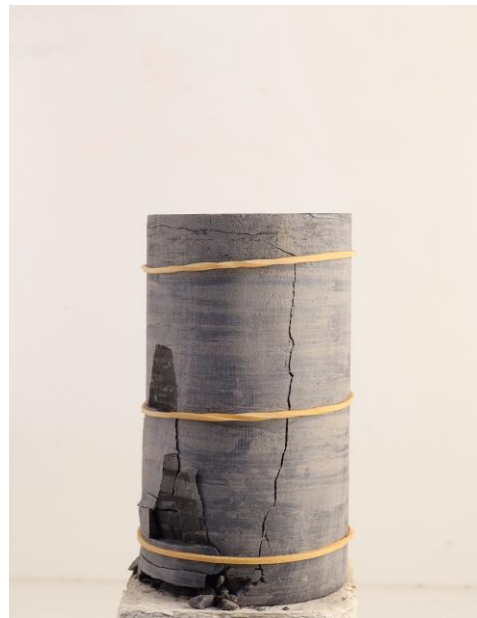
Client	CEC Geotechnical	Sample Source	BH01 10.20m
Address	4/83 Grose Street, North Parramatta, NSW 2151	Sample Description	Shale
Project	GR24220 - 215 219-239 PITT ST MERRYLANDS	Report #	S102965-UCS
Job #	S25020-1	Sample #	S102965

Test Procedure	AS 4133.4.2.2 Determination of uniaxial compressive strength-Rock strength less than 50 MPa		
Sampling	Sampled by Client - results apply to the sample as received	Date Sampled	16/12/2024
Storage History	Sealed	Storage Environment	Sealed at as received moisture condition
Sample Curing	-	Testing Machine	Matest 2000 kN Compression Machine

Uniaxial Compressive Strength 27 MPa

Date Tested: 22/01/2025	Moisture Content: 2.3 %
Specimen Height: 101.1 mm	Duration of Test: 634 seconds
Average Specimen Diameter: 51.6 mm	Rate of Displacement: < 0.1 mm/min

Borehole	Depth (m bgl)	Specimen Height (mm)	Average Specimen Diameter (mm)	Moisture Content (%)	Uniaxial Compressive Strength (MPa)
BH1	10.2	101.1	51.6	2.3	27
BH1	15.2	126.9	51.7	1.9	21
BH1	19.4	104.8	51.6	1.6	21
BH1	24.6	107.5	51.3	1.5	31
BH2	17.1	100.9	51.5	2.4	23
BH2	21.1	119.4	51.4	2.4	15
BH3	11.8	101.9	51.4	2.2	40
BH3	15.27	129.4	51.7	16.8	43

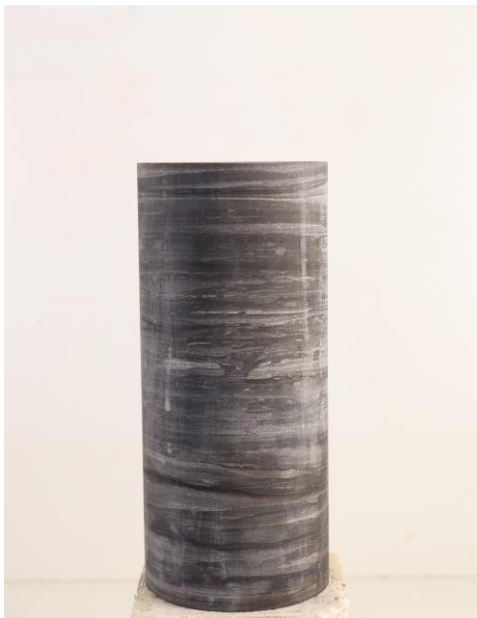
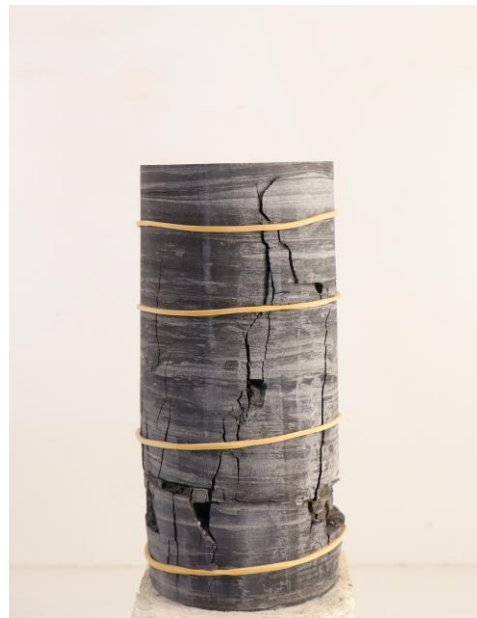
Client	CEC Geotechnical	Sample Source	BH01 15.20m
Address	4/83 Grose Street, North Parramatta, NSW 2151	Sample Description	Shale
Project	GR24220 - 215 219-239 PITT ST MERRYLANDS	Report #	S102966-UCS
Job #	S25020-1	Sample #	S102966

Test Procedure	AS 4133.4.2.2 Determination of uniaxial compressive strength-Rock strength less than 50 MPa		
Sampling	Sampled by Client - results apply to the sample as received	Date Sampled	16/12/2024
Storage History	Sealed	Storage Environment	Sealed at as received moisture condition
Sample Curing	-	Testing Machine	Matest 2000 kN Compression Machine

Uniaxial Compressive Strength 21 MPa

Date Tested: 22/01/2025	Moisture Content: 1.9 %
Specimen Height: 126.9 mm	Duration of Test: 620 seconds
Average Specimen Diameter: 51.7 mm	Rate of Displacement: < 0.1 mm/min

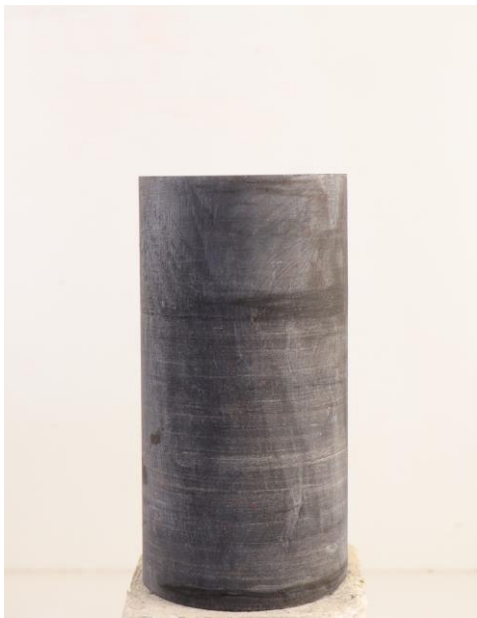
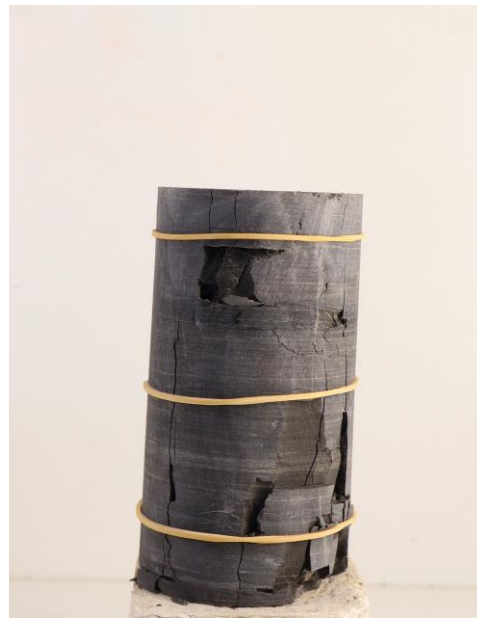
Client	CEC Geotechnical	Sample Source	BH01 19.40m
Address	4/83 Grose Street, North Parramatta, NSW 2151	Sample Description	Shale
Project	GR24220 - 215 219-239 PITT ST MERRYLANDS	Report #	S102967-UCS
Job #	S25020-1	Sample #	S102967

Test Procedure	AS 4133.4.2.2 Determination of uniaxial compressive strength-Rock strength less than 50 MPa		
Sampling	Sampled by Client - results apply to the sample as received	Date Sampled	16/12/2024
Storage History	Sealed	Storage Environment	Sealed at as received moisture condition
Sample Curing	-	Testing Machine	Matest 2000 kN Compression Machine

Uniaxial Compressive Strength 21 MPa

Date Tested: 22/01/2025	Moisture Content: 1.6 %
Specimen Height: 104.8 mm	Duration of Test: 609 seconds
Average Specimen Diameter: 51.6 mm	Rate of Displacement: < 0.1 mm/min

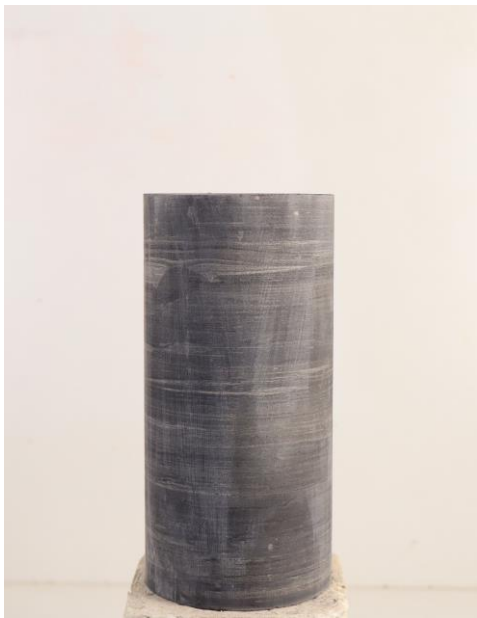
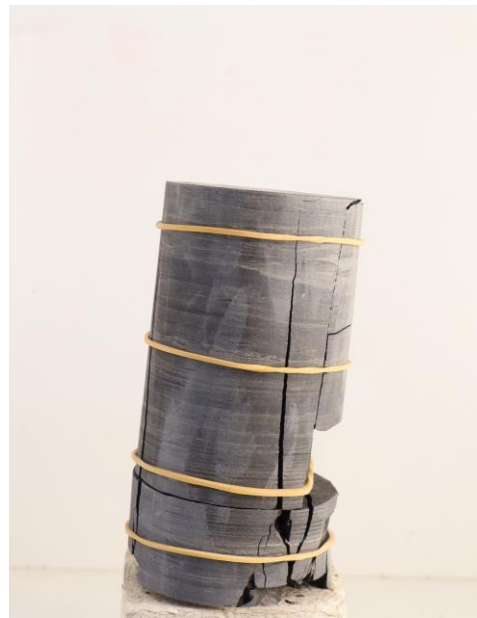
Client	CEC Geotechnical	Sample Source	BH01 24.60m
Address	4/83 Grose Street, North Parramatta, NSW 2151	Sample Description	Shale
Project	GR24220 - 215 219-239 PITT ST MERRYLANDS	Report #	S102968-UCS
Job #	S25020-1	Sample #	S102968

Test Procedure	AS 4133.4.2.2 Determination of uniaxial compressive strength-Rock strength less than 50 MPa		
Sampling	Sampled by Client - results apply to the sample as received	Date Sampled	16/12/2024
Storage History	Sealed	Storage Environment	Sealed at as received moisture condition
Sample Curing	-	Testing Machine	Matest 2000 kN Compression Machine

Uniaxial Compressive Strength 31 MPa

Date Tested: 22/01/2025	Moisture Content: 1.5 %
Specimen Height: 107.5 mm	Duration of Test: 668 seconds
Average Specimen Diameter: 51.3 mm	Rate of Displacement: < 0.1 mm/min

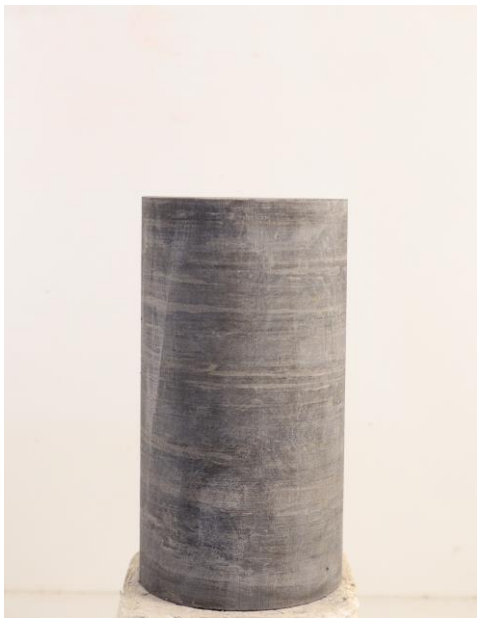
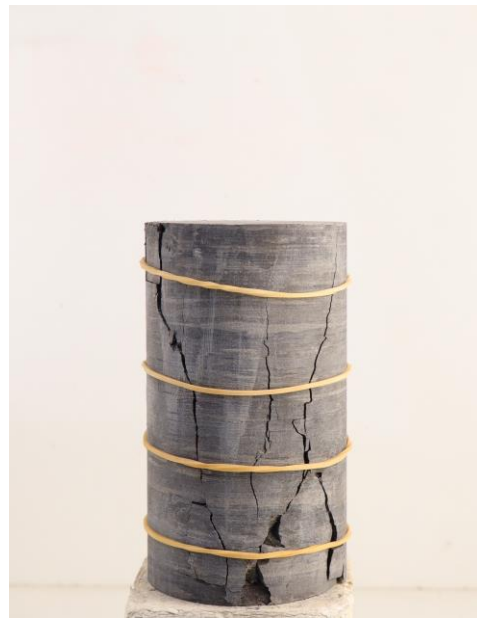
Client	CEC Geotechnical	Sample Source	BH02 17.10m
Address	4/83 Grose Street, North Parramatta, NSW 2151	Sample Description	Shale
Project	GR24220 - 215 219-239 PITT ST MERRYLANDS	Report #	S102970-UCS
Job #	S25020-1	Sample #	S102970

Uniaxial Compressive Strength 23 MPa

Date Tested: 22/01/2025	Moisture Content: 2.4 %
Specimen Height: 100.9 mm	Duration of Test: 611 seconds
Average Specimen Diameter: 51.5 mm	Rate of Displacement: < 0.1 mm/min

Failure Type: Mixed mode

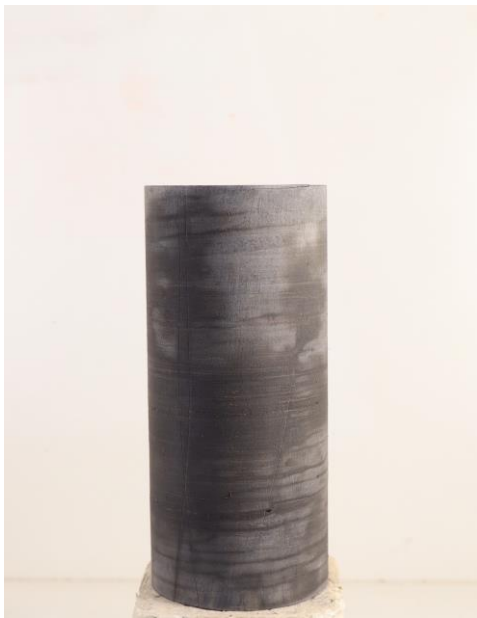
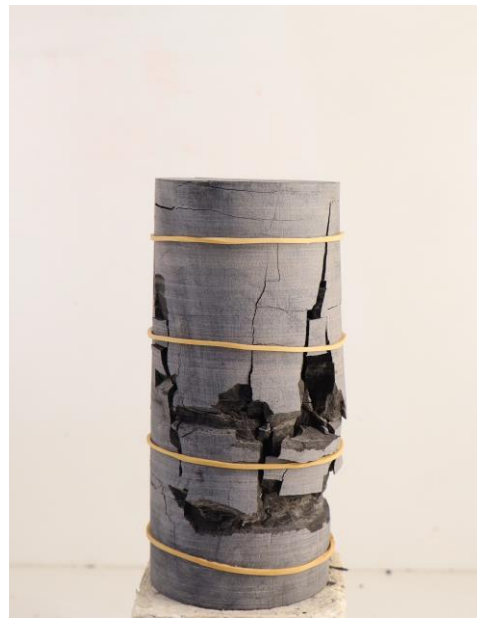
Client	CEC Geotechnical	Sample Source	BH02 21.10m
Address	4/83 Grose Street, North Parramatta, NSW 2151	Sample Description	Shale
Project	GR24220 - 215 219-239 PITT ST MERRYLANDS	Report #	S102971-UCS
Job #	S25020-1	Sample #	S102971

Uniaxial Compressive Strength 15 MPa

Date Tested: 22/01/2025	Moisture Content: 2.4 %
Specimen Height: 19.4 mm	Duration of Test: 604 seconds
Average Specimen Diameter: 51.4 mm	Rate of Displacement: < 0.1 mm/min

Failure Type:	Mixed mode
Other Pertinent Observations:	
Deviation from Standard:	Test specimen length to diameter ratio falls outside of standard limitations of 2.5-3.0.

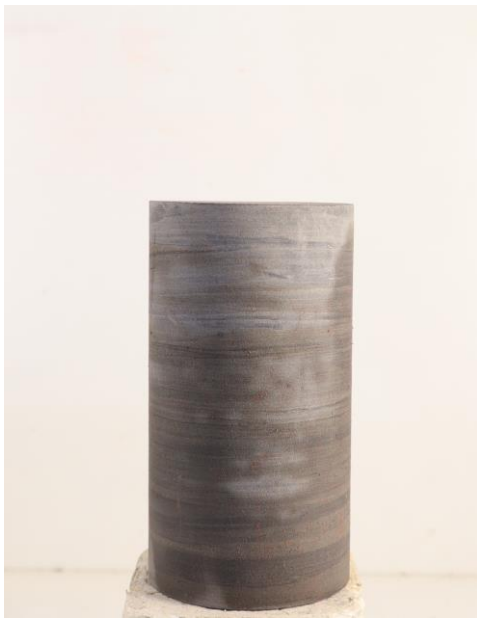
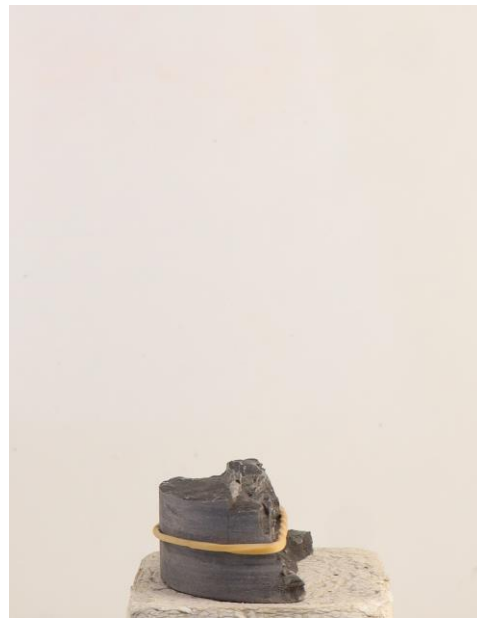
Client	CEC Geotechnical	Sample Source	BH03 11.80m
Address	4/83 Grose Street, North Parramatta, NSW 2151	Sample Description	Shale
Project	GR24220 - 215 219-239 PITT ST MERRYLANDS	Report #	S102973-UCS
Job #	S25020-1	Sample #	S102973

Uniaxial Compressive Strength 40 MPa

Date Tested: 22/01/2025	Moisture Content: 2.2 %
Specimen Height: 101.9 mm	Duration of Test: 653 seconds
Average Specimen Diameter: 51.4 mm	Rate of Displacement: < 0.1 mm/min

Failure Type: Tensile dominated

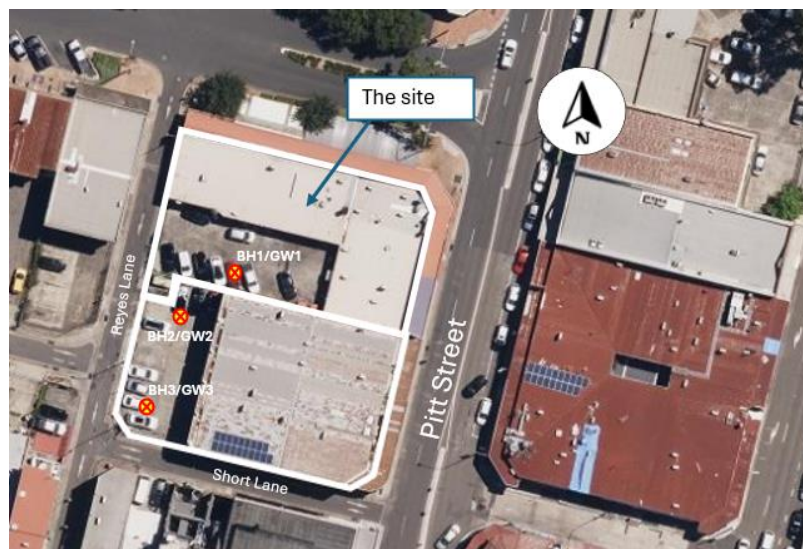
Figure 1. Site and Boreholes Location

KFM Geotech Pty Ltd (KFM) was commissioned by CEC Geotechnical to conduct a seepage assessment of the site for dewatering activities related to the basement excavation and construction at the proposed development site located at 229-239 Pitt St, Merrylands NSW 2160. This report will estimate groundwater take during the dewatering process and evaluate the impacts of groundwater drawdown on the adjacent properties. The seepage flow into the basement will be compared to Water NSW threshold 3 ML/year, which allows using a drained basement for the proposed development. The site is in the Cumberland City Council Local Government Area, and is bordered to the west by Reyes Lane, to the south by Milne Lane, to the east by Pitt St, and to the north by McFarlane St. The site covers approximately 2130 m². Ground levels decrease from about 16.9 m AHD on the northern boundary to 17.1 m AHD on the southern boundary. The site and borehole locations are shown in Figure 1.

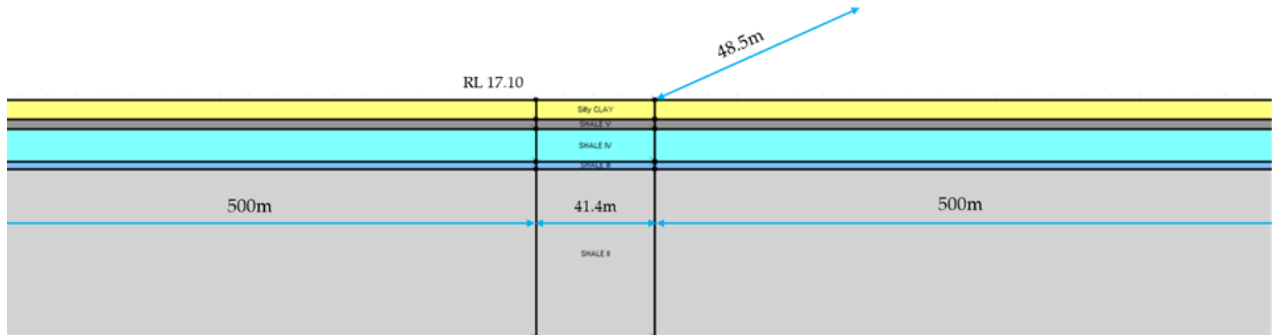
Figure 3. Numerical Model for Seepage Analysis Using SEEP/W

- Model distance from shoring wall: 500 m
- Ground level: RL 17.10
- Set groundwater level: RL 4.84

The numerical model for the seepage analysis is shown in Figure 3.

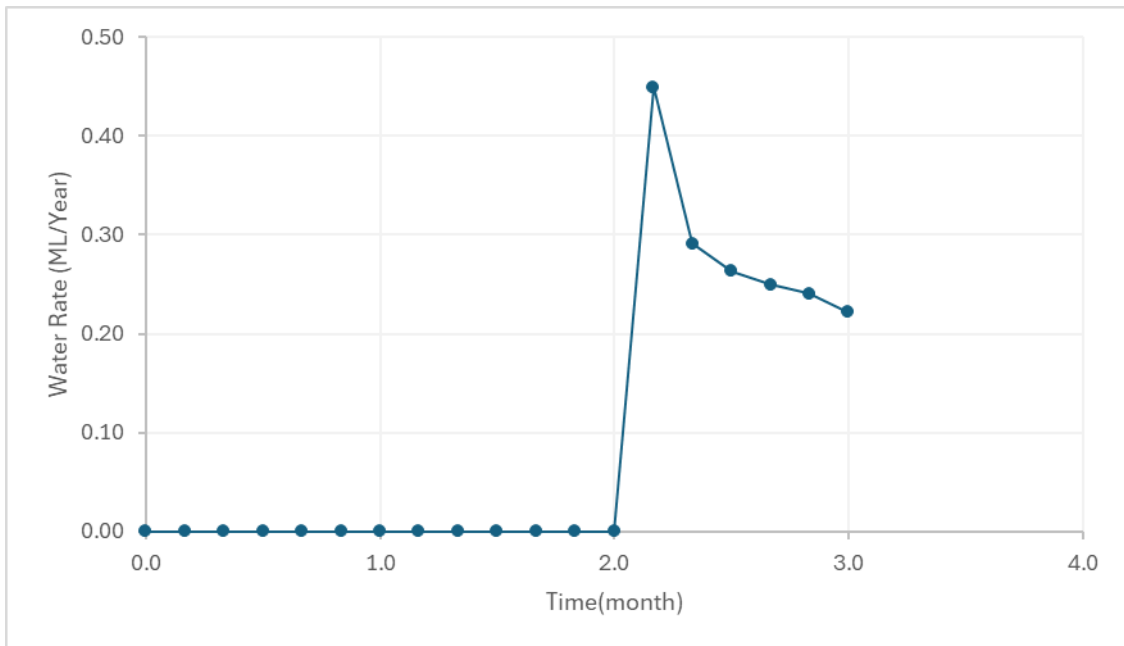
Figure 4. Groundwater Inflow Rate During Basement Excavation and Construction

Groundwater inflow rates and cumulative volumes for a 3,650-day dewatering period, as predicted by the 2D seepage model, are shown in Figures 4 to 7 and summarised in Table 2.

The estimated total groundwater extraction is approximately 0.024 ML during the 3-months period of basement excavation and construction, 0.16 ML after the first year, and 1.08 ML over the entire 121-month dewatering period. These volumes remain significantly below the 3 ML/year annual threshold. Consequently, in accordance with Water NSW’s Fact Sheet 250920 (Water Access Licence Exemptions), KFM Geotech concludes that the development is exempt from needing a Water Access Licence for both its construction and operational phases. However, Water Supply Works (WSW) approval from Water NSW may be required.

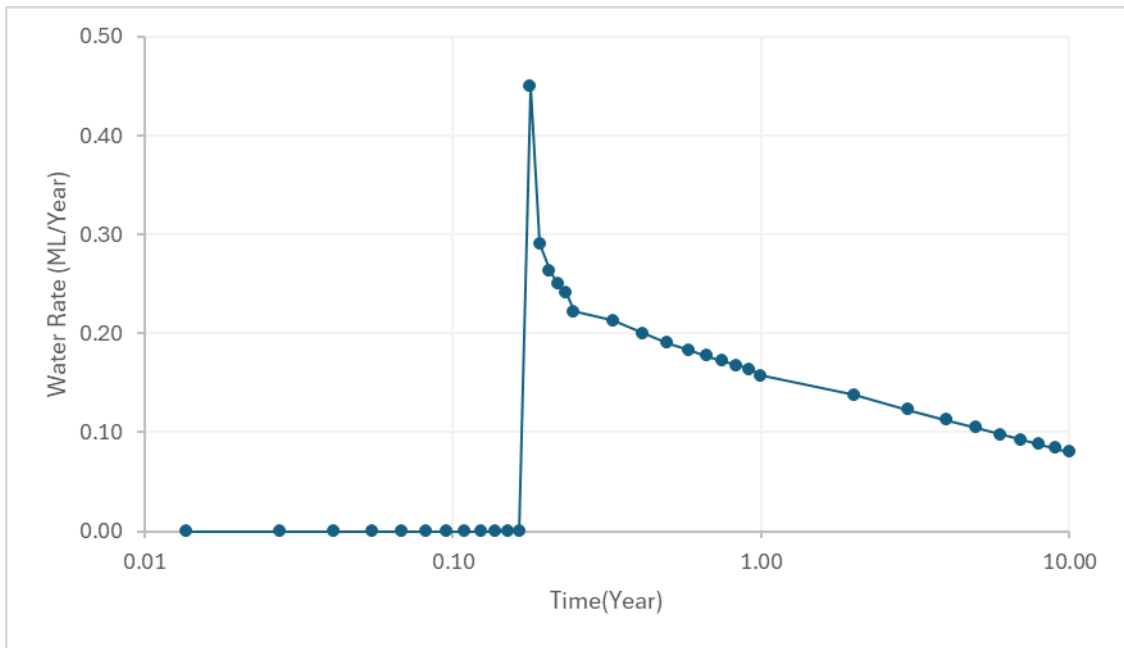
Figure 5. Groundwater Inflow Rate Over a Dewatering Period of 10.5 years

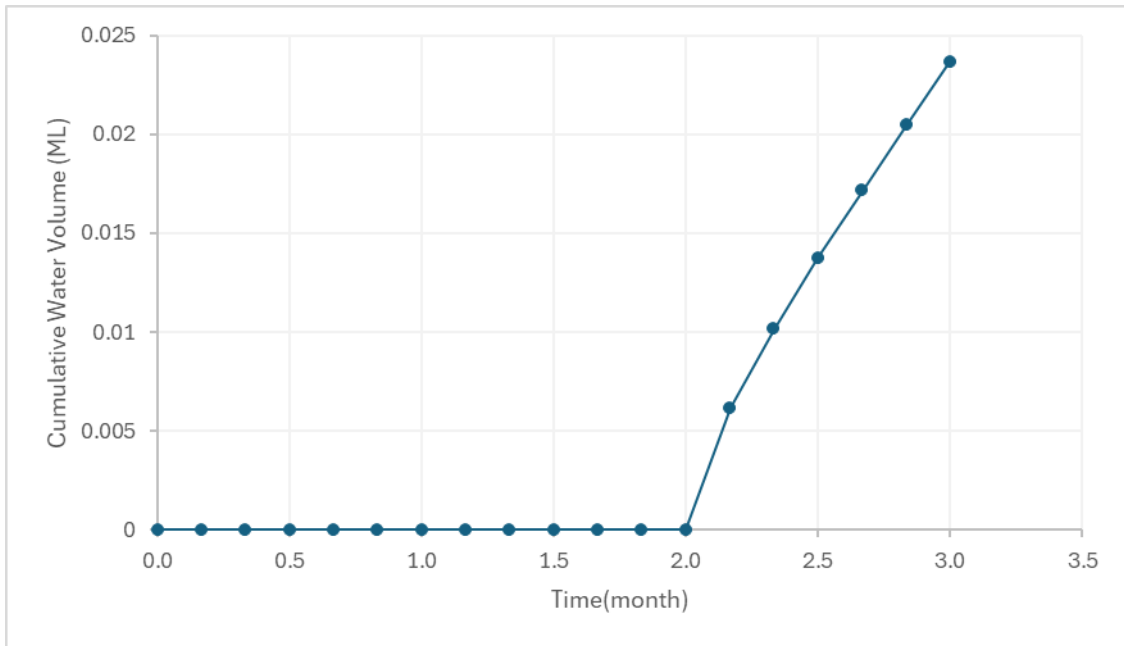
Figure 6. Cumulative Inflow Volume During Basement Excavation and Construction

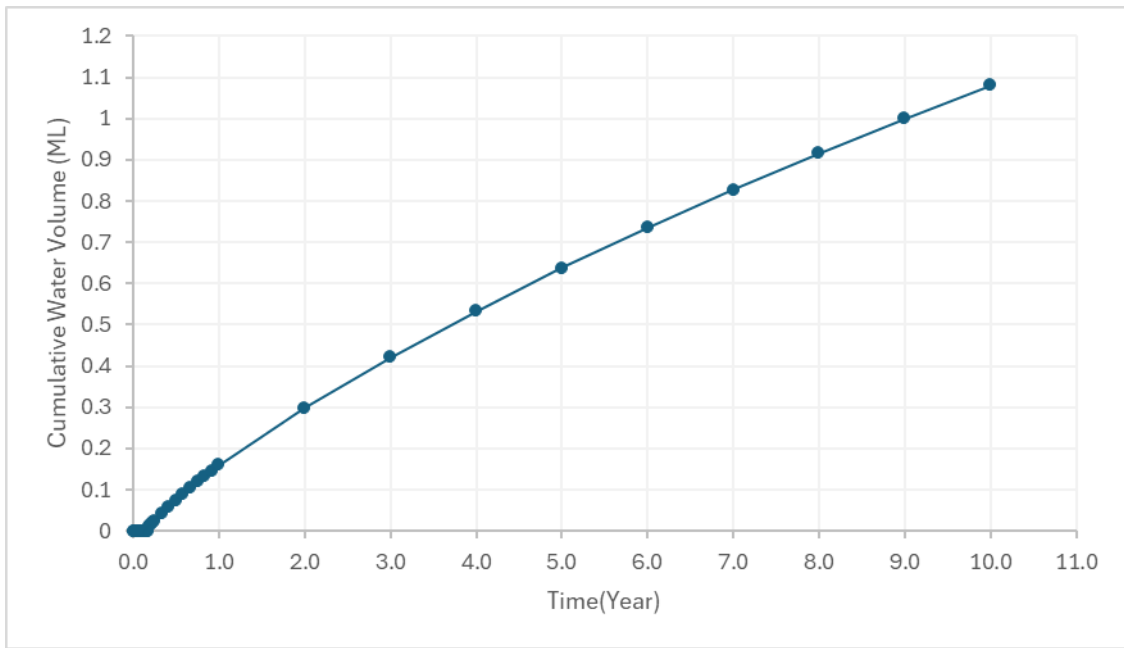
Figure 7. Cumulative Inflow Volume Over a Dewatering Period of 10.5 years

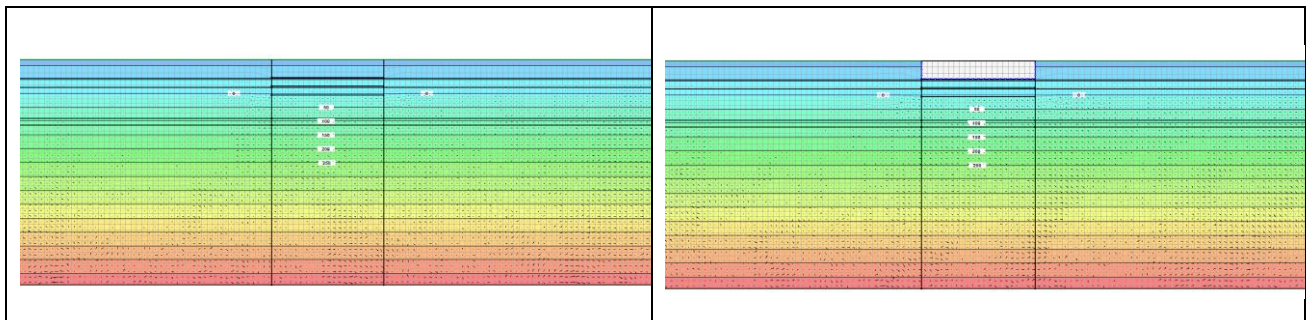
Figure 8. Contours of Pore-water Pressure After the Start of Dewatering a) 0 day, b) 30 days, c) 60 days, d) 90 days, e) 12 months, f) 121 months

The two-dimensional (2D) seepage analysis performed using SEEP/W allows for the determination of groundwater levels (indicating zero pore-water pressure) at various time intervals following the start of dewatering, as shown in Figure 8.
