# **Geotechnical Investigation Building A - Lot 102, 3 Halifax Street, Macquarie Park NSW**

**Prepared for: Lachlans Line A1 Pty Ltd**

**Reference: P3006\_18**

**Date: 23 February 2026**

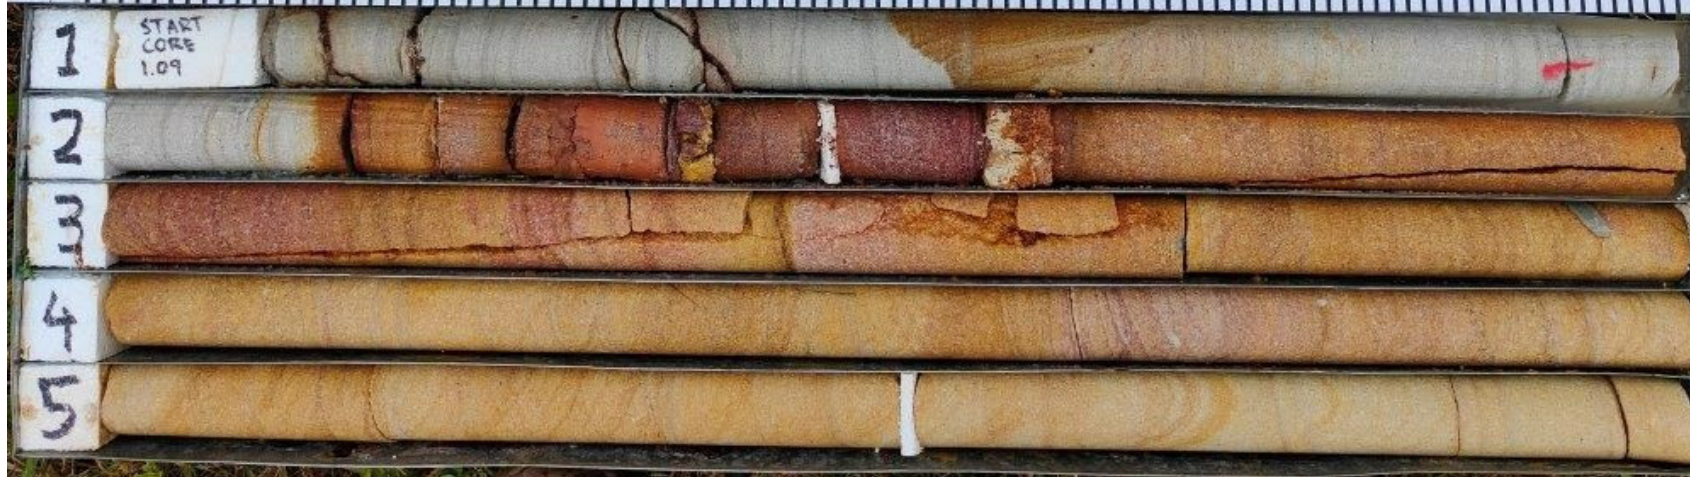
BOREHOLE ID: BH2  
DEPTH: 1.09 - 6.00m  
CORE TRAY NO.: 1 of 4  
DATE: 8/8/23

CLIENT NAME: LANDMARK GROUP  
PROJECT: 5 HALIFAX STREET  
LOCATION: MACQUARIE PARK  
JOB NUMBER: P2968  
LOGGED BY: AB+FL

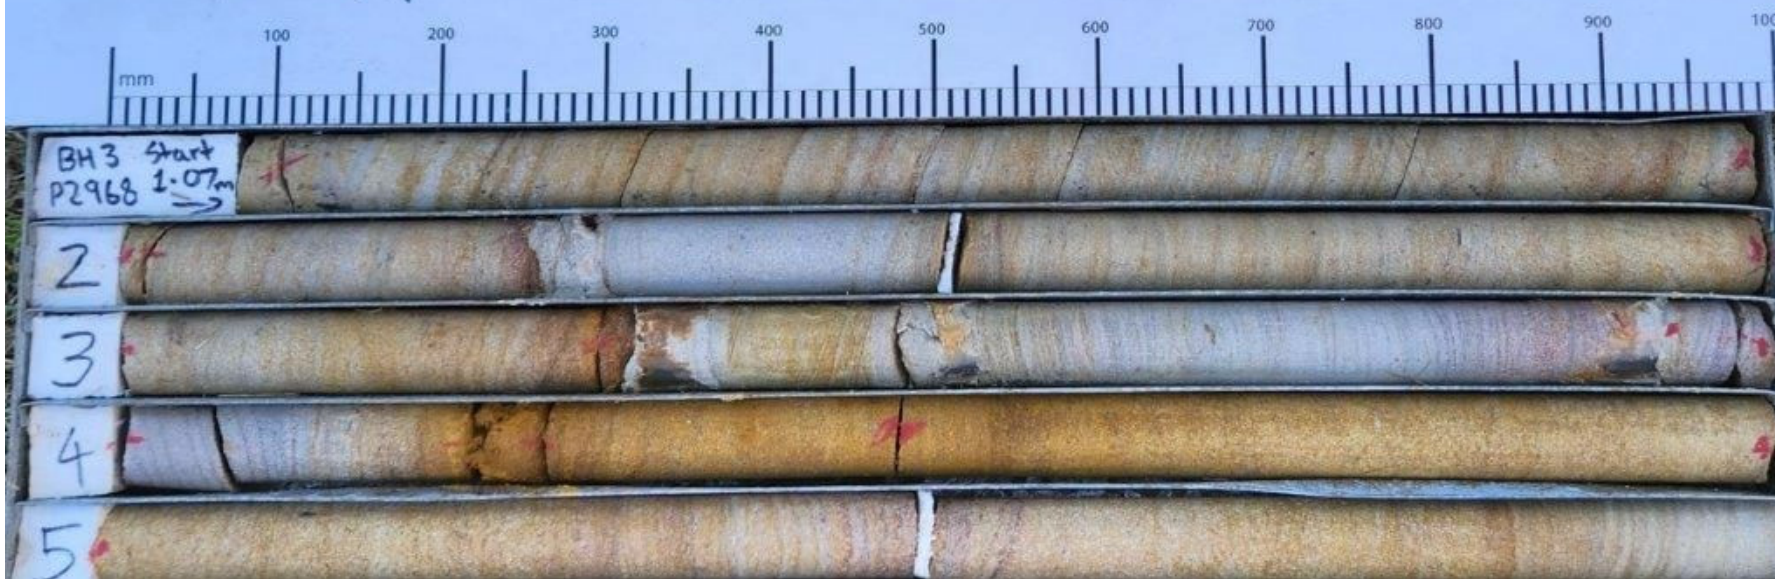
BOREHOLE ID: BH3  
DEPTH: 1.07m to 6.0m  
CORE TRAY NO: Box 1 of 6  
DATE: 10/08/23

CLIENT NAME: LANDMARK GROUP  
PROJECT: MACQUARIE PARK  
LOCATION: 5 HALIFAX STREET  
JOB NUMBER: P2968  
LOGGED BY: MP

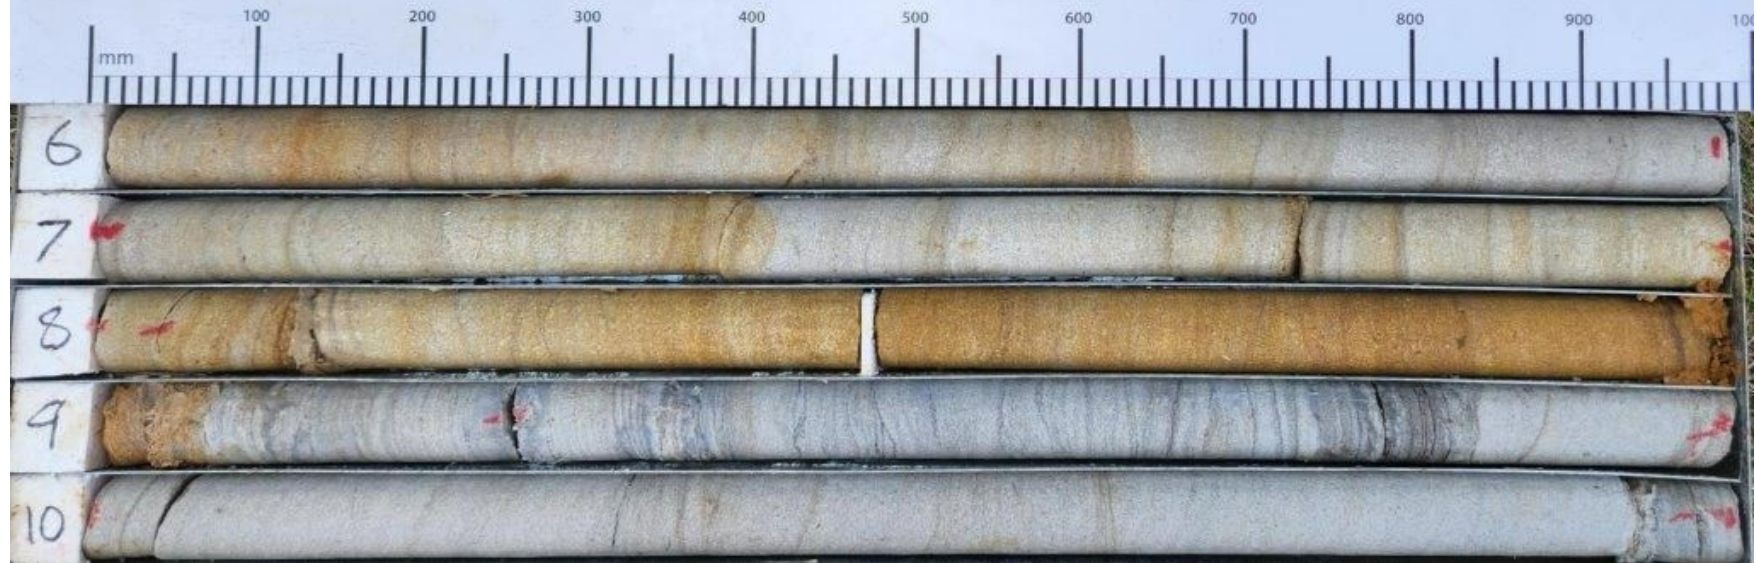
BOREHOLE ID: BH3  
DEPTH: 6.0m to 11.0m  
CORE TRAY NO: Box 2 of 6  
DATE: 10/08/23

CLIENT NAME: LANDMARK GROUP  
PROJECT: MACQUARIE PARK  
LOCATION: 5 HALIFAX STREET  
JOB NUMBER: P2968  
LOGGED BY: MP

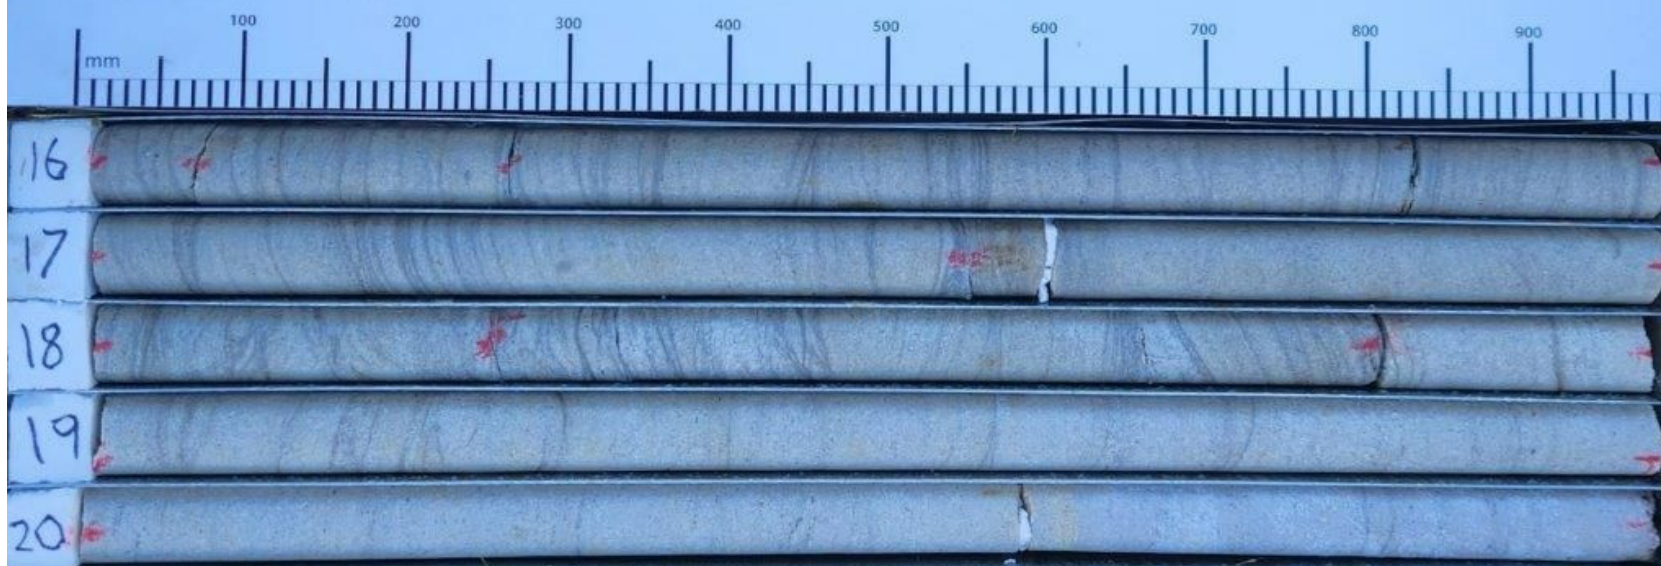
BOREHOLE ID: BH3  
DEPTH: 16.0m to 21.0m  
CORE TRAY NO: Box 4 of 6  
DATE: 11/08/23

CLIENT NAME: LANDMARK GROUP  
PROJECT: MACQUARIE PARK  
LOCATION: 5 HALIFAX STREET  
JOB NUMBER: P2968  
LOGGED BY: MP

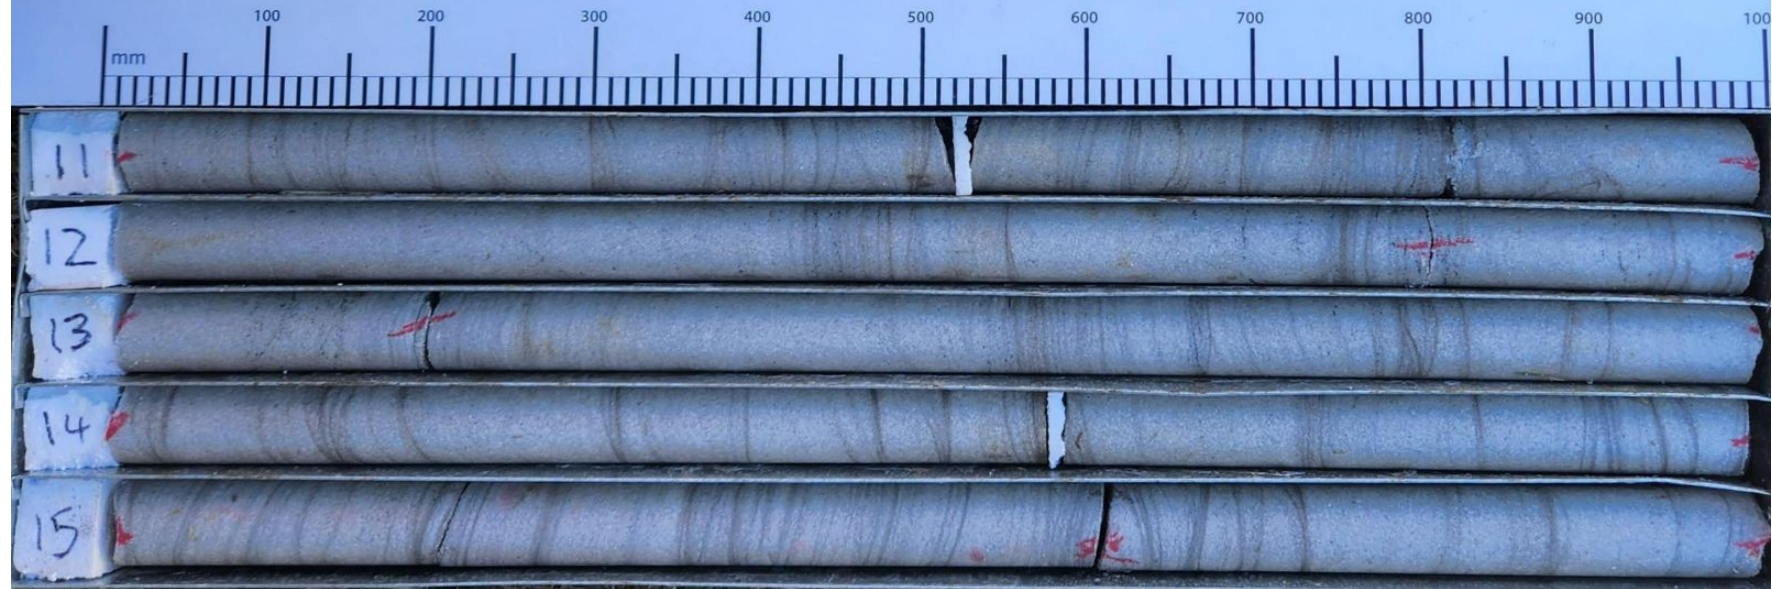
BOREHOLE ID: BH4  
DEPTH: 11.0m to 16.0m  
CORE TRAY NO.: Box 3 of 4  
DATE: 17.08.23

CLIENT NAME: LANDMARK GROUP  
PROJECT: MACQUARIE PARK  
LOCATION: 5 HALIFAX STREET  
JOB NUMBER: P3006  
LOGGED BY: MP

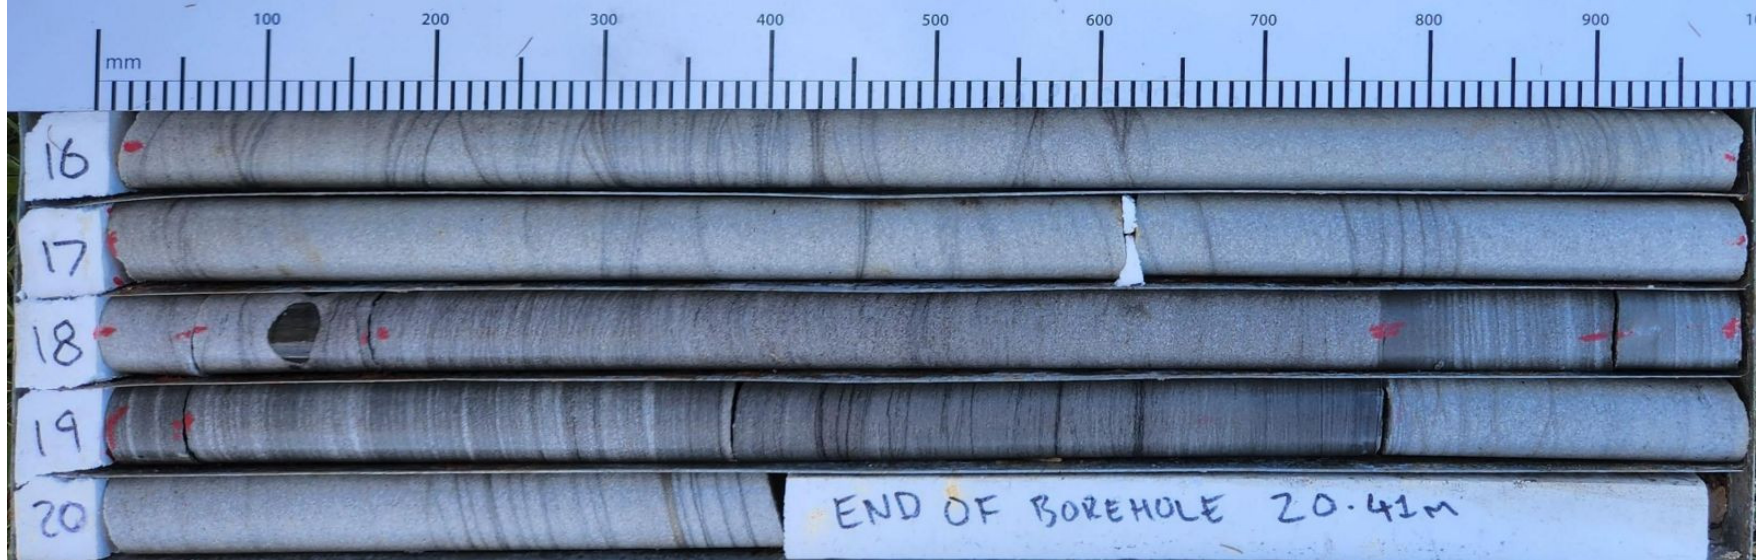
BOREHOLE ID: BH4  
DEPTH: 16.0 m to 20.41 m  
CORE TRAY NO.: Box 4 of 4  
DATE: 17.08.23

CLIENT NAME: LANDMARK GROUP  
PROJECT: MACQUARIE PARK  
LOCATION: 5 HALIFAX STREET  
JOB NUMBER: P3006  
LOGGED BY: MP
