# 3.2.4 Building CC4

### 3.2.4.1 Exterior

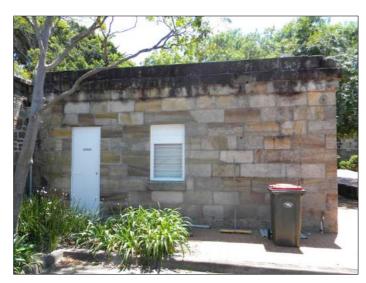
Figure 88: Southern elevation.

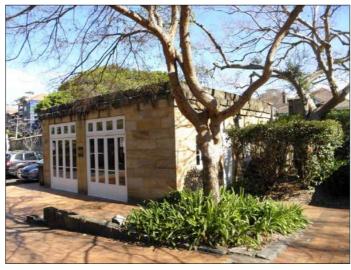
Figure 89: Northern and eastern elevations.

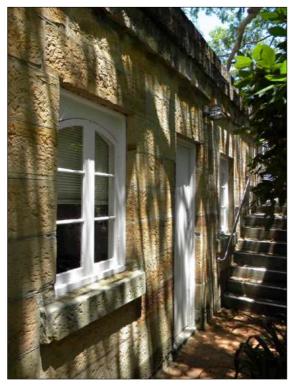
Figure 90: Northern elevation.

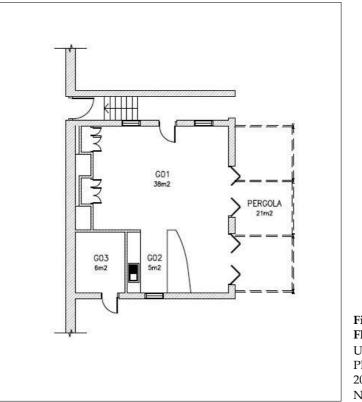
Figure 91: Floor Plan. UNSW Information Services. Plan last modified Setpember 2010. Note: there is no pergola.

The internal floor plan is best understood with reference to Figure 91.

Only G01 was accessible at the time of the site visits. The floor is of concrete. The stone walls are exposed. The ceiling and partition walls are of plaster board. Windows have tapered timber architraves. There is a modern kitchenette fit out. Figures 92 to 95 illustrate this space.

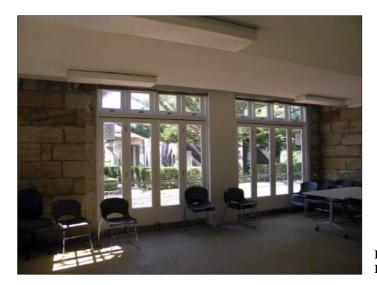
Figure 92: Interior, looking east.

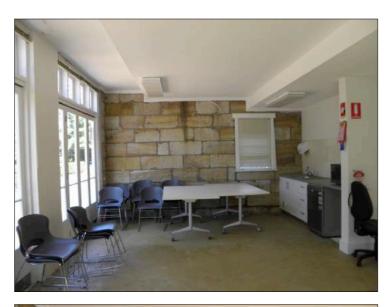
Figure 93: Interior, looking south.

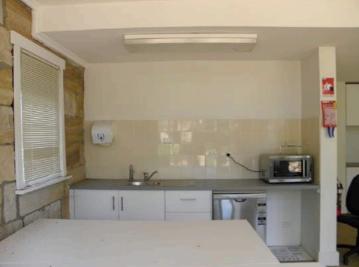
Figure 94: Interior, south western corner.

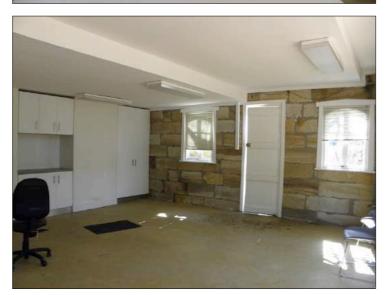
Figure 95: Interior, north western corner.

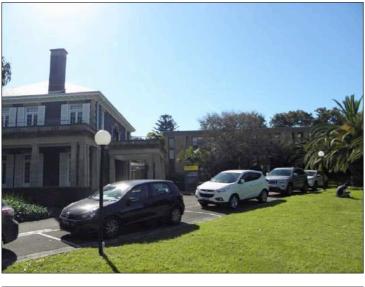
Figure 96: Building CC4 relative to *Cliffbrook*.

Building CC4 is a substantial two and three storey free standing building with walls of pale orange brick and a concealed roof form. The building was constructed in several phases and comprises two wings, forming an 'L-shape.' The majority of windows and doors are metal framed. Glazing patterns vary around the building. The southern elevation of the east-west wing and the western elevation of the northsouth wing have vertically orientated patterns of glazing. Windows are located one above the other and recessed into vertical channels. Windows on the western elevation of the north-south running wing have timber screens. The south eastern corner of the north-south wing has a stronger horizontal emphasis.

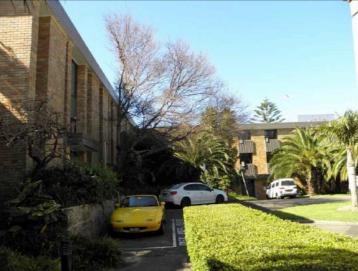
Figure 97: Looking east towards CC4, showing the southern elevation of the east-west wing and the western elvation of the north-south wing.

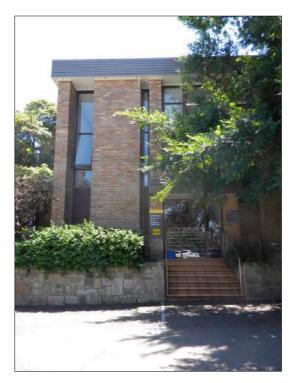
Figure 98: Western end of the southern elevation of the east-west running wing.

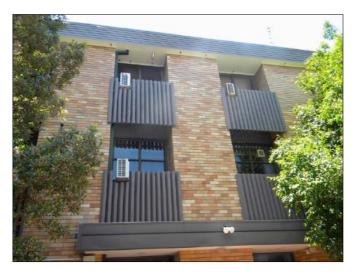
Figure 99: Northern end of the western elevation of the north-south running wing.

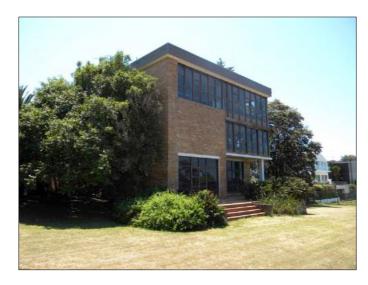
Figure 101: Southern end of the northsouth running wing.

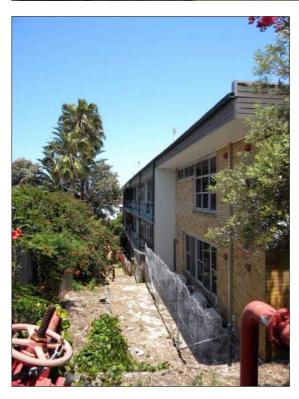
Figure 103: Looking south along the eastern elevation of the north-south running wing.

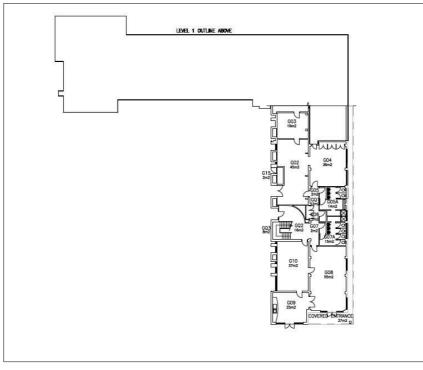
### Figure 104: Ground Floor.

UNSW Information Services. Plan last modified June 2004.

The interior floor plans are best understood with reference to Figures 104 to 106.

The north-south running wing was the only part of the building that could be accessed internally at the time that the site visits were carried out. Finishes in this wing are simple. The majority of the dividing walls at ground and first floor level are constructed of rendered masonry. At first floor, many of these walls are of plaster board. Ceilings are square set or plaster board with a shadow line. Doors are single panel doors. Timber joinery, where present, is simple in profile. Bathrooms and kitchens were refitted in 1993 and later.

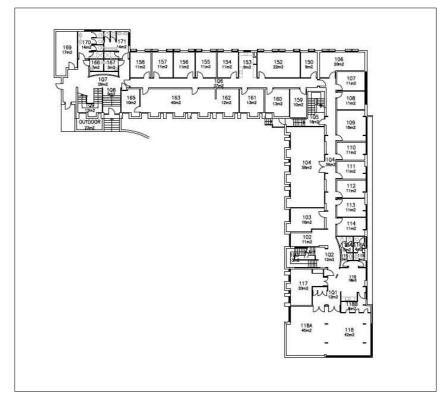
#### **Figure 105: Level 1** UNSW Information Services. Plan last modified: March 2013.

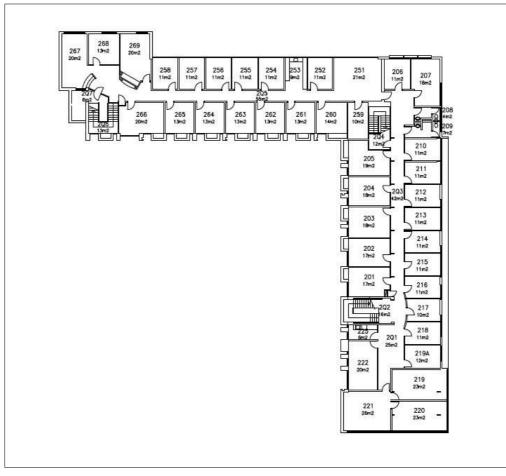
#### Figure 106: Level 2.

UNSW Information Services. Plan last modified: November 2011.

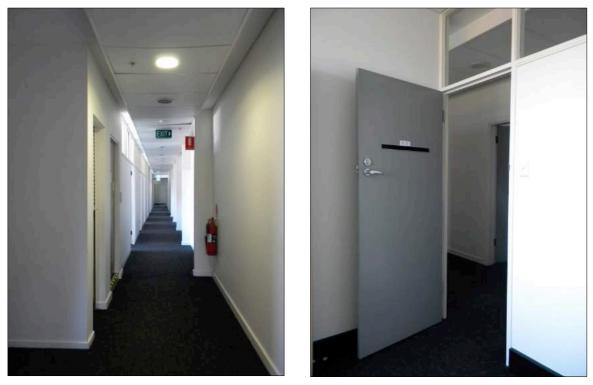
Figure 107: Hallway, Level 2.

Figure 108: Typical door in the north-south wing. Also showing a detail of the partition wall with fixed fanlights that line both sides of the corridor. This wall at this level is masonry.

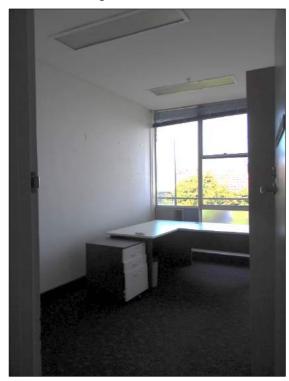
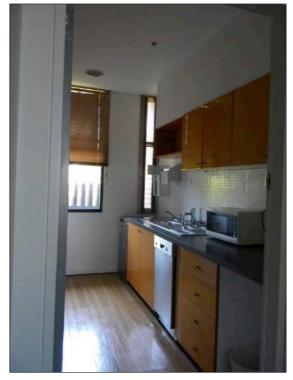
Figure 109: Typical room in the north-south wing (Room 210). Figure 110: Typical ktichenette fitout on Level 2.

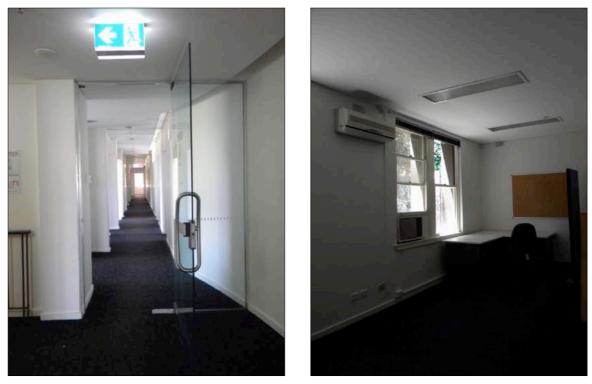
Figure 111: Hallway on Level 1.

Figure 112: Level 1, Room 106 at the northern end of the north-south wing. This room retains timber framed windows and belongs to the first phase of cosntruction.

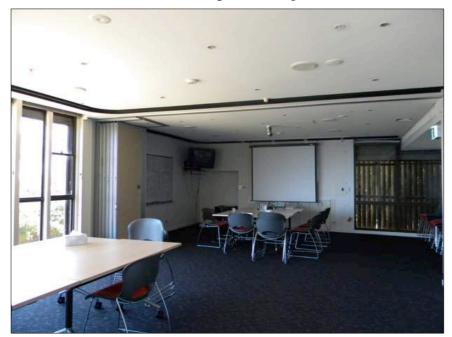
Figure 113: Room at the southern end, Level 1 (Rooms 118 and 118A).

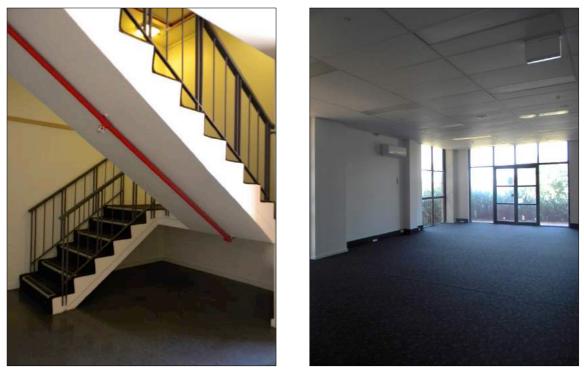
Figure 114: Detail of the staircase at the southern end of the north-south wing. Figure 115: Room 118.
