7.1.4 West Cliff Coal Wash Emplacement

Stage 3 Coal Wash Emplacement Version 4 6 April 2019

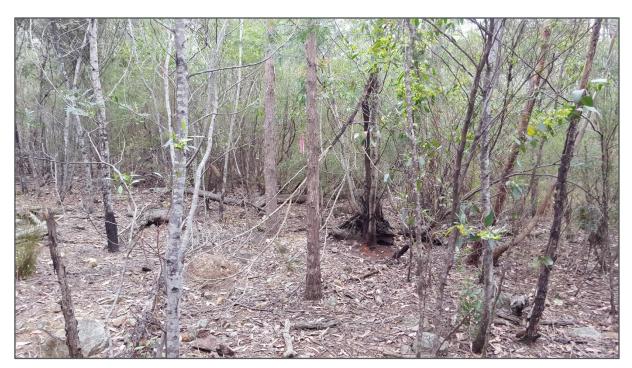
Plate 7-1 – West Cliff Stage 1 Coal Wash Emplacement Area – 14 Years After Completion Source: Illawarra Coal (2015b).

Plate 7-1 shows the West Cliff Stage 1 Coal Wash Emplacement approximately 14 years after completion of landform shaping and revegetation. Plate 7-2 shows the West Cliff Stage 2 Coal Wash Emplacement approximately five years after completion of landform shaping, with a dense cover of shrubs and high native species diversity.

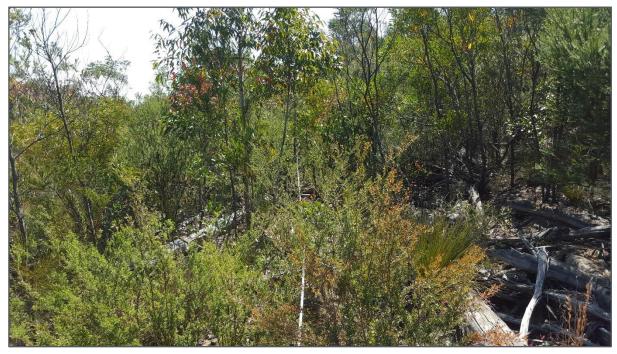
Plate 7-2 – West Cliff Stage 2 Coal Wash Emplacement Area – Five Years After Completion Source: Illawarra Coal (2015b).

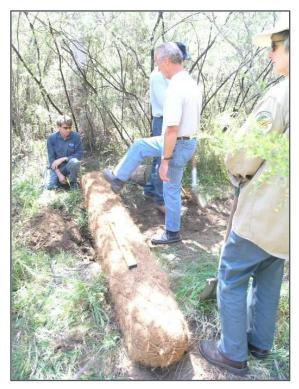
Maintenance of moisture in rehabilitation areas can be accomplished via water-spreading techniques. These techniques include implementing long lengths of coir logs and hessian 'sausages', linked together in such a way that water flow builds up behind them and slowly seeps through the water spreaders (Plate 7-7).

Plate 7-7 - Round Coir Logs Installed to Spread Water Source: Good et al. (2010).

Erosion control and water spreading involves soft-engineering materials that are biodegradable and would eventually become integrated into the soil profile.
