HYDROGEOLOGICAL REPORT AND DEWATERING MANAGEMENT PLAN

16-20 Carrington Road, Castle Hill NSW 2154

ARADA Pty Ltd

20 June 2025

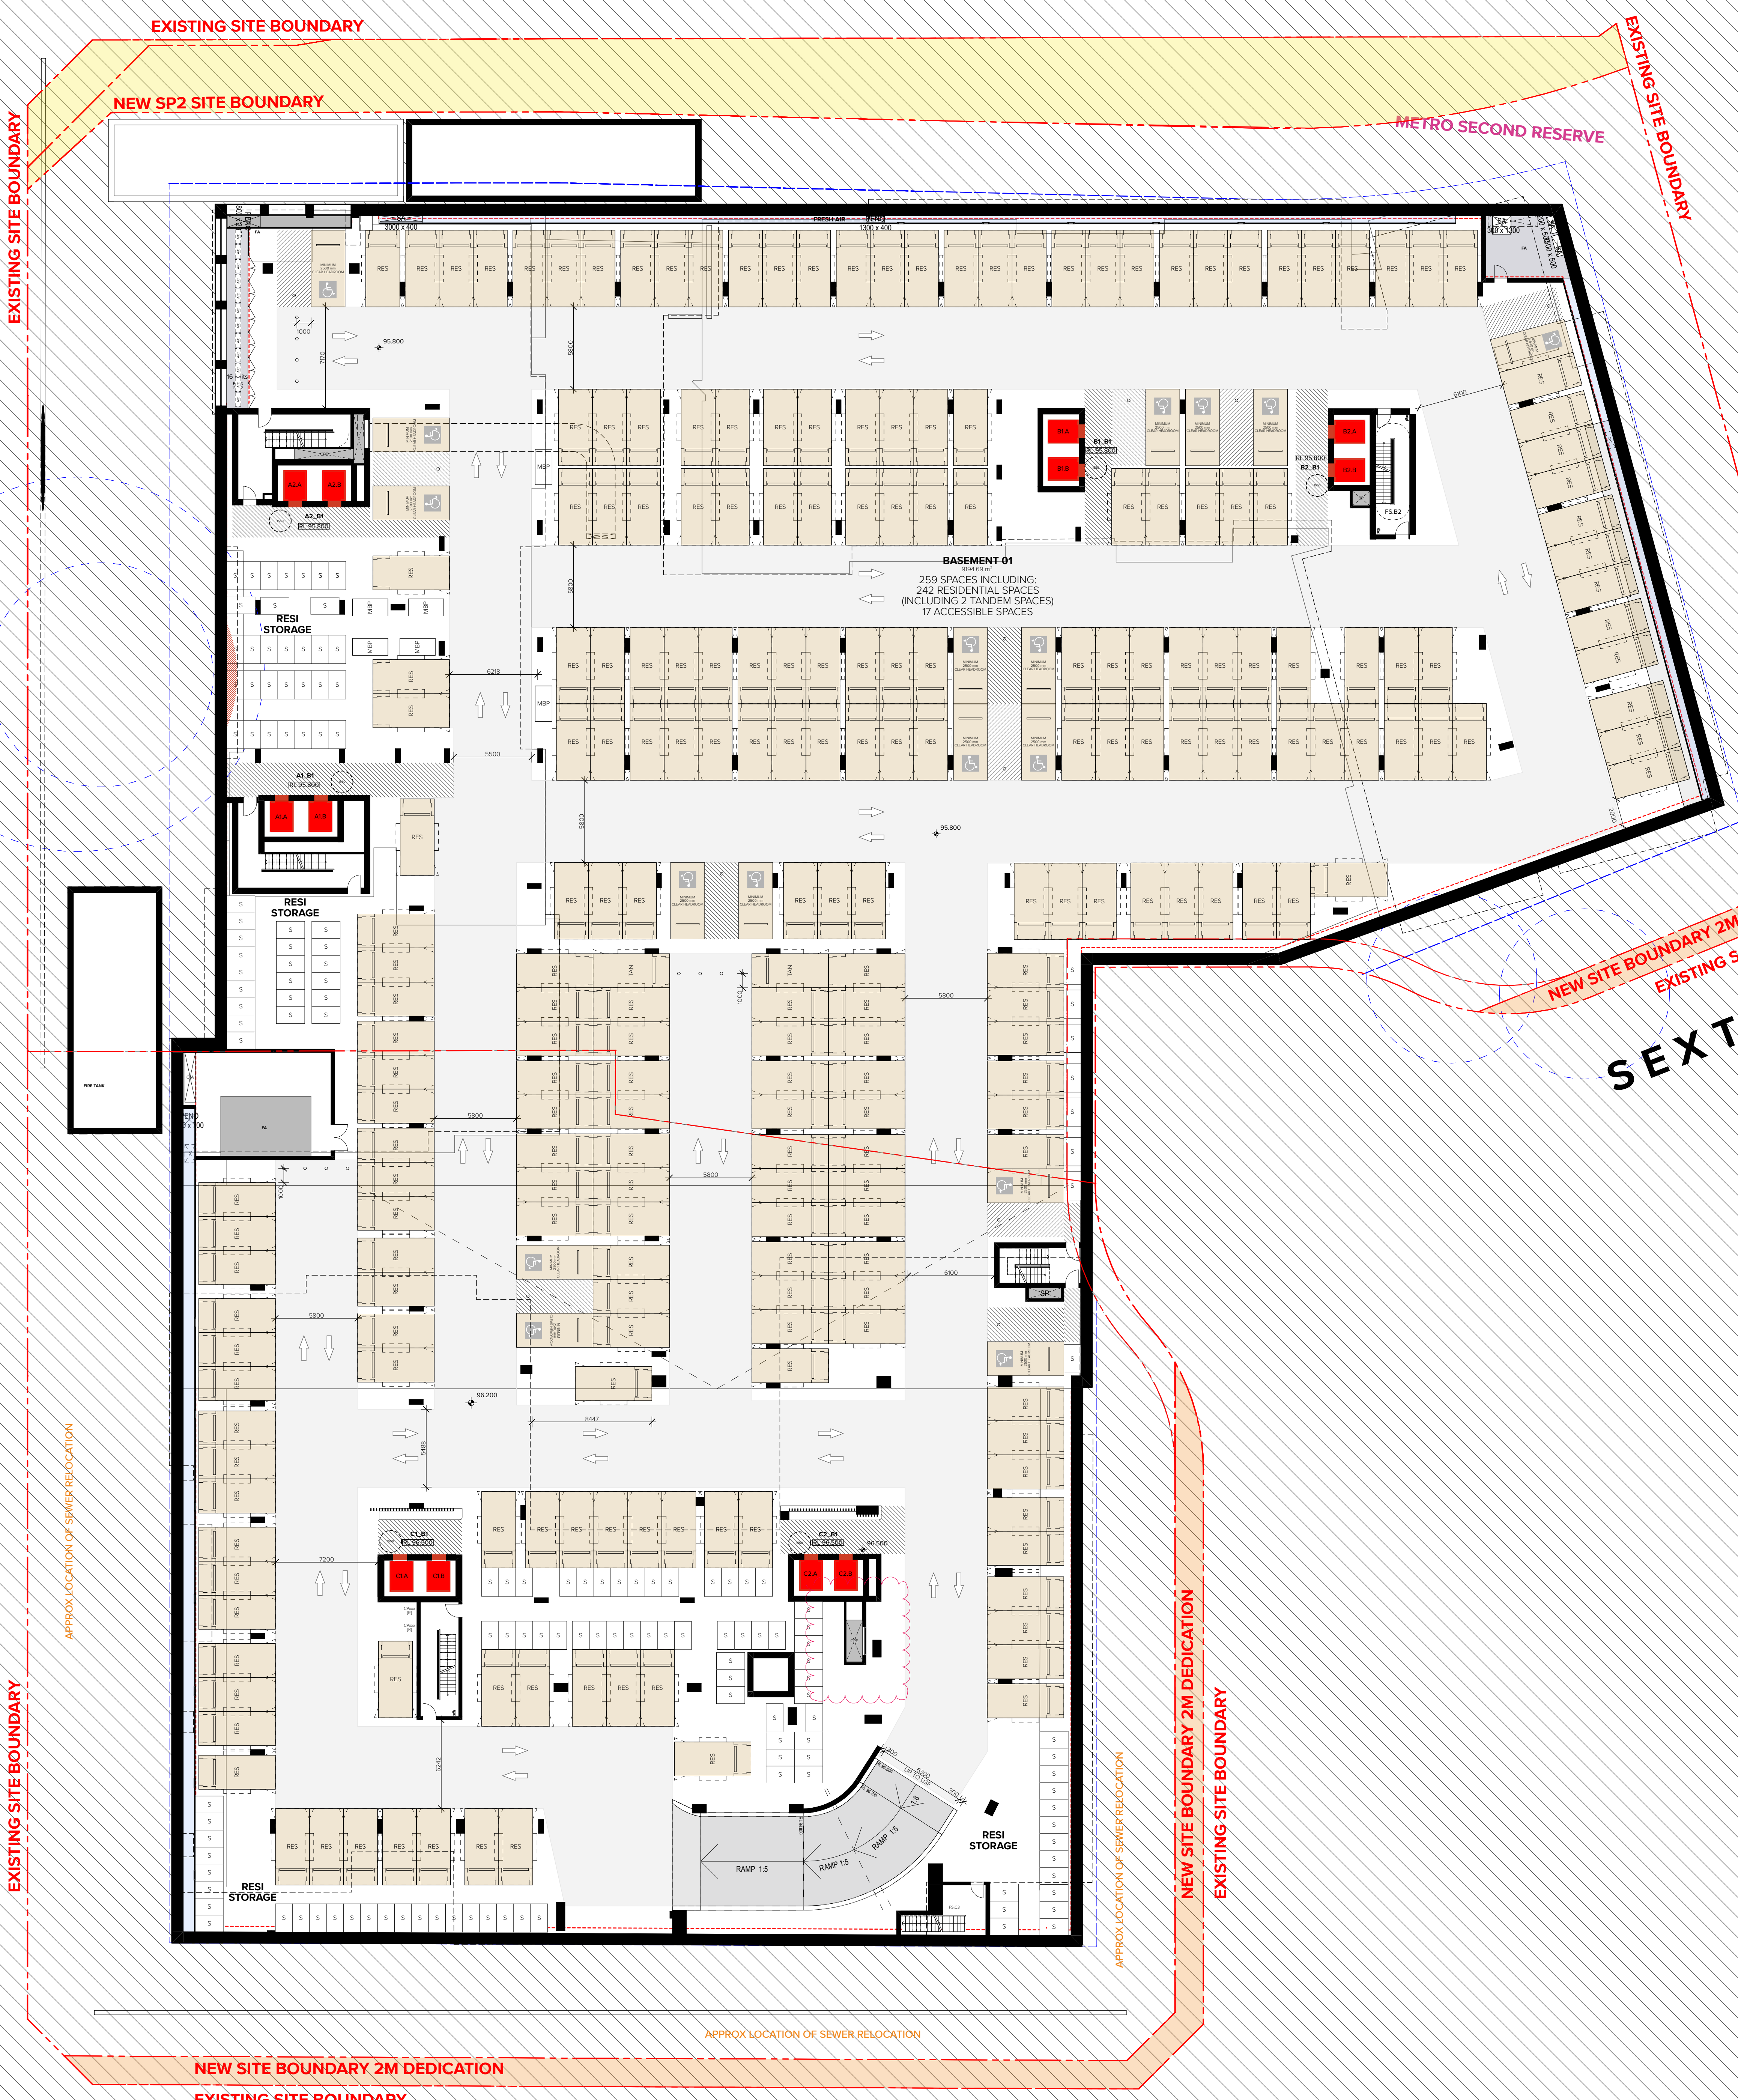
MIDDLETON AVENUE
MINOR COLLECTOR (24M) + CYCLE WAY

FISHBURN CRESCENT
LOCAL STREET (17M)

NEW SITE BOUNDARY 2M DEDICATION
EXISTING SITE BOUNDARY
