**Report on Groundwater Impact  
Assessment**

**Proposed Multistorey Residential  
Development**

**5-7 Church & 42 Donald Street, Nelson Bay  
NSW**

**Project 227295.03**

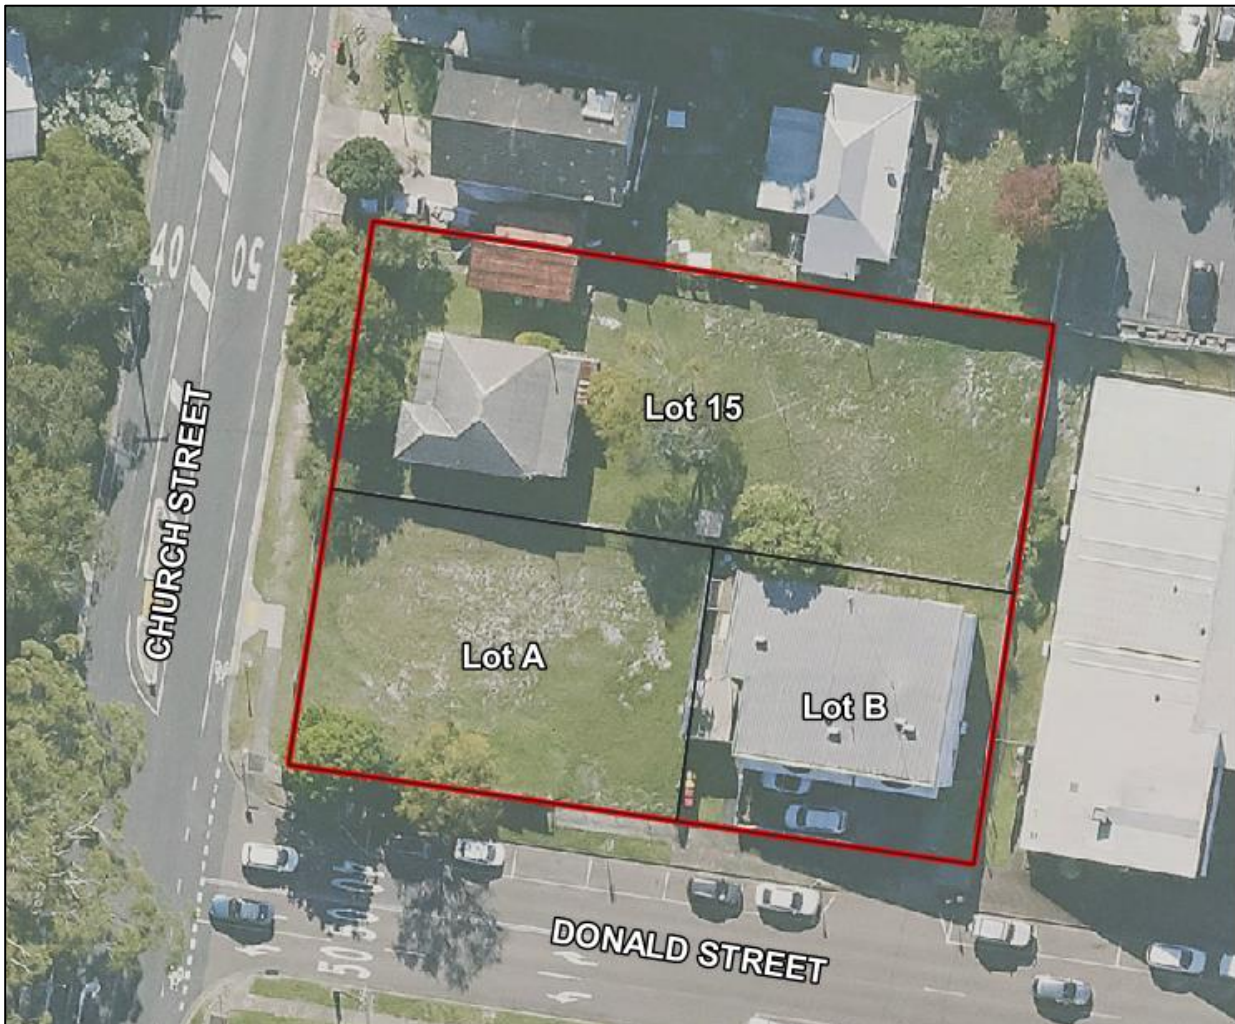
**Figure 1: Site location, approximate site boundary shown in red.**

A The site currently comprises a single commercial building in the south eastern area of the site (Lot B). Previous investigations by Douglas indicate that the ground surface at the site slopes to the south east with elevations from approximately RL 25 (AHD) in the north western area of the site to RL 20 in the south eastern area of the site.

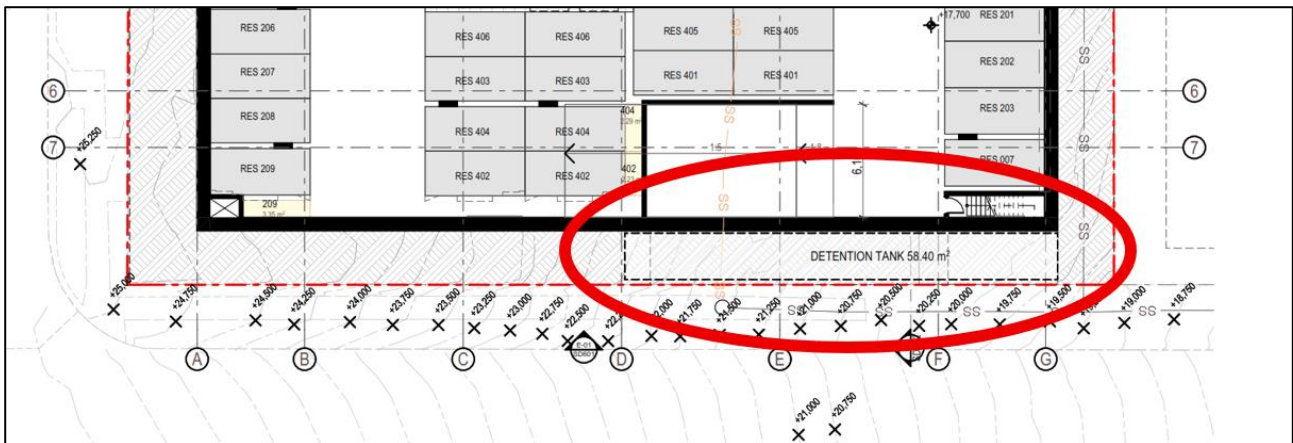
**Figure 4: Detention tank shown in red, figure adapted from client supplied drawings (Hayes Anderson Lynch Architects Pty Ltd GA Plan – Basement 02 drawing TP201)**

A detention tank is also proposed in the south eastern area of the site. From discussions with the client it is understood that the detention tank will partially infiltrate stormwater and therefore requires subsurface conditions which are favourable to soil infiltration. Based on client supplied drawings it is understood that the tank footprint is approximately 50 m<sup>2</sup> and will be installed to a depth less than the basement floor level (i.e. RL 17) (see Figure 3 and Figure 4).

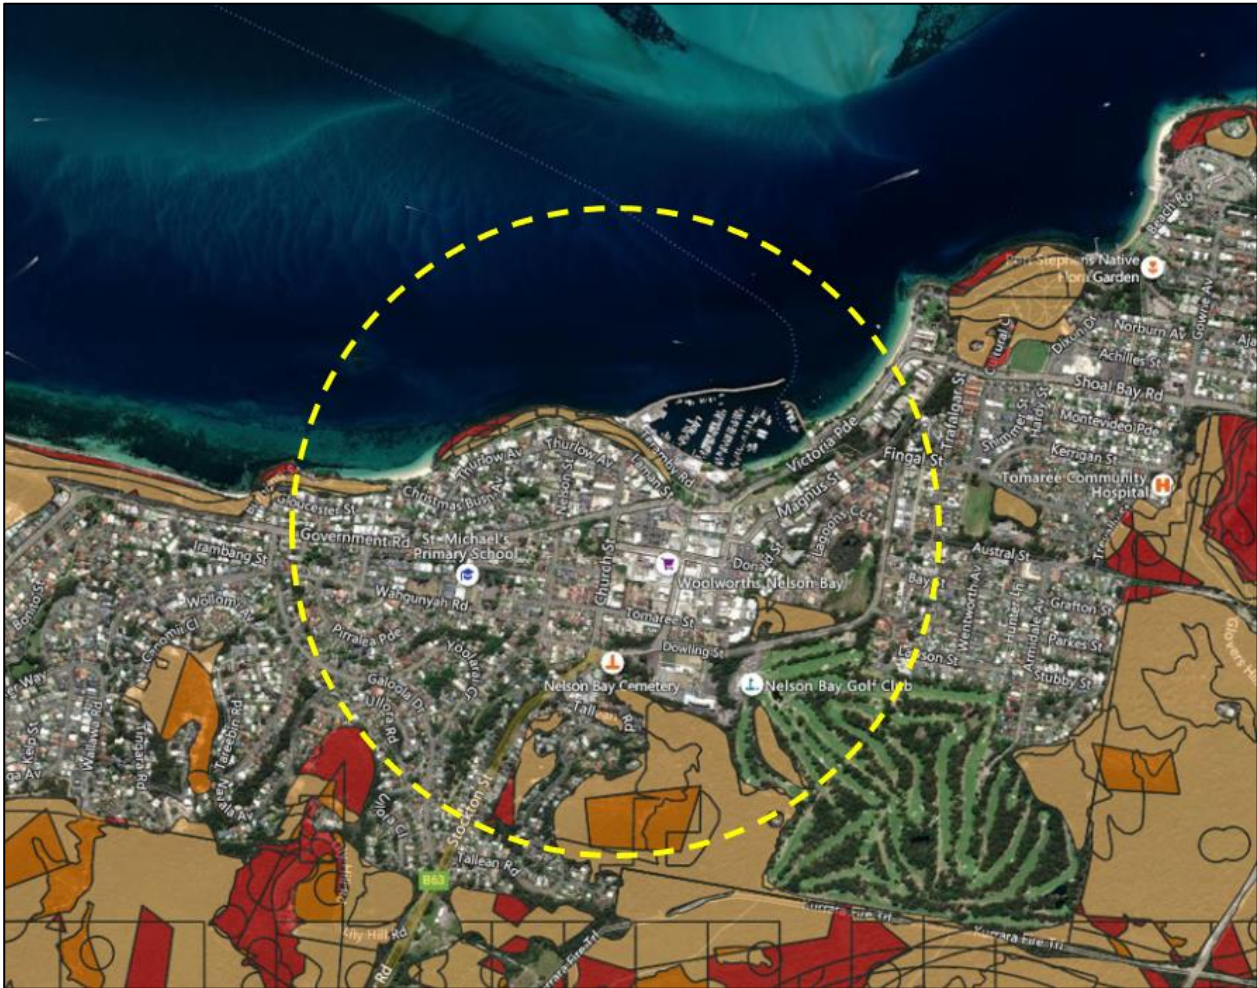
**Figure 6: Approximate 1 km buffer from the site shown with yellow dash circle, high potential GDE (red), moderate potential GDE (pale orange), low potential GDE (orange).**

Reference to the Australia GDE atlas indicates the following groundwater dependent ecosystems (GDEs) within 1 km of the site:

- 250 m north mapped as low to high potential for terrestrial GDE. These locations are located immediately along the foreshore of Nelson Bay.;
- 400 m east/south east mapped as moderate potential for terrestrial GDE;
- 450 m south mapped as low to high potential for terrestrial GDE; and
- 1 km south west mapped as high potential for terrestrial GDE.

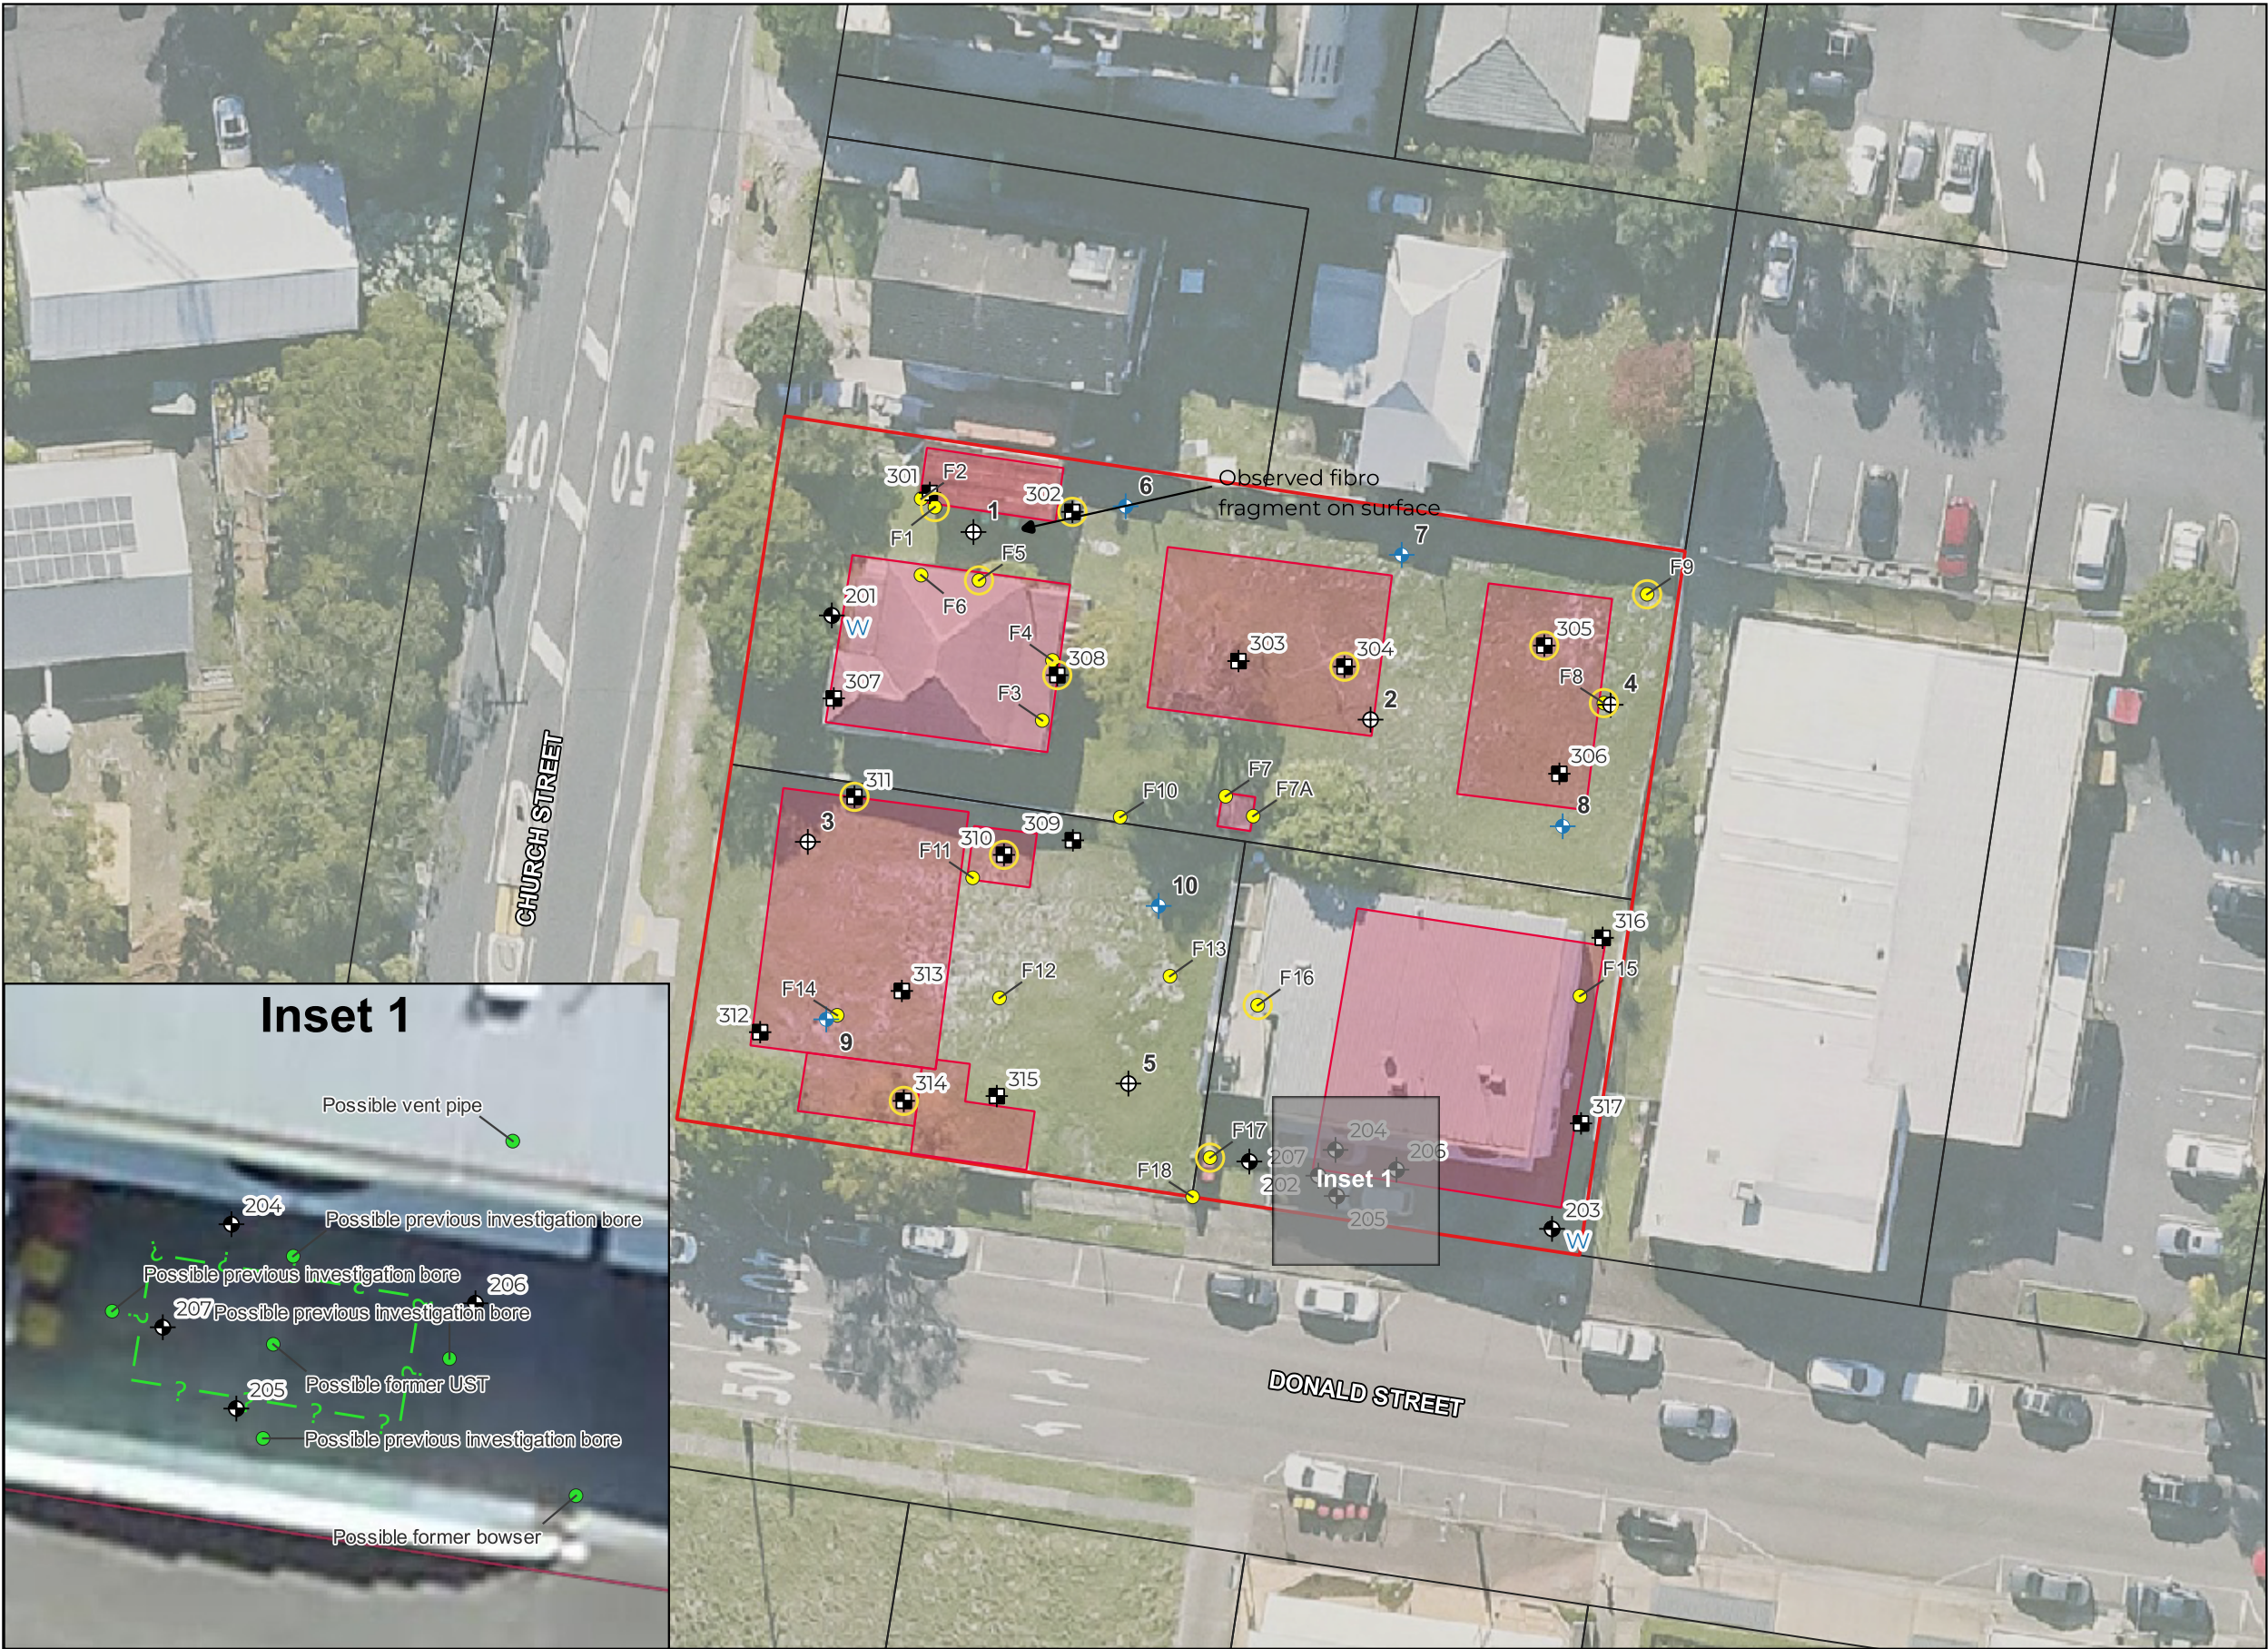
Project: 227295.01  
DRAWING No: 1  
REVISION: 0

Drawing 1 – Test Location Plan (Douglas, 2025b)
