# CPTED Design Input Report

Project Address: 43-45 Beane St & 2 Keevers Lane, Gosford,  
NSW 2250

Prepared for: Tony Owen Partners

Report Ref: 460352-43-45BeaneSt&2KeeversLane-  
LoteCPTEDDesignInput-RevC

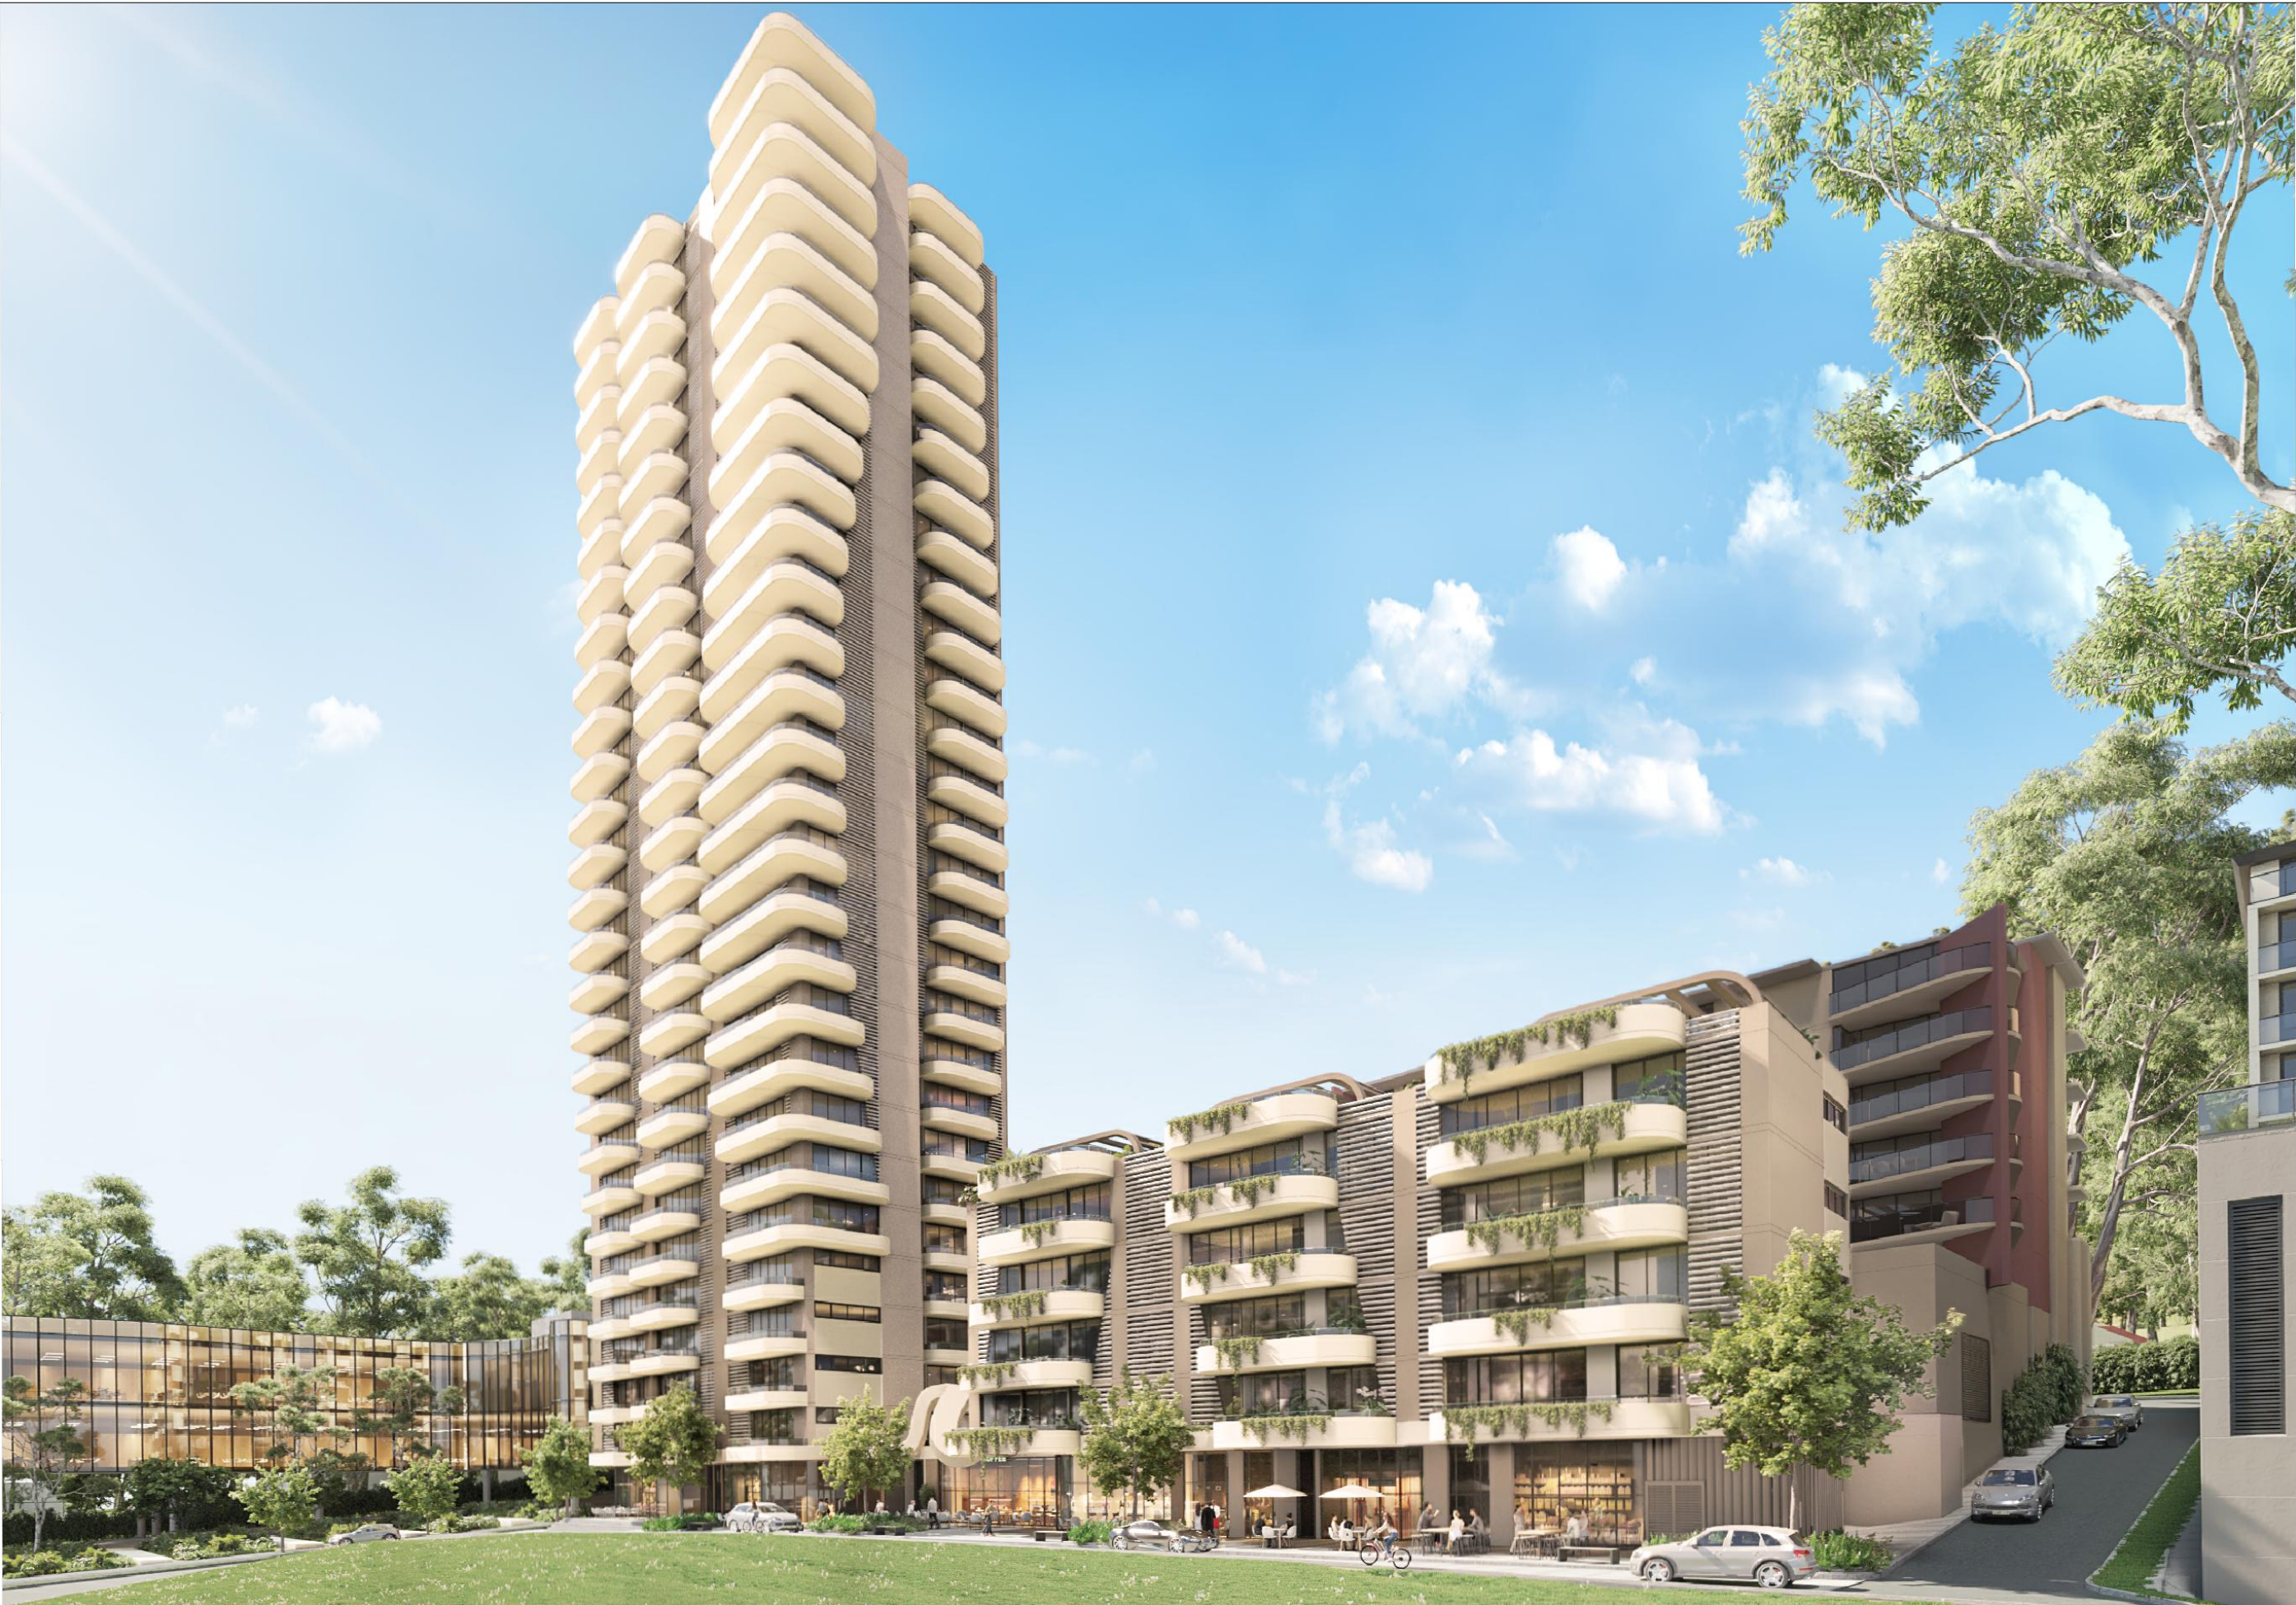
| Rev. | Description | By | Date | Disclaimer | Notes | Legend | DRAWING LABEL | Client | Architects | Project | Project address | Key plan | Scale | Date |
|---|---|---|---|---|---|---|---|---|---|---|---|---|---|---|
| A | ISSUE TO CLIENT | ZS | 03/2025 | THESE DRAWINGS ARE PRELIMINARY DRAWINGS AND ARE SUBJECT TO CHANGE WITHOUT NOTICE DURING THE COURSE OF THE PROPOSED DEVELOPMENT AND IN CONSULTATION WITH COUNCIL. SUBMISSION OF THE DRAWINGS DOES NOT CONSTITUTE A REPRESENTATION OR WARRANTY BY THE DESIGNER OR ITS SUBSIDIARIES, AGENTS OR CONTRACTORS THAT THE DRAWINGS ARE FINAL AND THAT THE PROPOSED DEVELOPMENT WILL TAKE PLACE IN ACCORDANCE WITH THESE DRAWINGS. BEFORE CARRYING OUT ANY WORK, ENSURE THAT THE DRAWINGS USED CARRY THE LATEST AMENDMENT NO. | THESE DRAWINGS ARE MADE TO A LARGER SCALE AND THOSE SHOWING PARTICULAR SCALE OF WORKS SHALL TAKE PRECEDENCE OVER DRAWINGS MADE TO A SMALLER SCALE AND FOR MORE GENERAL PURPOSES. WHERE ANY DISCREPANCY EXISTS BETWEEN FIGURED AND SCALED DIMENSIONS, THE FIGURED DIMENSIONS SHALL PREVAIL. BUILDER TO CHECK ALL SITE DIMENSIONS PRIOR TO FABRICATION OF FIXTURES. | | | MING TIAN REAL PROPERTY PTY LTD | body<br>ptnrs | BEANE STREET & KEEVER LANE HOUSING DEVELOPMENT | 43-45 BEANE STREET & 2 KEEVERS LANE, GOSFORD, 2163 NSW | | Drawing title<br>PERSPECTIVES | Project no. 1081<br>Drawing no. A150 |

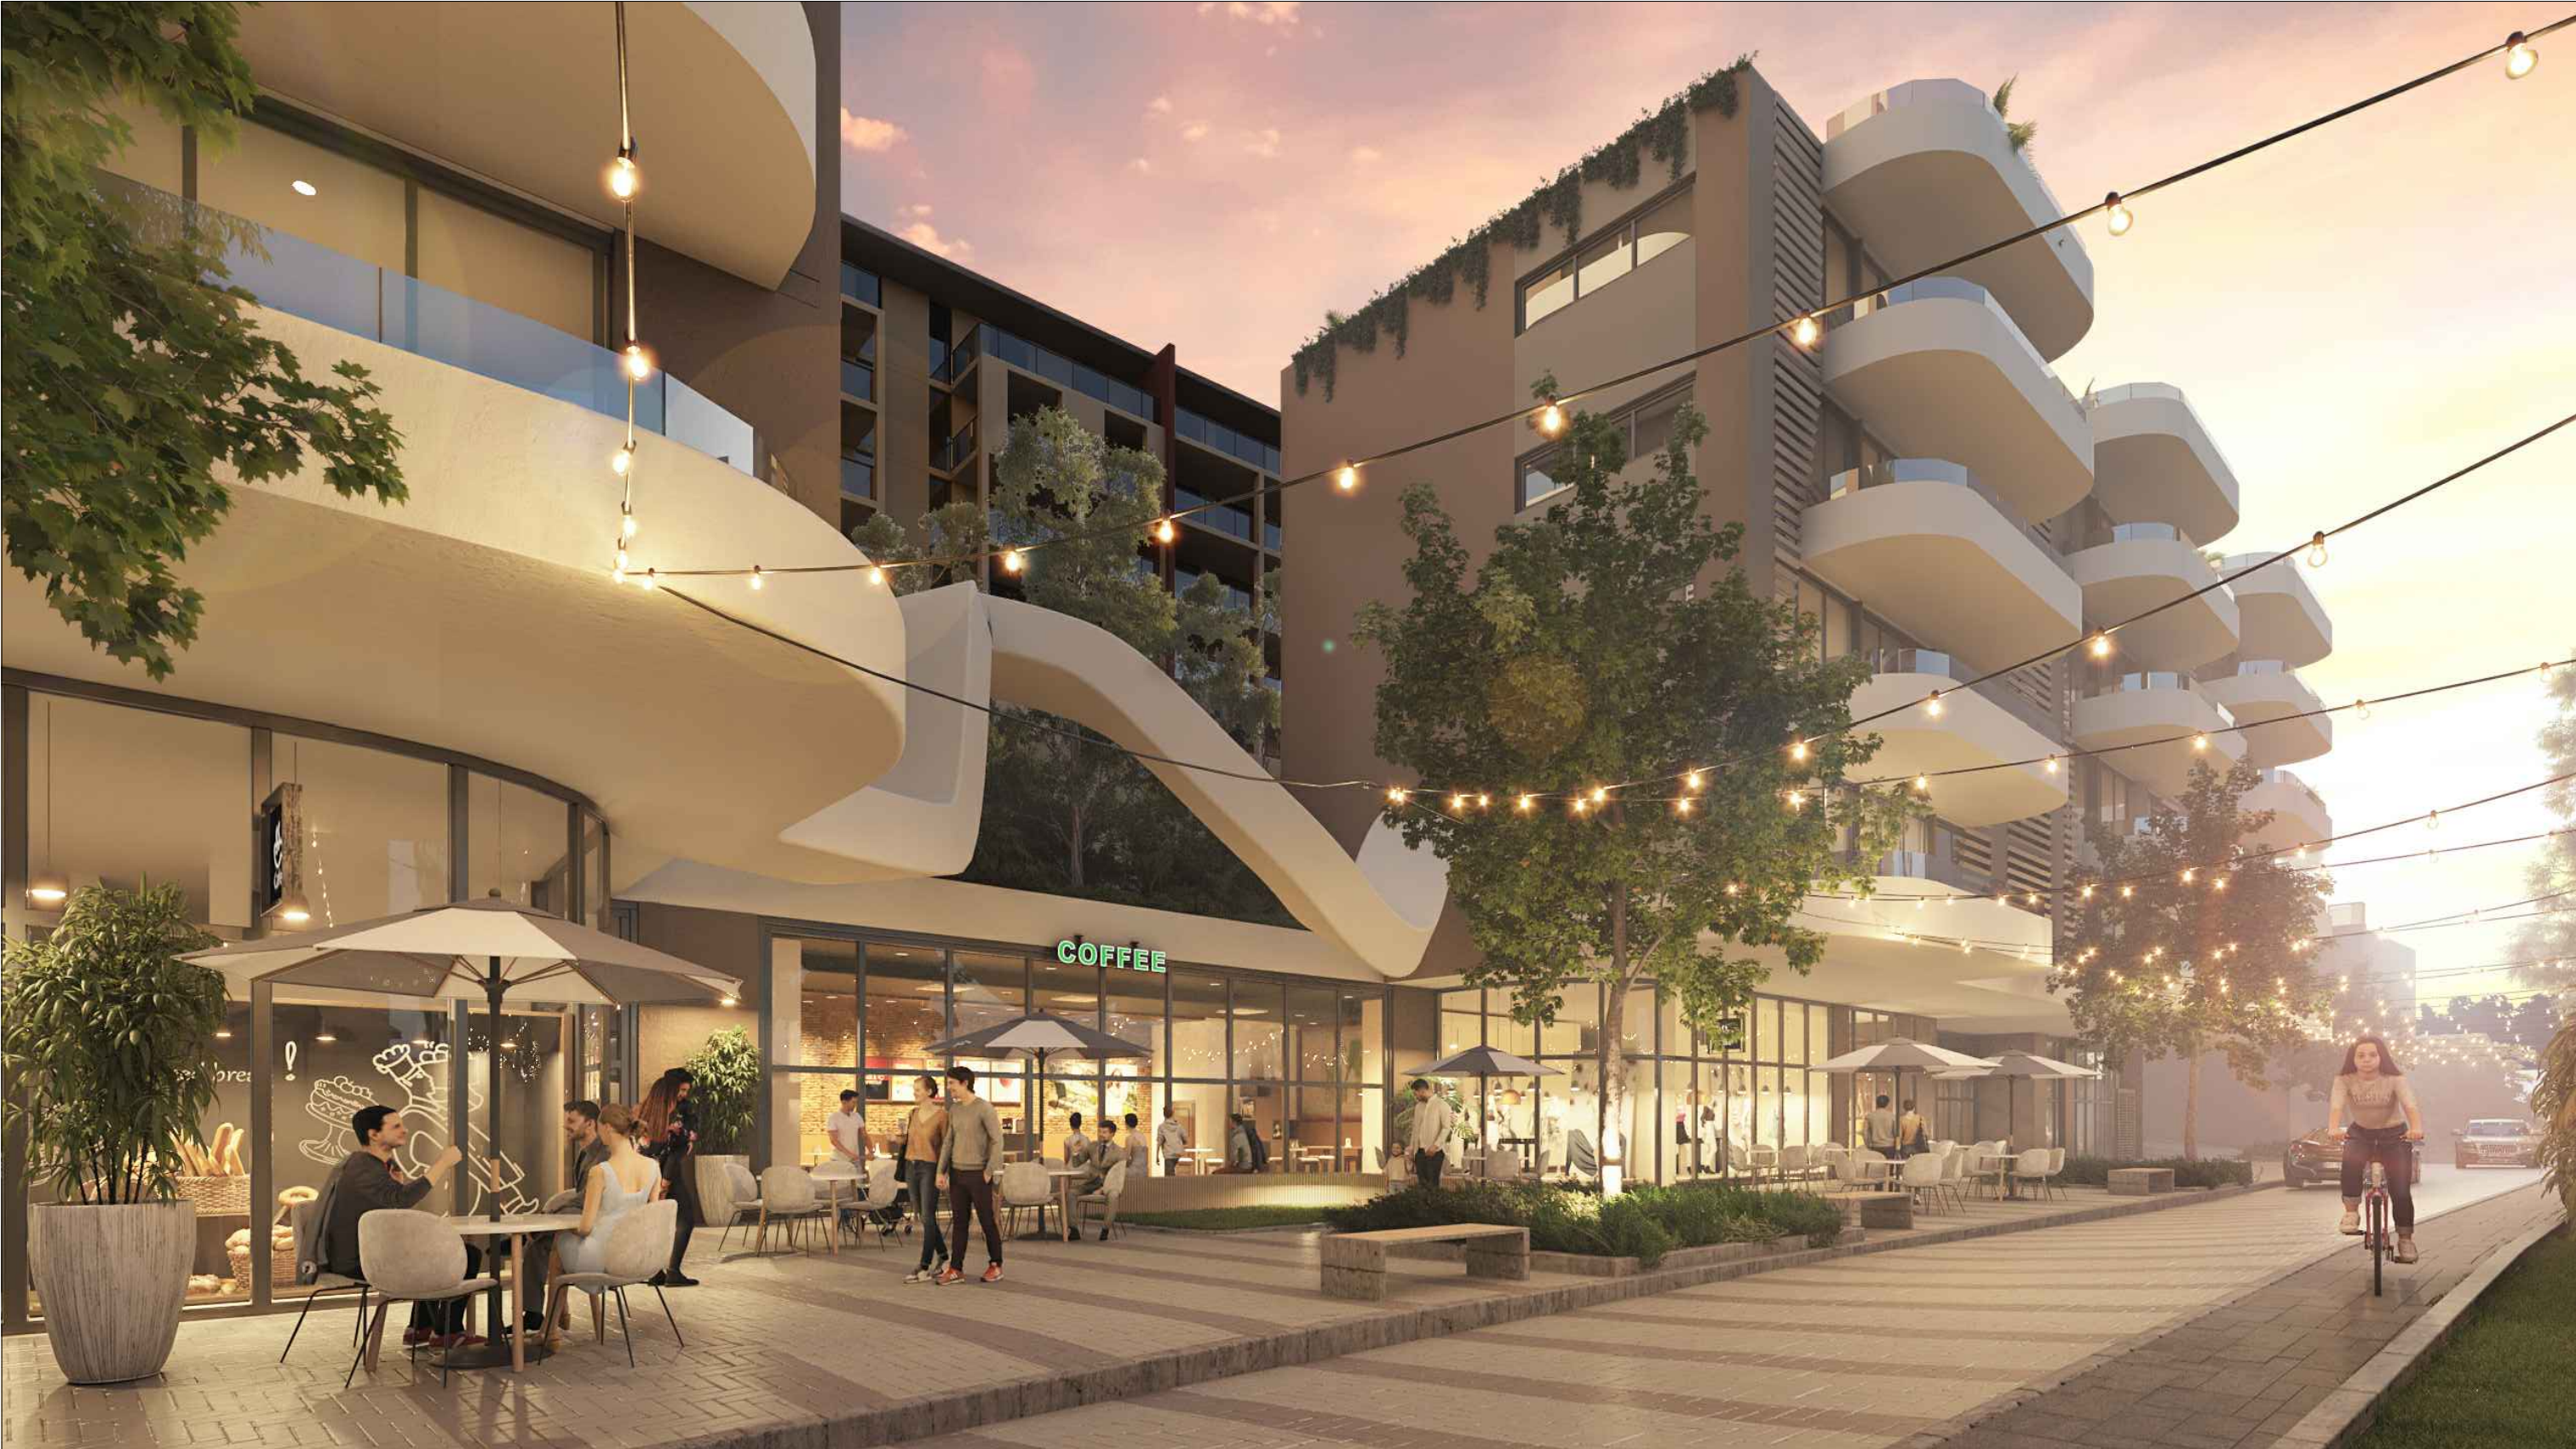
All planters and street furniture shown in this perspective should be upgraded to vehicle-rated elements to enhance protective measures against vehicular intrusion. Given that the shared lane way also serves as a cycle way and pedestrian corridor, it is essential to implement additional security features such as impact-rated vehicle barriers, clearly delineated pedestrian and cyclist paths, and prominent street signage to guide movement and improve safety. These upgrades will contribute to a safer, more resilient public realm and support CPTED principles by reducing opportunities for conflict between vehicles and vulnerable users.
