## Engineering Log - Cored Borehole

project: **HW10 Pacific Highway Upgrade - Section 3 (Glenugie to Tyndale)**

Borehole ID: **BH1023**

project no: **GEOTLCOV24443AA**

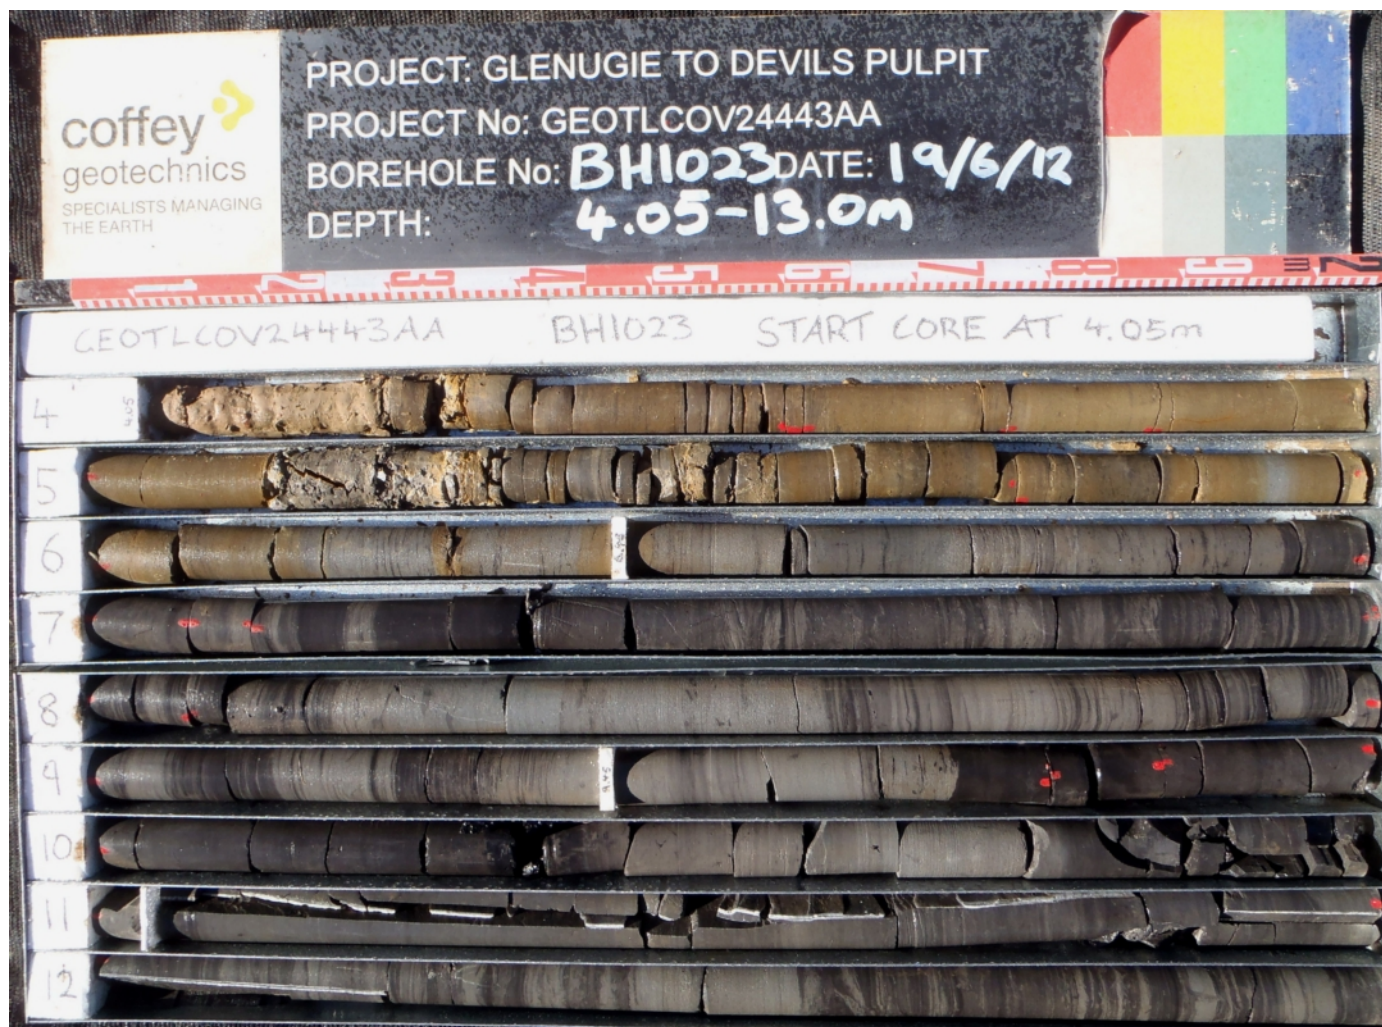
| scale | N.T.S. | | project no: GEOTLCOV24443AA | fig no: <b>FIGURE 1</b> | rev: |

PointID : BH1023 Depth Range: 4.05 - 13.00 m

| date | 25/10/2012 | | title: <b>CORE PHOTOGRAPH<br/>BH1023</b> | | |

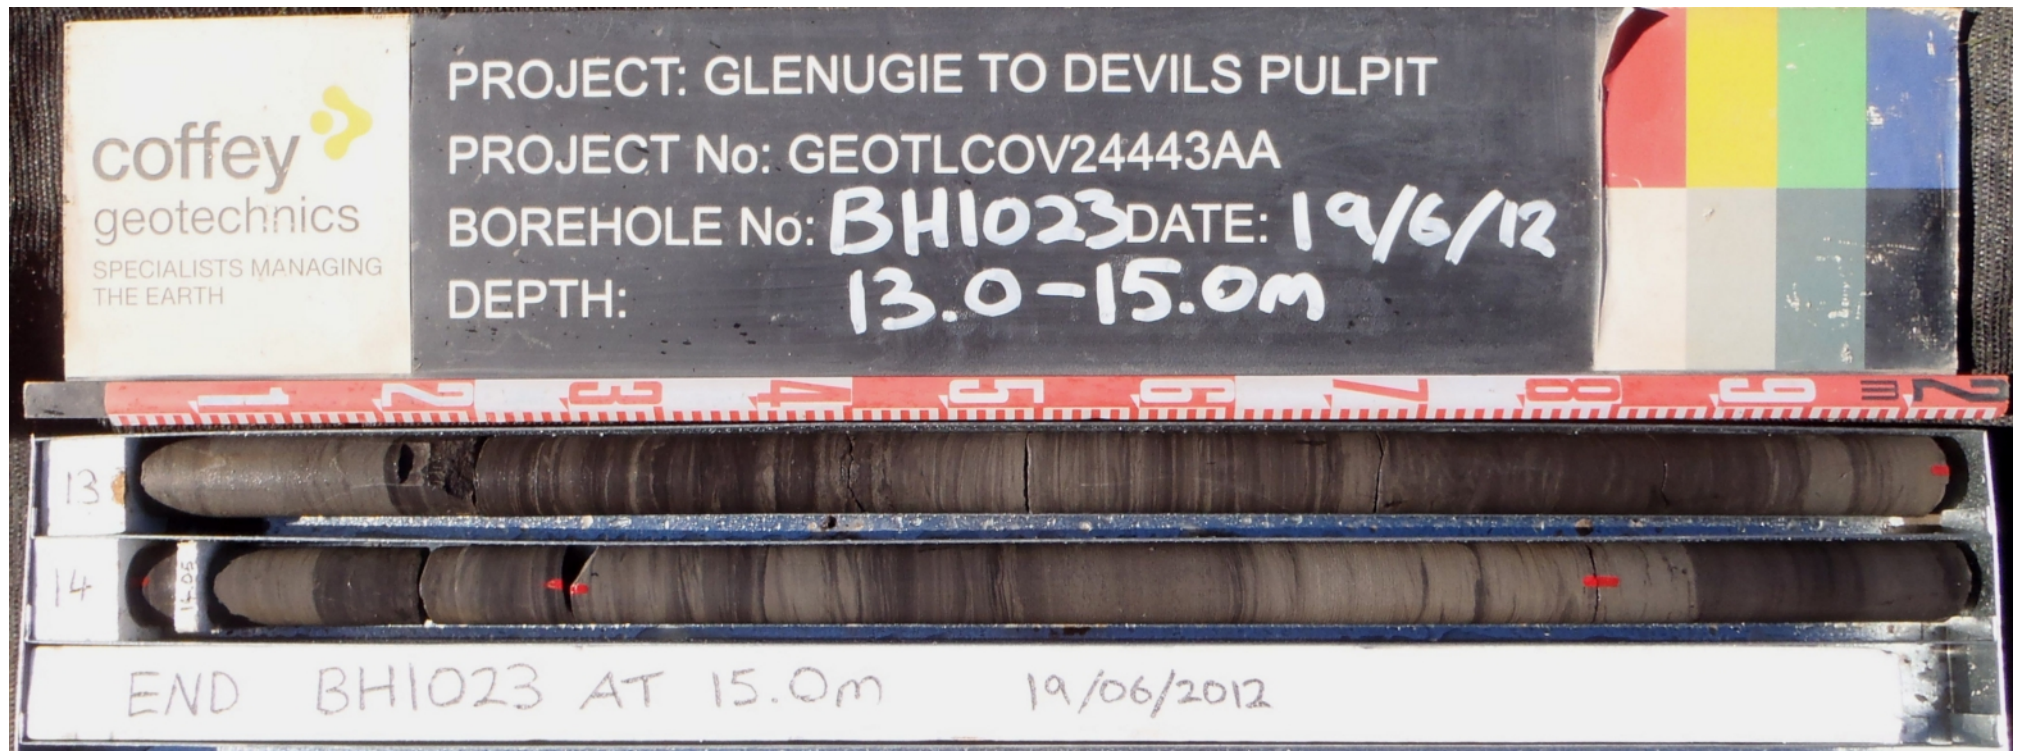
| scale | N.T.S. | | project no: | GEOTLCOV24443AA | fig no: | FIGURE 2 |

PointID : BH1023 Depth Range: 13.00 - 15.00 m

| date | 25/10/2012 | | title: | CORE PHOTOGRAPH<br>BH1023 | | |

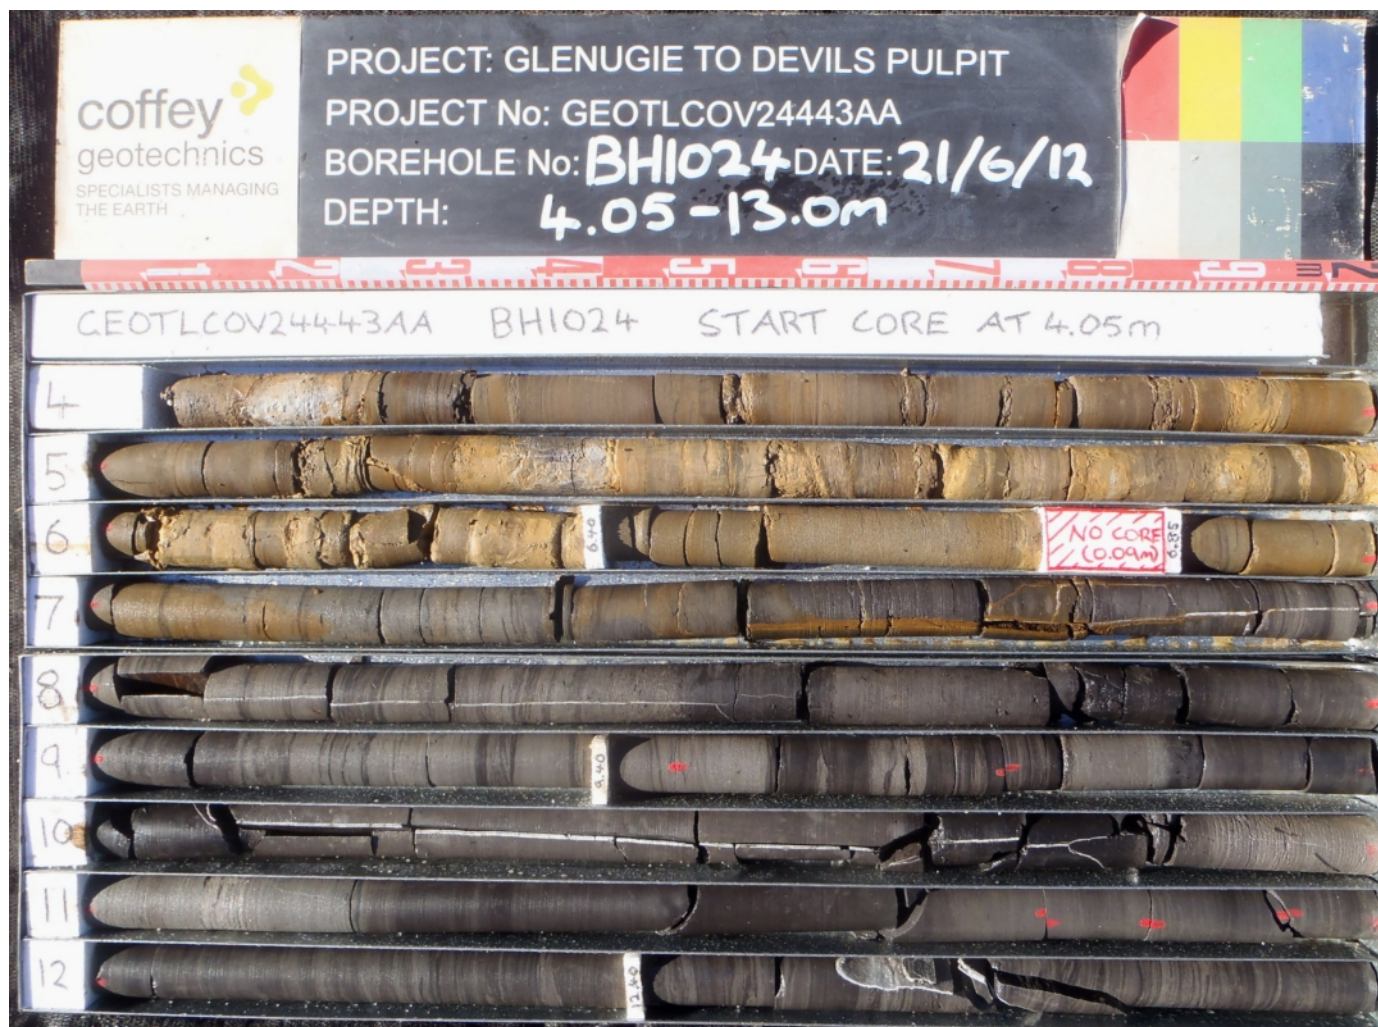
| scale | N.T.S. | | project no: | GEOTLCOV24443AA | fig no: | FIGURE 1 |

PointID : BH1024 Depth Range: 4.05 - 13.00 m

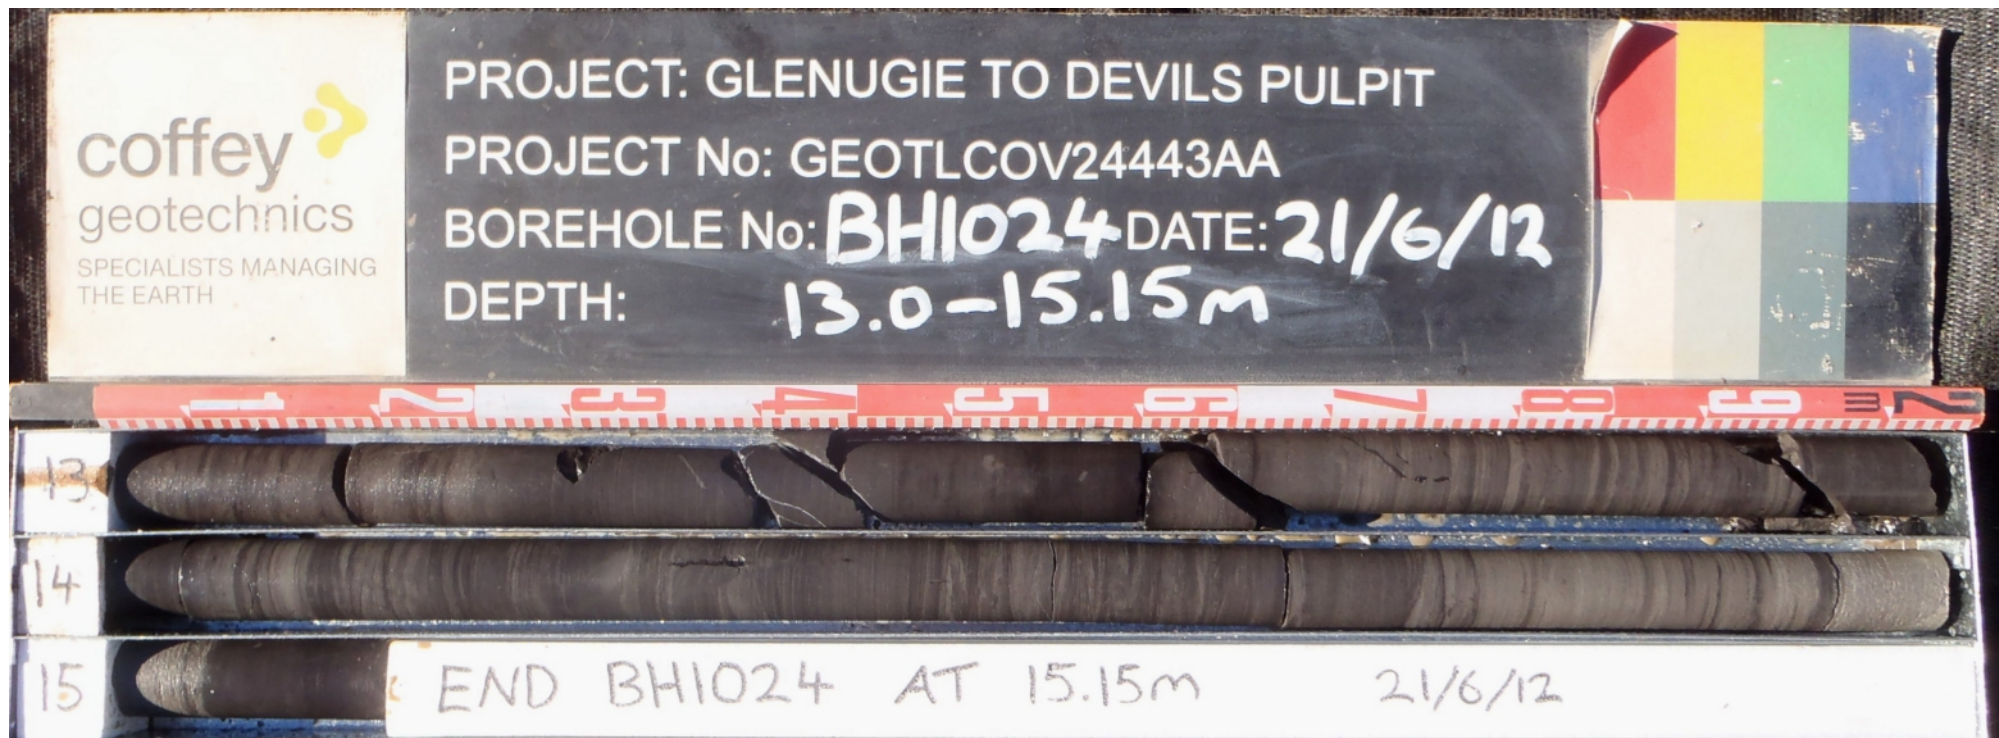
PointID : BH1024 Depth Range: 13.00 - 15.15 m

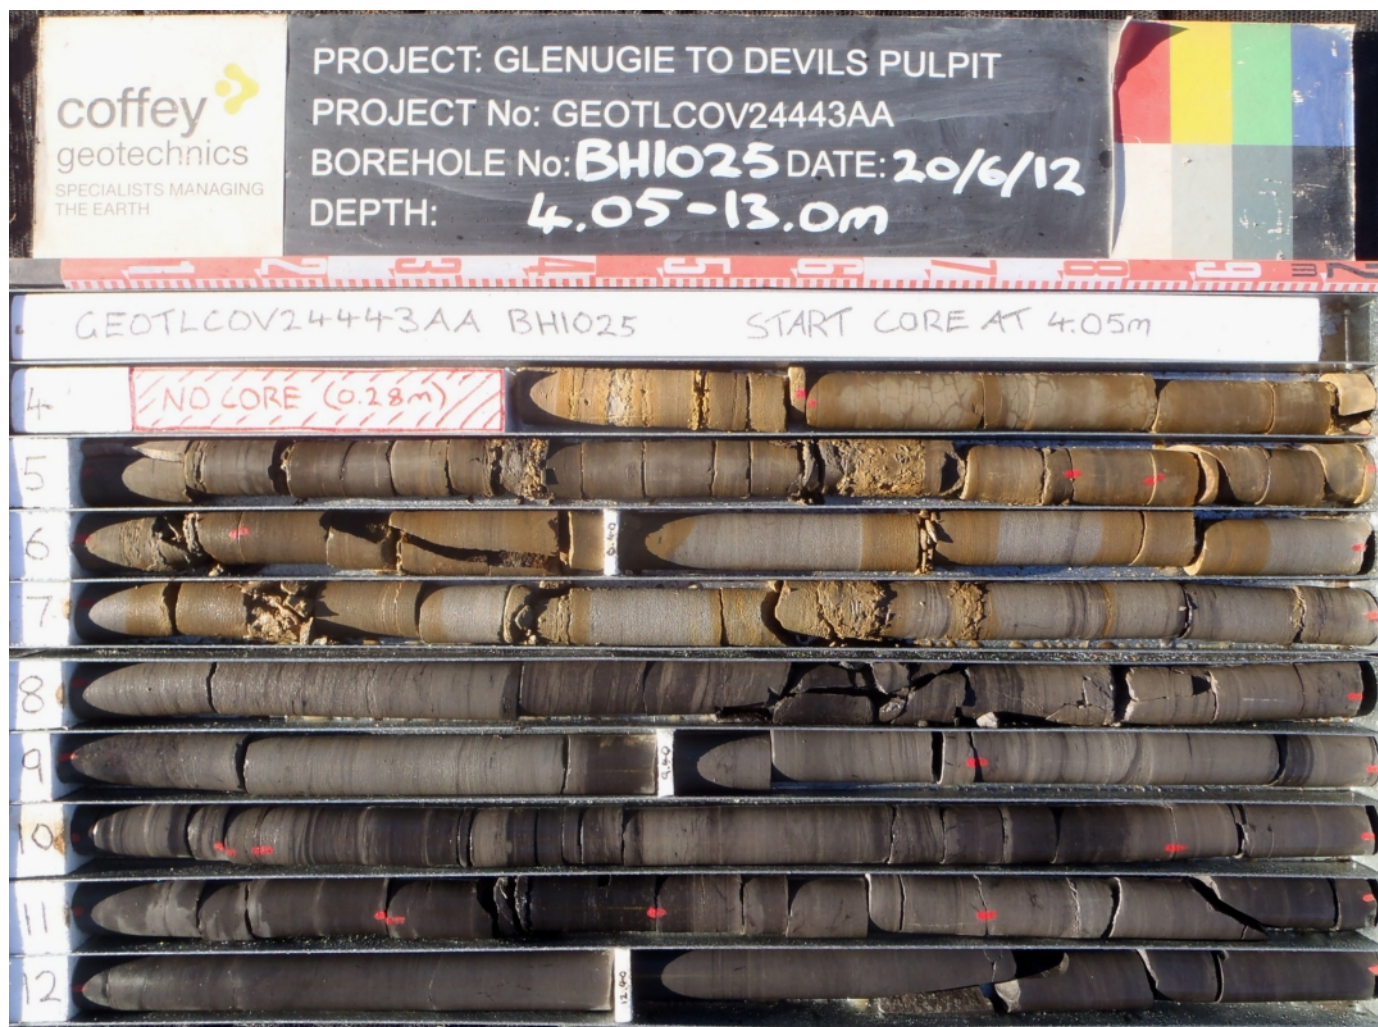
| scale | N.T.S. | | project no: | GEOTLCOV24443AA | fig no: | <b>FIGURE 1</b> |

PointID : BH1025 Depth Range: 4.05 - 13.00 m

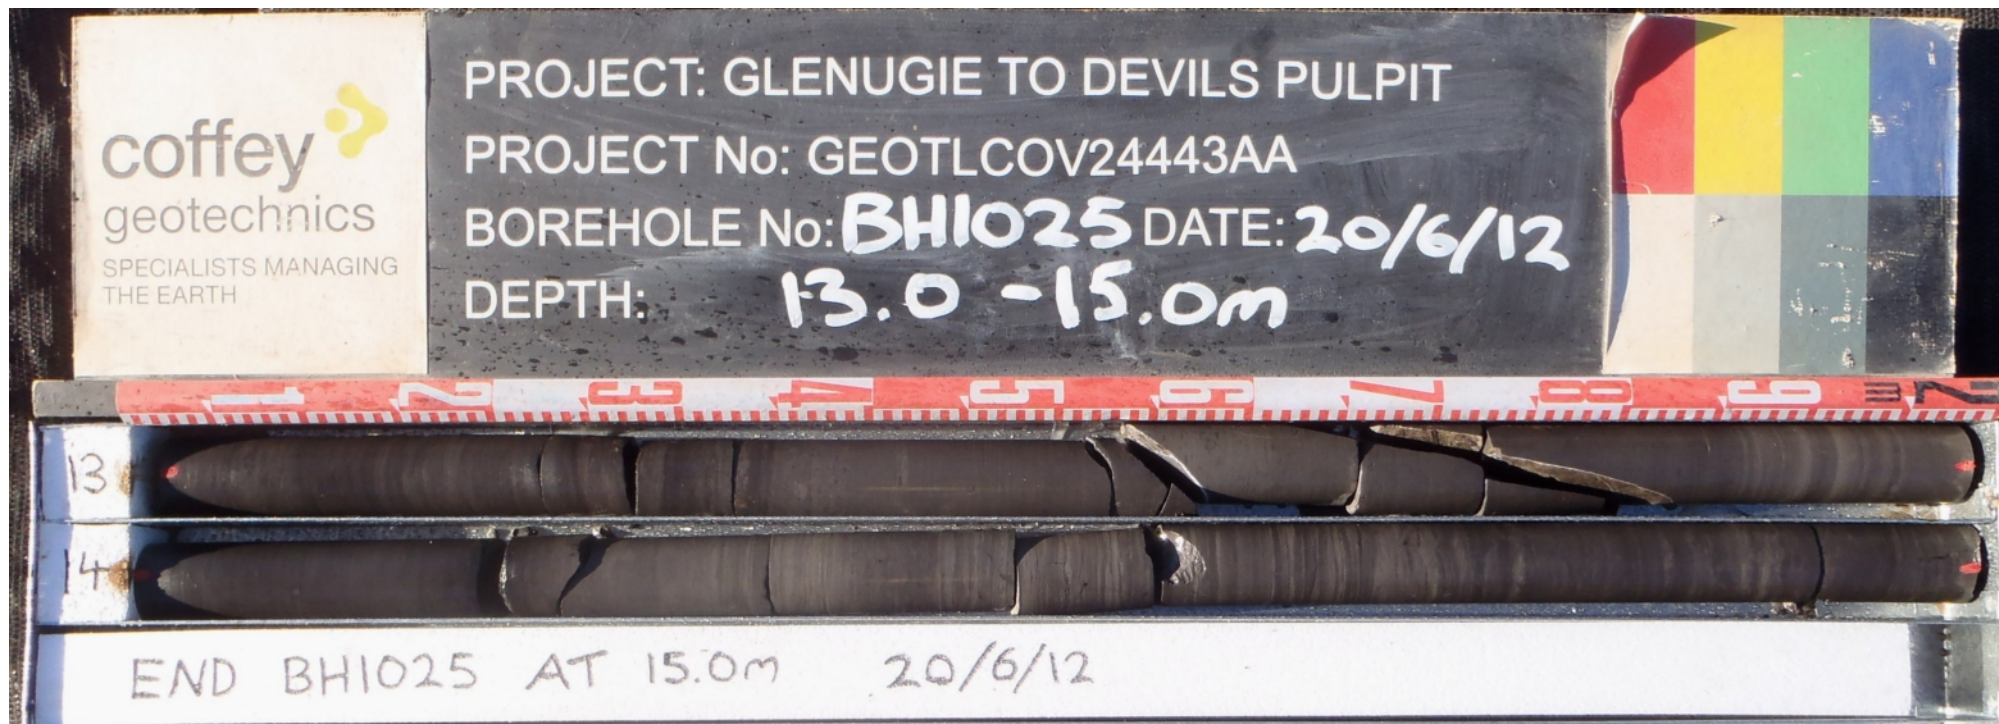
PointID : BH1025 Depth Range: 13.00 - 15.00 m
