**Validation Report: Alexandria Park Community  
School (Phase 1) – 7 Park Road, Alexandria NSW**

**754-SYDEN224285-R04**

## Validation Report: Alexandria Park Community School (Phase 1) – 7 Park Road, Alexandria NSW

Prepared for  
Richard Crookes Construction Pty Ltd

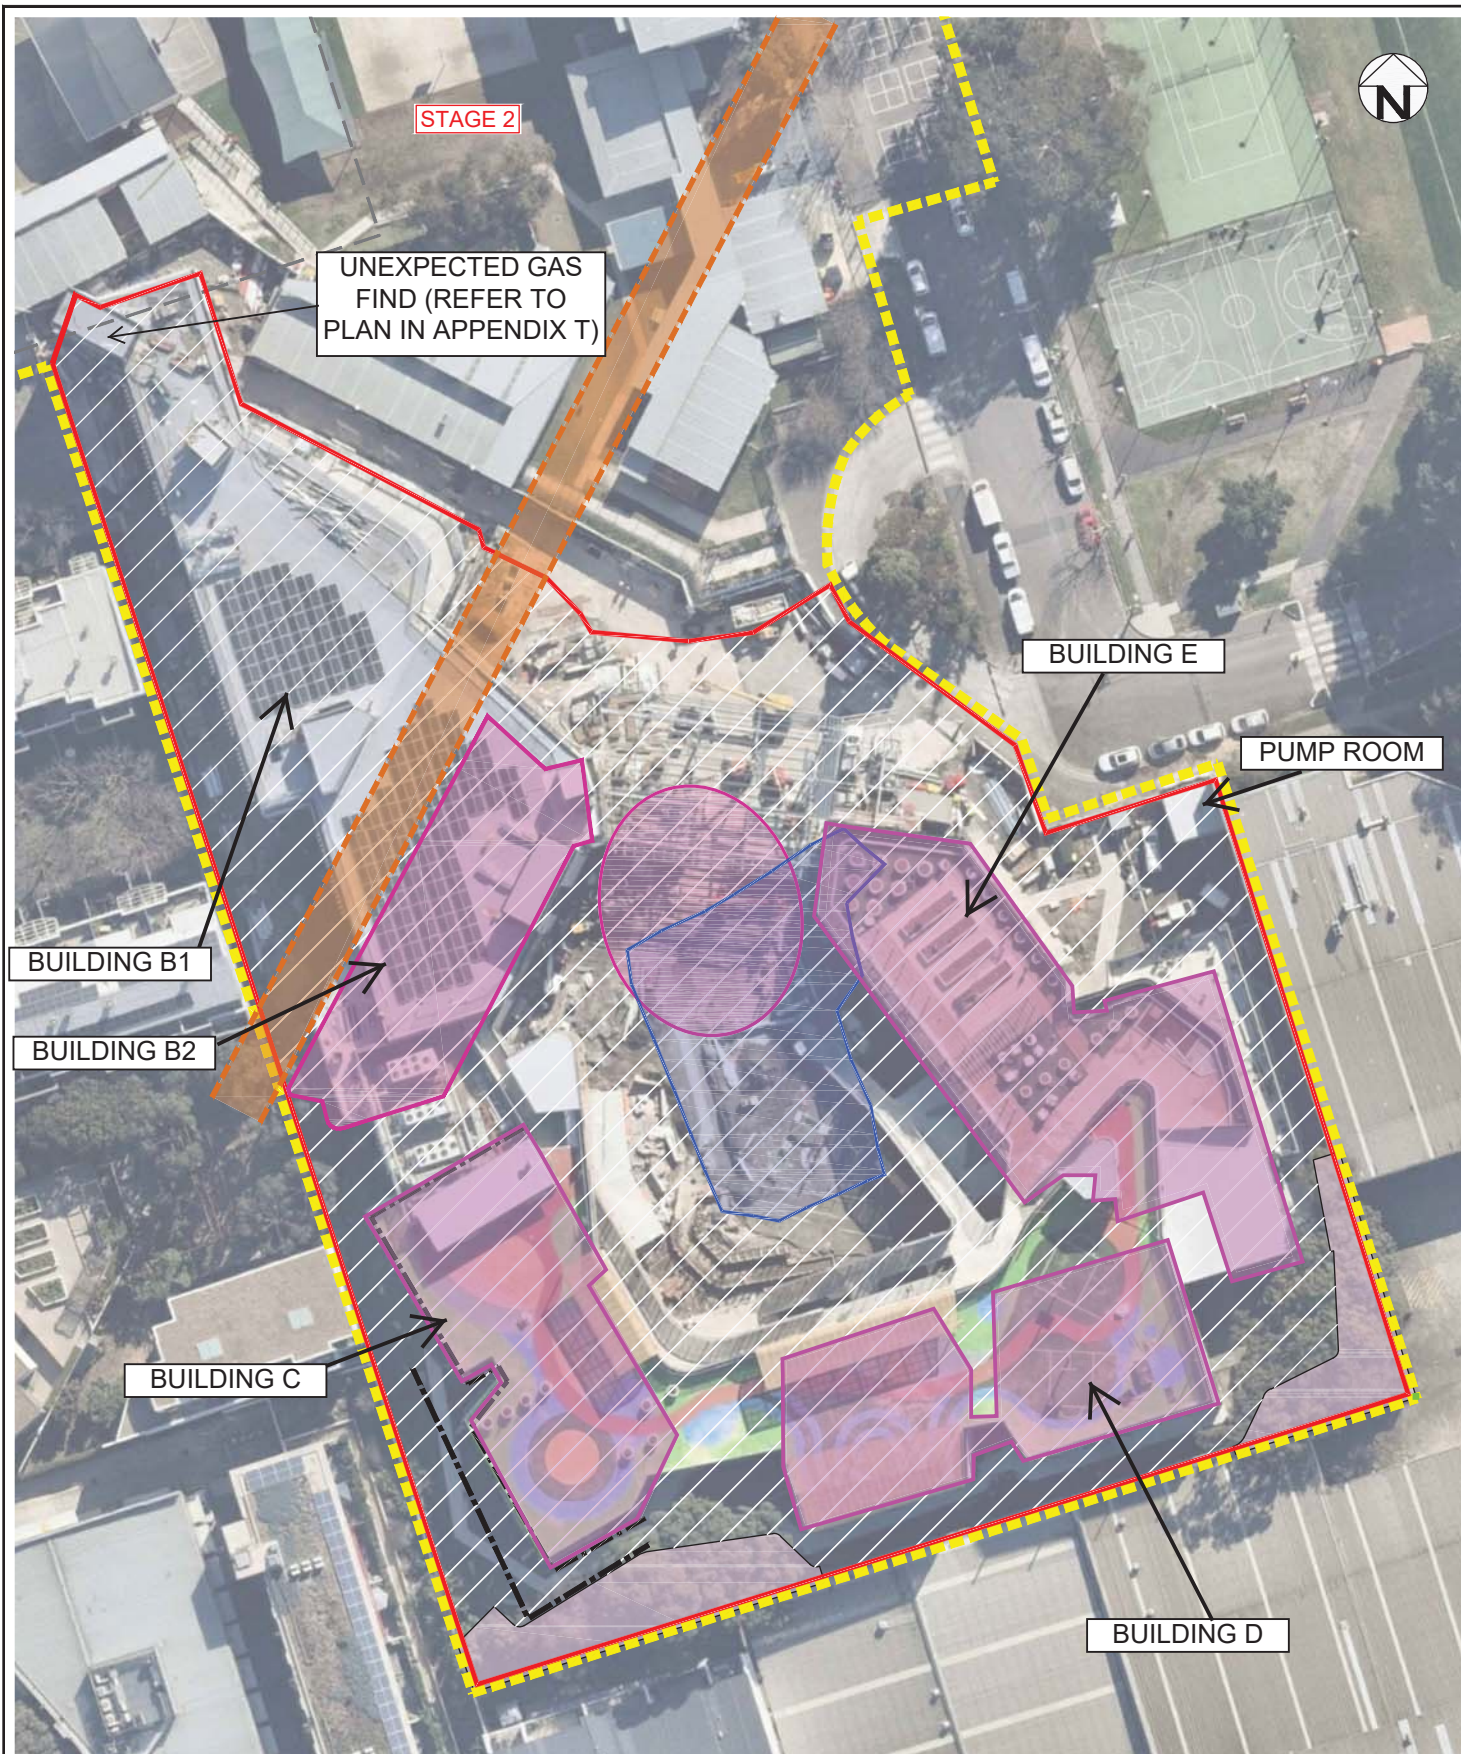
revision	no.	description	drawn	approved	date	<div><div><div>LEGEND</div><div><div><div><div></div></div><div>APPROXIMATE ALEXANDRIA PARK SCHOOL PROPERTY BOUNDARY</div></div><div><div><div></div></div><div>SITE BOUNDARY</div></div><div><div><div></div></div><div>TREE PROTECTION ZONE (TPZ)</div></div><div><div><div></div></div><div>LOCATION OF CULVERT</div></div></div><div><div><div></div></div><div>BORROW PIT BOUNDARY</div></div><div><div><div></div></div><div>RECYCLED DG B20 CONTAINING ASBESTOS (NOT CONTAMINATED)</div></div><div><div><div></div></div><div>CAPPING EXTENT (refer to Appendix J for detailed capping plan)</div></div><div><div><div></div></div><div>ASBESTOS CONTAMINATED 10mm AGGREGATE IN SERVICE TRENCHES</div></div></div></div>			
	A	ORIGINAL ISSUE

<div><div><div>5</div><div>0</div><div>5</div><div>10</div><div>15</div><div>20</div></div><div>Scale (metres) 1:600</div></div>	drawn	AP / AW	<div><div><div>coffey</div><div>A TETRA TECH COMPANY</div></div></div>	client: RICHARD CROOKES CONSTRUCTION PTY LTD		
	approved	AP		project: ALEXANDRIA PARK COMMUNITY SCHOOL PARK ROAD, ALEXANDRIA, NSW		
	date	15/09/2020		title: SITE LAYOUT PLAN		
	scale	AS SHOWN		project no: 754-SYDEN224285-R04		
	original size	A3		figure no: FIGURE 3	rev: A
