Report on Preliminary Geotechnical Investigation

Proposed School Structures, Kingscliff Primary School, Orient Street, Kingscliff

Prepared for School Infrastructure NSW/ Department of Education

Project 98084.00 April 2020

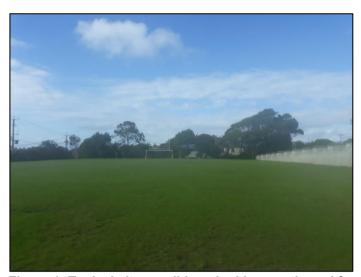
Figure 1: Typical site conditions looking southward from Bore 3.

Figures 1 and 2 indicate typical site conditions encountered at the time of the investigation.

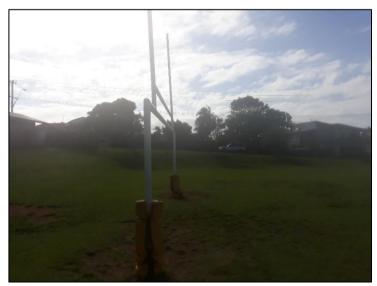
Figure 2: Typical site conditions looking eastward from Bore 3.
