**Report on Groundwater Impact  
Assessment**

**Green Square Stage 3**

**960A Bourke Street,  
Zetland**

**Project 72258.23**

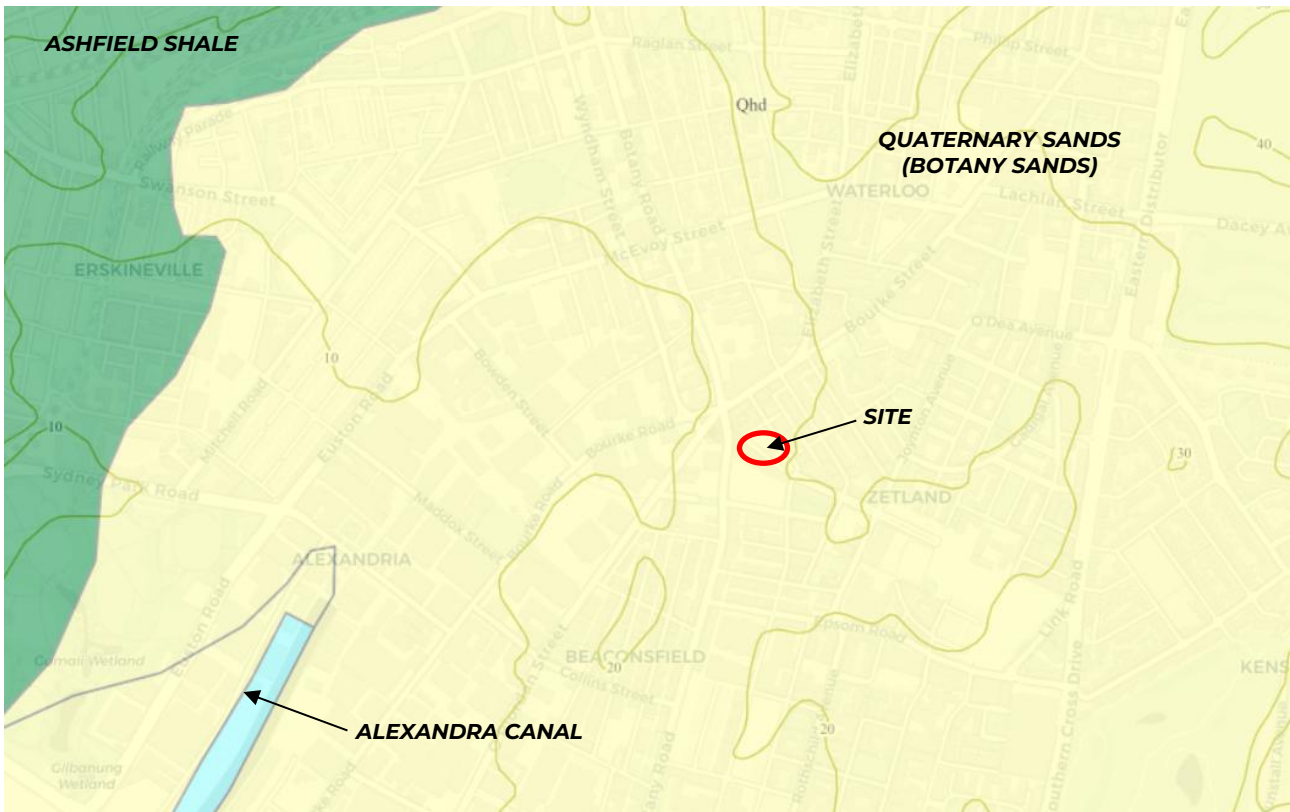
The site is therefore not underlain by the Botany Sands as nearby sites are but rather Ashfield Shale.

**Figure 2: Extract from geological map with surface contours shown at 10 m intervals to AHD**

An extract of the mapping is provided in Figure 2.

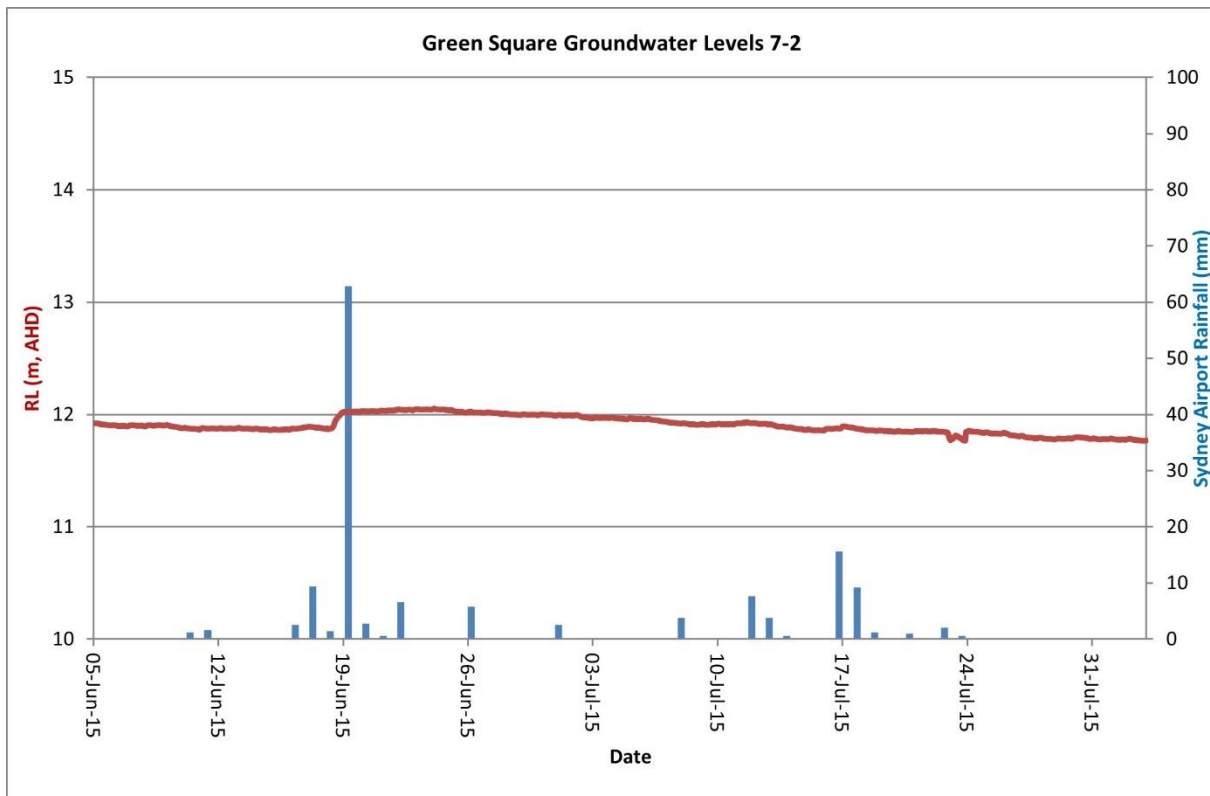
Groundwater levels were monitored using the vented loggers installed in the wells. The loggers were configured to record water levels at two-hourly intervals during the monitoring period.

**Figure 3: Results of Groundwater Monitoring in Monitoring Well 7-2**

A graphical summary of the monitoring data is shown in Figures 3 to 5. Daily rainfall information recorded by the Bureau of Meteorology at Sydney Airport is also included on the graphs. It should be noted that the daily rainfall totals are reported as rainfall in the 24 hours to 9 am rather than from midnight to midnight.

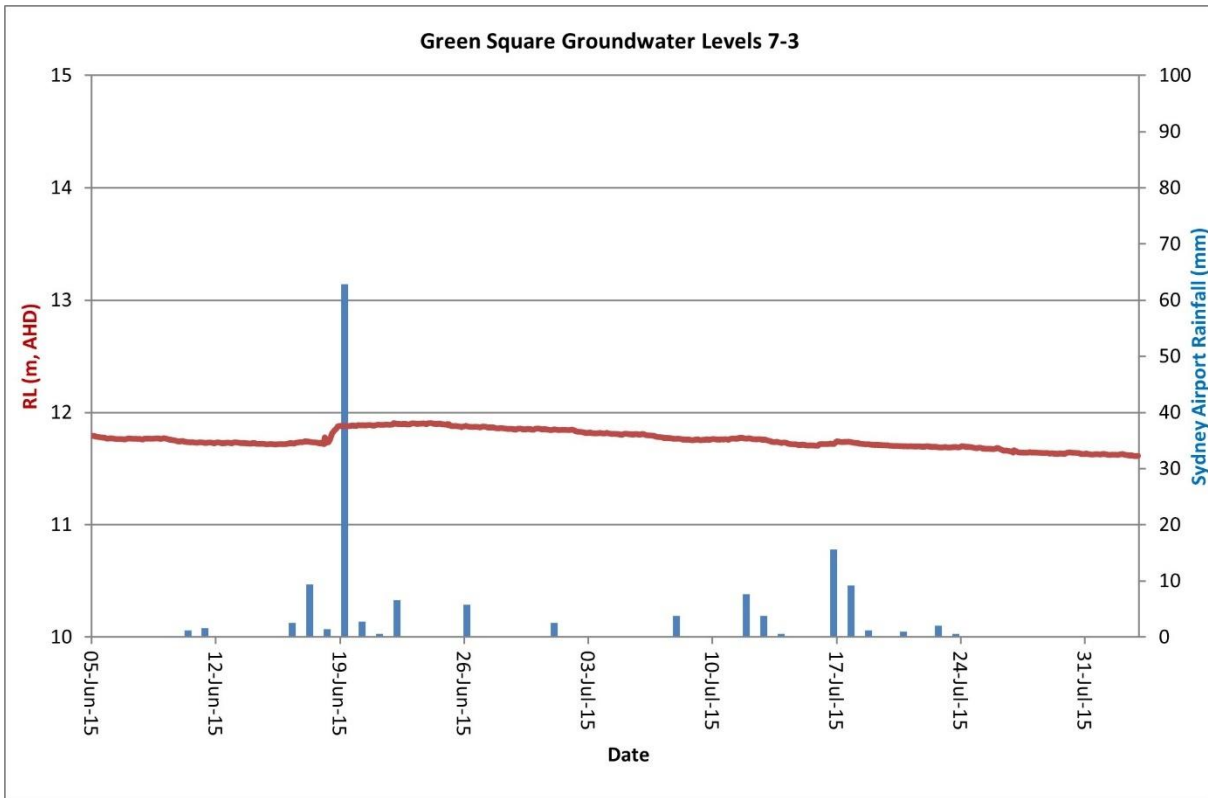
**Figure 4: Results of Groundwater Monitoring in Monitoring Well 7-3**

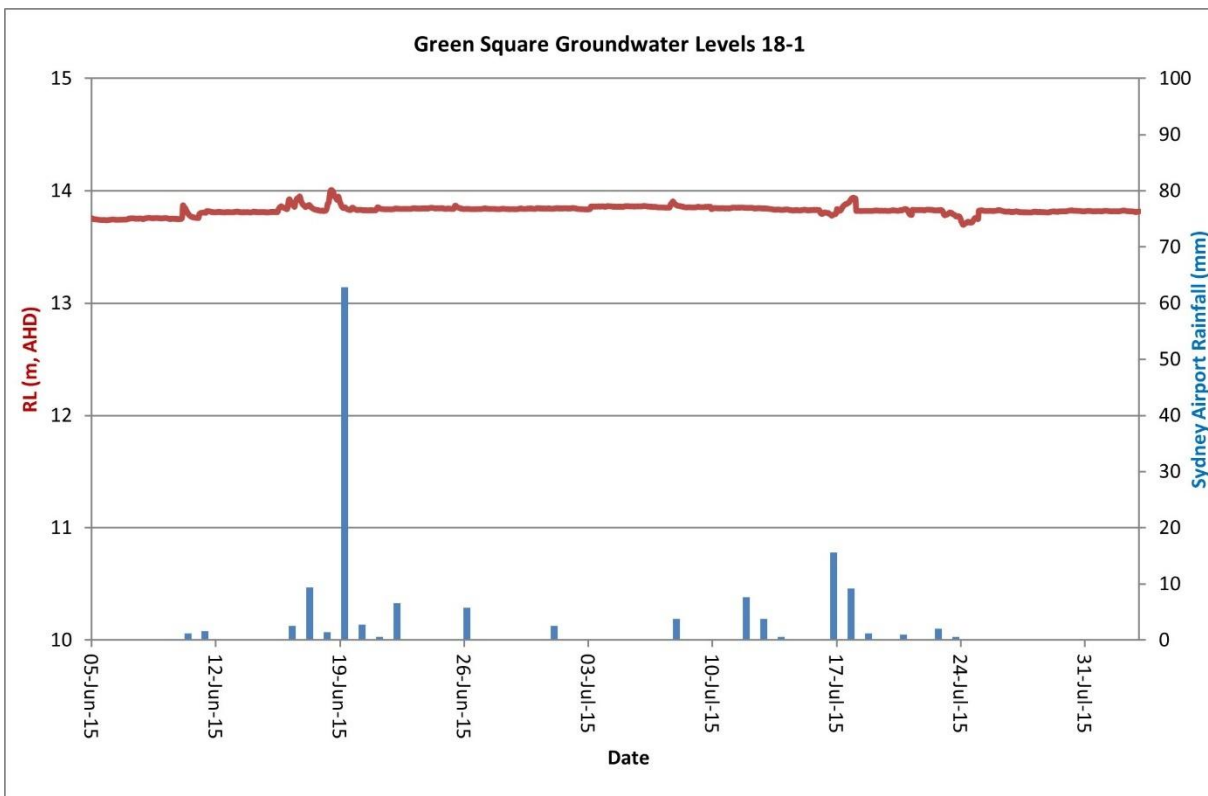
**Figure 5: Results of Groundwater Monitoring in Monitoring Well 18-1**
