## Locomotive Workshops

Mirvac

## Response to SSDA Submissions Package

May 2018

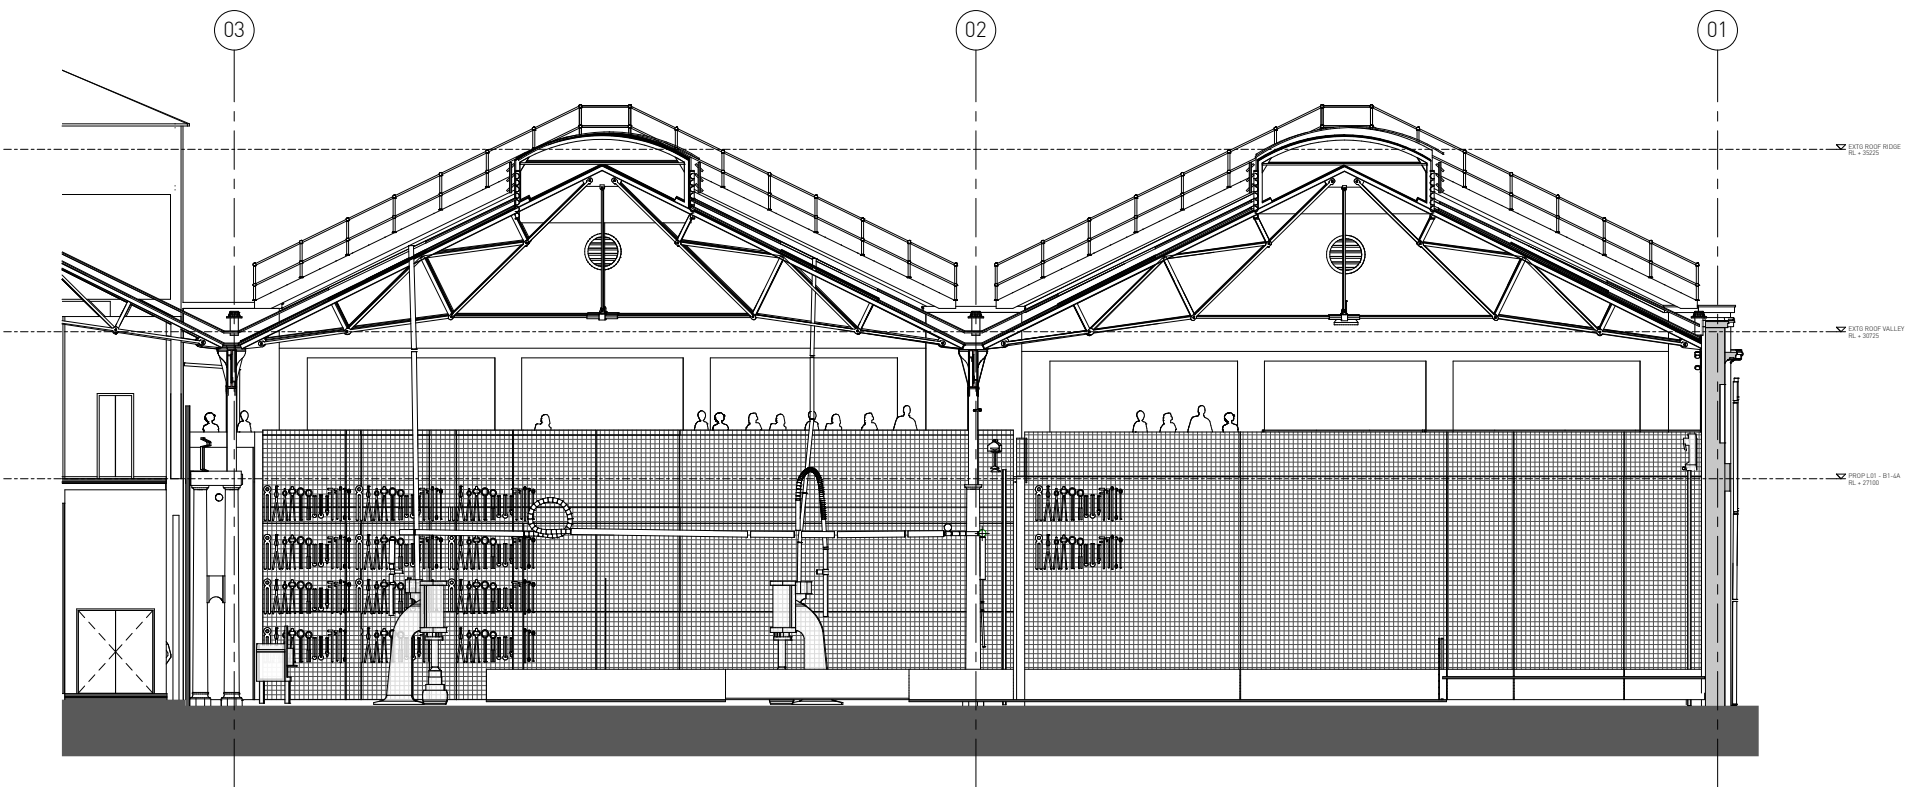
Loading Dock - Elevation A

Where back of house loading dock areas are bounded by heritage walls and columns, a new protective wall lining is proposed on the dock side to protect the heritage fabric from wear and tear. Refer to the attached diagrams for indicative details.

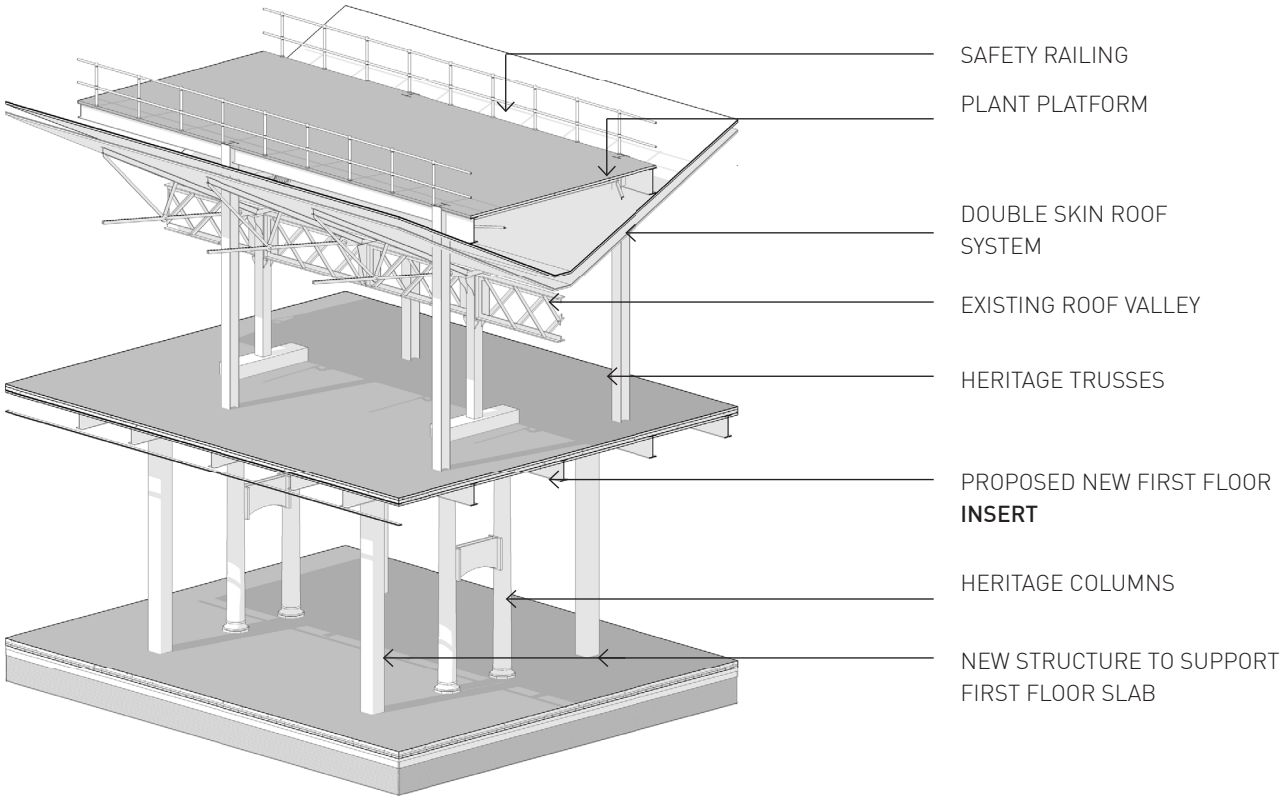
Roof Platforms - 3D Sectional View

Roof plant platforms are set back from the building perimeter and will not be visible from the public domain, as clearly indicated on page 41 of the Design Report.

The platforms are to be supported by new columns which are to transfer the load to bear on the supports for the new first floor slab in Bays 3-4A. As such no additional groundworks will be required as a result of the platforms. The platforms are to be accessed via new access stairs leading from the fire egress stairs in Bay 3 and Bay 4A.

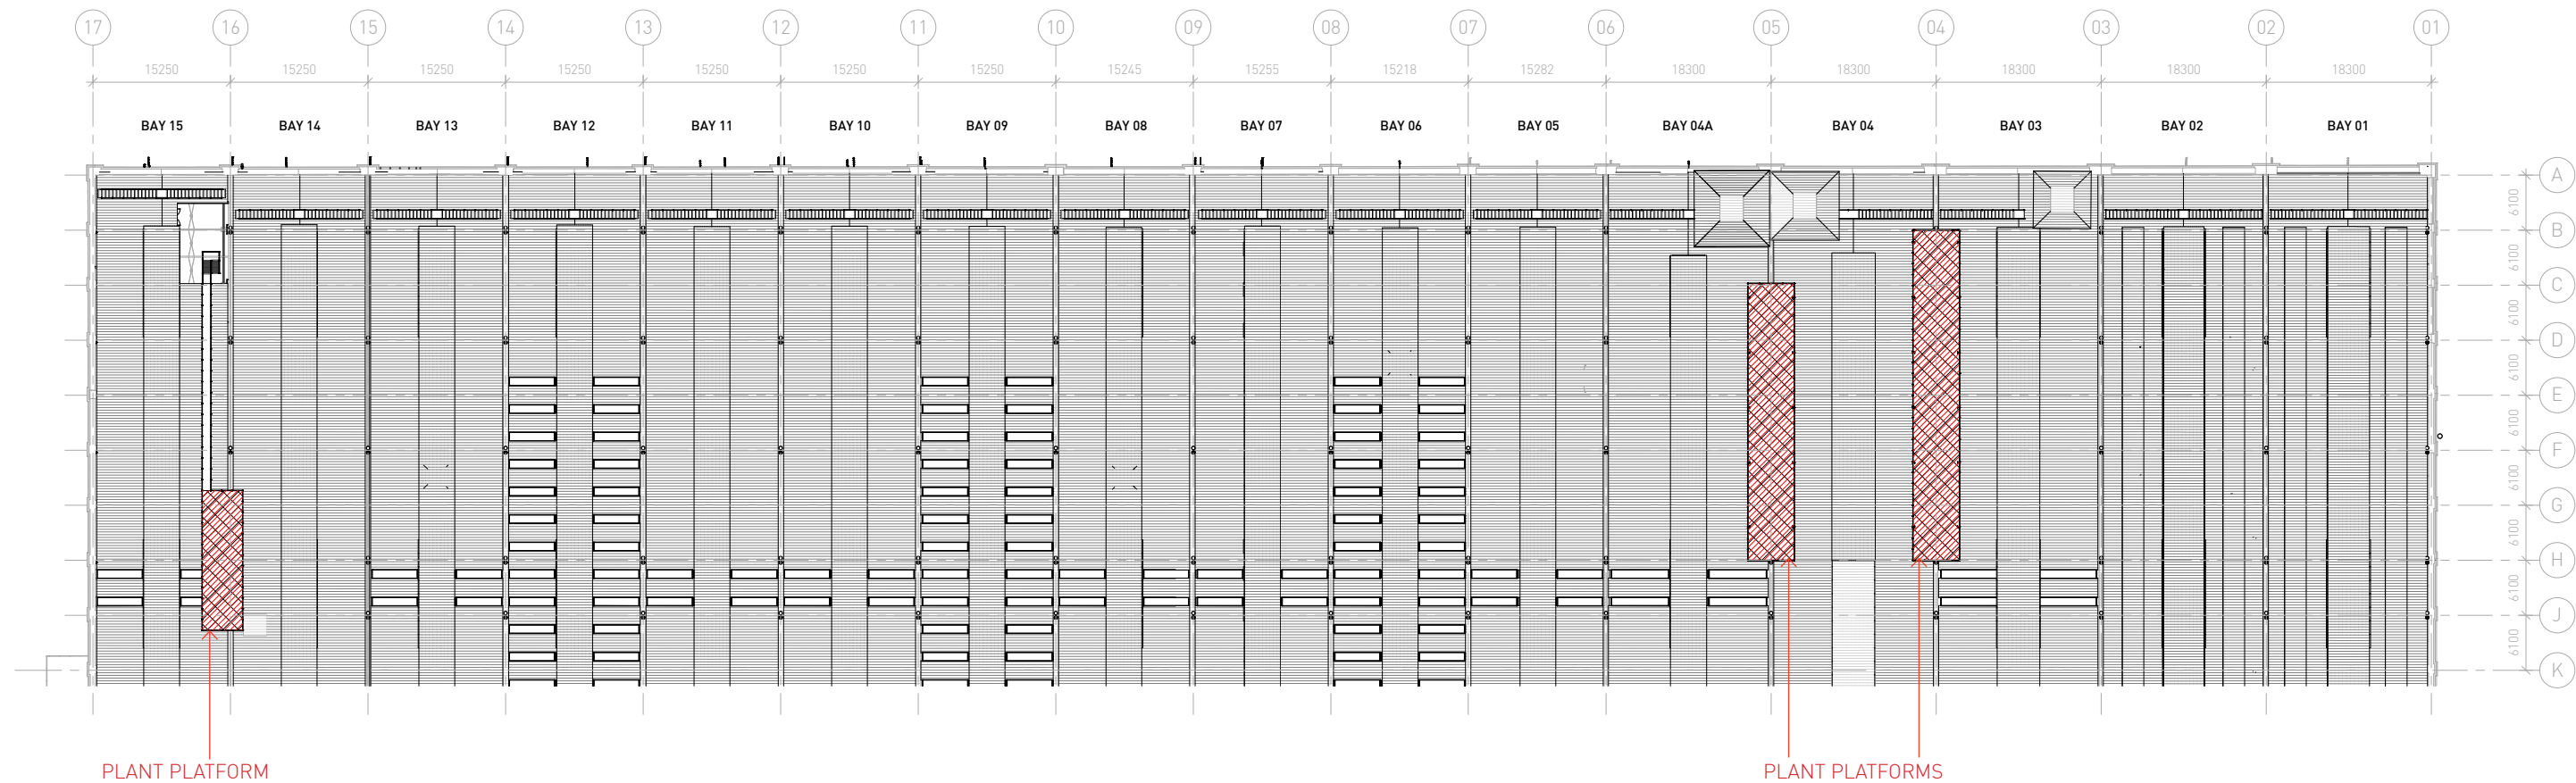
Roof Plant Platforms - Excerpt Plan

A third plant platform is proposed in the valley between bays 14 and 15, its location at grid line H is well concealed from view from the public domain. This platform is support by new columns to go to ground.
