# Memo

**RE:** Gunnedah Solar Farm – Water Levels at Fence boundary

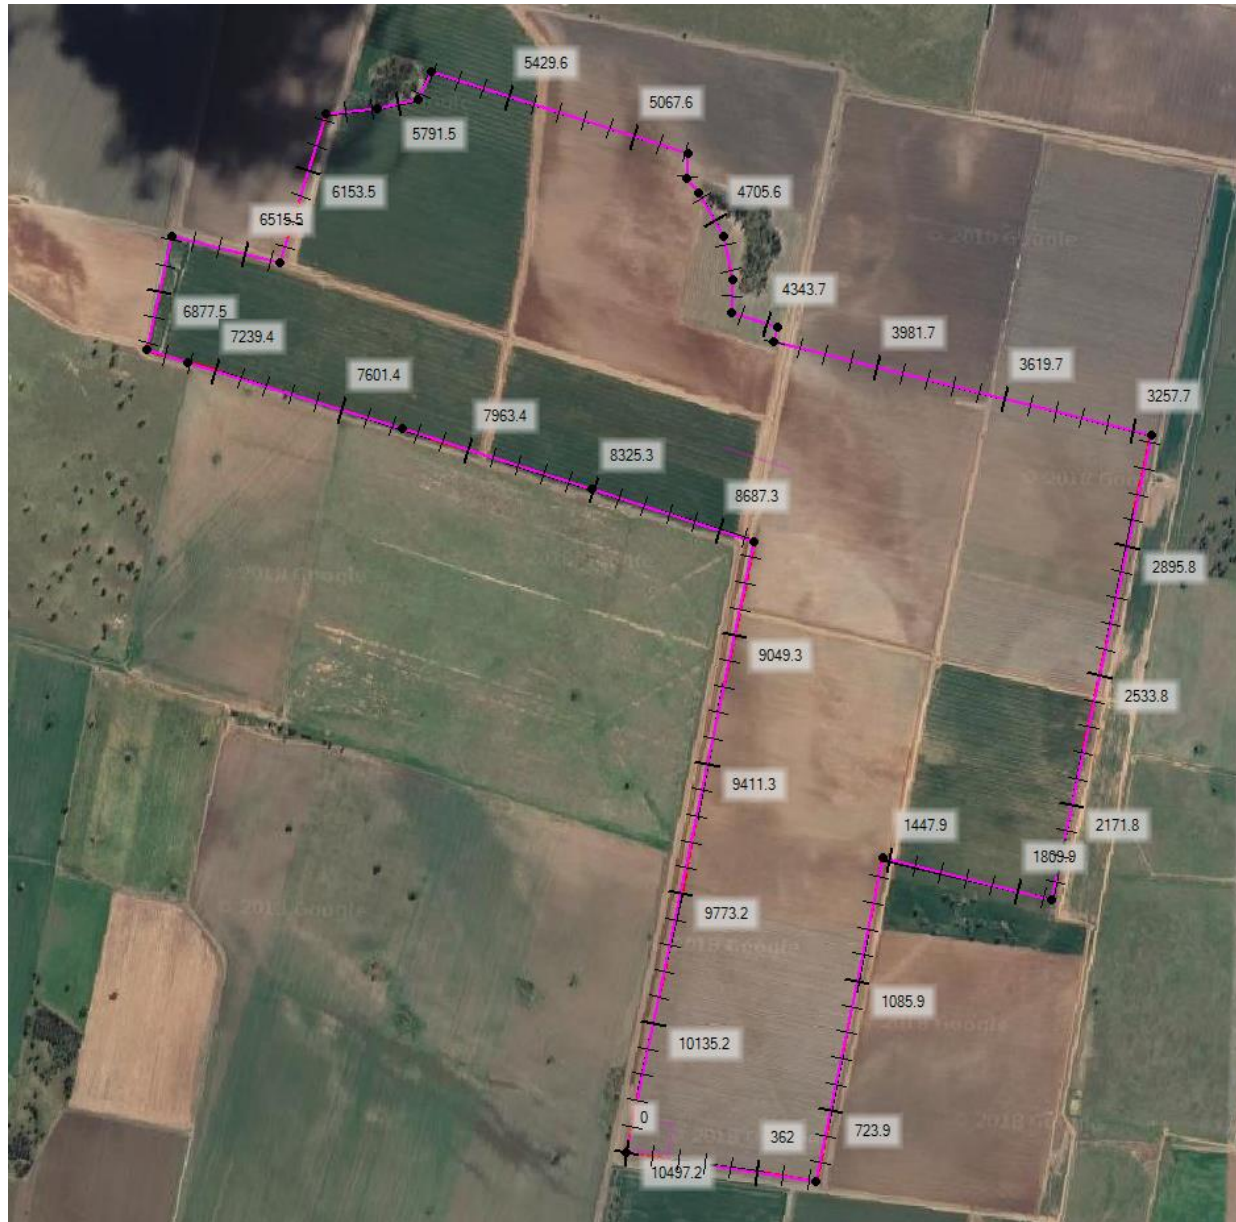
Figure 1 Fence layout and chainages

Figure 1 illustrates the location of the proposed fence layout of configuration 4, the chainages are also displayed with a total length of approximately 10.5 km.
