ATTACHMENT 5: *Supplementary Information re Key Project Components*

Scope of Works

The Concert Hall projects comprise:

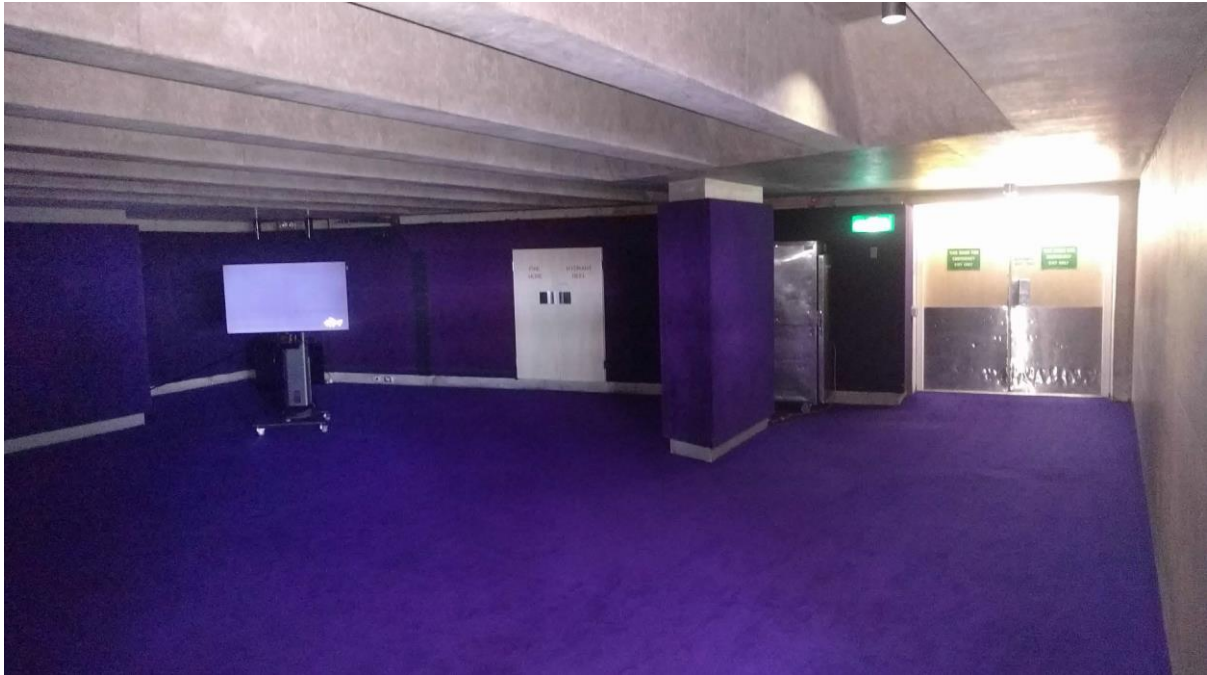
The south wall of the Caves is currently formed by a plywood wall, covered in carpet, sitting on a concrete plinth. Behind the plinth the floor level is lower than the floor of the Caves. The plywood wall conceals the following services and equipment: an air-conditioning duct and diffusers, up-lighting of the beams, and a fire hydrant pipeline and hose reel. This is shown in the following photos.

Existing South Wall of the Caves

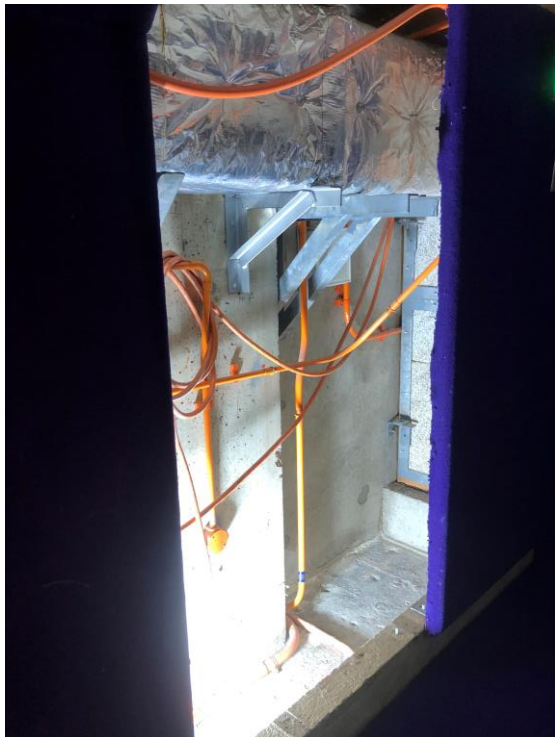
View behind carpet clad wall, showing a/c duct, electrical services and floor level lower beyond plinth

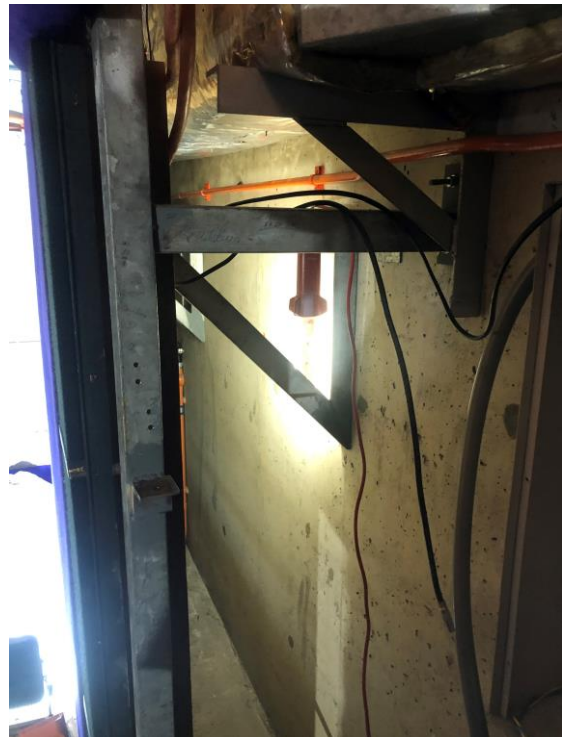
View behind carpet clad wall showing a/c duct

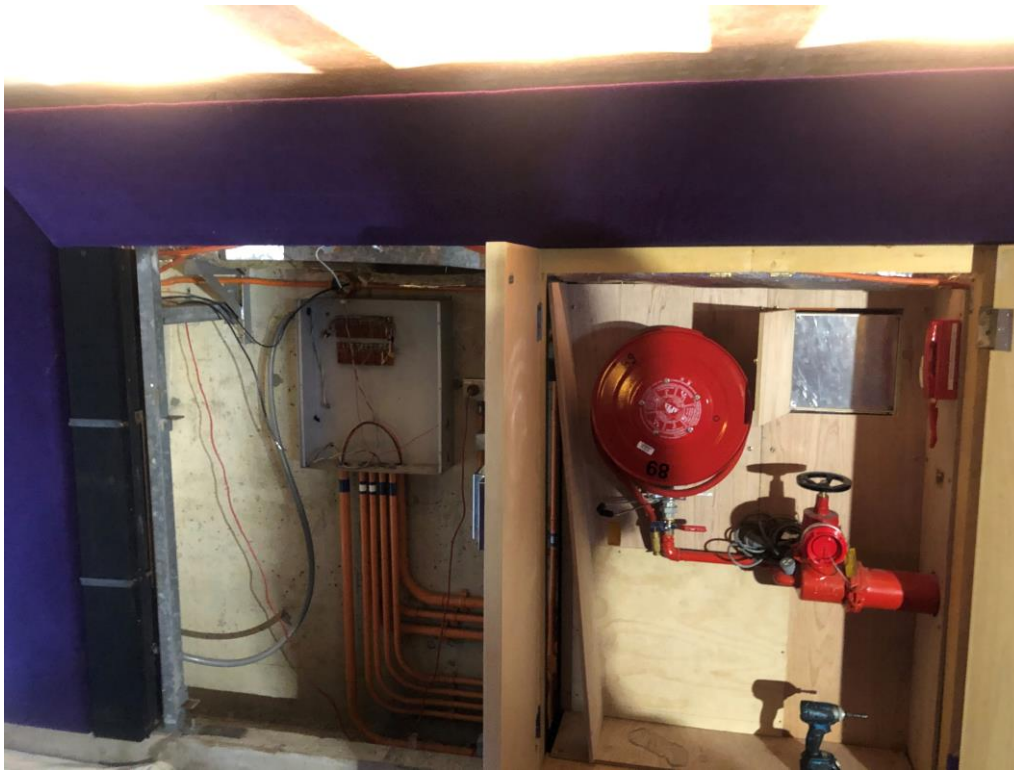
View of partially removed carpet clad wall, showing fire hose reel, electrical services, and uplighting of beams

The Panel viewed the condition within the Caves, noting the extensive and continuous services located on the southern wall including an air conditioning duct, electrical cabling and a fire services cabinet. As a result, it is not appropriate to reveal the concrete wall.

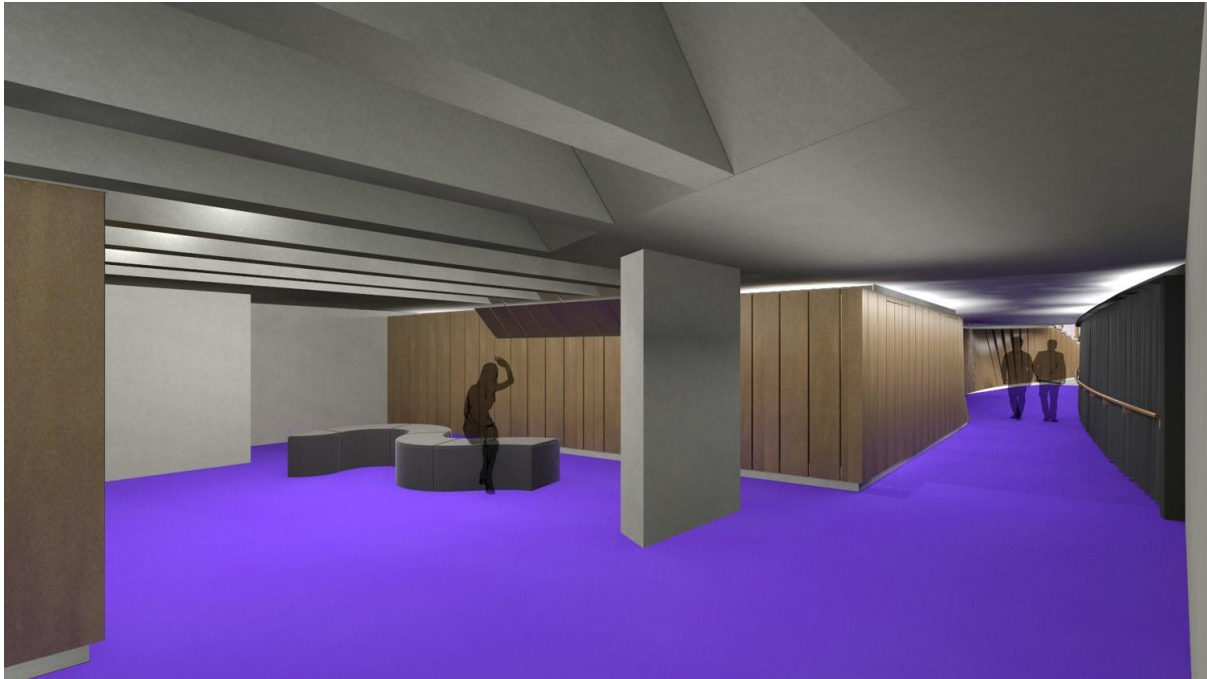
The proposed finish for the Caves is shown in the following render:

Similar to other locations in the Concert Hall, the wall panelling will finish short of the floor, leaving an off-form concrete finish recessed below the bronze panelling as the skirting detail. This can be seen in the above renders.

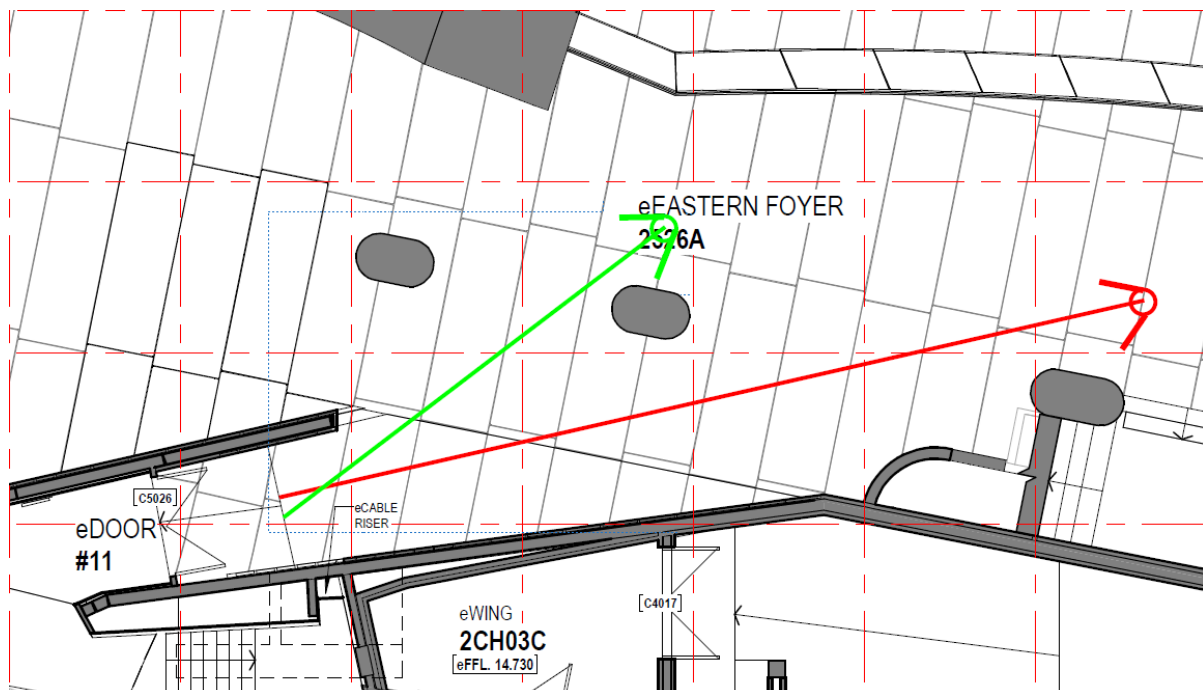
The following diagram shows the existing condition of the Eastern Foyer:

The red marked position is as one approaches from the Southern Foyer and first can see the entry doors into the foyer. The second is further into the side foyer and a more likely point to orient oneself. In both positions the stalls entry can be viewed.

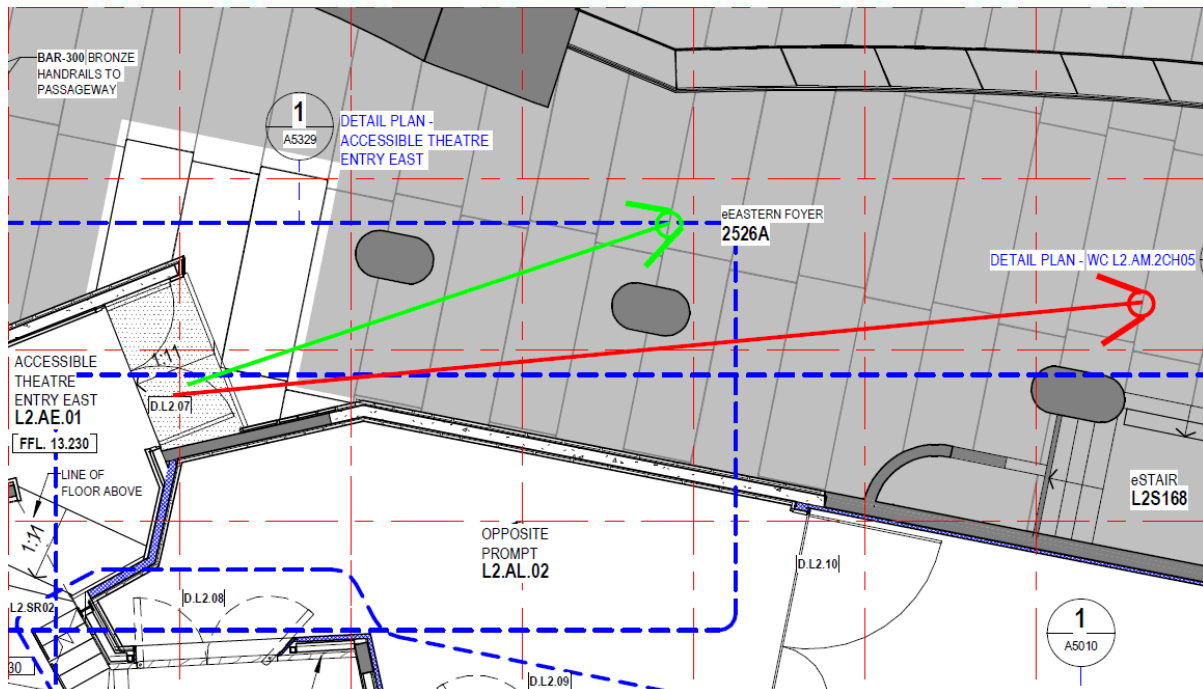
This diagram shows the relocated condition of the Eastern Foyer:

Again, in both positions the stalls entry can be viewed. In particular the relationship of the entry doors to the second (green) position is more immediate and will aid in the orientation of people looking to make their way into the Hall. Similarly, people who are making their way up to the Northern Foyer or northern doors into the Concert Hall are not impeded by this entry as the natural ant track to these spaces remains on the eastern side of the large columns and within the grand volume of the side foyer.
