# St George Private Hospital Expansion at 119 – 129 Princes Highway and 2 Hogben Street, Kogarah, and 1 South Street, Kogarah

## Groundwater Impact Assessment

**Report reference number: SYDGE381816AB**

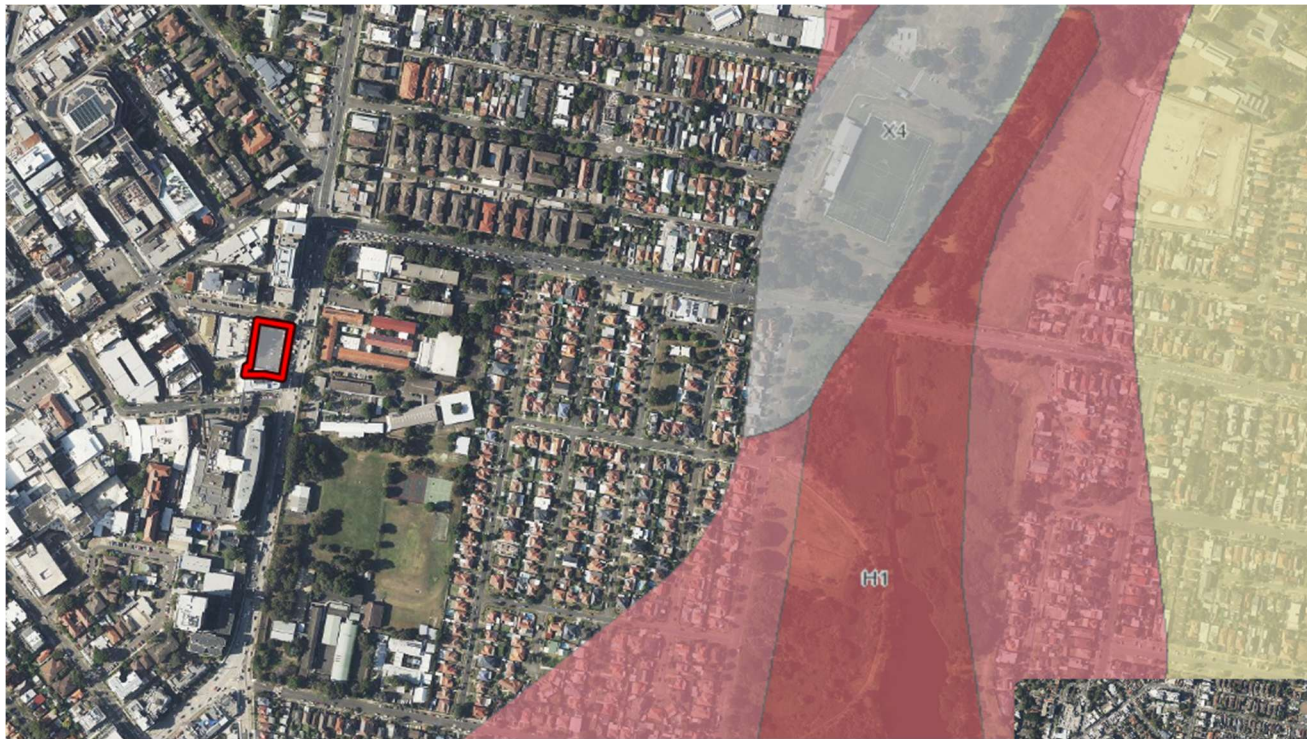
Figure F: SEED Acid Sulfate Hazard Map

The proposed development is not located within areas of acid sulfate soil risk according to the NSW Government SEED (Sharing and Enabling Environmental Data) database. The nearest known acid sulfate soils (Class H2) are located approximately 500m east of the site as shown in Figure F.
