**Catholic Education Office -
Diocese of Wollongong**

130, 132, 150, 160 and 170 Jardine Drive, Edmondson Park,
NSW

Remedial Action Plan

September 2016

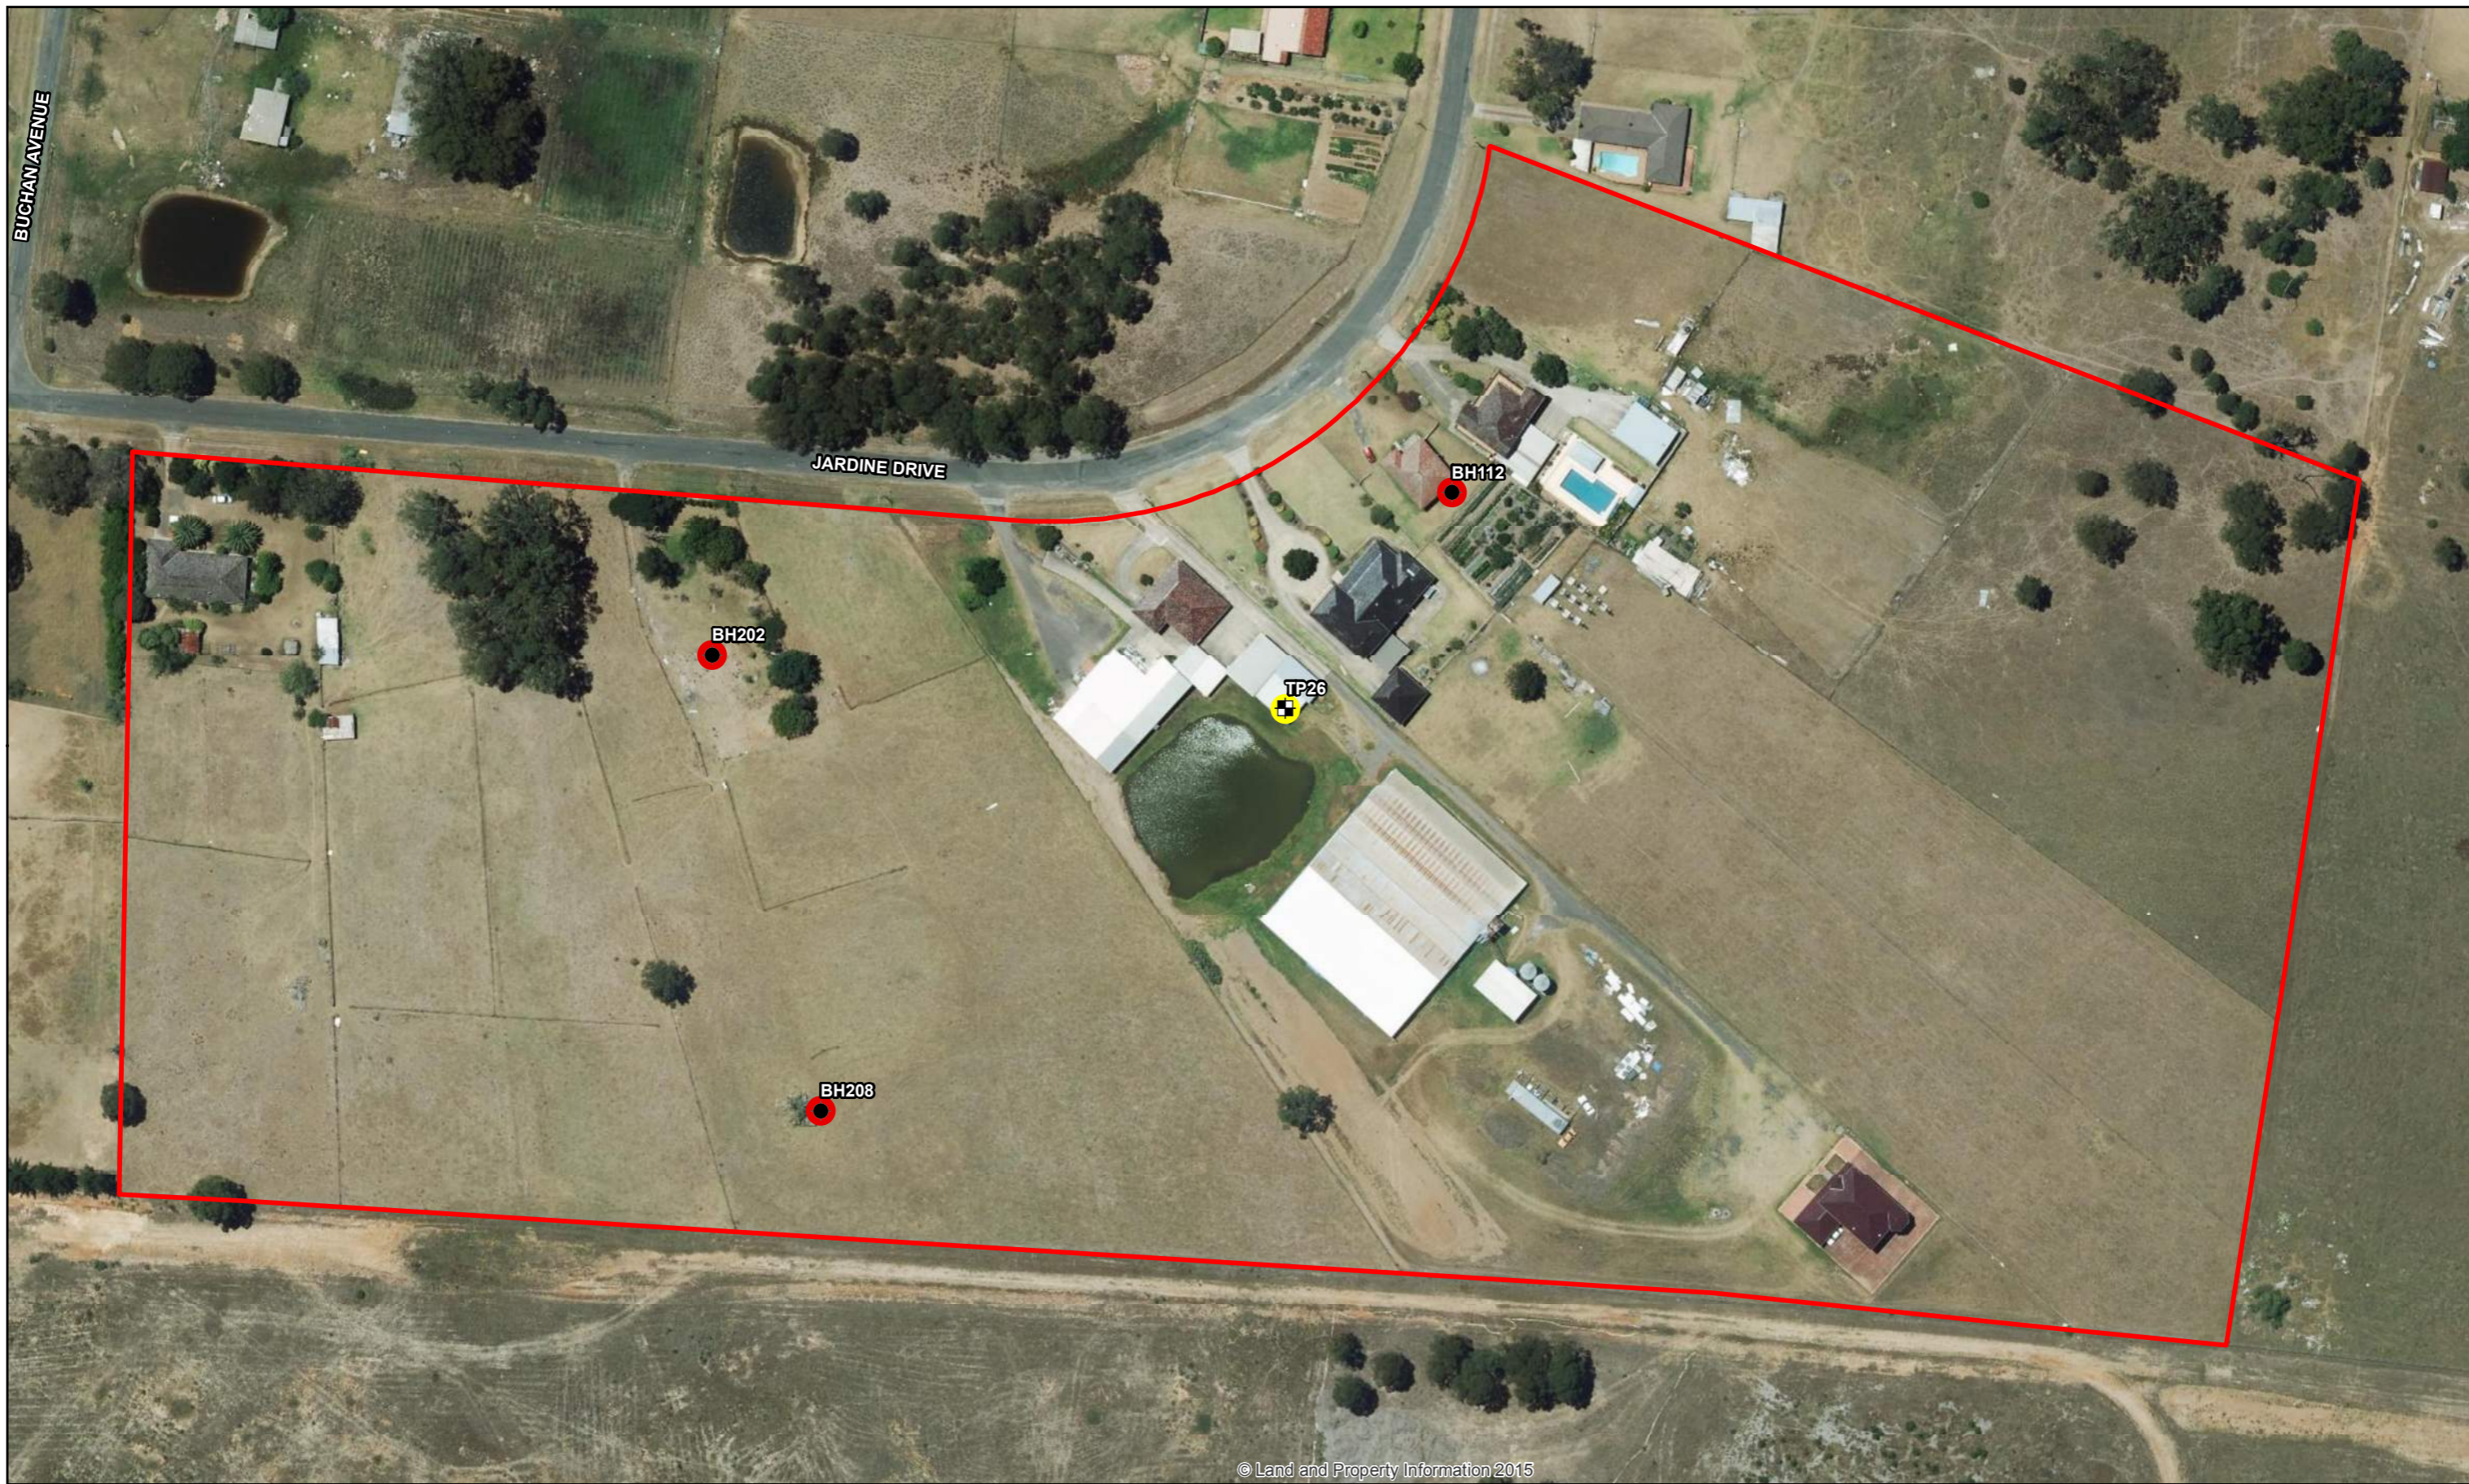
Figure 2 – Remediation Areas

The contamination status of the five lots covered by this RAP have been assessed within two Preliminary Site Investigation (PSI) reports (refer to section 3.1). According to information provided within the two PSI documents, there are several areas throughout the five lots that require remediation, as illustrated on **Figure 2, Appendix A**. These are as follows:
